# Earthworks, supporting track

Hector Kidds  
Principal Engineer  
Geotechnical, Drainage & Off-Track

Network Rail  
Southern Region

PWI 10 June 21

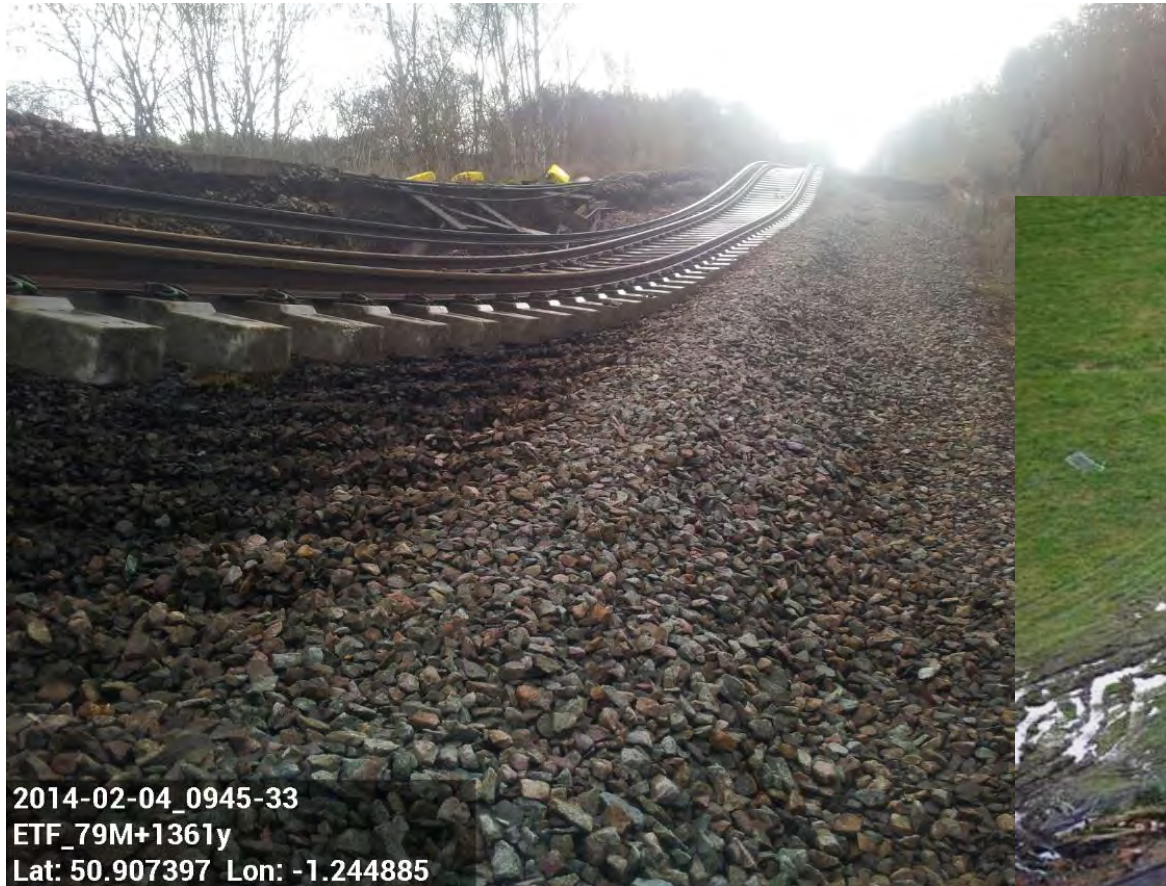
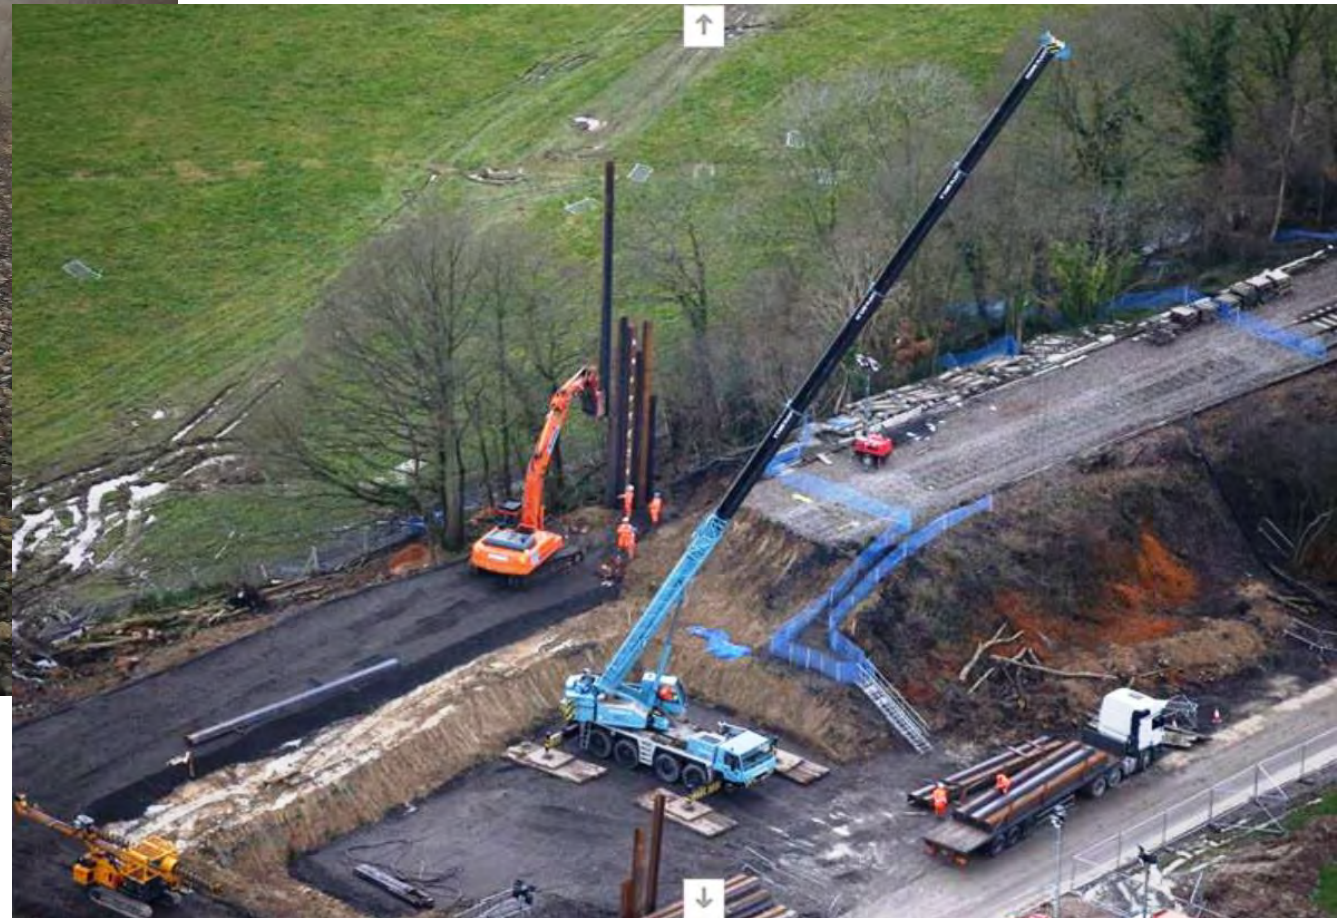
# Botley Embankment Feb 2014

| | Rapid Failure | Geotech Prior Knowledge | Pway Prior Knowledge | Track Recording | Detected by | Operational Restriction | Response |
|---|---|---|---|---|---|---|---|
| <b>Botley</b> | Yes | No | No | Yes | Rough Ride | Line closed | Reactive |

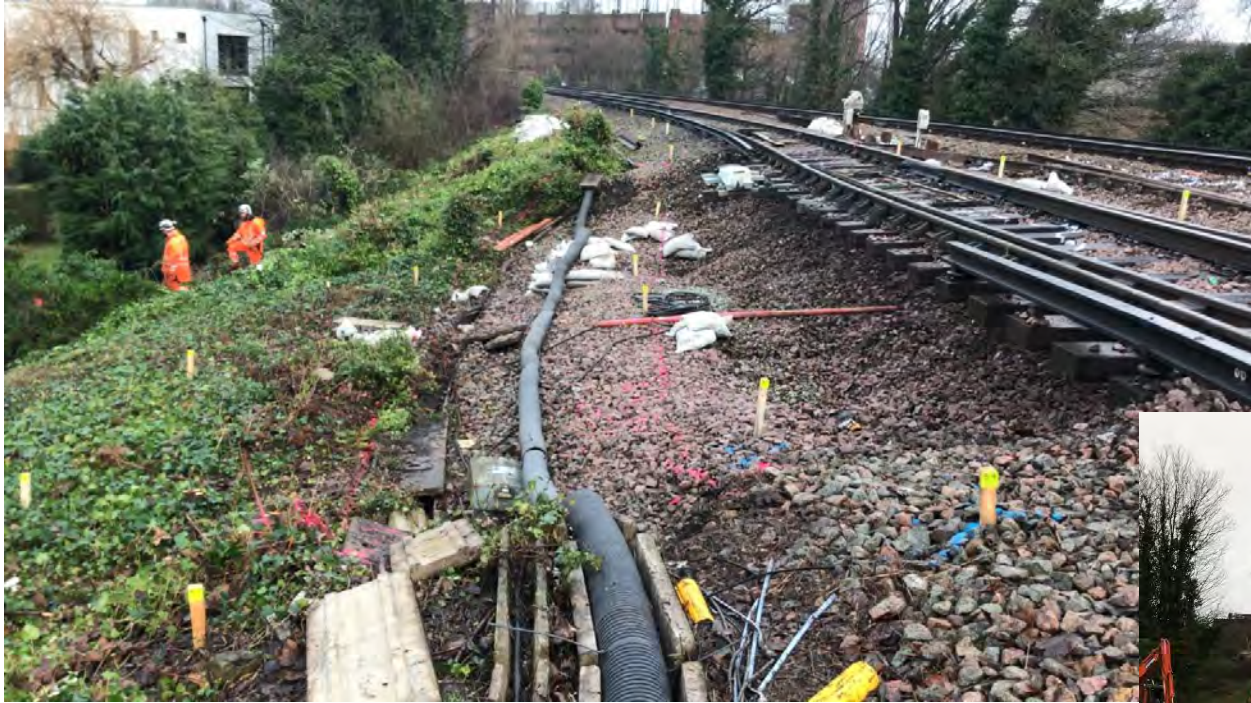
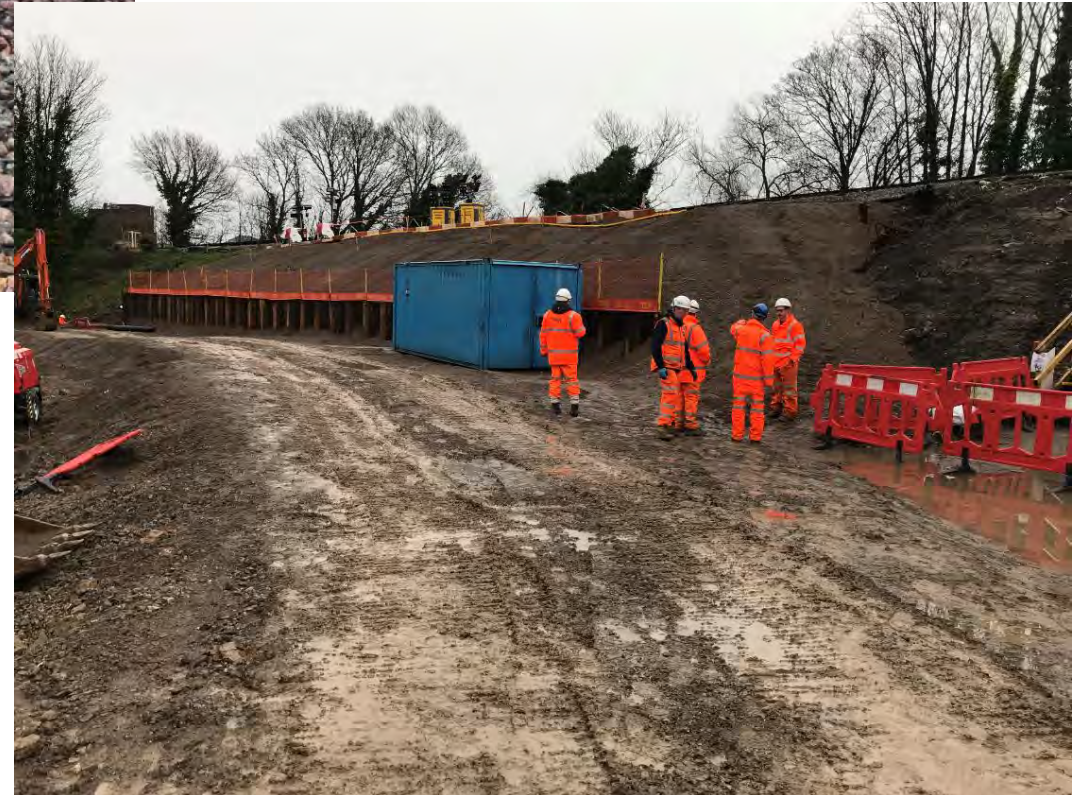
# Epsom Embankment Dec 2019

| | Rapid Failure | Geotech Prior Knowledge | Pway Prior Knowledge | Track Recording | Detected by | Operational Restriction | Response |
|---|---|---|---|---|---|---|---|
| <b>Epsom</b> | Yes | No | Yes | No | Points lost detection | Line Closed | Reactive |

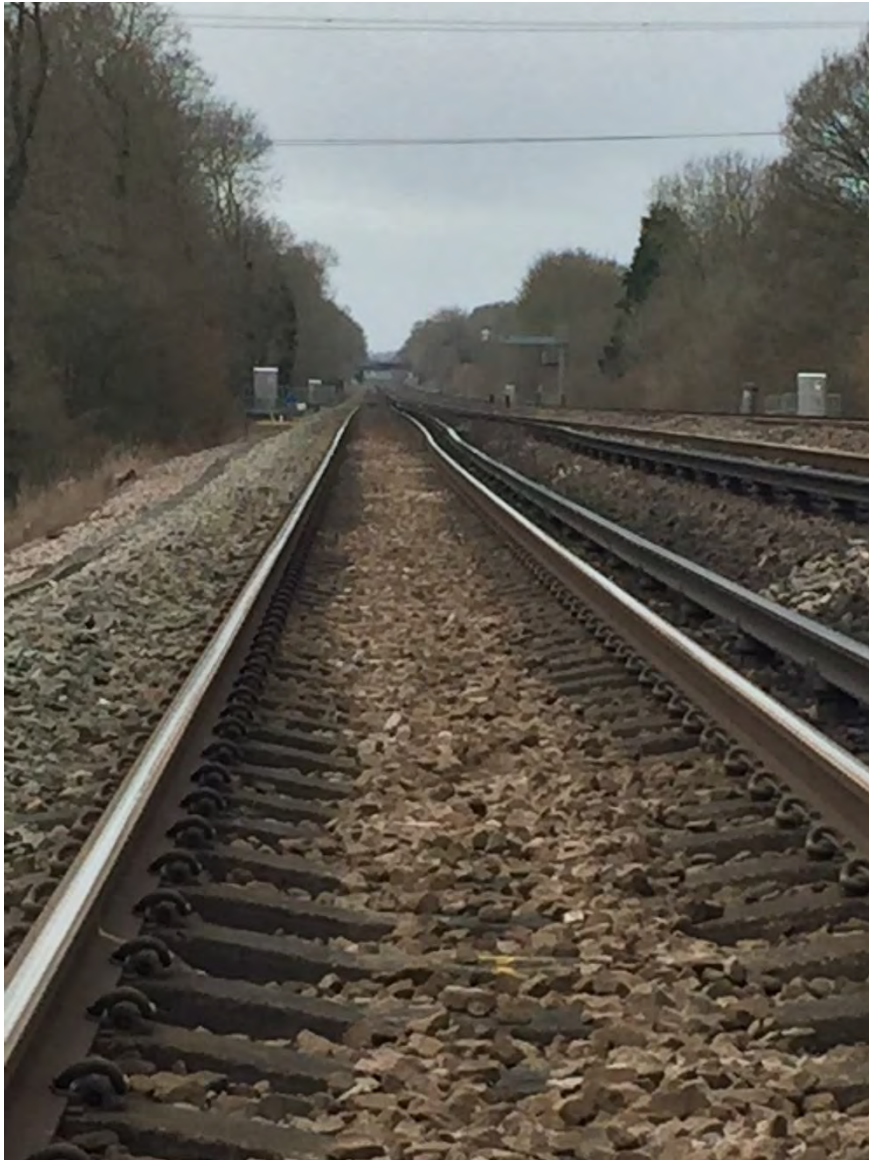
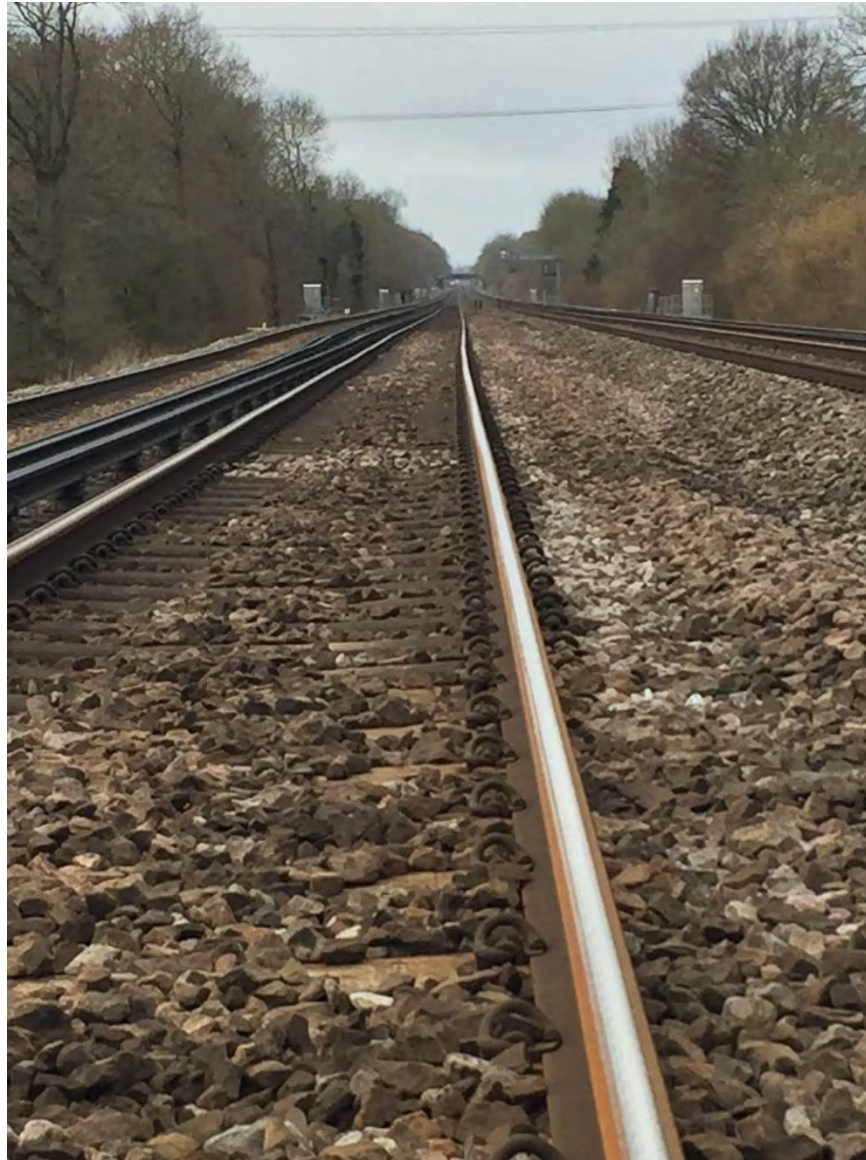
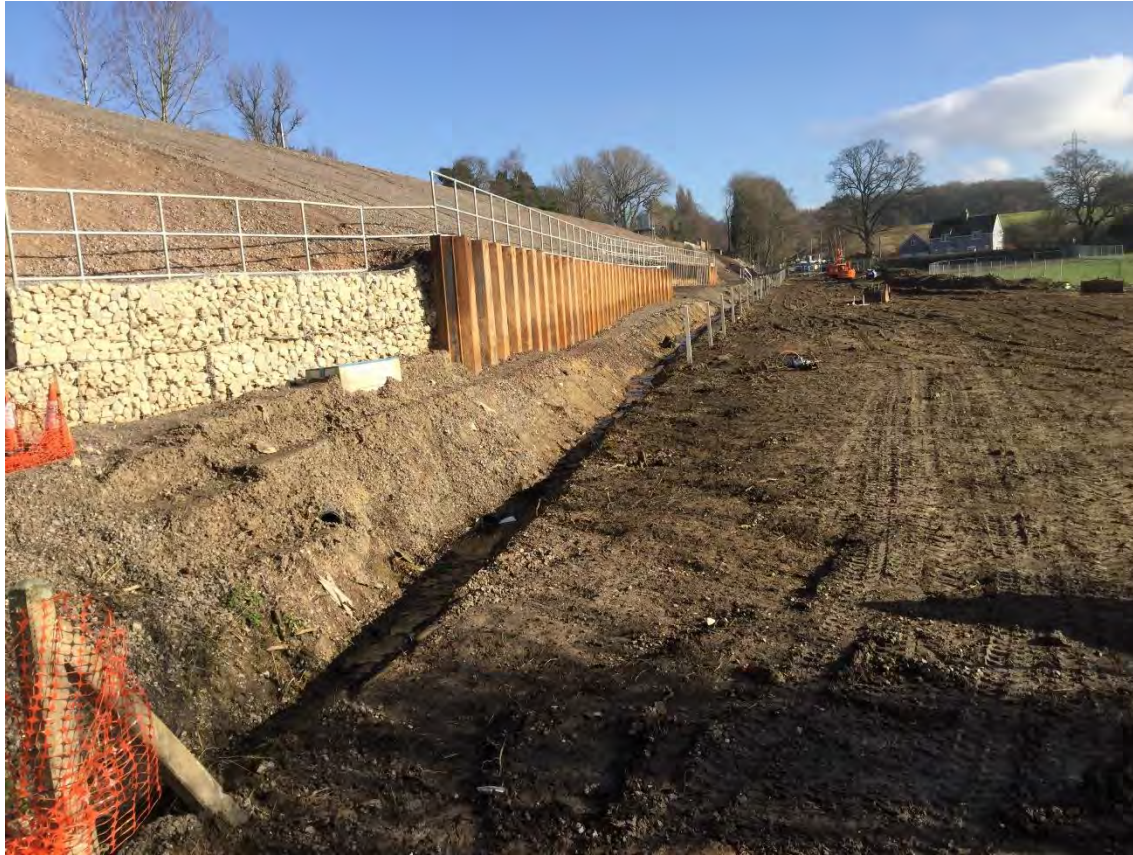
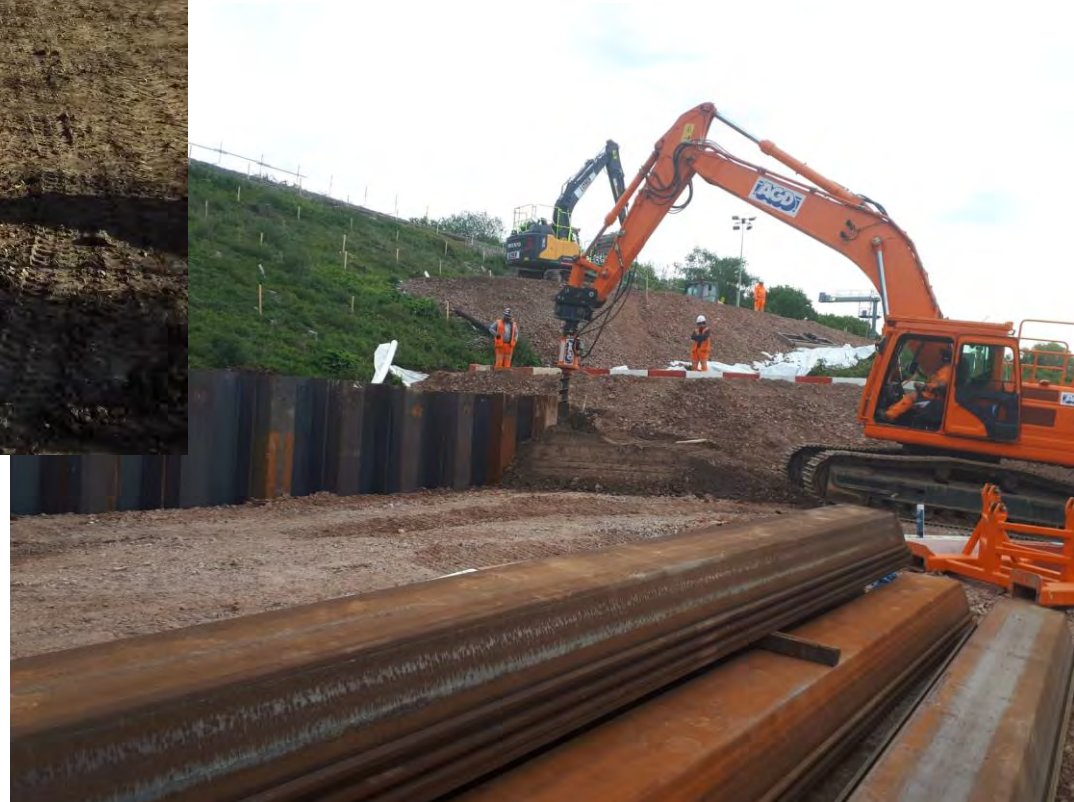
# Ashmead Embankment October 2019

| | Rapid Failure | Geotech Prior Knowledge | Pway Prior Knowledge | Track Recording | Detected by | Operational Restriction | Response |
|---|---|---|---|---|---|---|---|
| <b>Ashmead</b> | No | Yes | Yes | Yes | TQ/Rough Ride | Speed Restriction/Line Closed | Planned/Accelerated/Reactive |

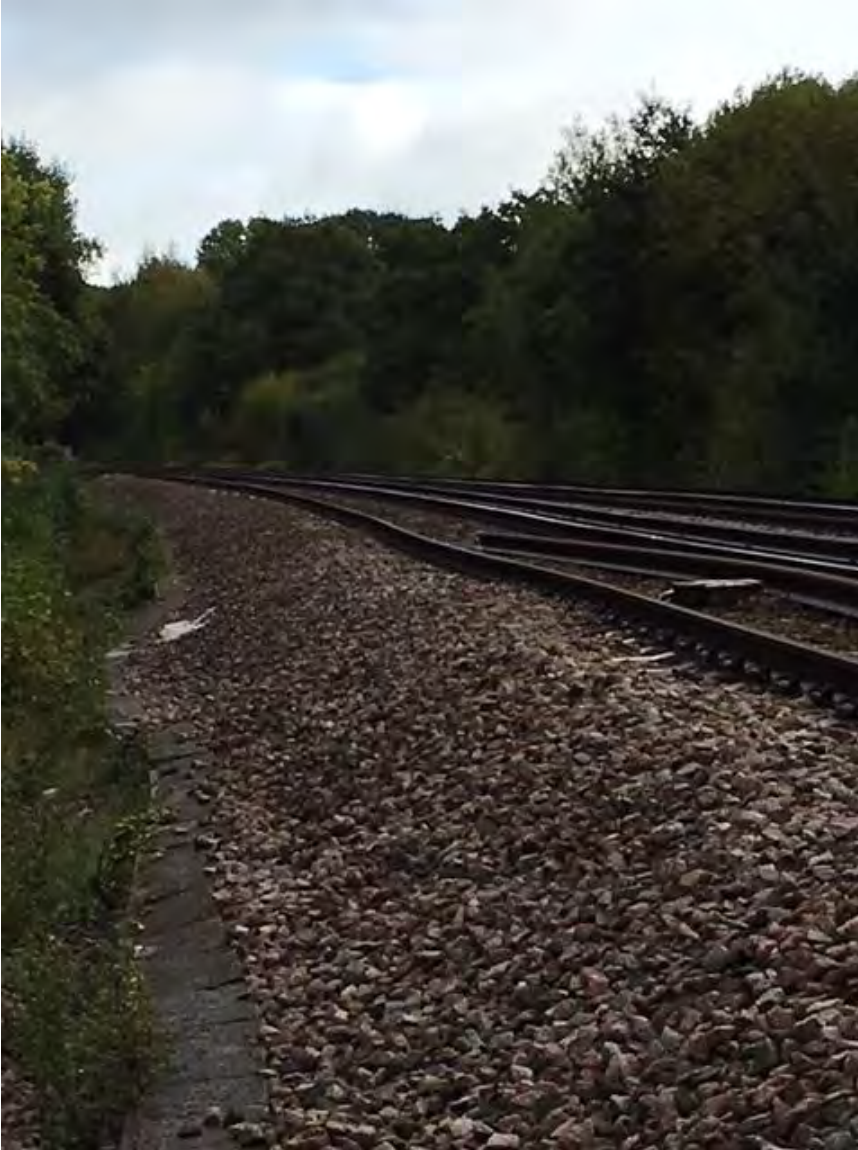
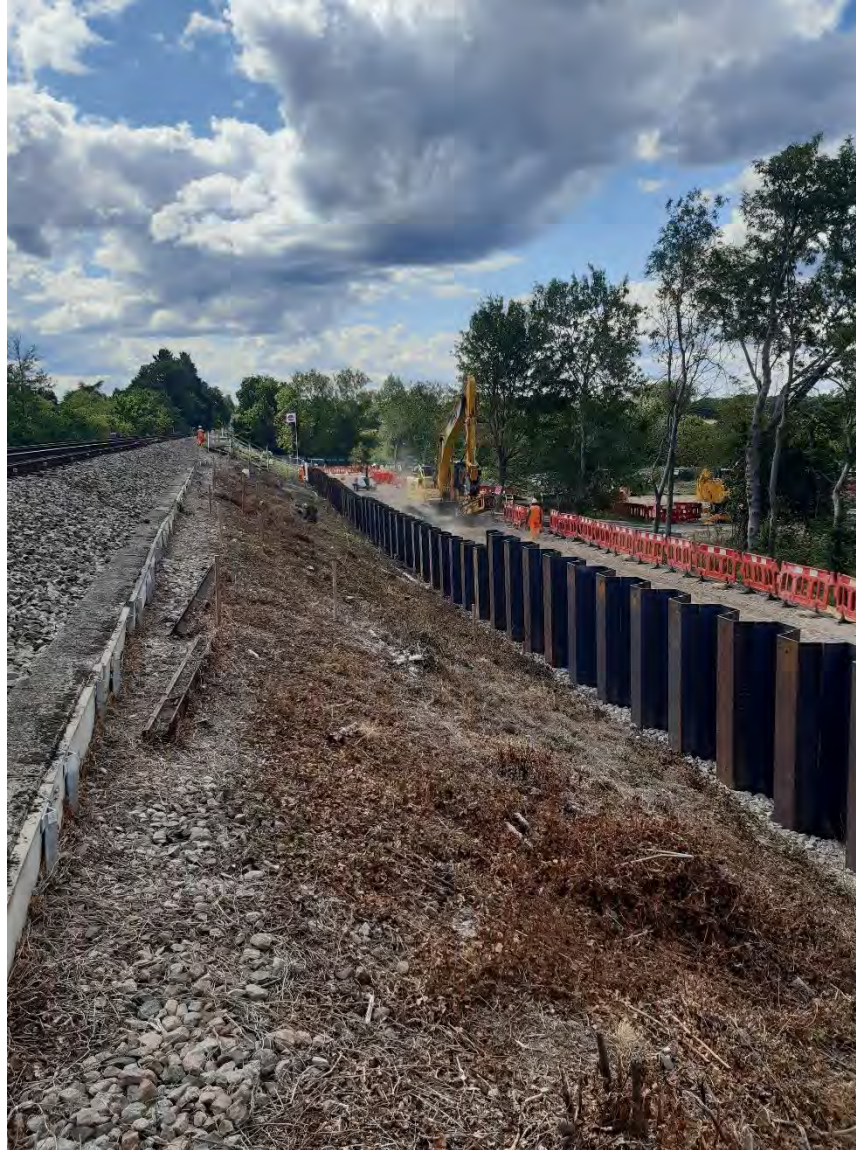
# The Street Embankment Oct 2019

| | Rapid Failure | Geotech Prior Knowledge | Pway Prior Knowledge | Track Recording | Detected by | Operational Restriction | Response |
|---|---|---|---|---|---|---|---|
| <b>The Street</b> | No | Yes | Yes | Yes | TQ/Rough Ride | Speed Restriction | Accelerated |

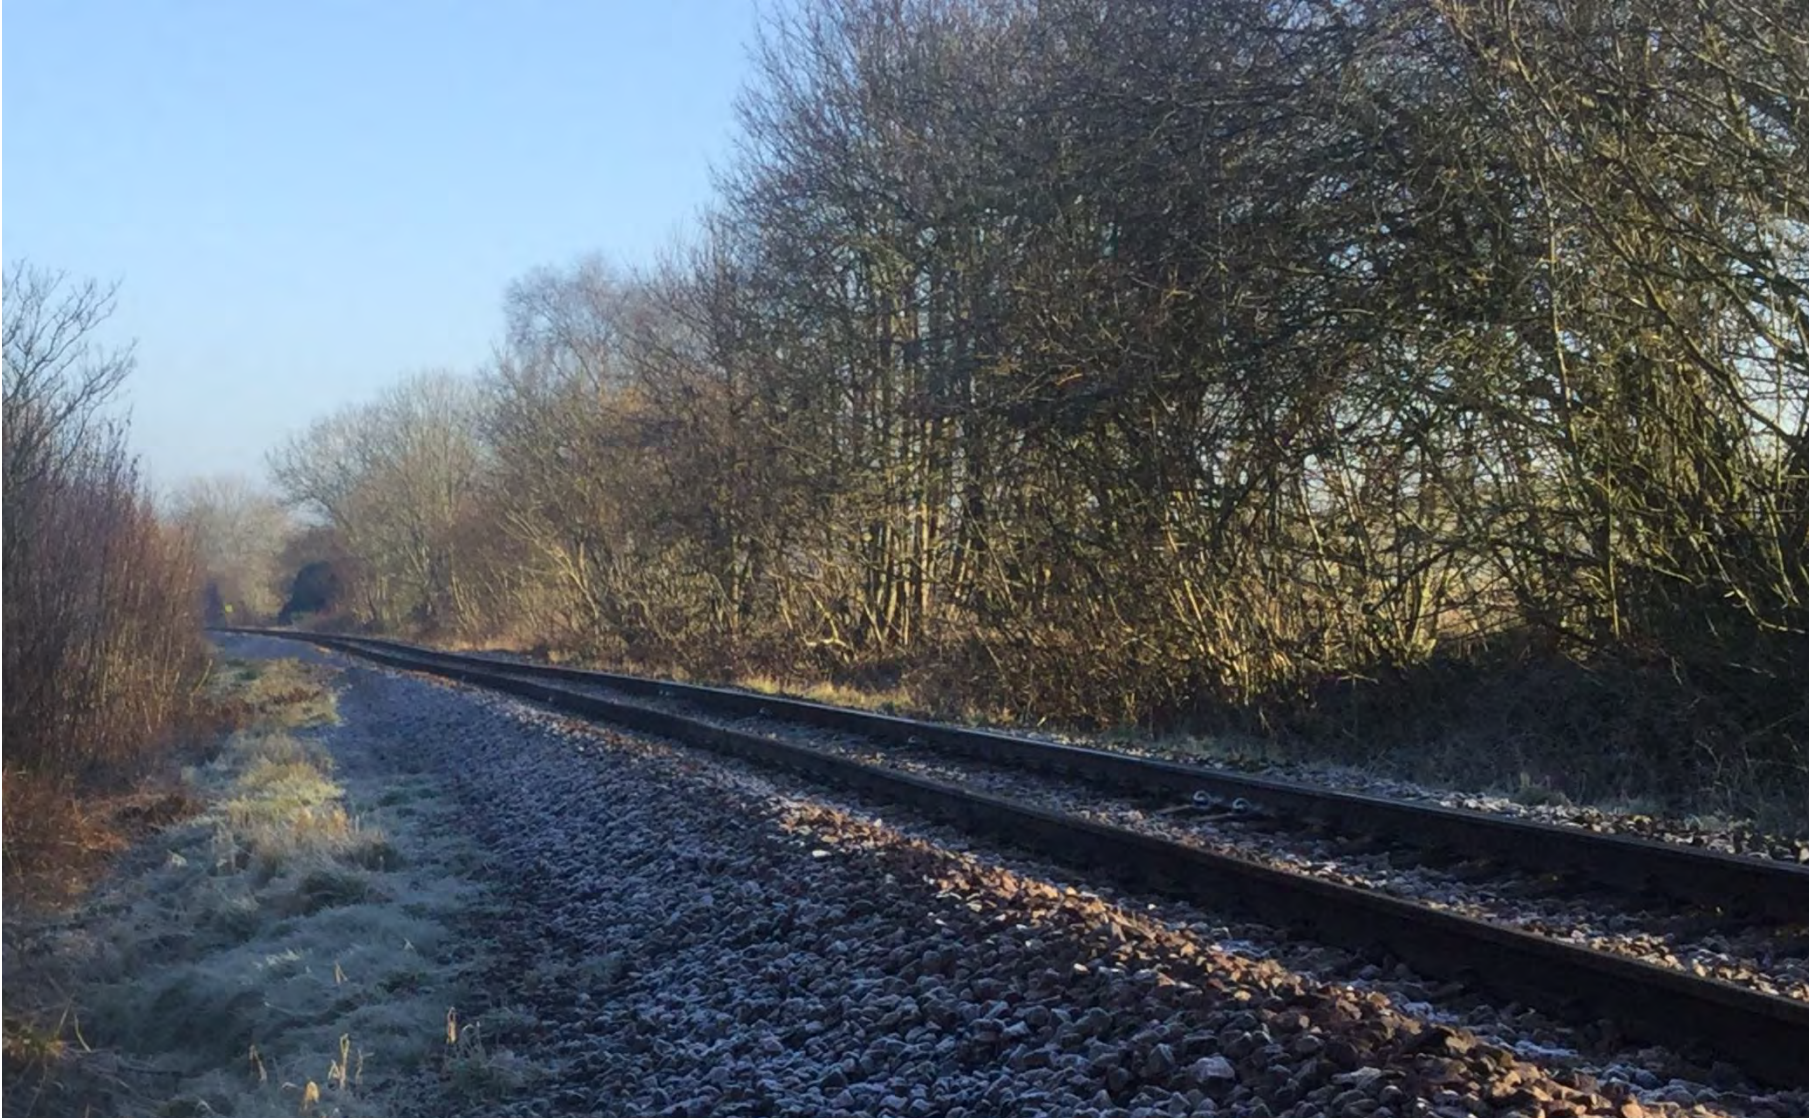
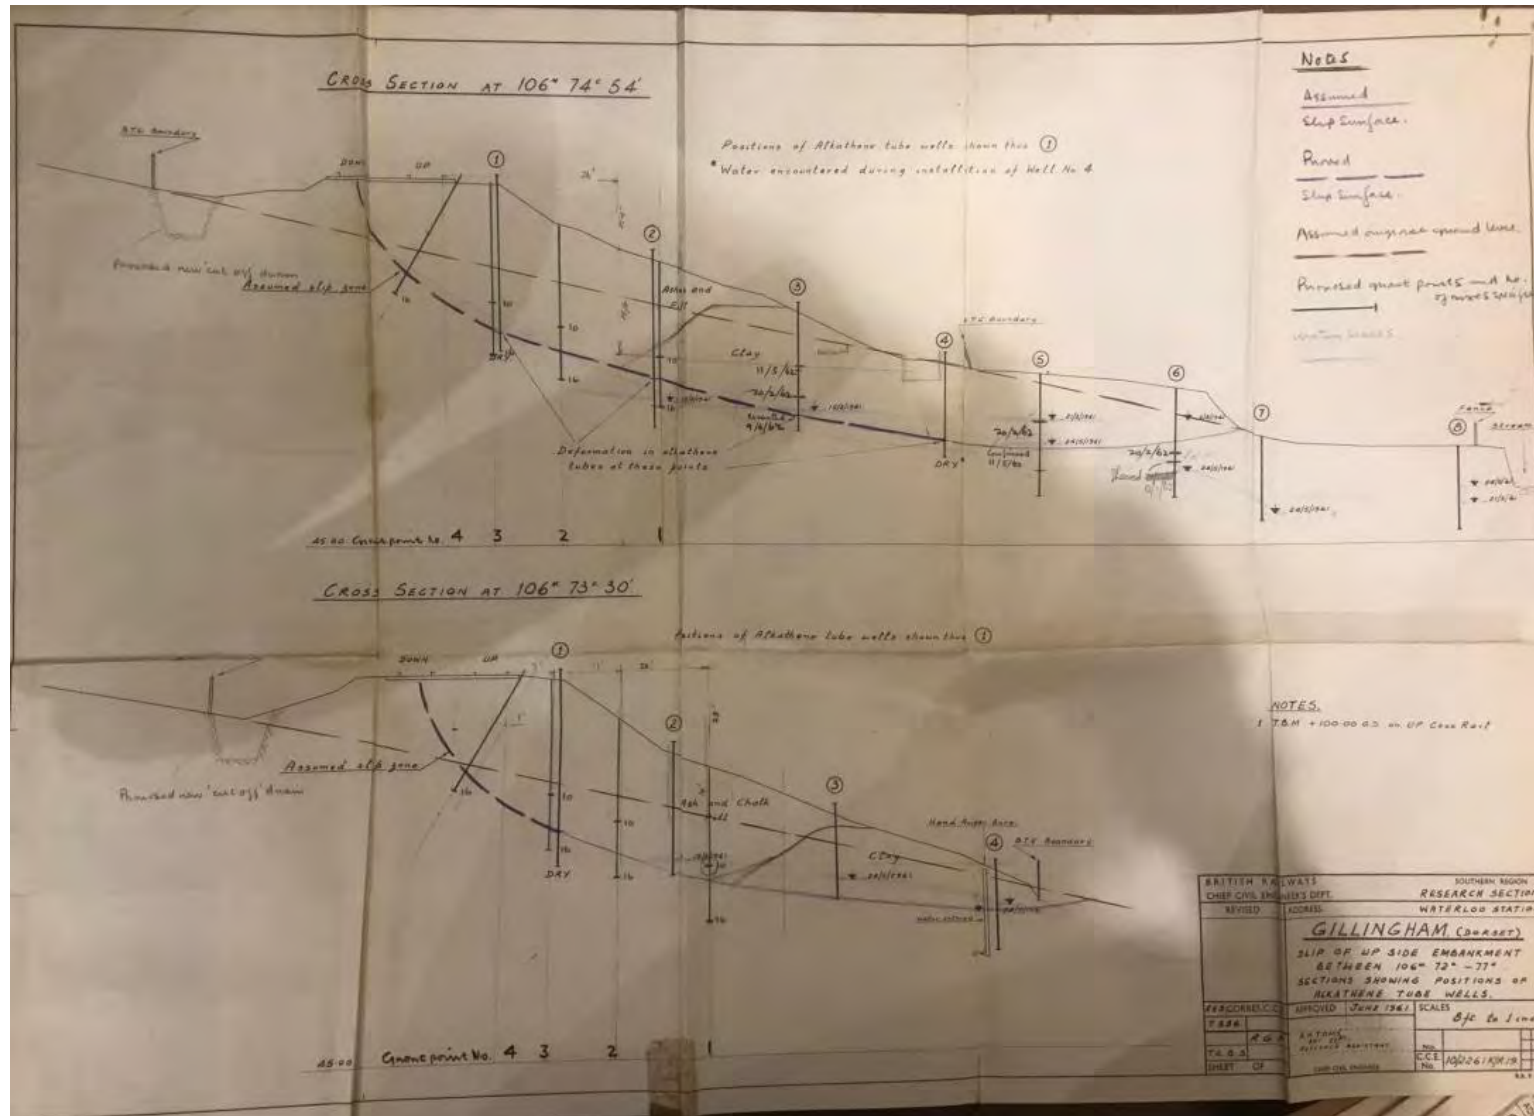
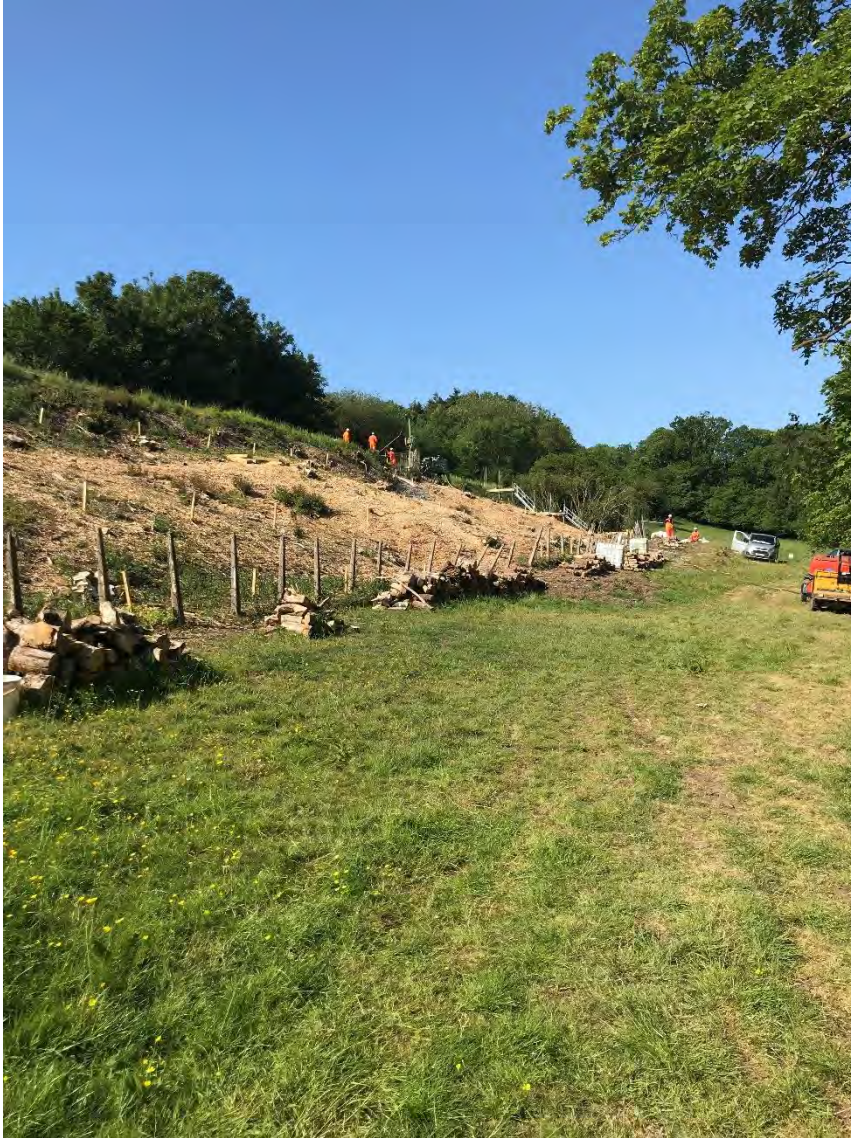
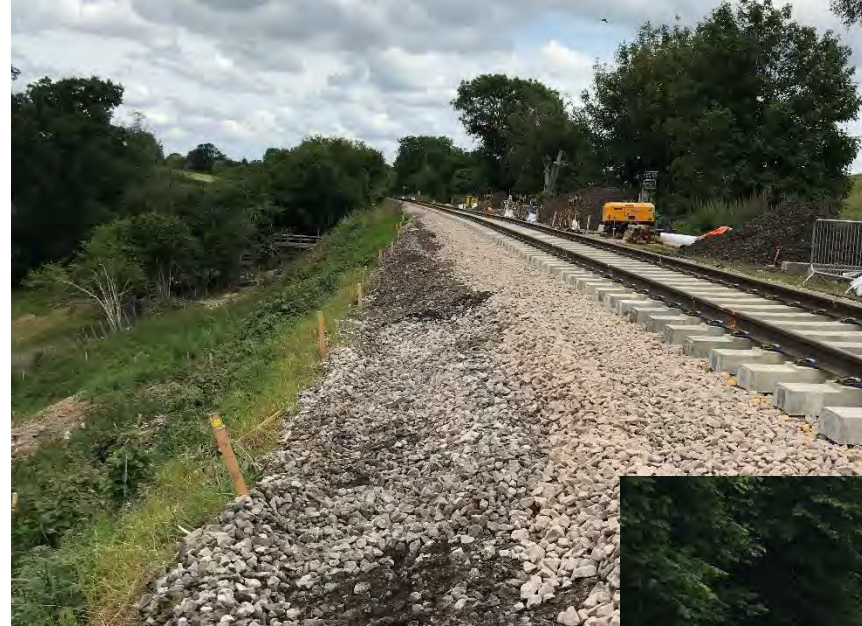
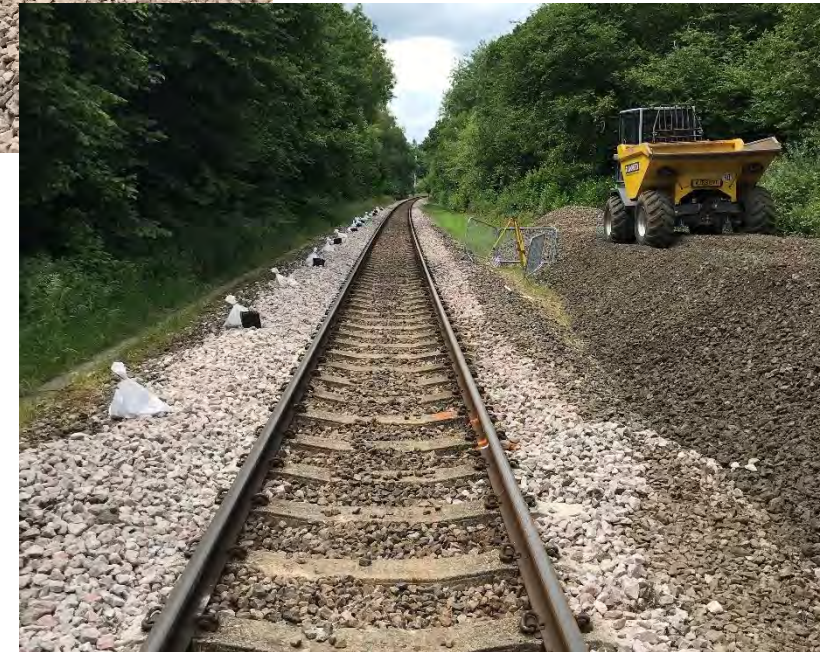
## Bugley Bridge Embankment Mar 2020

| | Rapid Failure | Geotech Prior Knowledge | Pway Prior Knowledge | Track Recording | Detected by | Operational Restriction | Response |
|---|---|---|---|---|---|---|---|
| <b>Bugley Bridge</b> | No | Yes | Yes | Yes | TQ/Rough Ride | Speed Restriction | Active Management |

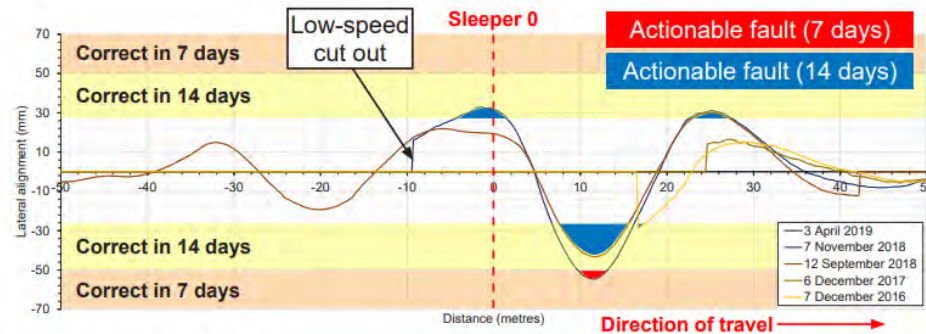
Figure 8: Lateral track alignment recorded on various track geometry measurement train runs prior to the derailment. Locations where low-speed cut out resulted in data loss are highlighted. On 3 April 2019 no lateral track geometry measurement data was recorded in the vicinity of the designated point of derailment, identified as 'Sleeper 0'.

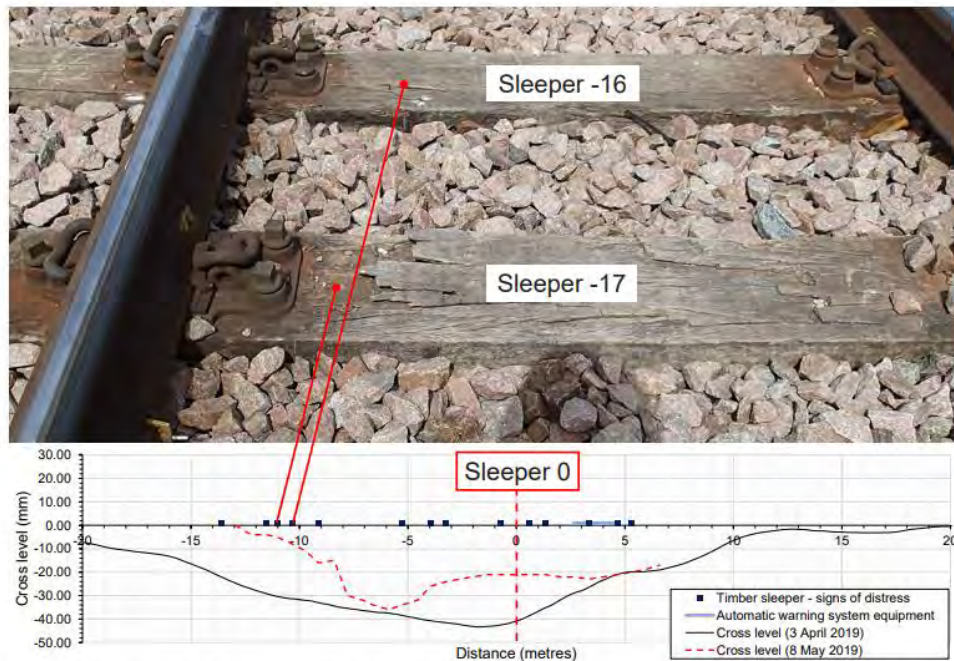
Figure 13: Location of distressed sleepers and automatic warning system equipment close to 0 miles 27 chains compared to cross-level profiles measured on 3 April 2019 and 8 May 2019

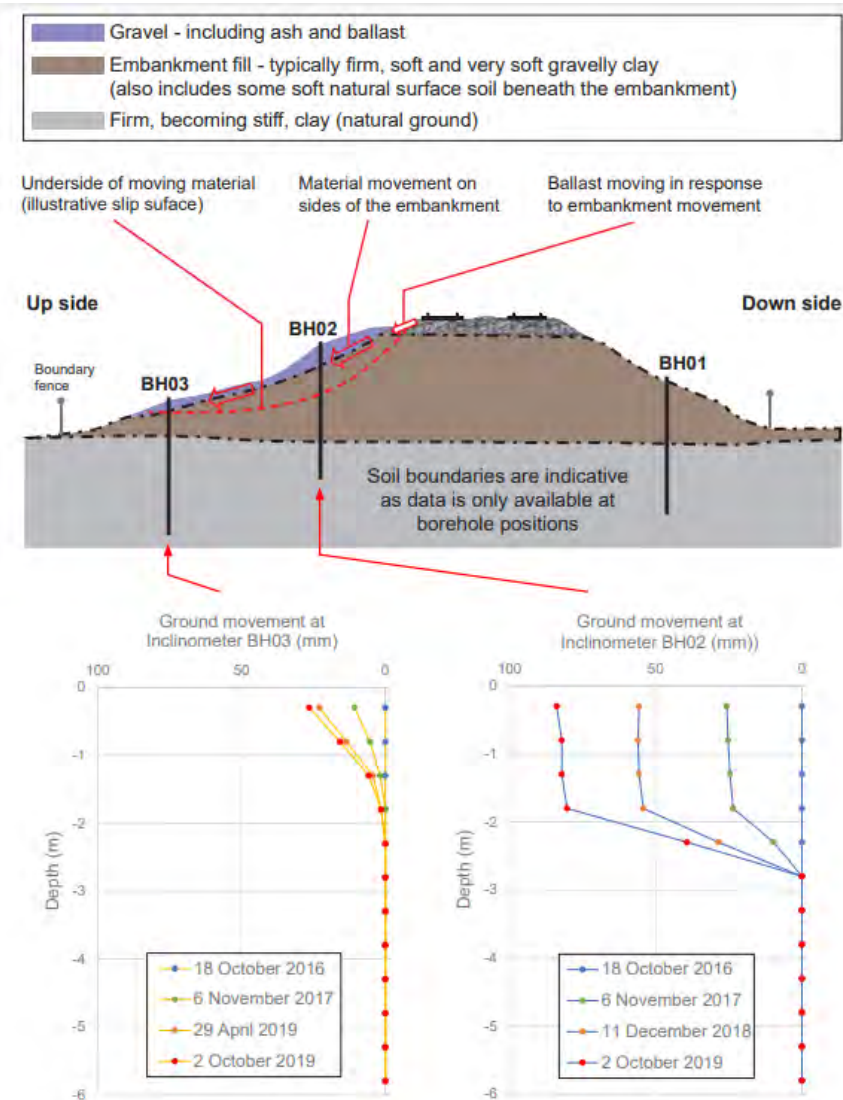
Figure 14: Cross-section of Mitre Bridge Curve embankment showing illustrative slip surface and simplified ground movement. Graphs show how the lateral movement measured at inclinometers BH02 and BH03 varied with borehole depth.

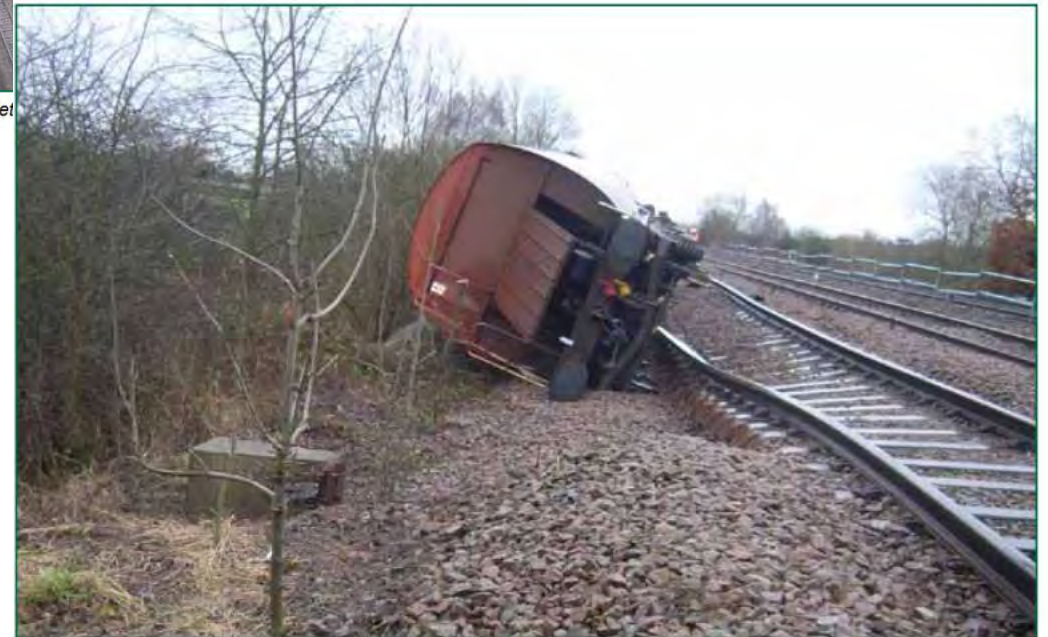
Figure 7: The rearmost wagon and loss of support under the cess rail of the Up Slow line

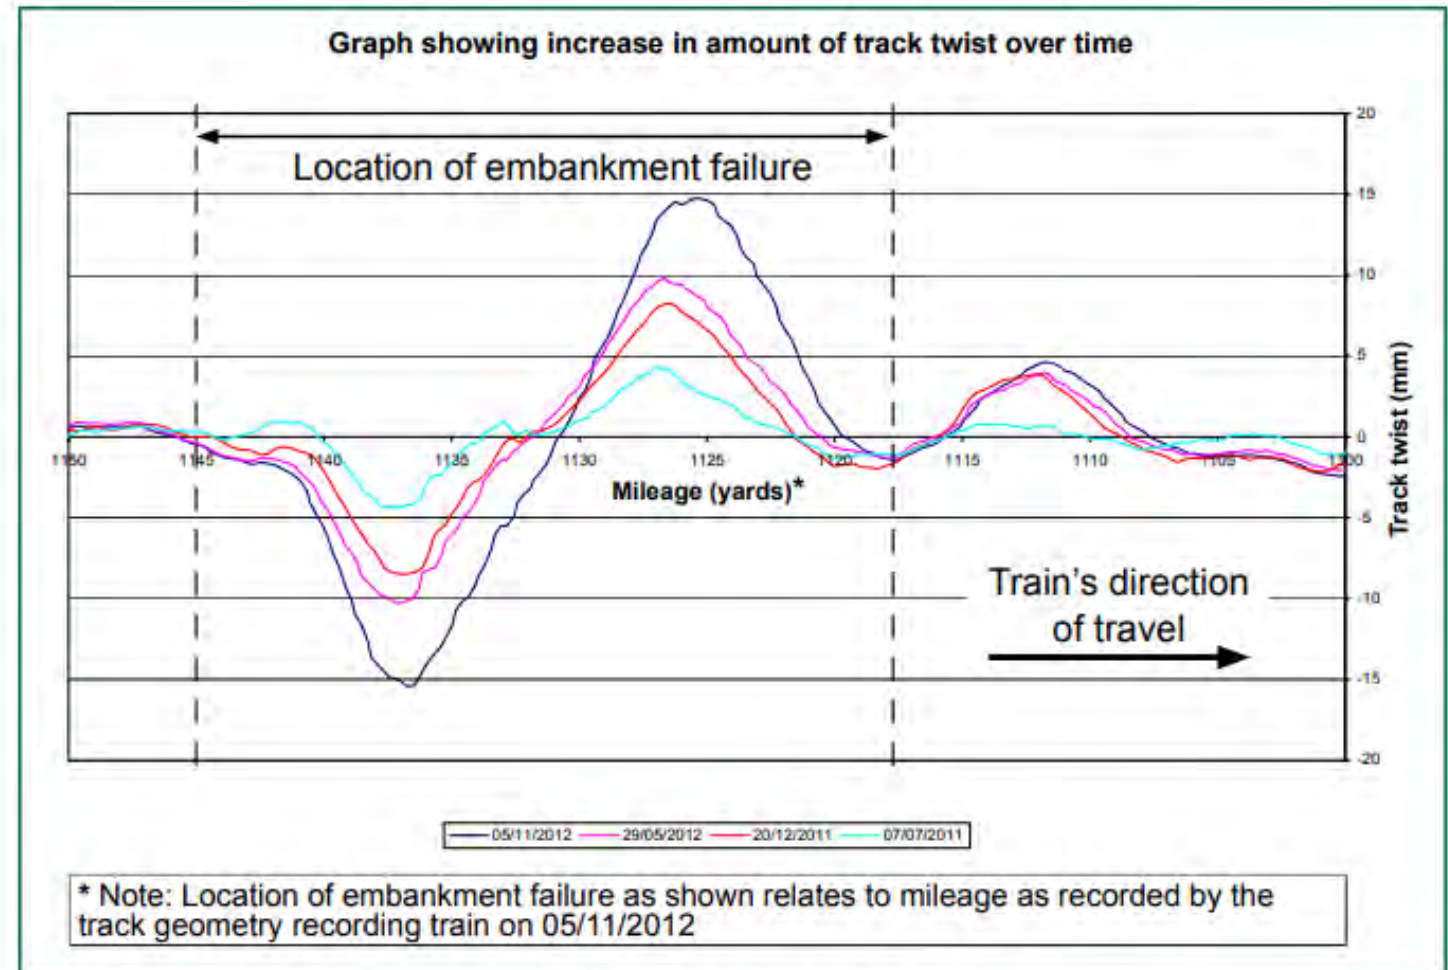
Figure 15: Track twist at the point where the embankment failed
