# Gipsy Patch Lane

PWI Briefing

2<sup>nd</sup> December 2021

**Gypsy Patch  
Bridge**

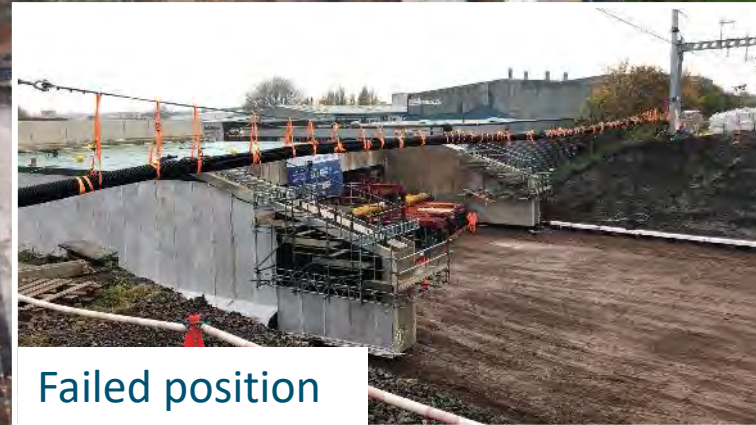
Failed position

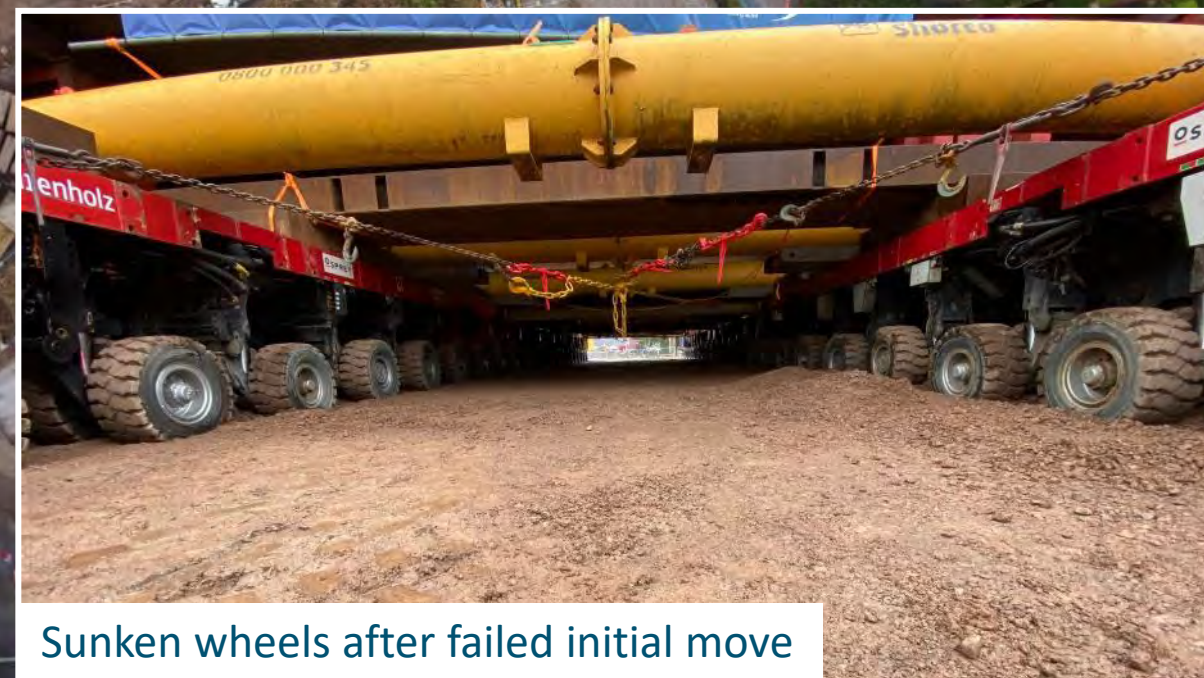
Sunken wheels after failed initial move

- The key failure point was the wheels of the SPMT sinking into the roadway and the bridge becoming stuck midway through its transit. The location in which it became stuck added further complication due to the constraints of surrounding infrastructure and services.

- The SPMT roadway was not constructed to specification to mitigate surface water risk. This is the root cause of the failure and consequential overrun. This can be attributed to the fact that holistic risk reviews weren't regularly / robustly undertaken. **Furthermore, there was no single driving mind for the risks in design and construction. This all comes down to the discharging of CDM duties from the Principal Designer.**

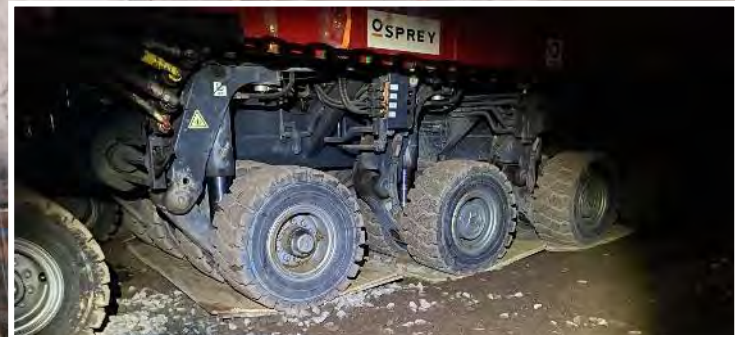
Re-packed 6N and plywood sheets

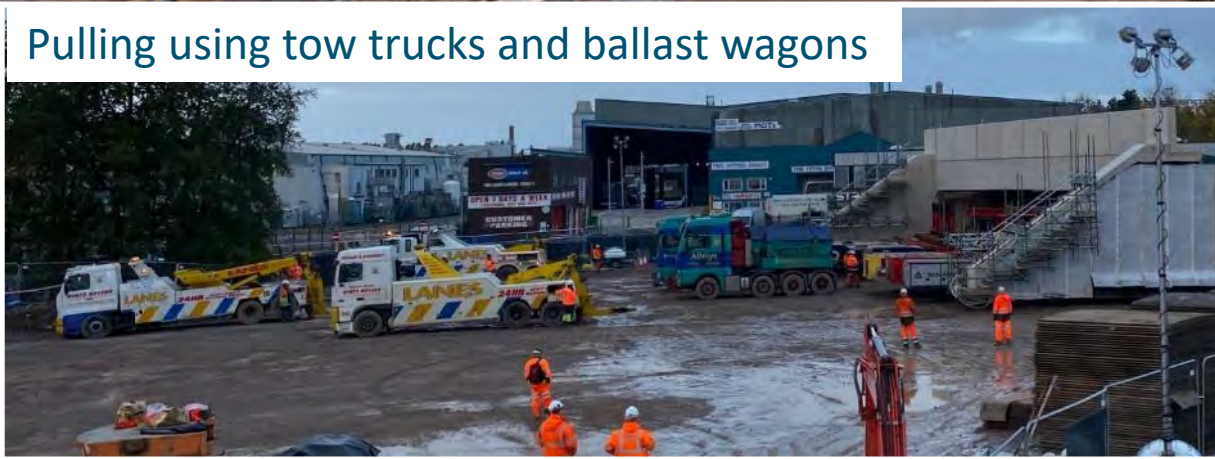
Pulling using tow trucks and ballast wagons

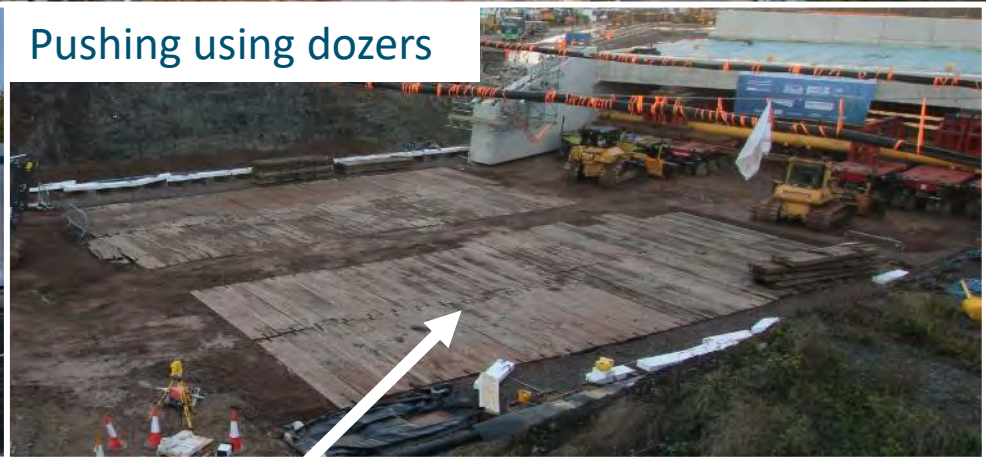
Pushing using dozers

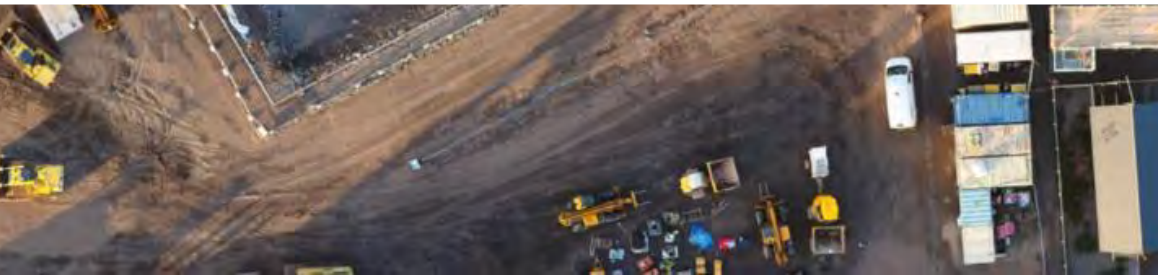
N.B. landing area excavated  
and ekki mats installed  
ahead of attempted move

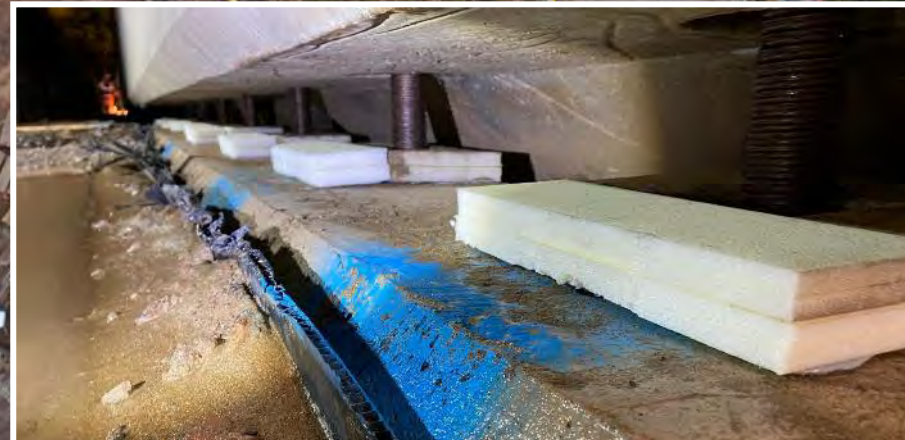
SMPT adjustment required to get the MacAlloy bars to fit into all the screw threads in the pile cap.

MacAlloy Bar Installation (55/56 achieved)

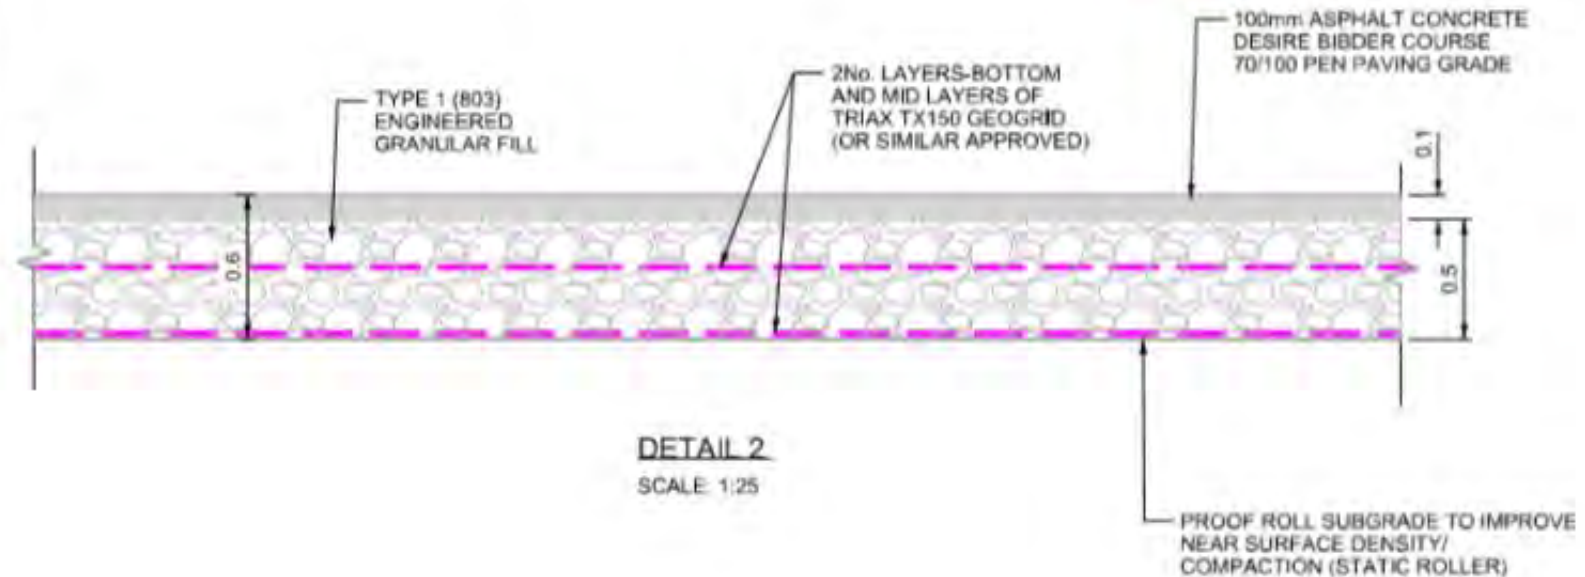
No asphalt or trackway was installed for any of the SPMT roadway for construction pre blockade(s) or during the original construction (pre initial move).

Also insufficient surface water management in place

- **The Principal Contractor made a commercial decision not to build the roadway fully to the temporary works design.** This removed building an asphalt or aluminium trackway where dry steering was to be done. **This was not formally accepted by the designer and nor were Network Rail consulted in this decision being made.**

- SPMTs can travel on a well compacted granular surface. However, had the roadway been surfaced with an asphalt or aluminium track this would have mitigated the failure.

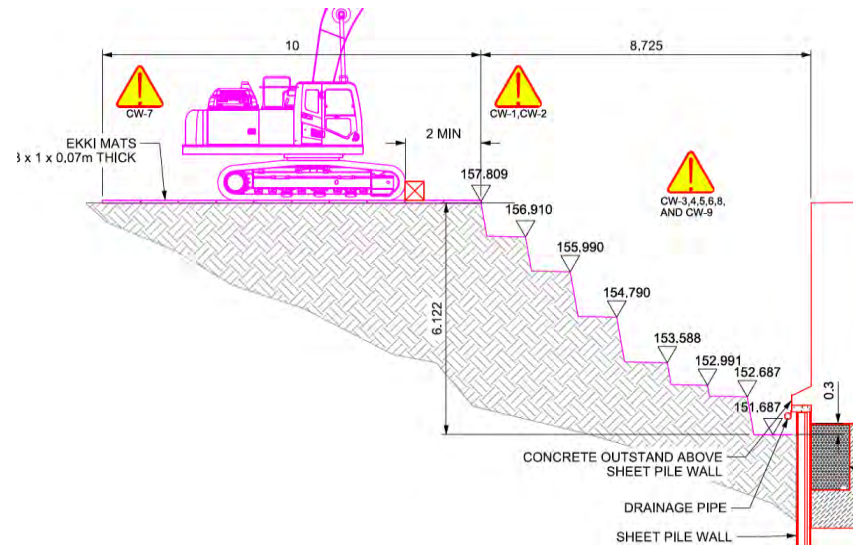
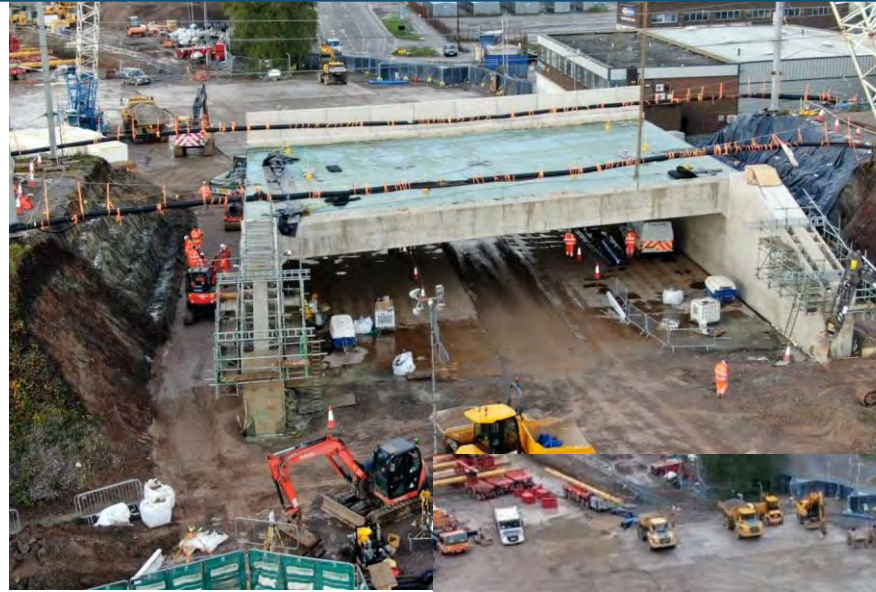
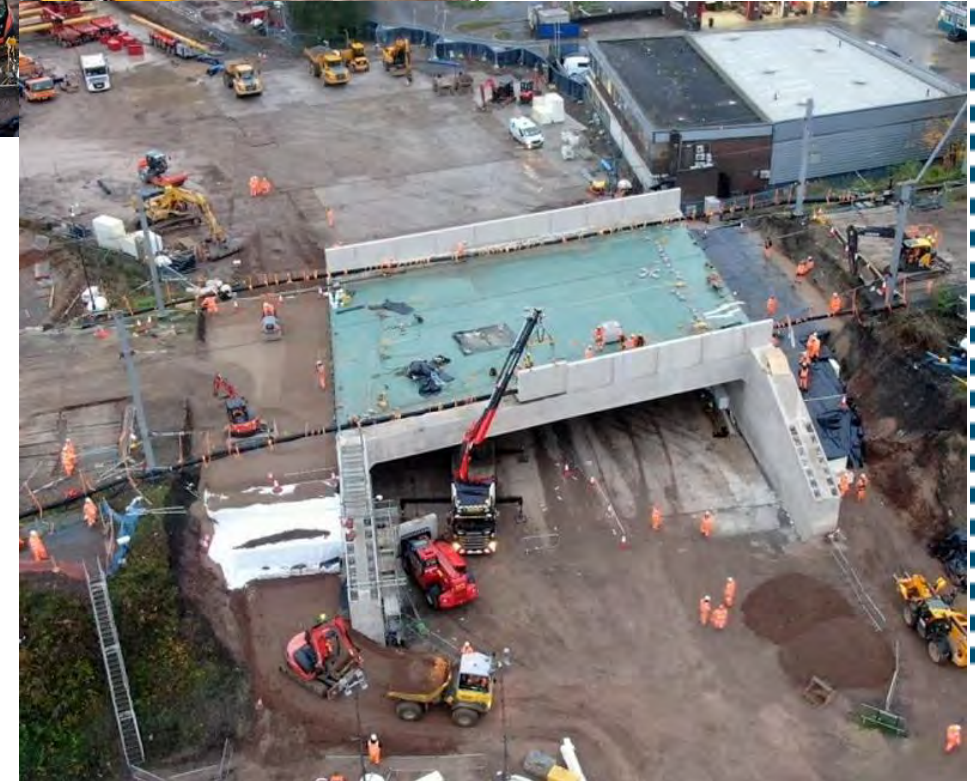
1. Steps were cut in the embankment face to match the EPS block layout.
2. The blocks were not individually wrapped because of programme time constraints for the originally planned blockade.
3. Where we had some fit problems with a step we trimmed the EPS and/or used semi dry concrete.

- Other activities undertaken during the railway closure were not completed in the planned durations. One example of this was the backfilling of the embankment using polystyrene blocks. The contractor's timings were not interrogated sufficiently by Network Rail's project team.

EPS blocks should be ideally wrapped prior to any blockade where possible and spare wrapping/jointing capability available if the seal is broken during installation. Noting this has to be typically in dry conditions.
