# Wide Gauge Derailment Risk

TME Conference

Chris Fuller / Rich Gibson / Andrew Turner

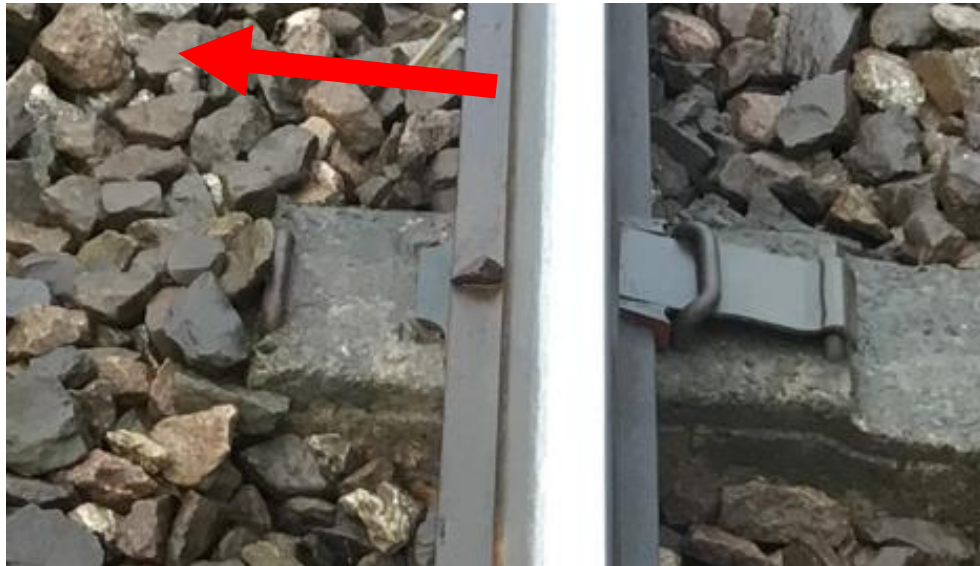
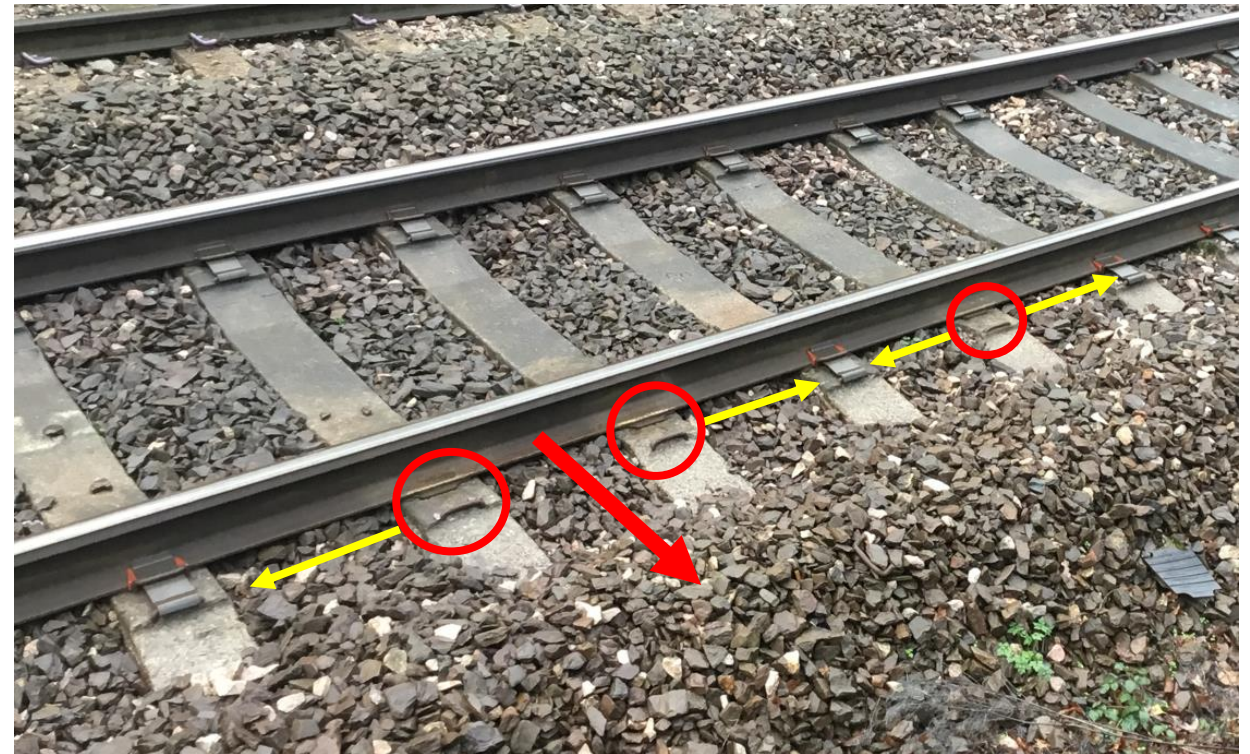
# F19 SHC Sleepers – Gauge Spread Failure Mechanism

- Hoop fails and detaches from sleeper
- Increases forces on adjacent sleeper hoops
- Adjacent sleeper hoops subsequently fail
- Increases forces on their adjacent sleeper hoops
- Rail ‘unzips’ causing gauge spread
- Wide gauge derailment risk

Nothing to prevent rail movement

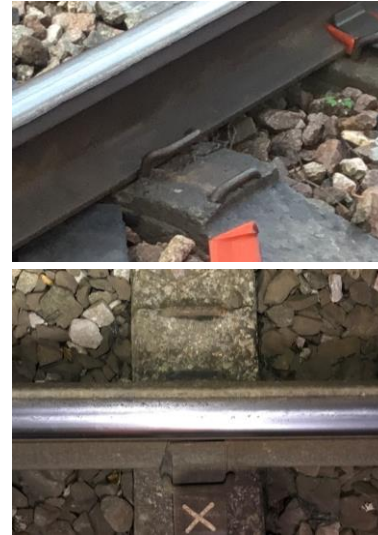
Can identify missing clips / broken hoops with missing clips

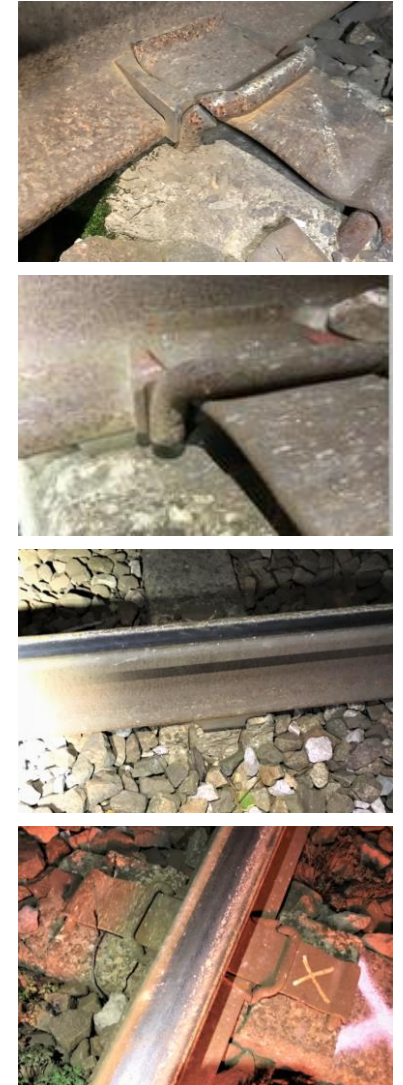
Can't identify broken hoops with clips and hoops still in place / broken off sleeper ends or defects with heavy ballast / broken or cracked sleepers with clips in-situ

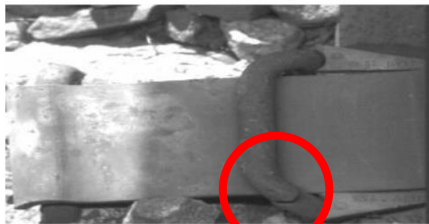
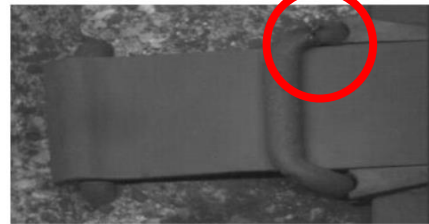
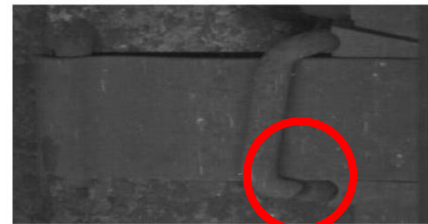
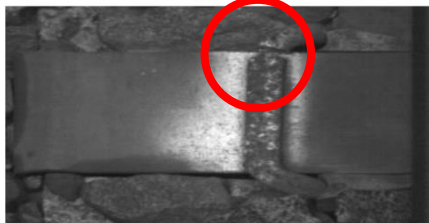
- Some examples of SHCs with a 'Defective Housing' defect class from the trial that were not identified are shown in the images below

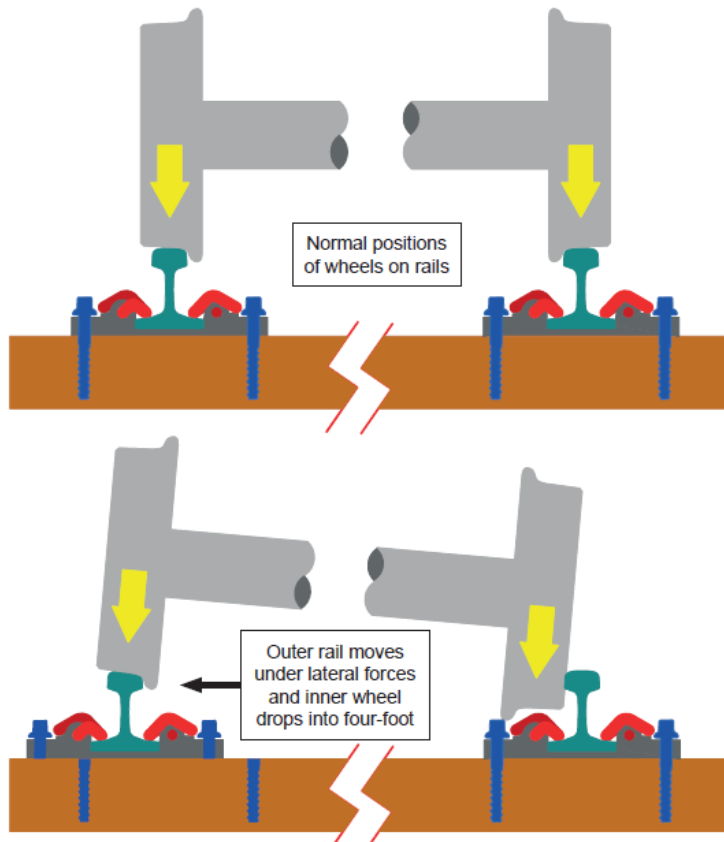
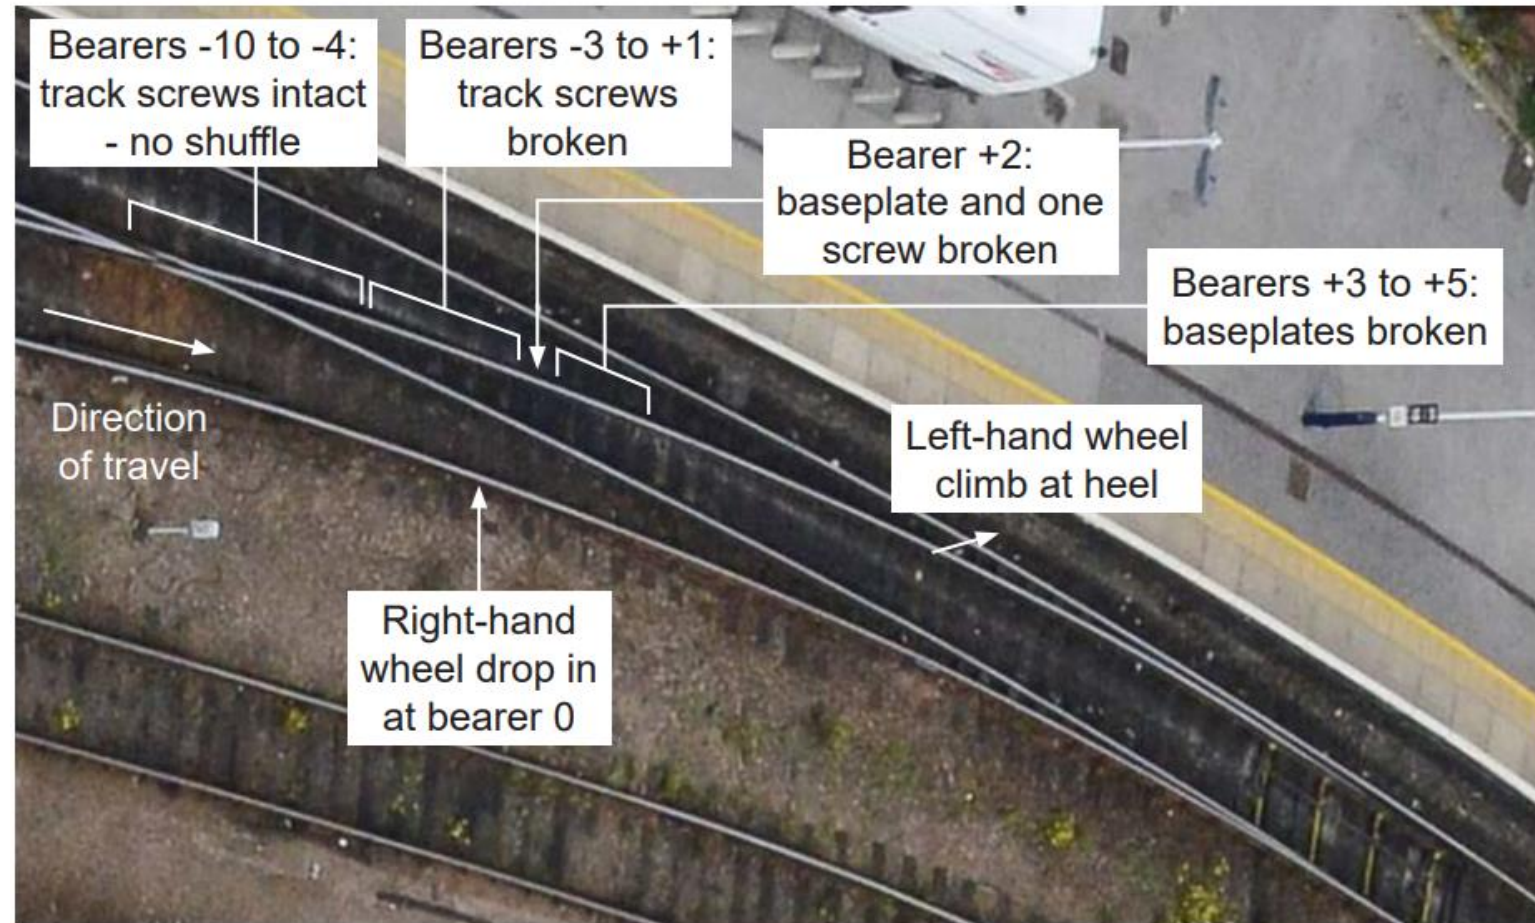
# Sheffield Derailment

The track gauge had widened because a number of screws in the timber bearers had broken, allowing the rails to spread apart under load.

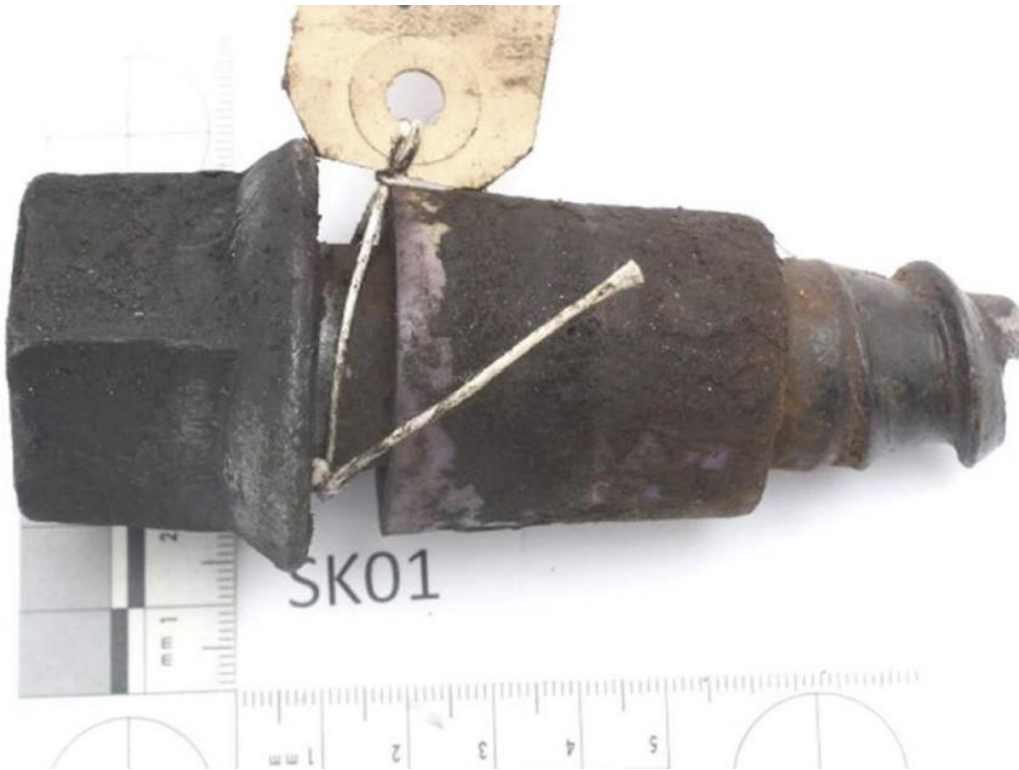
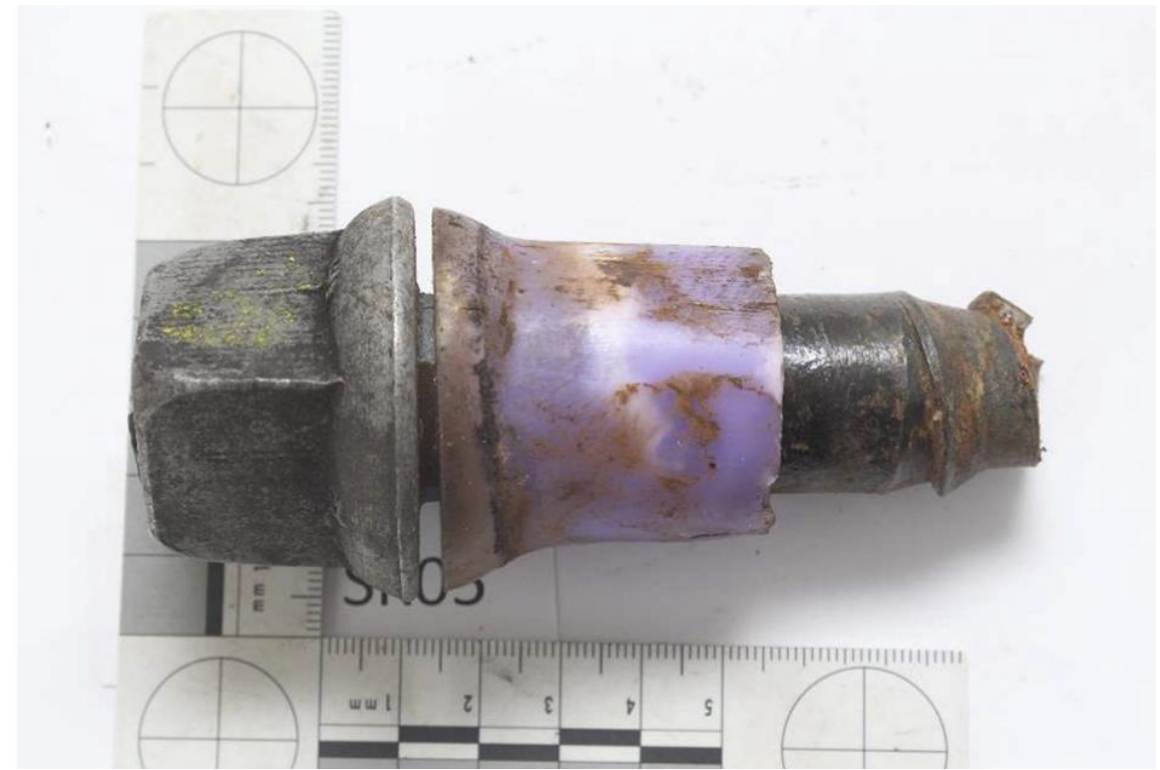
# Sheffield Derailment

The repeated lateral loading of the outer rail under the passage of loaded freight trains led to fatigue cracking of the screws and subsequent failure over an extended period, despite the track screws being compliant with standards.

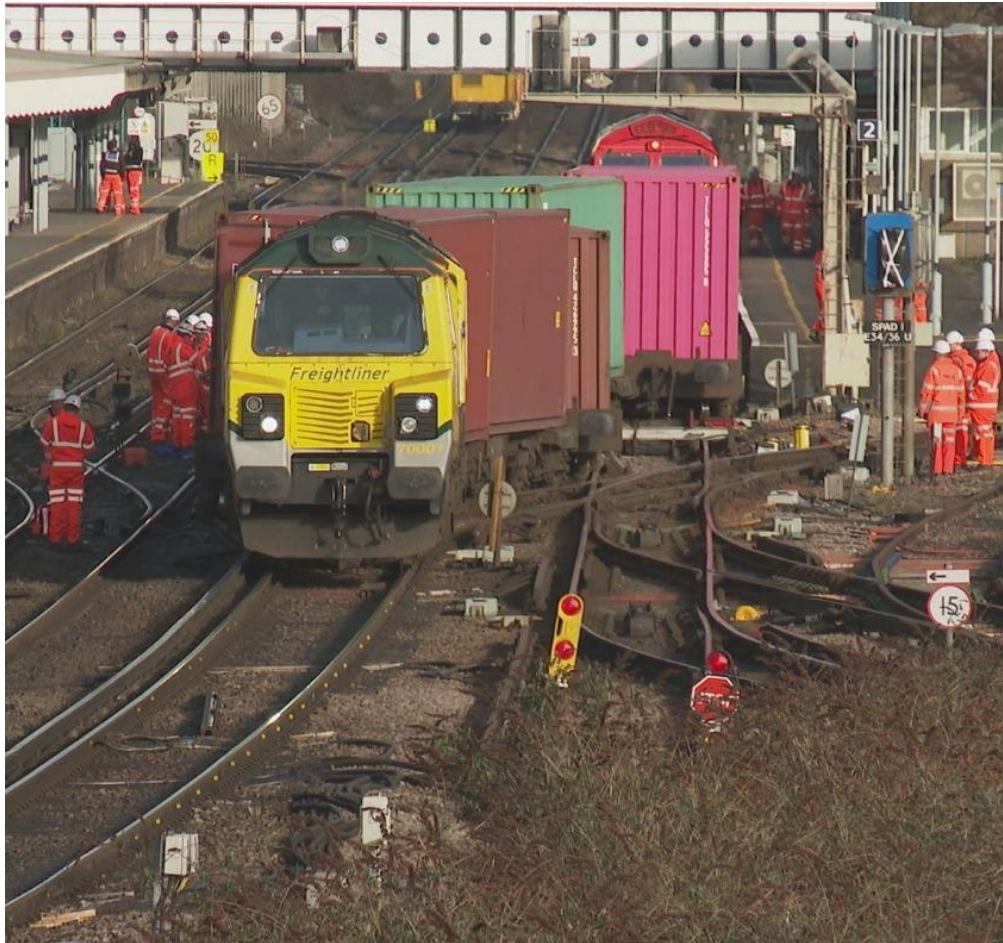
- Eastleigh 450A points
- 28<sup>th</sup> January 2020
- Balfour Beatty RT60 S&C
- Failure of elevated housings leading to gauge spread

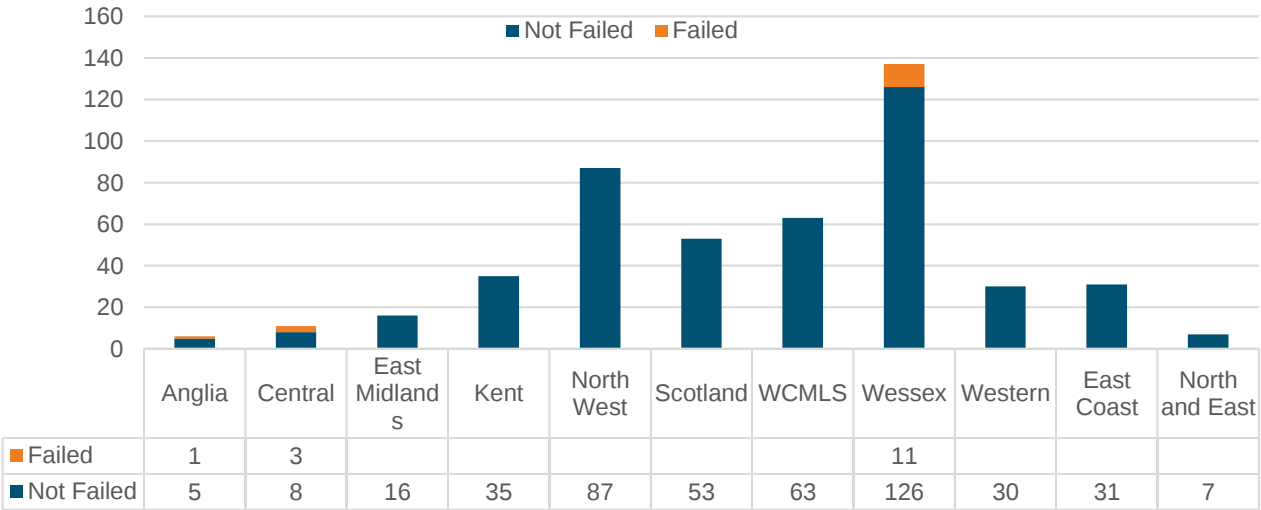
Number of BBRT60 point ends found with failed housings

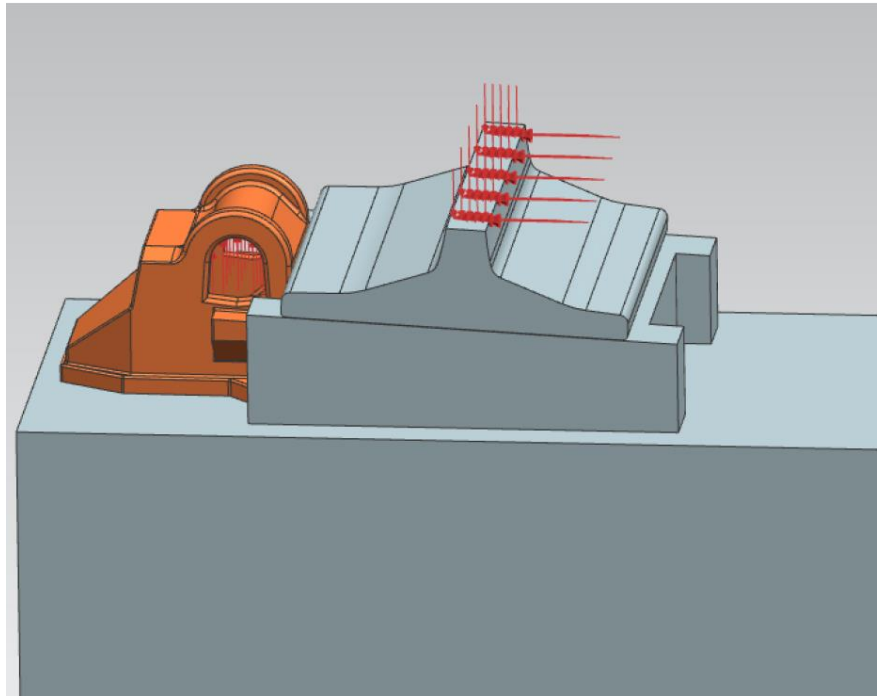
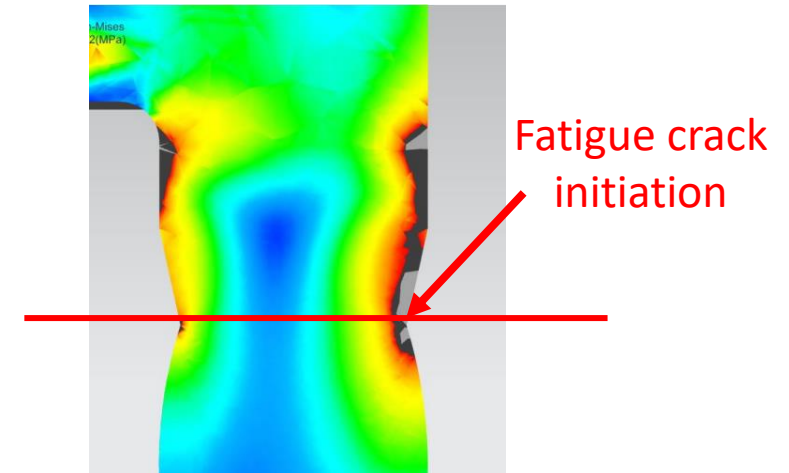
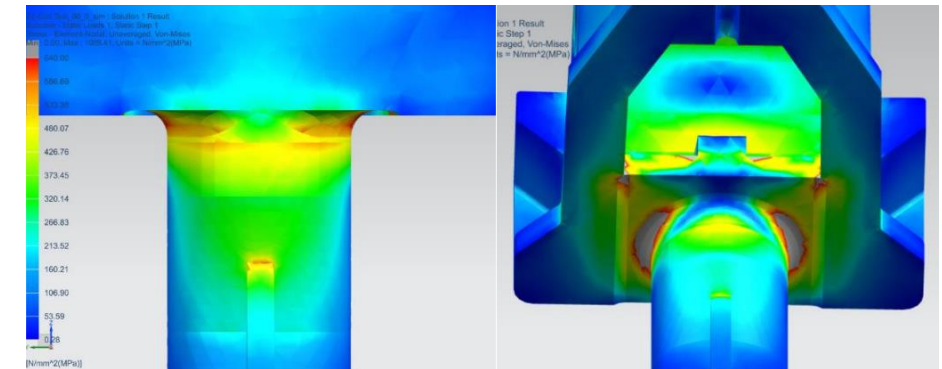
Finite Element Analysis of existing housing stem

FEA conducted on existing design in an attempt to emulate current failure modes

Optioneering study has selected optimal design modifications to improve resilience

Chosen modifications will be prototyped and mechanically tested before implementation in rail
