# TRAETH MAWR (BIG SANDS) TIMBER TRESTLE RAILWAY VIADUCT REFURBISHMENT

**F**urther to presentations given to PWI Section meetings at Cheshire & North Wales plus Manchester & Liverpool, this article has been prepared to share an interesting project delivered in 2021.

The Dovey Junction to Pwllheli railway crosses the River Glaslyn over Traeth Mawr just outside Porthmadog. The structure was built before the opening of the railway in 1867 and was originally 40-plus spans, but was significantly altered over the years to its present day 16 spans. (**Figure 1**).

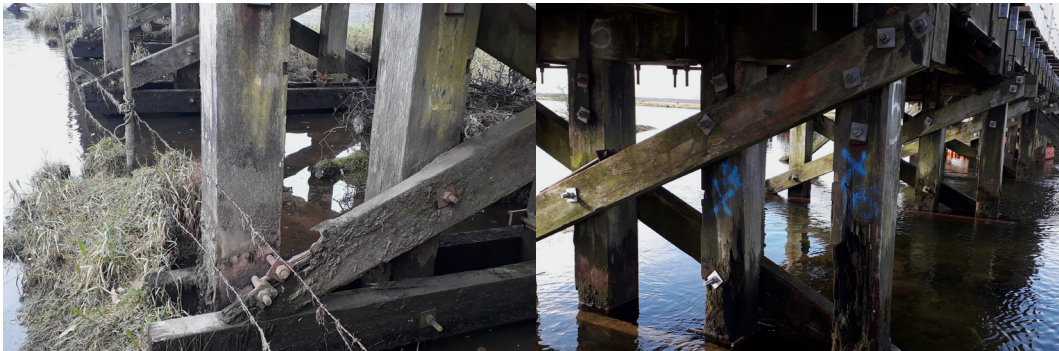
Figure 6: Typical defects

Some of the structures' timbers were in varying states of decay, and the metal straps had severe corrosion as one would expect in a marine estuary environment. Timber decay usually propagates in joint areas particularly just above the water line (Figure 6). The new pile splices were moved to lower positions, either in the riverbed or below water level as this prolongs their life, being subject to one condition rather than wetting and drying.

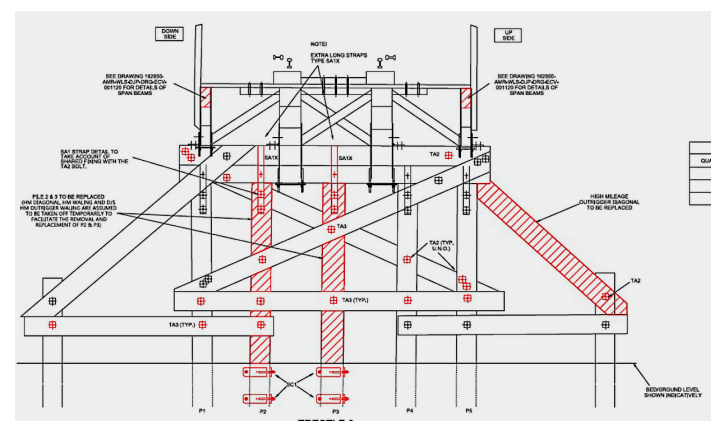
Figure 9: Design drawing showing elements for replacement in red

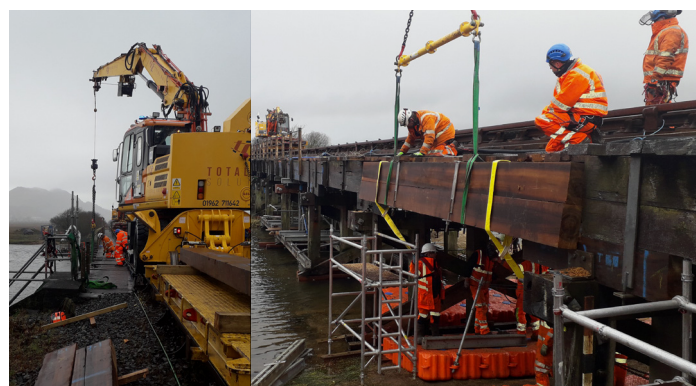
Figure 12: RRV delivering materials and Edgebeams being replaced by RRV (staff tethered with safety lines)

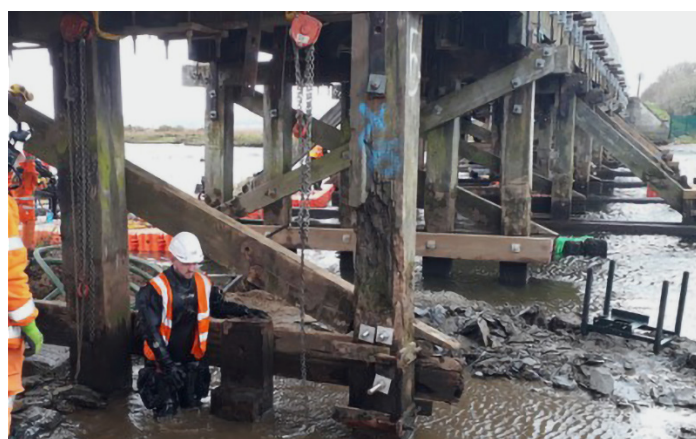
Figure 13: Partially submerged diver replacing pile/splice
