# Managing Overhead Line Equipment on Network Rail's Wales & Western region

Jai Parhar BEng – Asset Engineer (OLE Mtce support)

Darrel Tiddy – IEng IET – Senior Asset Engineer (OLE Mtce support)

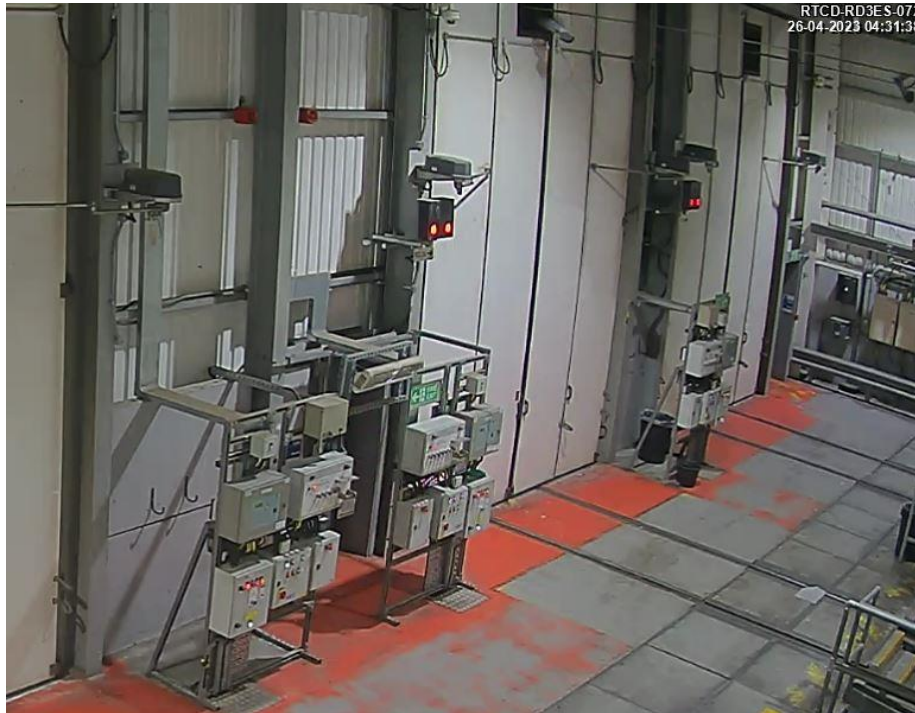
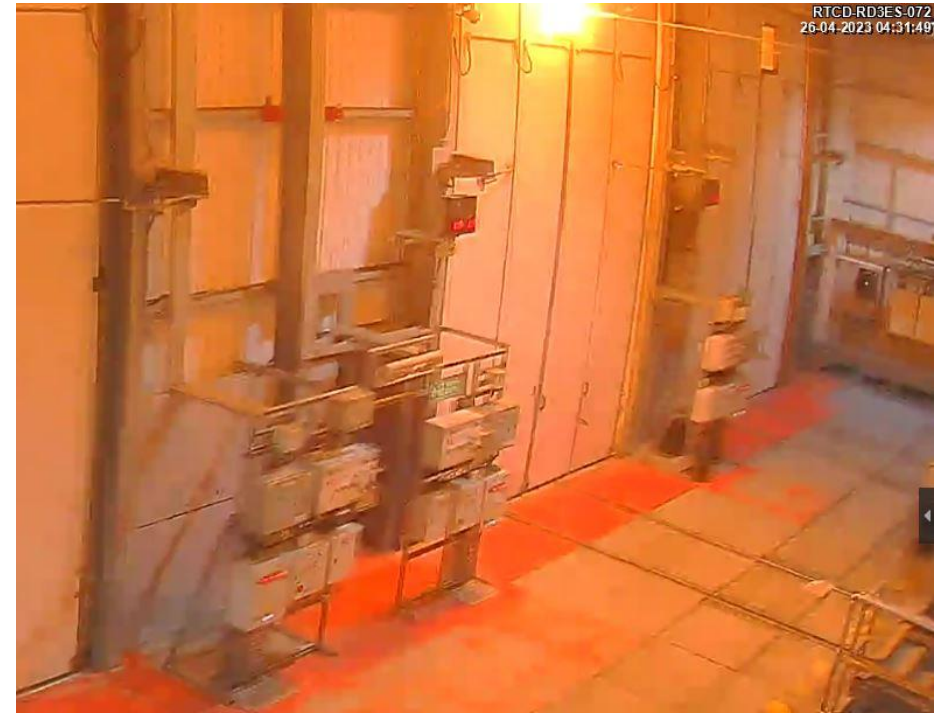
Overhead line tripping – Reading Train Care Depot - April 2023

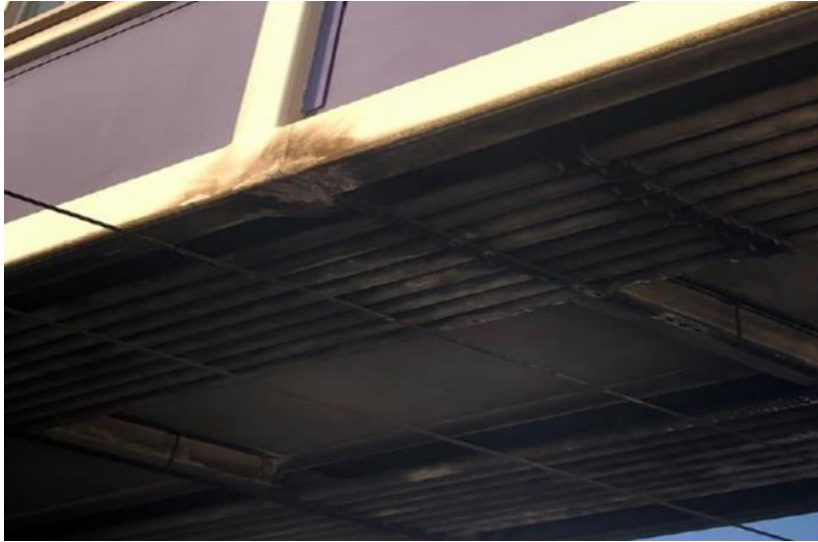
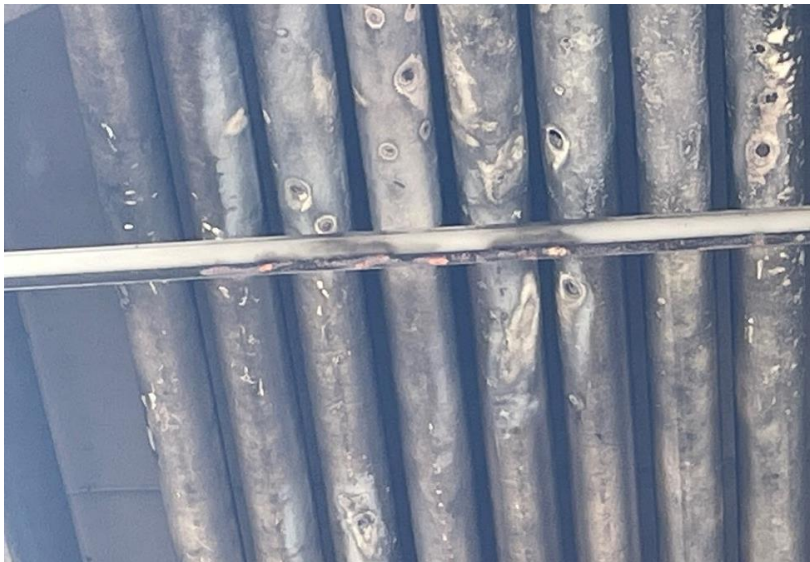
Repeat Tripping's - Twyford station – March 2023

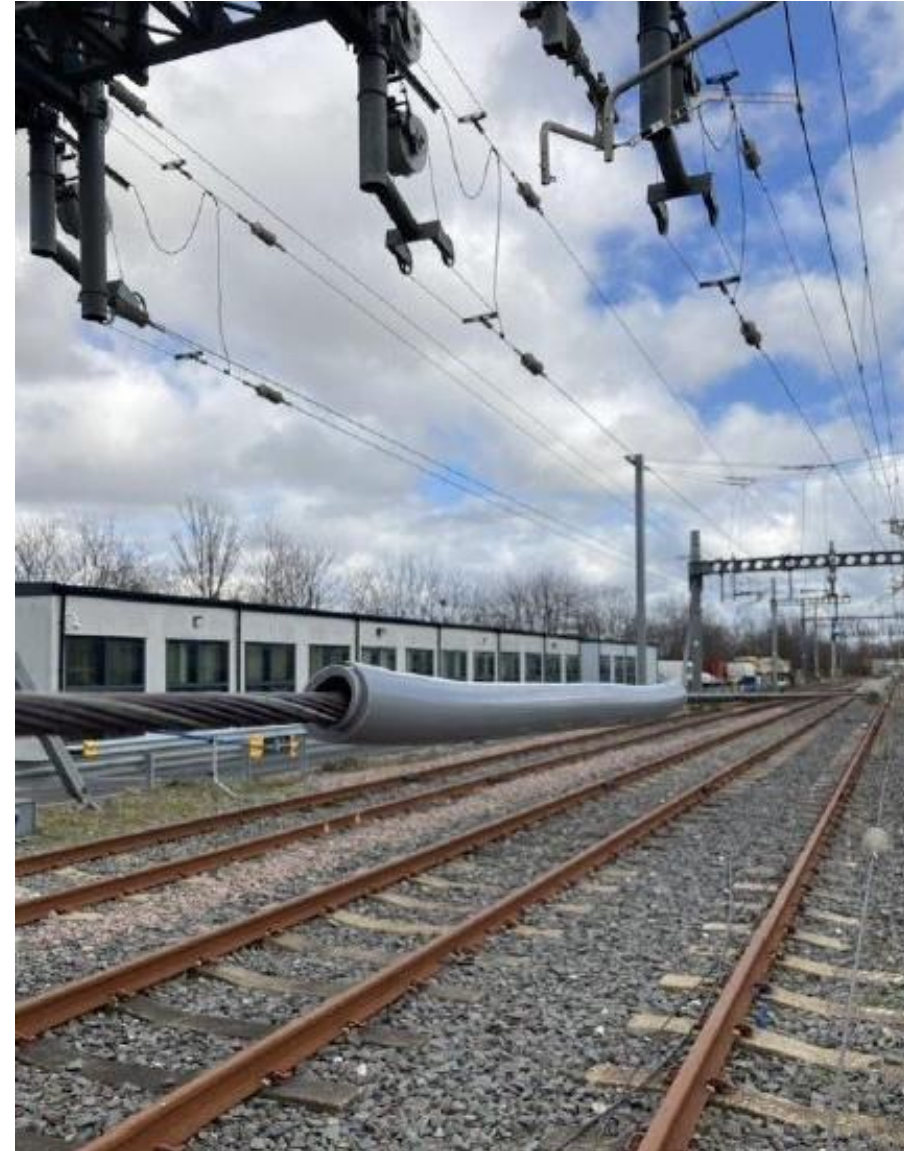
Line hose – secondary insulation

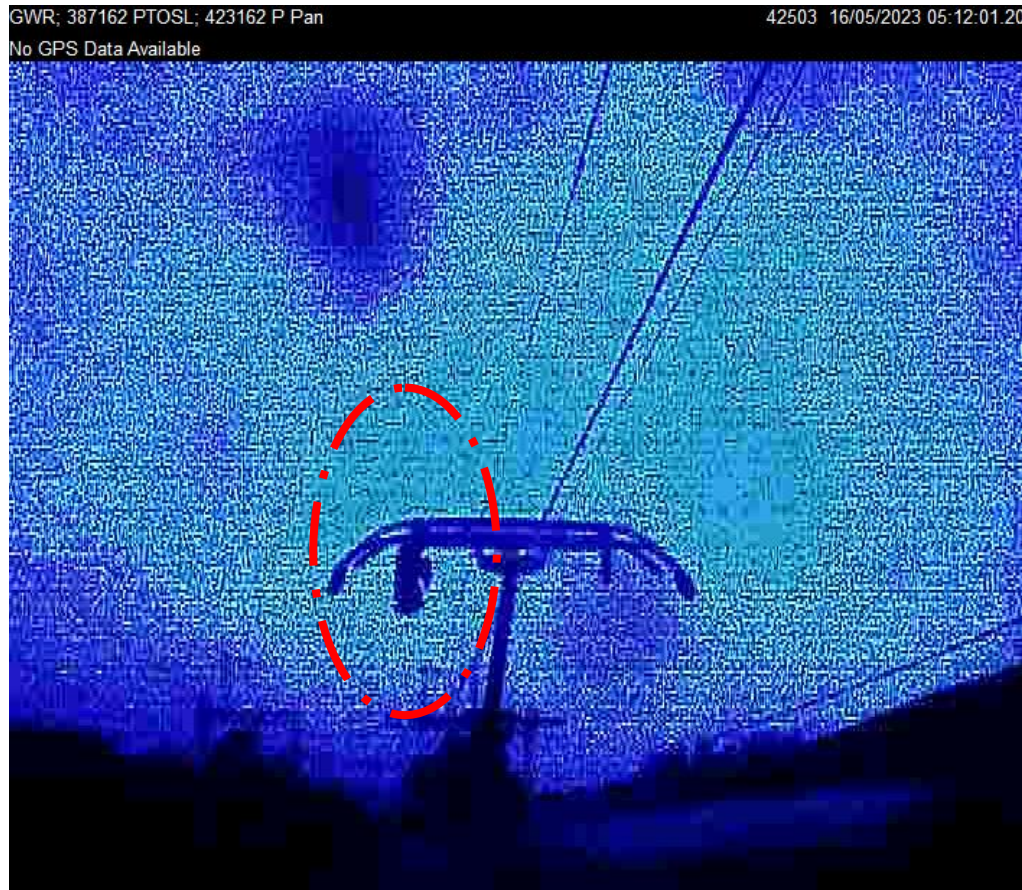
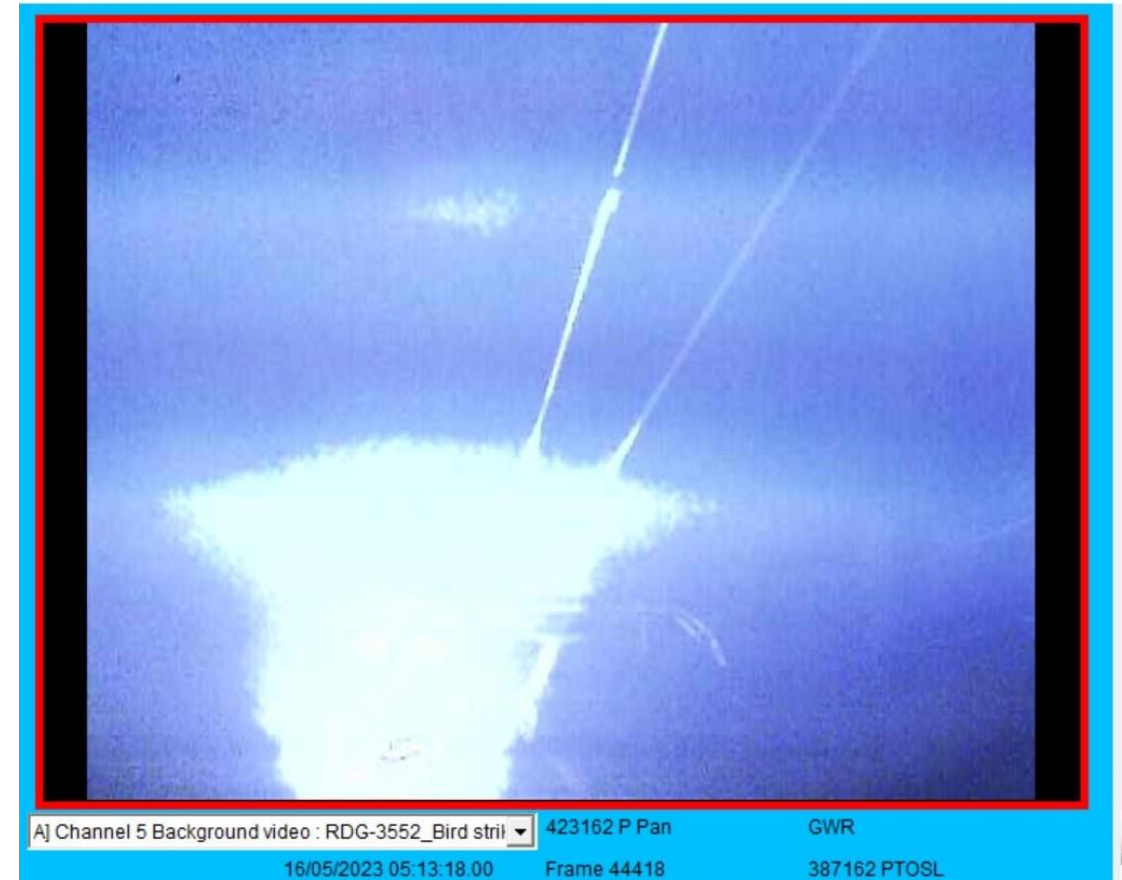
Overhead line tripping – Didcot area / A34 Bridge - May 2023

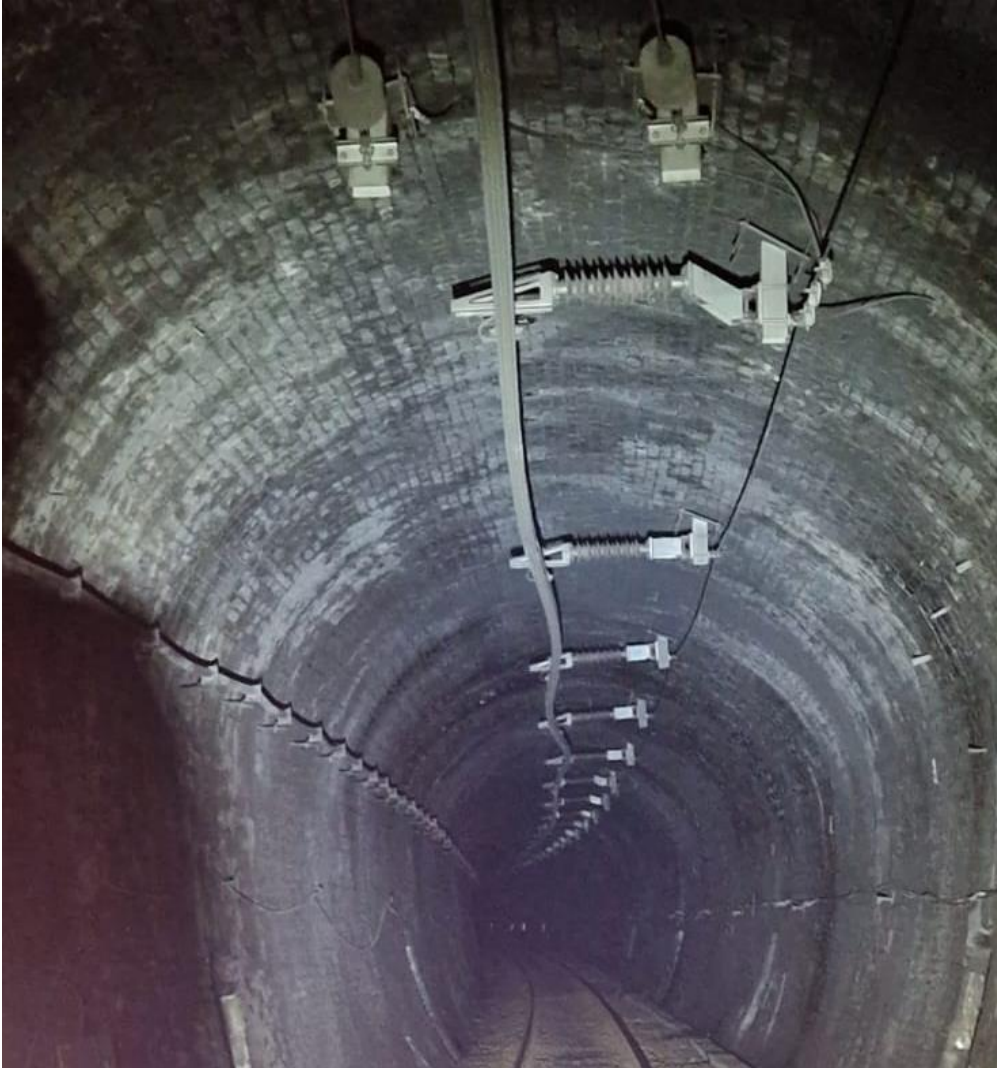
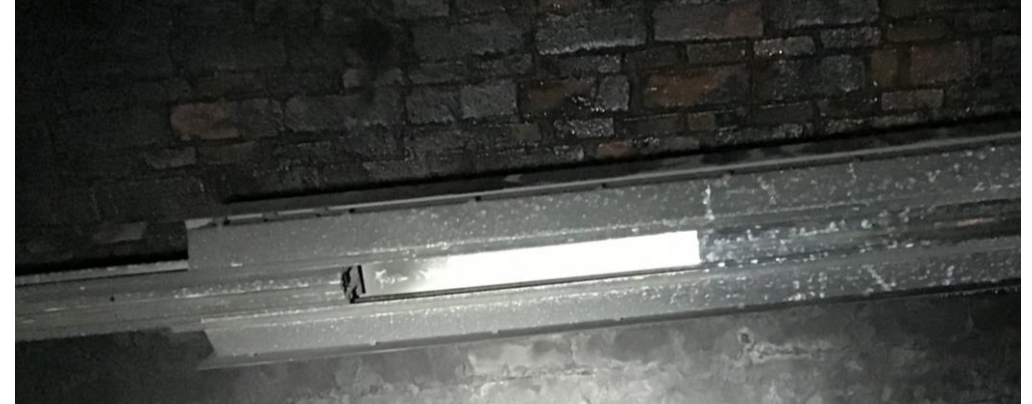
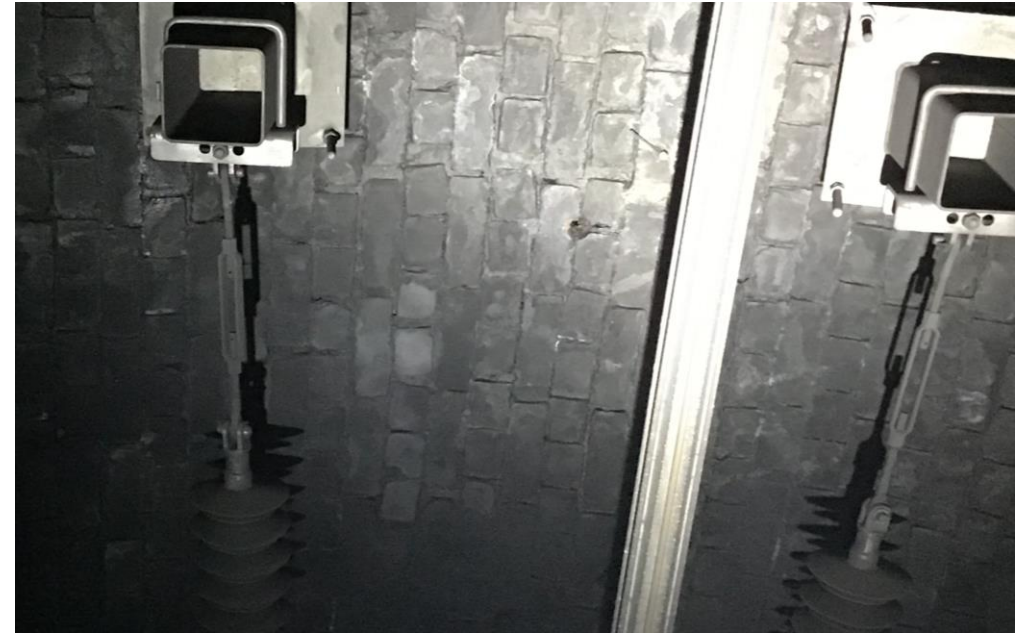
Conductor beam misalignment – June 2023

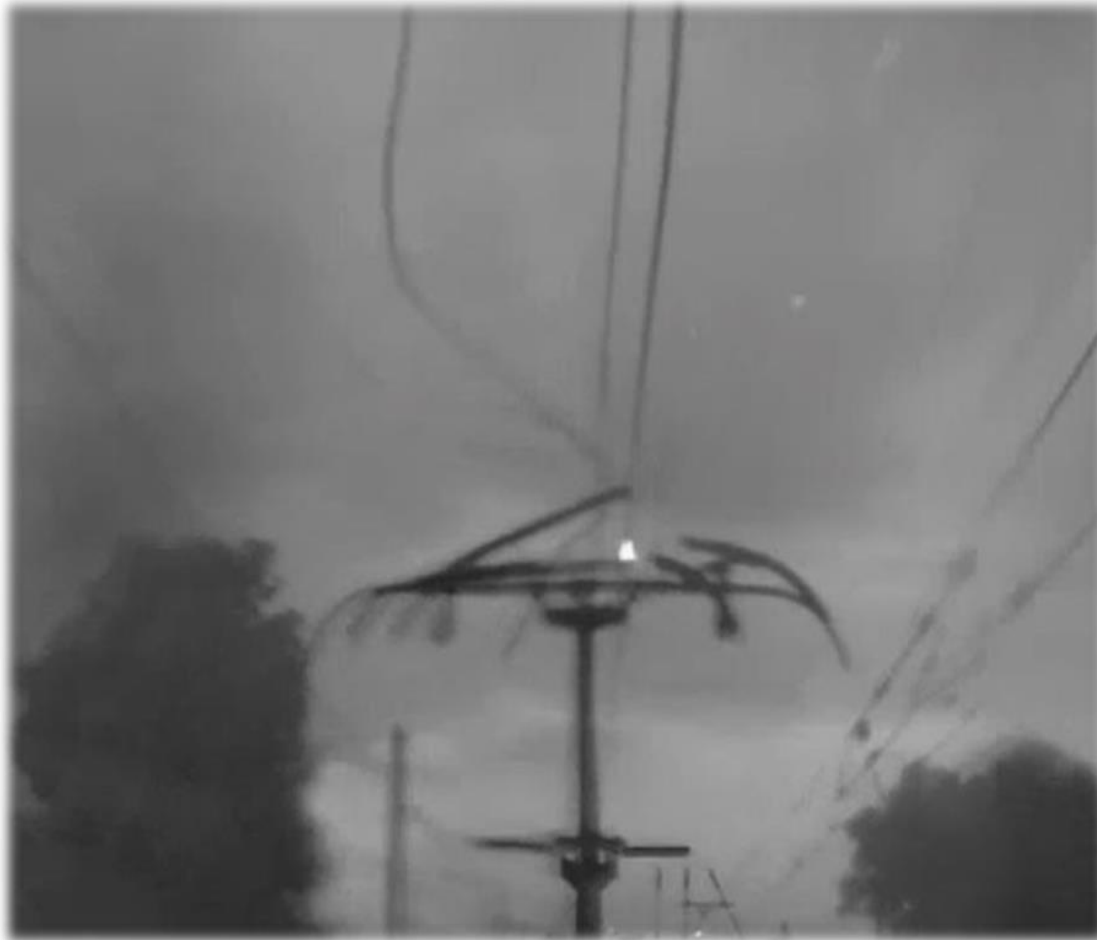
- Droppers (mishandle at time of installation)
- Droppers (saddles not installed)
- Jumpers (too short - hot weather issue)
- Earth wires (too tight - cold weather issue)
- Isolator setup (performance issue)

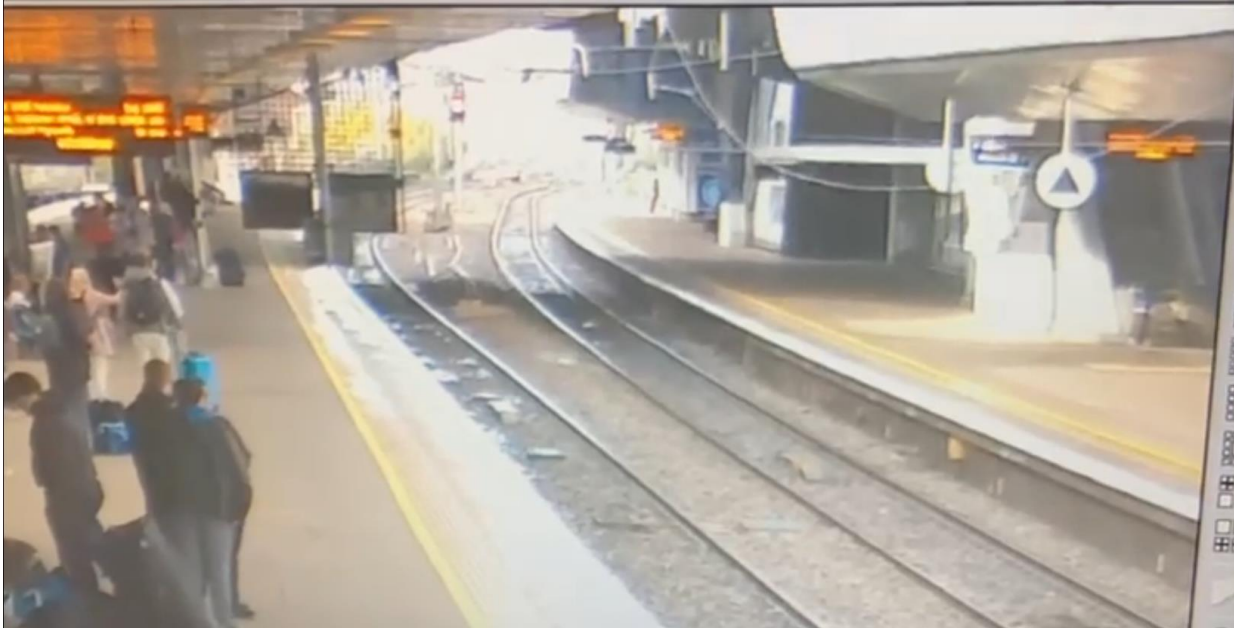
Above - Reading station – OLE tripping and dewirement caused by a helium balloon – November 2022.

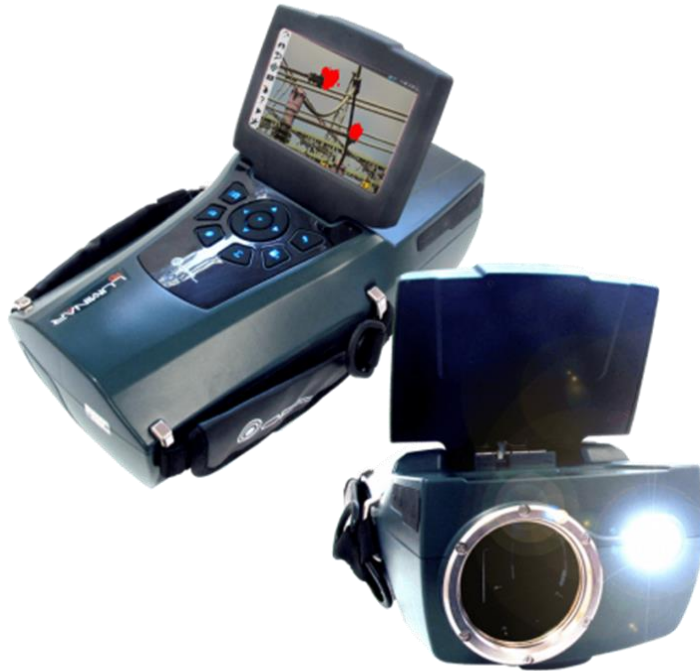
The corona camera allows intervention before failure by identifying electrically poor performing insulators.

| INSULATOR ID | GAIN | COUNTING |
|---|---|---|
| 194 – 706 DT | 180 | 31510 |

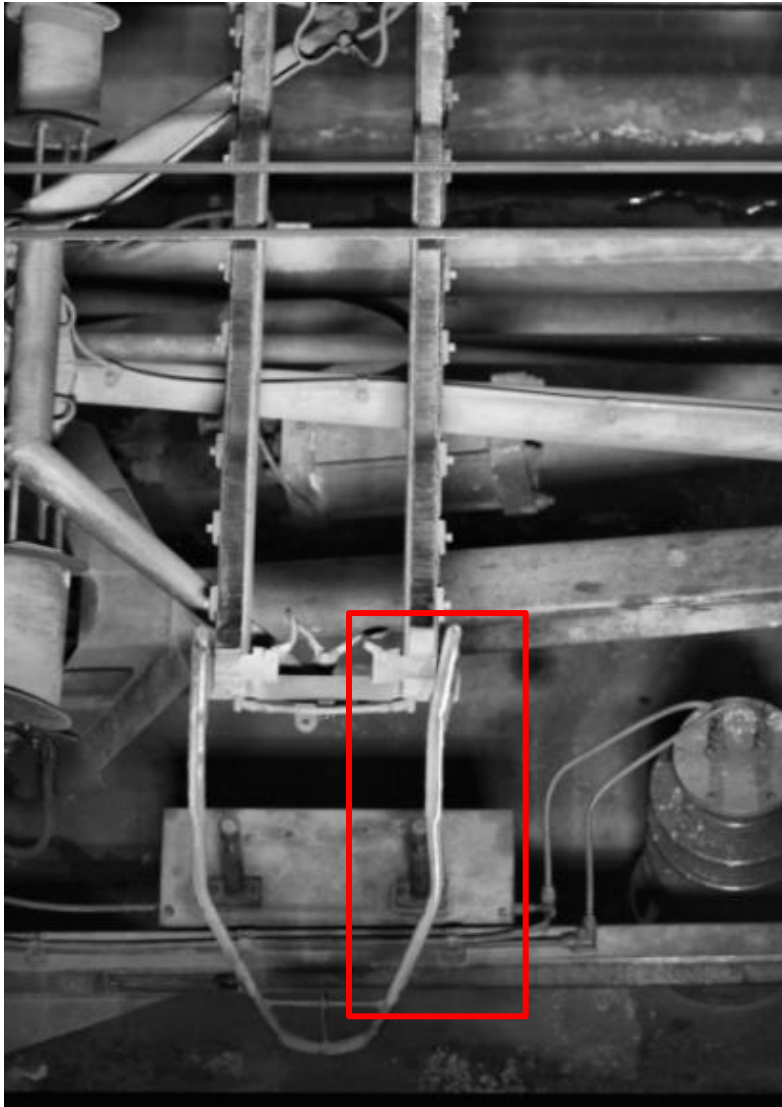
Horn damage identified by Pantobot at Heathrow

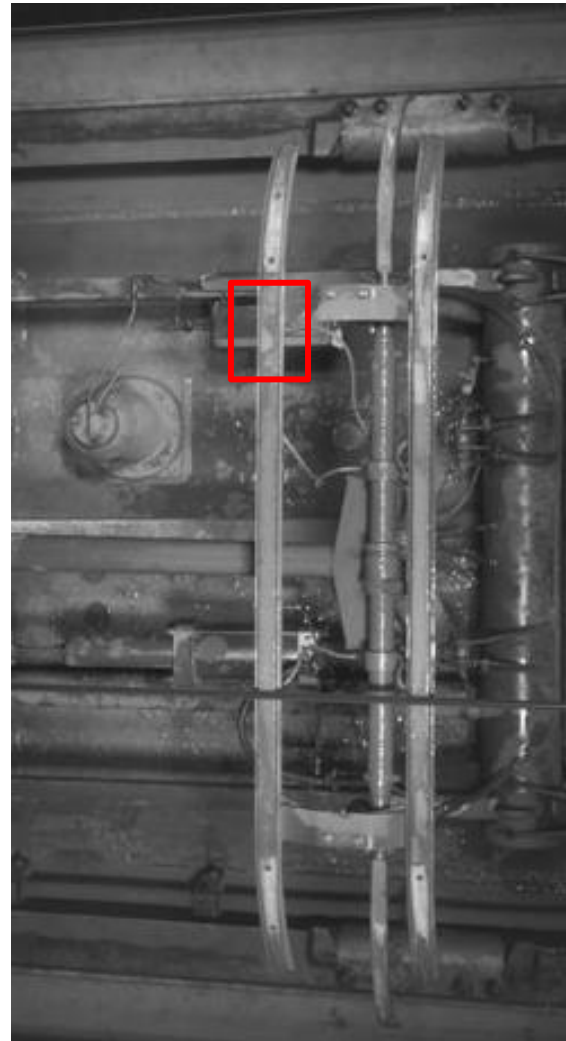
Pantograph alarmed on a carbon chip by Pantobot at Southcote

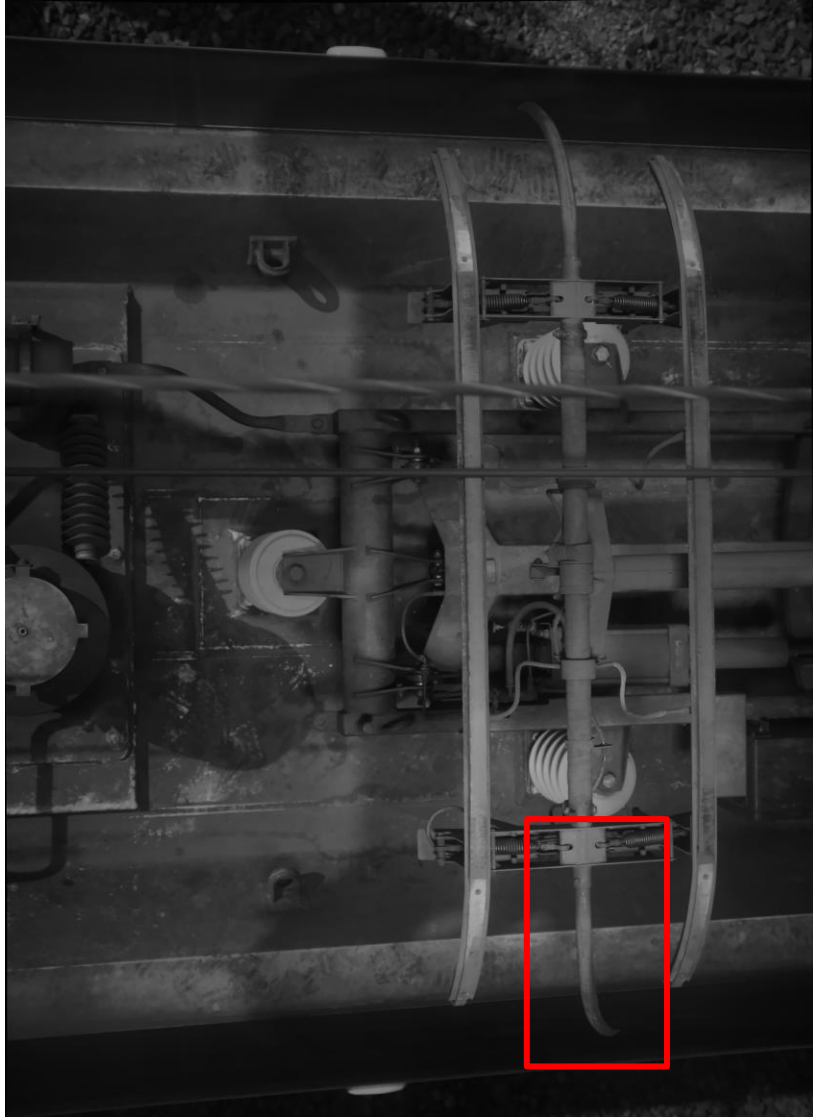
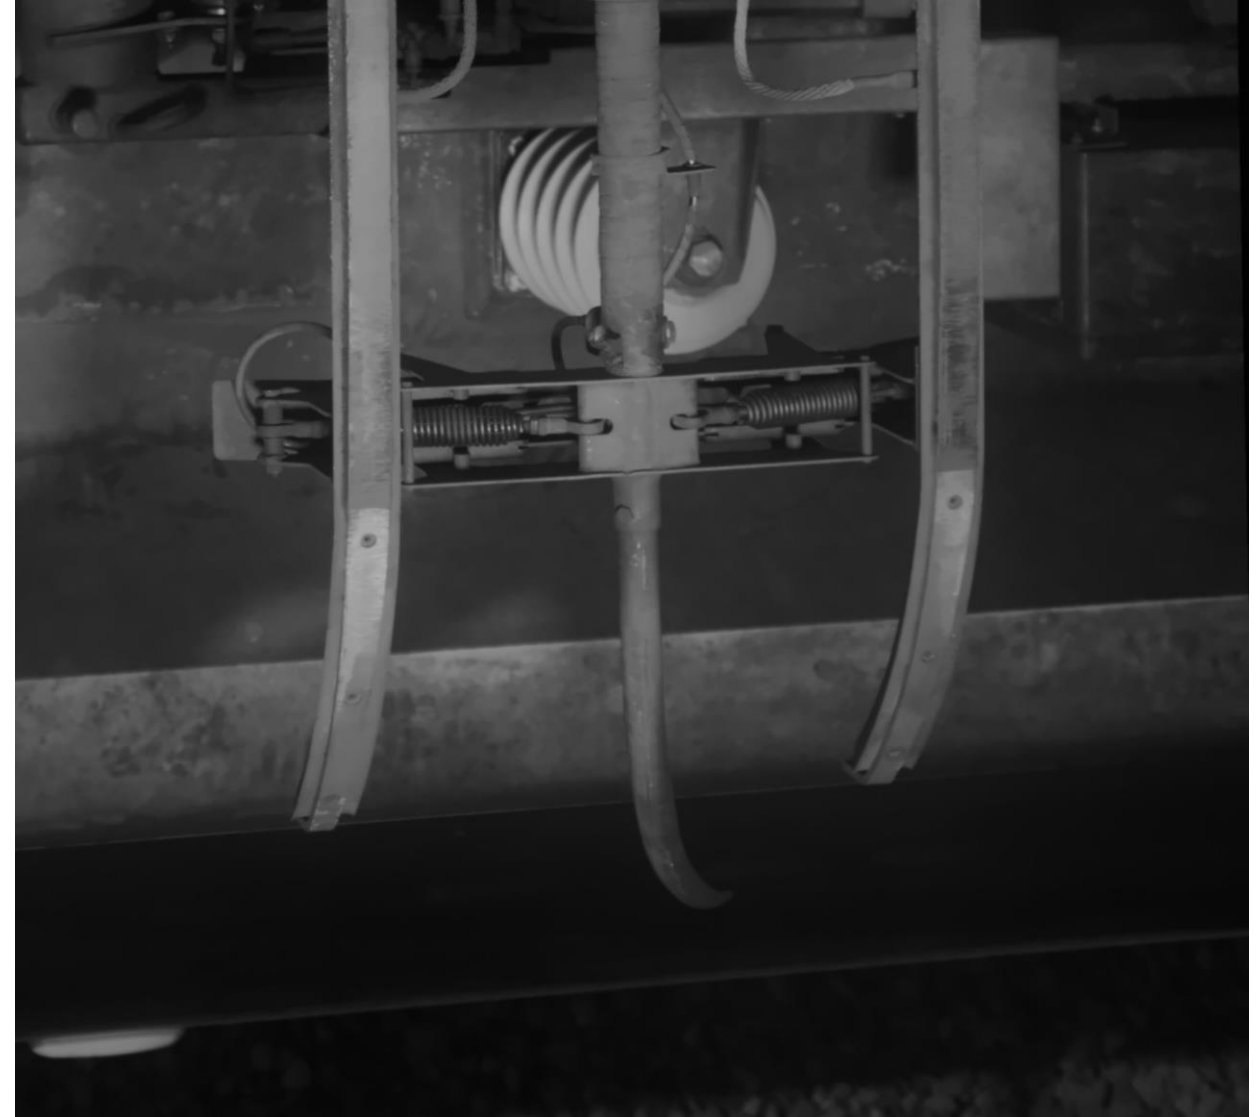
Rotated pantograph horn

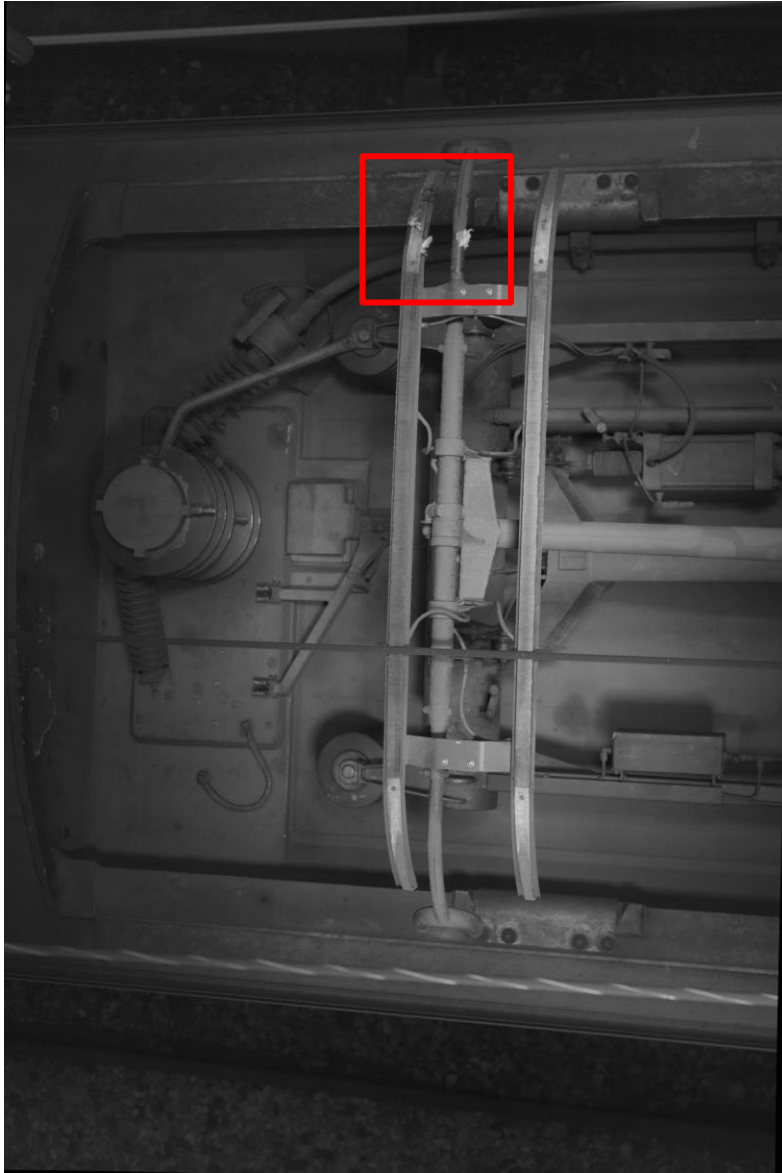
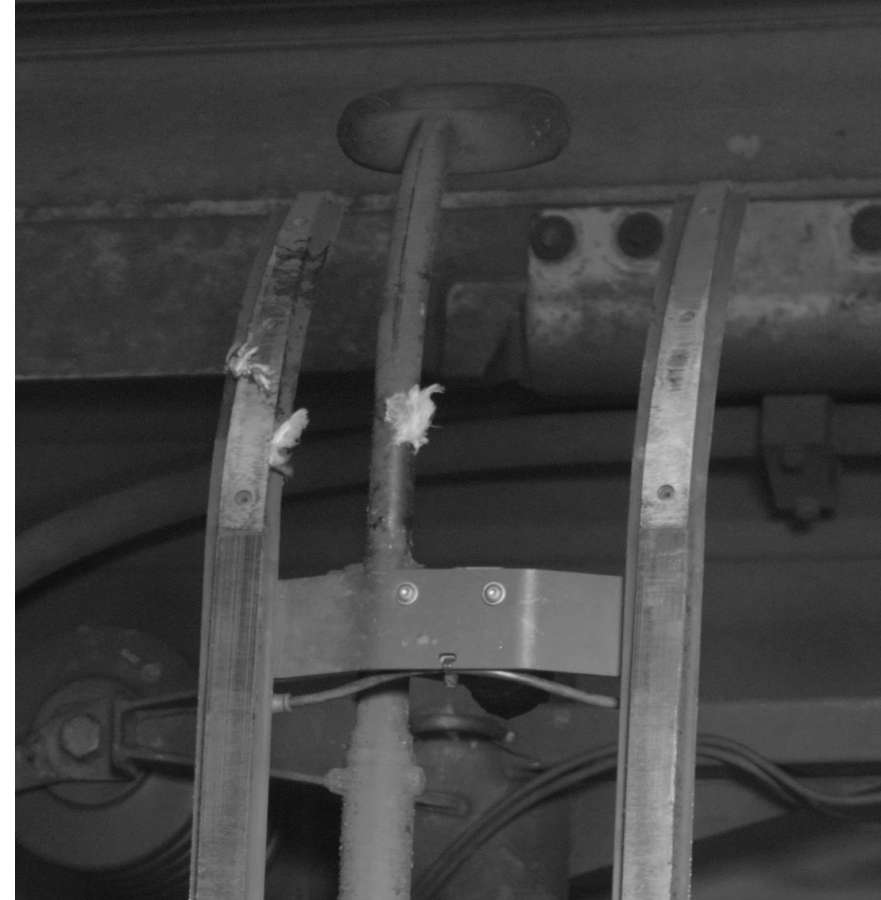
Result of a bird strike
