# What in the world...?

# New Zealand

## The Kaikoura Job; Rebuilding Kiwirail's Main North Line

## TECHNICAL ARTICLE

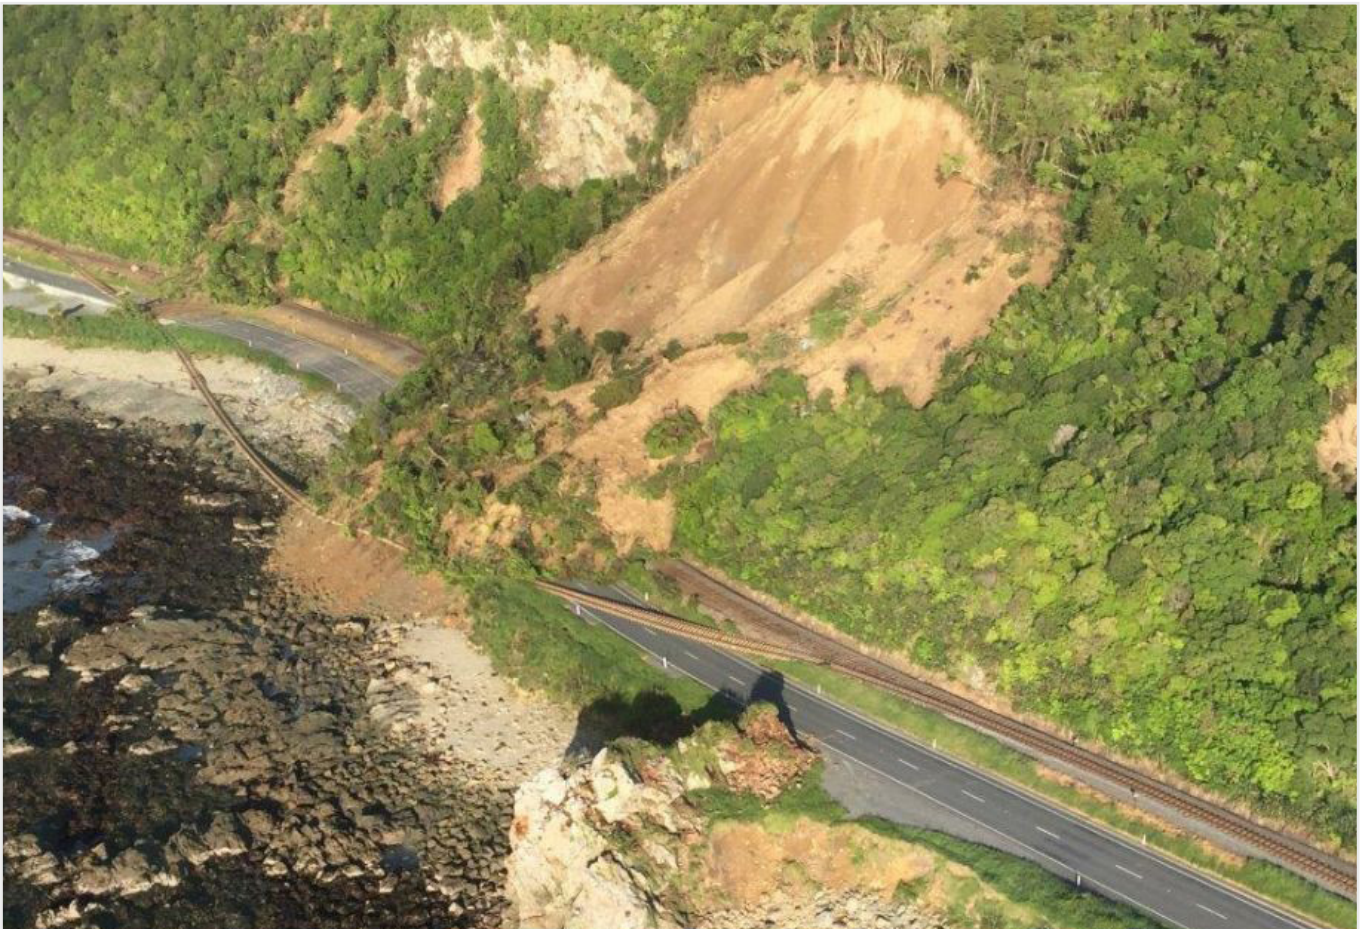
Image 4: One of the numerous, devastating landslips that buried State Highway 1 and the North Main line between Kaikoura and Blenheim. Photo courtesy of Tim Burt

**See image 4.**

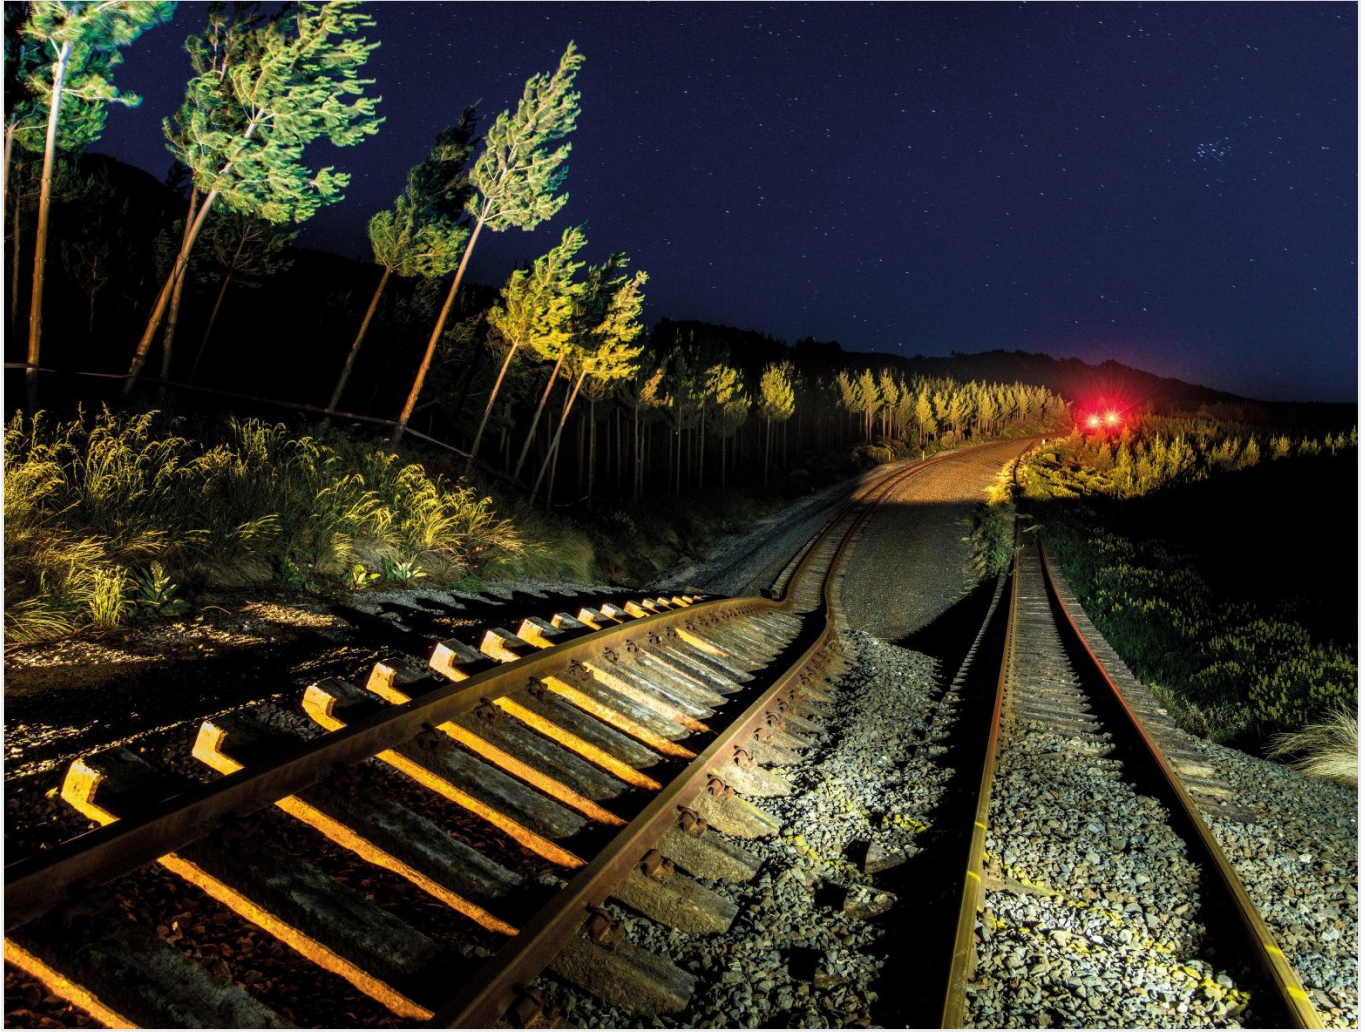
Image 5: A twisted and contorted permanent way north of Kaikoura. Photo courtesy of KiwiRail

The permanent way was heaved and pushed in directions hitherto not seen around the world. The forces of mother nature drove stressed CWR off the track bed, across the state highway and over the beach into the sea.

High quality track was twisted and contorted into amazing geometrical shapes, whilst in other locations instant severe track gradients appeared that rendered normal train operations impossible.

**See images 5, 6 and 7.**

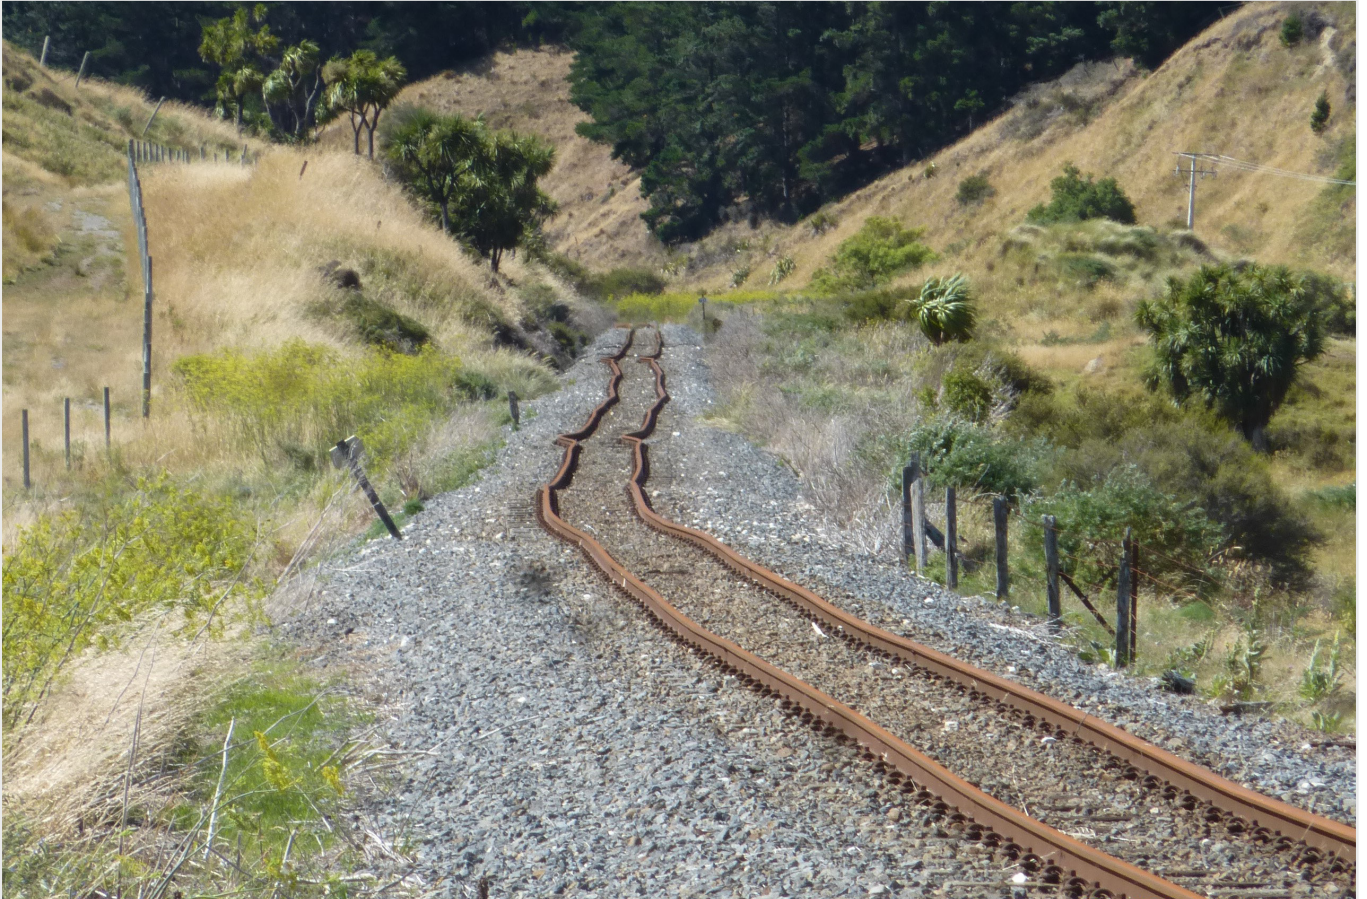
Image 6: Permanent Way damage south of Blenheim. Photo by Phil Kirkland

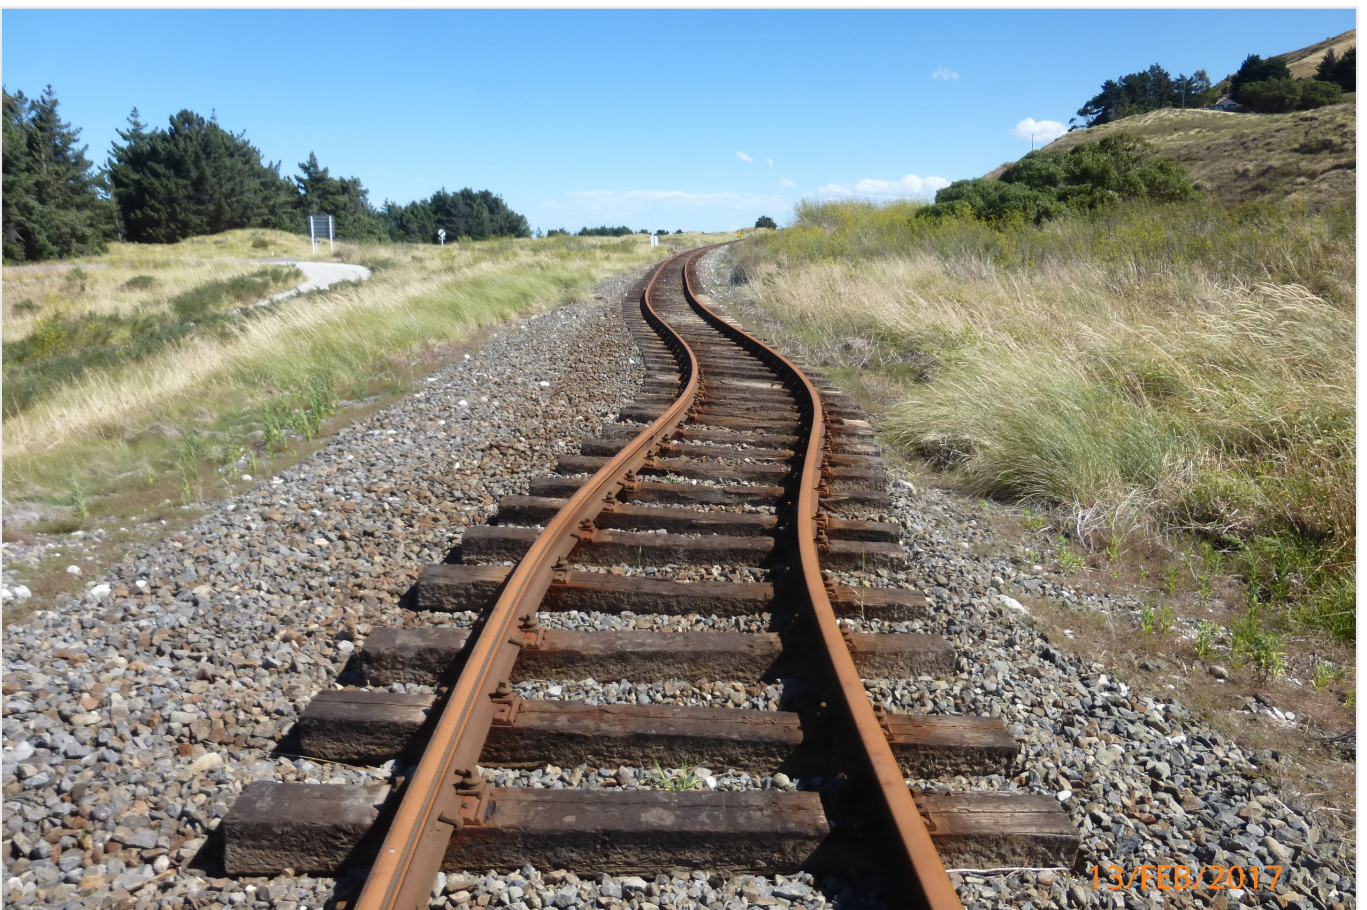
Image 7: Permanent Way damage south of Blenheim. Photo by Phil Kirkland

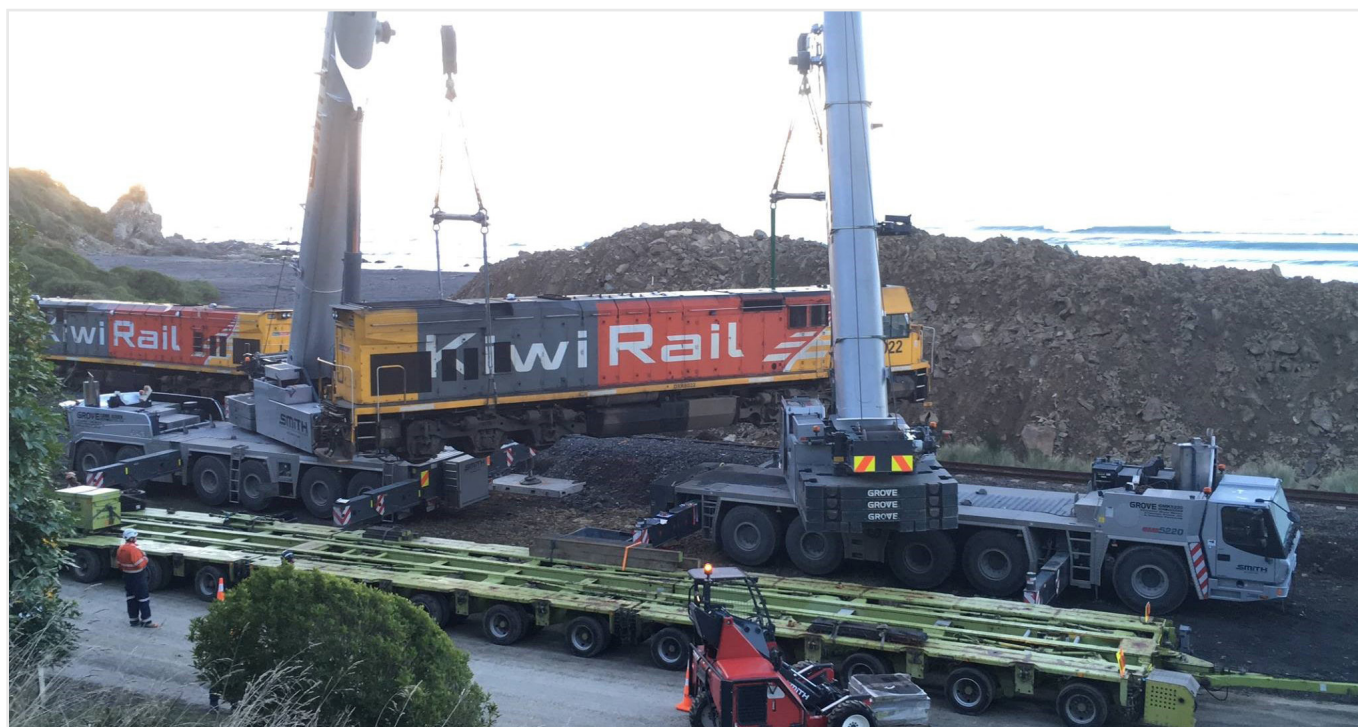
Image 8: Locomotives being recovered from the earthquake site once a route had been constructed alongside State Highway 1 at Kaikoura. Photo courtesy of KiwiRail

and reconnaissance helicopters and aircraft. A long freight train had also become trapped between landslides, fortuitously not being buried or colliding with any debris. However, the train could not be moved in either a forward or propelling direction because of debris. This in itself presented challenges as all of the perishable goods had to be recovered from the train, the majority being donated to locals, and locomotives had to be drained of fuel, and protected from the sea etc.

The stranded train was near a damaged bridge which had to be strengthened to allow the train across and into a tunnel where the locomotives sat for weeks until they could be rescued.

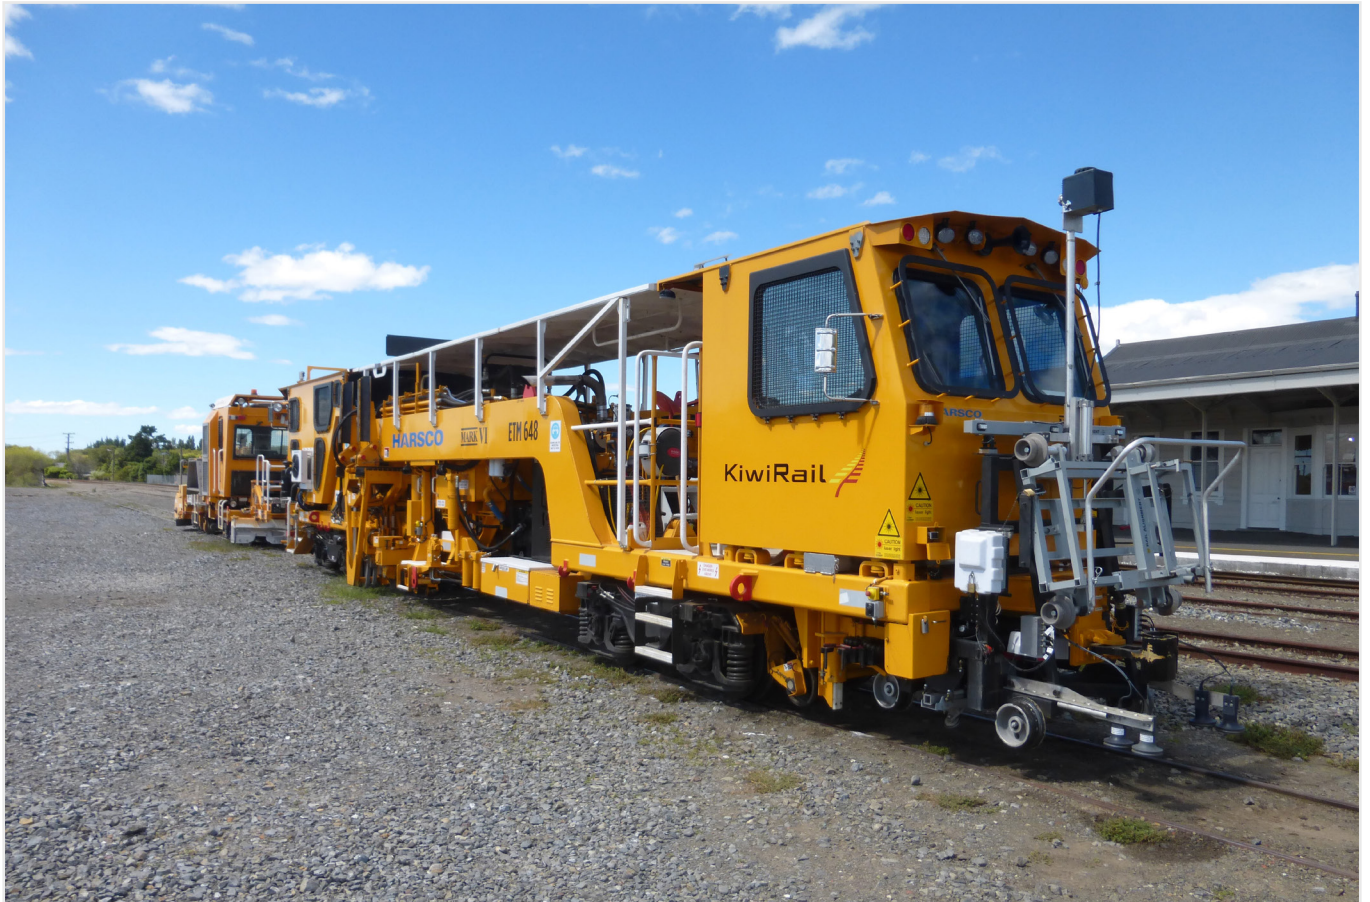
Image 9: KiwiRail Harsco MkVI tamping machine and ballast Regulator. Photo by Phil Kirkland

On 15 March 2017, additional KiwiRail on track plant was transported across Cook Strait on the rail ferry Aratere comprising Tamper, Ballast Regulator and DTS at a combined weight of 230 tonnes. The equipment, along with its crew of six, is normally based in Palmerston North, in the North Island, and was moved south as part of the plan to re-open the earthquake-damaged line as quickly as possible. Bringing the equipment down from the North Island enabled work on the line from both ends at once to get the line up and running as quickly as possible. The on-track machines followed the daytime maintenance trains, which were replacing ballast that was lost during the earthquake. There were already two sets of on track machines based in the South Island but they were both south of where the line was cut. Eventually they were also brought up to the Kaikoura site. **See image 9.**

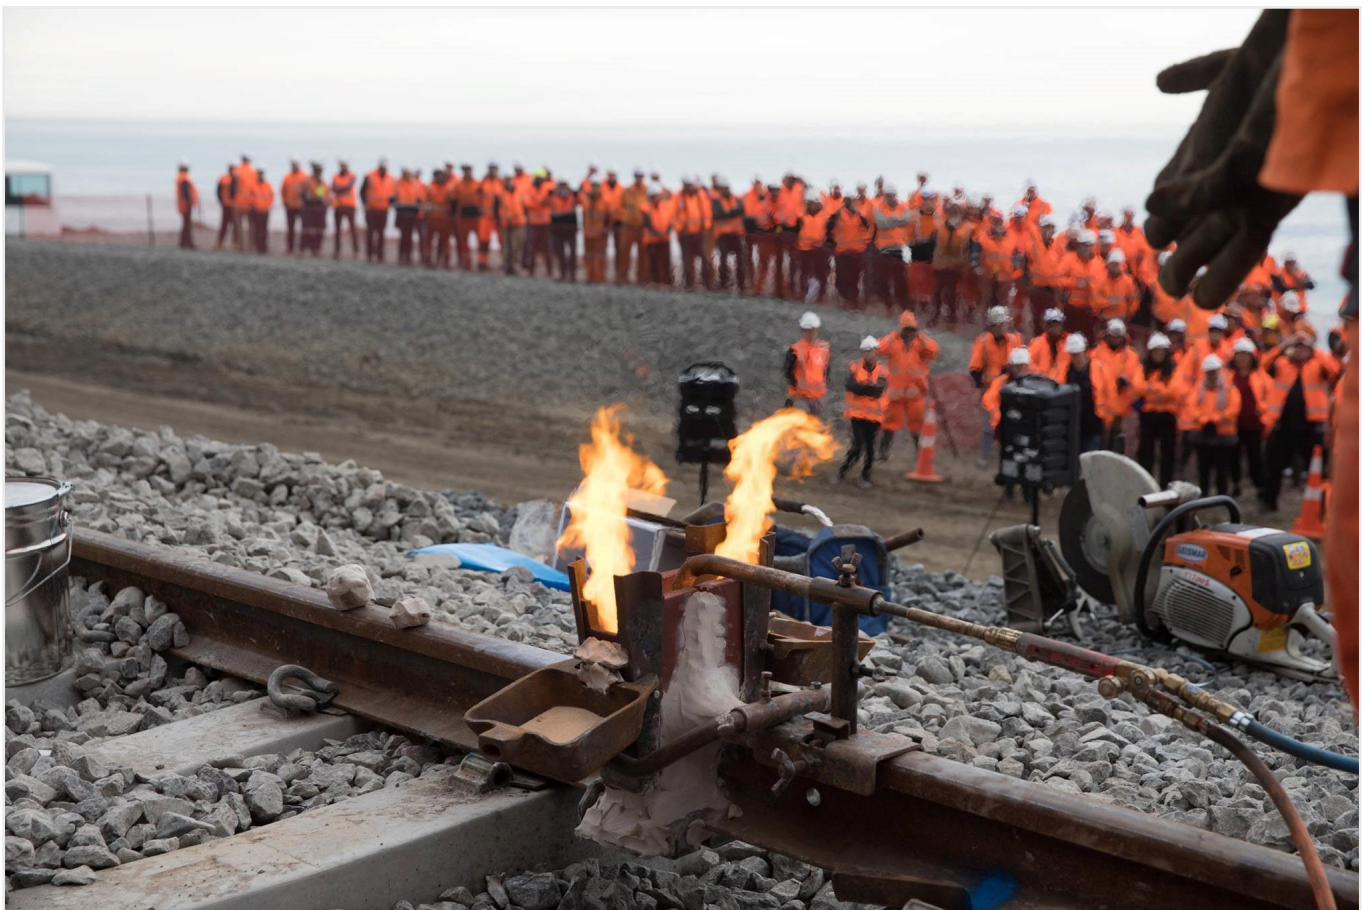
Image 10: The final Thermit rail weld at Kaikoura . Photo courtesy of KiwiRail

A milestone on the rail line's repair was reached on August 8 2017 when a thermit welding ceremony at Half Moon Bay on the Kaikoura coast marked the joining of the north and south sections, with work trains able to get through from both ends to help with the reconstruction. **See image 10.**
