# Technical justification for 6mm T pieces

*Transport For London*

AS PUBLISHED IN

The Journal July 2019 Volume 137 Part 3

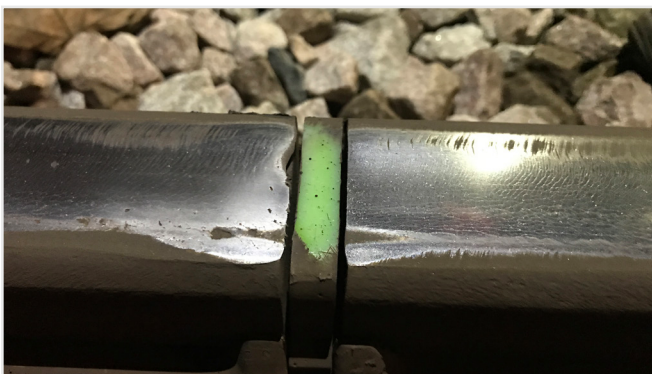
Insulated rail joint (IRJ)

The purpose of an Insulated Rail Joint (IRJ) is to separate two electrical track circuits whilst connecting two sections of running rail. An IRJ consists of two insulated fishplates and an insulated endpost, which is positioned between the two running rails (as seen in figure 1). This assembly is secured by either 4 or 6 bolts dependent on the selected configuration for each installation.

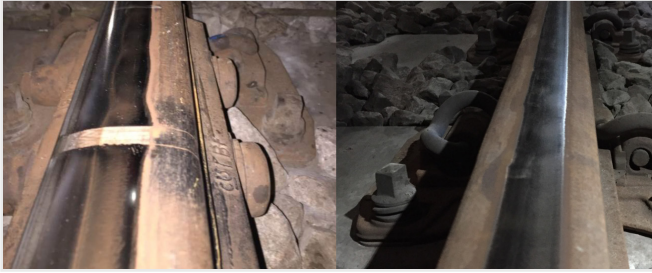
Figure 2: Rail burn beyond a 12mm T-piece

Cases have been observed where discontinuities in the rail head, (such as endposts), can result in micro-slippage in the contact patch between the wheel and the rail. This slippage will result in rail burns on the opposing rail, (seen in figure 2), where there is an inconsistency in wheel rail adhesion between each wheel on a wheelset. In figure 2, it can be seen that the running band beyond the endpost displays a variation in profile. This can be attributed to vertical loading variation, triggered by the "bounce" at the rail gap from wheel unloading. This occurs where there is rapid unloading and loading of the wheelset, transmitting high impulsive loads to the IRJ and associated components. Consequently the disparity in tractive force on the opposing sides of the wheel set creates an imbalance in the frictional forces between the respective surfaces. This in turn unsettles the bogie and can also trigger hunting oscillation, which in severe cases can lead to poor ride quality and excessive lateral forces on track components.

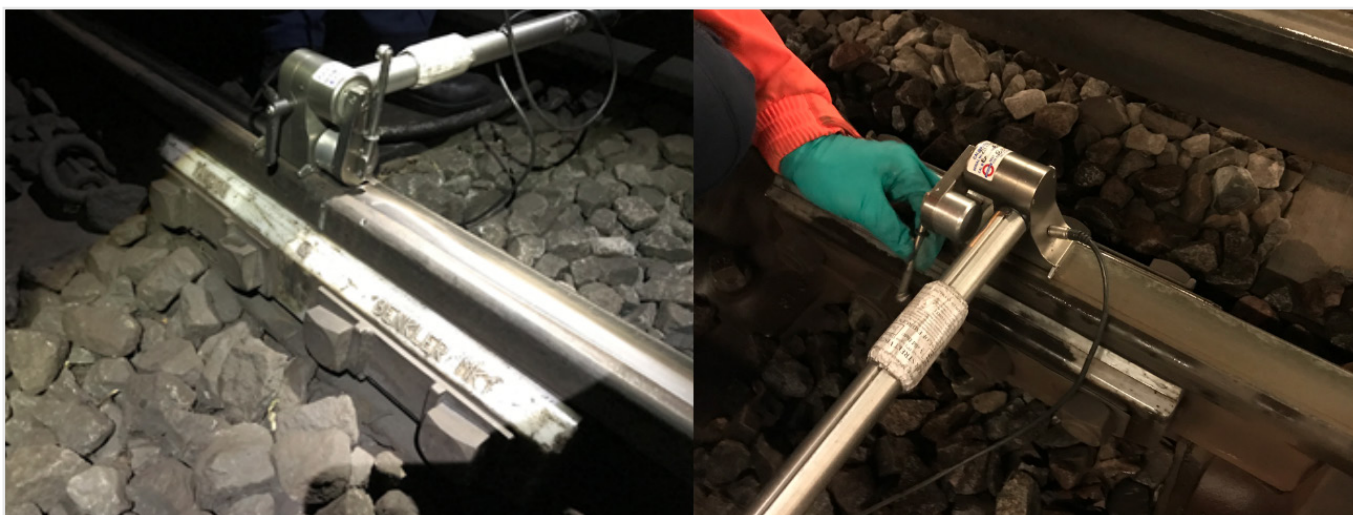
Figure 7: Mini-prof measurement adjacent to endposts

A series of rail profile measurements were taken adjacent to endposts on LU track. The purpose of this investigation was to determine the impact of an increase in endpost thickness on the rail profile. LU standards detail an incremental system for the minimum actions required to be carried out following the detection of significant headwear/sidewear. Any headwear exceeding 14mm is required to be replaced within one week, where this allowable value decreases with an increase in sidewear (see figure 7).

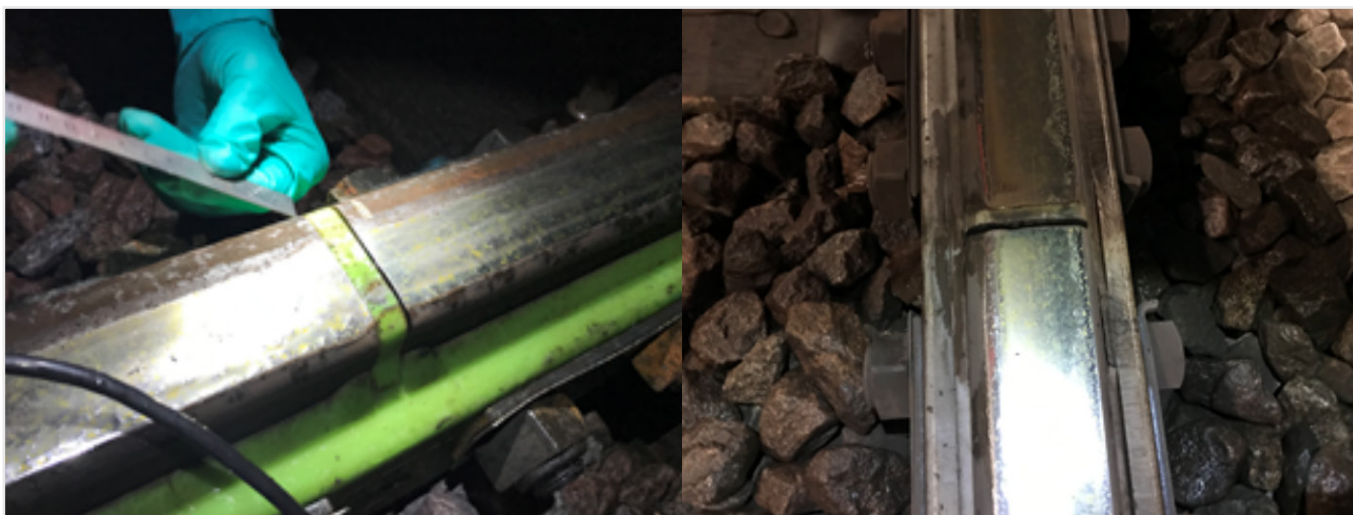
Figure 9: Endpost filler voiding

Whilst measuring the endposts sections it was noted that in several cases there was clear voiding between the endpost material, and the rail sections (displayed in figure 9), in particular for 12mm endposts. How this has occurred is not currently understood, but where the endpost material is not in contact with the railhead, there is no physical barrier preventing the occurrence of lipping (see figure 9).
