# Development and implementation of novel cryogenic railhead cleaning technology

## TECHNICAL ARTICLE

**The PWI Journal**  
**April 2020**

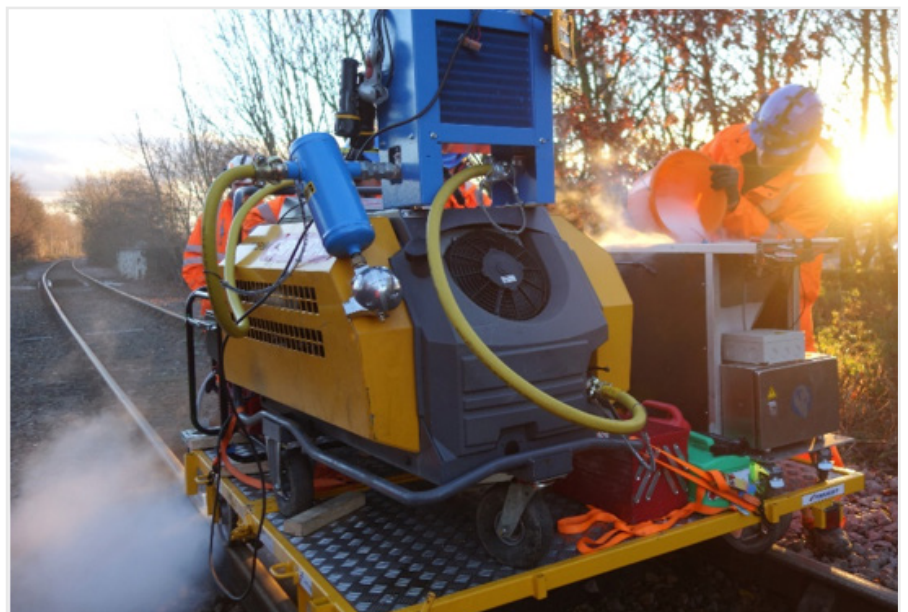
Image 1: The track trolley mounted equipment in use on a low traffic freight line in South Yorkshire.

Initial field trials funded by Arriva Rail North were conducted over 12 sessions during autumn 2018 on a low traffic freight line prone to heavy leaf contamination. Typically no treatment is conducted on the freight line, although it is notorious for low adhesion, to the extent that it is used for TOC (train operating company) low adhesion driver training. The equipment was scaled to enable mounting on a Type B rail track trolley, as shown in image 1. Although treatment speed was limited to walking pace, it was an opportunity to regularly clean a black leaf layer.

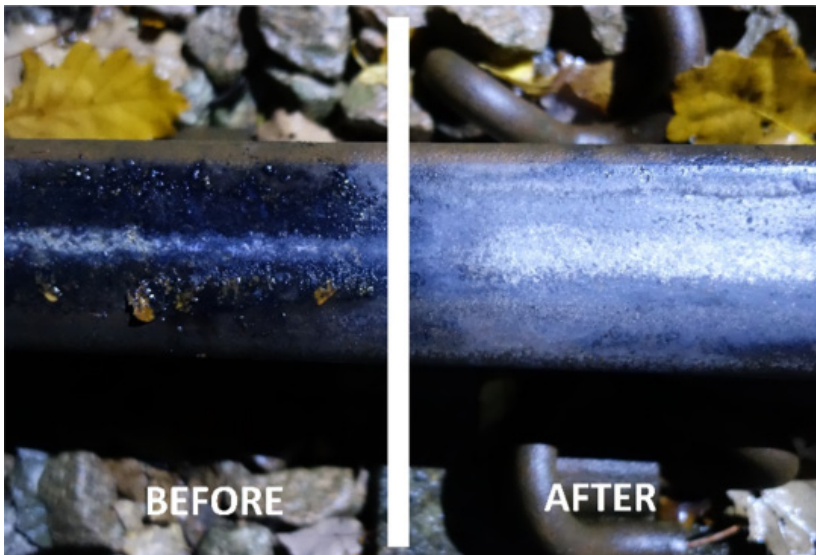
Image 2: A photograph showing where cryogenic cleaning of the 'blackened leaf layer' has stopped.

The trials were shown to be a great success, with the blackened leaf layer being visibly removed (image 2), particularly in the running band on each treatment date (twice weekly November - January). The blasting nozzles

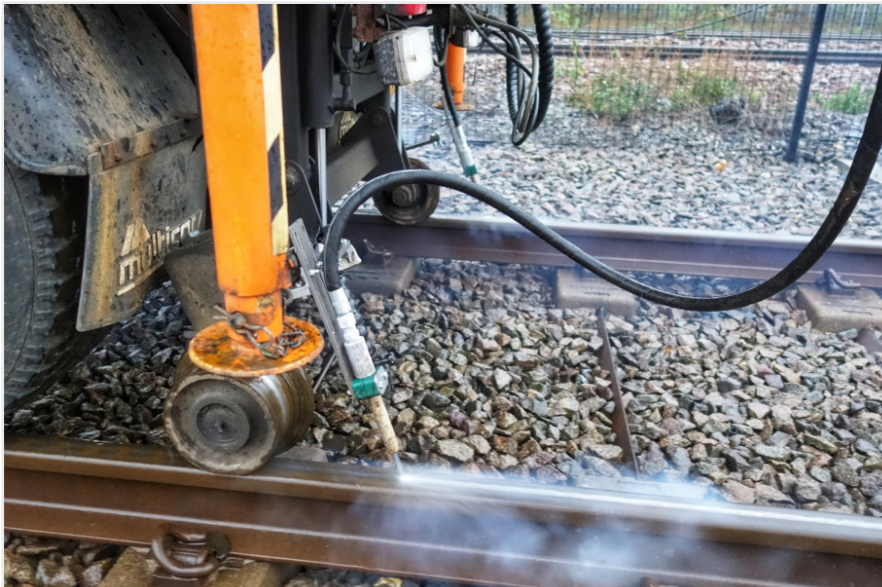
Image 3: The cryogenic cleaning system mounted on the RRV multicar at Sheffield Supertram depot, cleaning heavily oxidised track.

To demonstrate how the application could be successfully used in the field, the cryogenic cleaning equipment was mounted onto a road rail vehicle (RRV) with collaboration from the light rail operator Stagecoach Supertram (Sheffield). The cleaning equipment was mounted on the flatbed of the 'multicar' RRV, while the blasting nozzles were mounted on the rear rail wheel axle. Mounting in this manner ensured that when in road transport mode, the nozzles were lifted clear and protected but were ready for use as soon as the vehicle mounted the rails. The equipment was trialled on a heavily oxidised track in the Supertram depot (image 3). The running band was effectively cleaned in a single pass, at an operations speed of 10 mph. Image 4 shows a still taken from one of the nozzle cameras, showing the running band being cleaned, but also the removal of water from the railhead, present from heavy rain on the day of the trials.

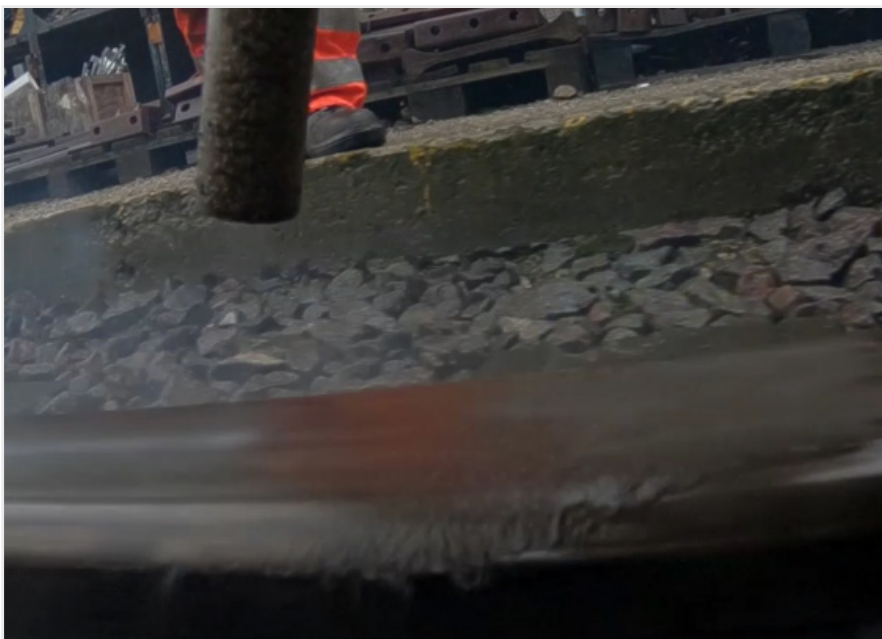
Image 4: A still from the nozzle camera showing water being removed from the railhead.

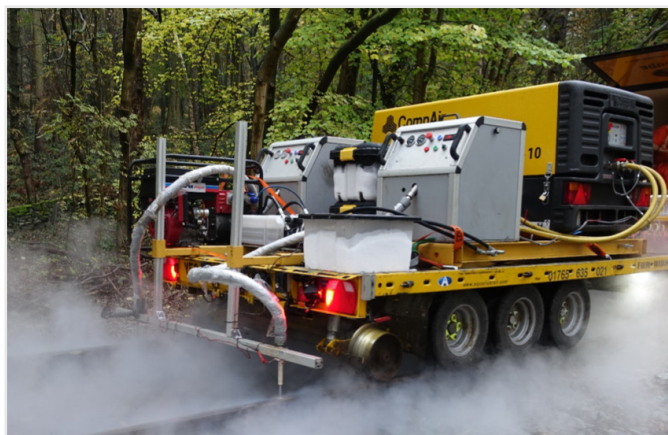
Image 5: The RRV trailer mounted cryogenic cleaning skid in operation.

For the use as a railhead cleaning device a prototype skid was developed, carrying the air compressor, generator and specialist dry ice blasting units developed by The University of Sheffield. The skid was constructed for ease of use, both during transport and on site. All components were securely fastened to the skid, which was fitted with hydraulic outriggers, meaning the skid could easily be mounted onto existing road rail trailers (image 5), propelled by typical RRVs. An electrical control box could quickly be connected and removed, enabling remote operation and monitoring of equipment from the RRV cab. Wireless cameras provided a live feed of each nozzle cleaning the railhead

The cryogenic cleaning equipment performed well overall; some teething issues were identified such as the importance of weatherproofing. The RRV trailer mounted skid system was found to provide extra flexibility through the self-loading nature, meaning that the transport logistics across the country were simplified.

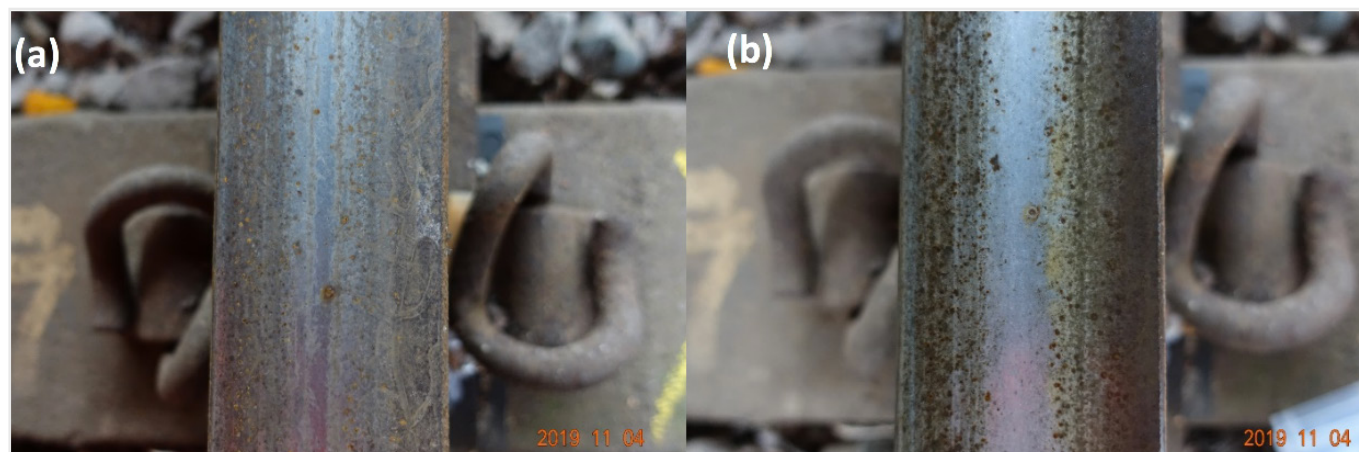
Image 7: Contaminated untreated railhead (a), treated cleaned railhead (b)

The swab results for one of the other test sites, at Deepcar, gave similar results to those at Oban/Connel and these are shown in figure 4. Image 7 shows images of rails at the Deepcar test site before and after treatment indicating that the rail surface has been cleaned.
