# Central Rail Systems Alliance

Newark Crossing Renewal – August 2019

Newark Crossing a.k.a:  
Newark Flat Crossing  
Newark 'Star'  
Newark 'Diamond'

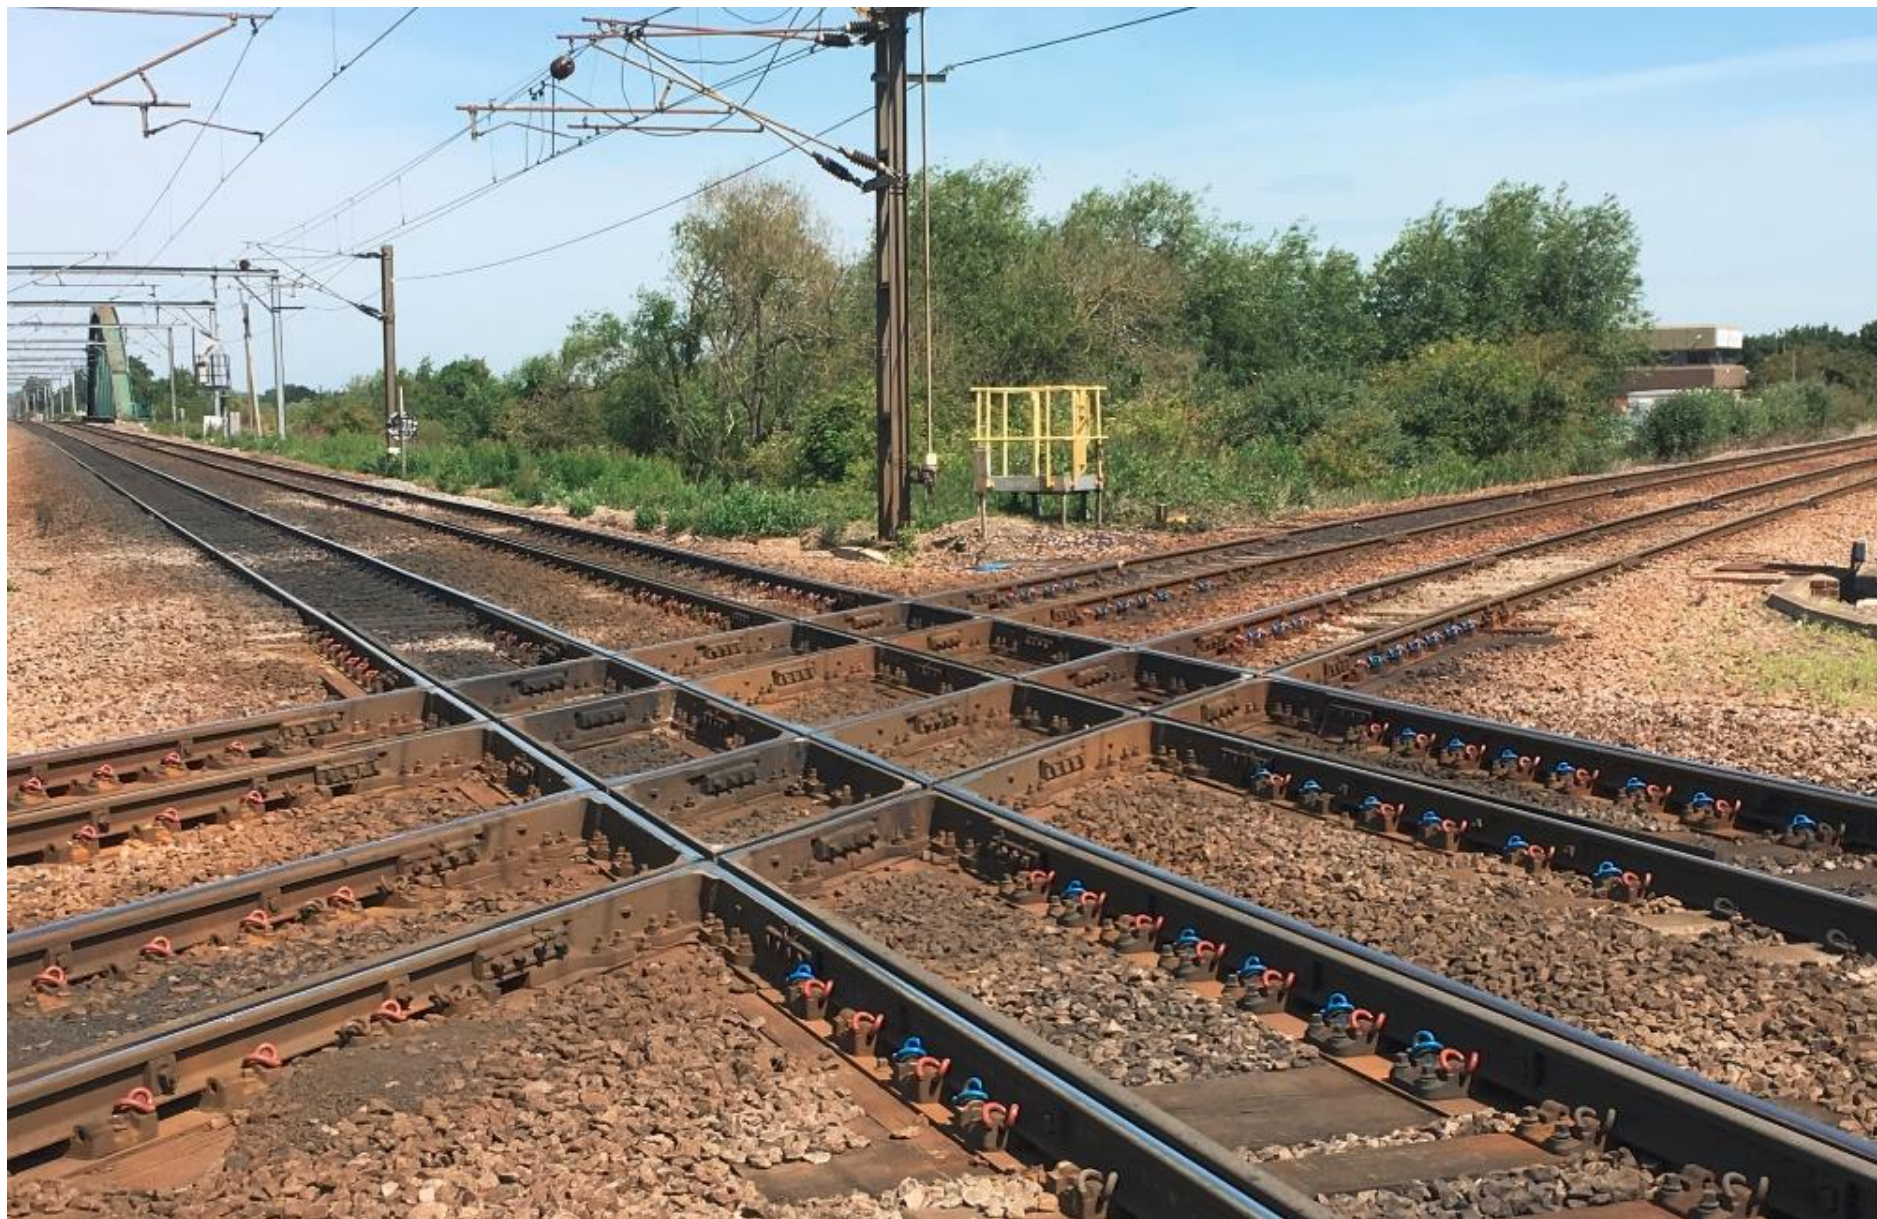
Comprises 8 x 'double star'  
crossings on longitudinal  
timber structure

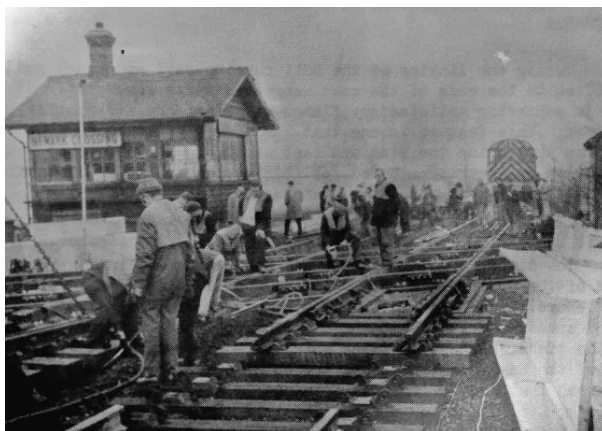
Nov  
1972

Planning and execution of the installation was the responsibility of the Area Assistant Divisional Civil Engineer, Doncaster, who was in attendance throughout the two shifts with his Assistant. Remaining personnel employed over the weekend 5th/6th November, 1972, were as follows :-

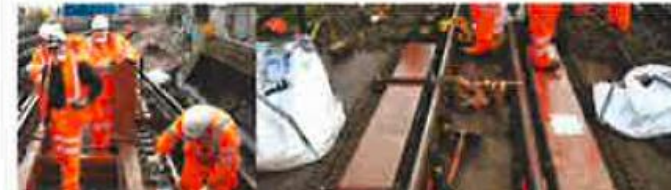
### Product Image

Sekisui Chemical GmbH Fibre-reinforced Foamed Urethane (FFU) longitudinal baulks – in the directly fastened and cross-sleeper (bridge sleeper) configurations.

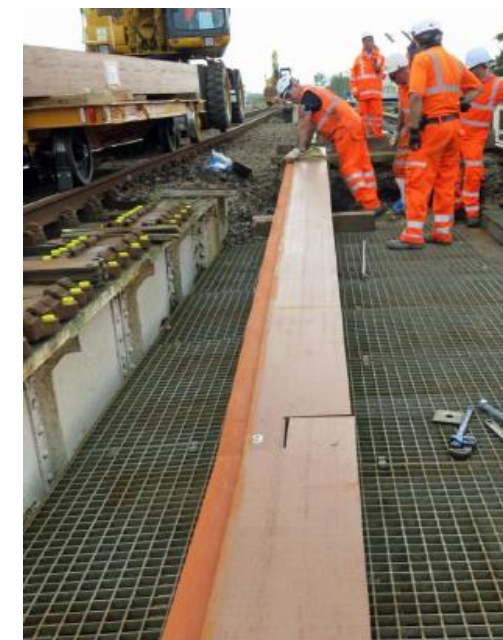
## Pultrusion process

Continuous glass-fibre and Polyurethane  
FFU sleepers are manufactured by  
Pultrusion.

Glass fibers are soaked in polyurethane  
and the linkage is then hardened at a  
raised temperature

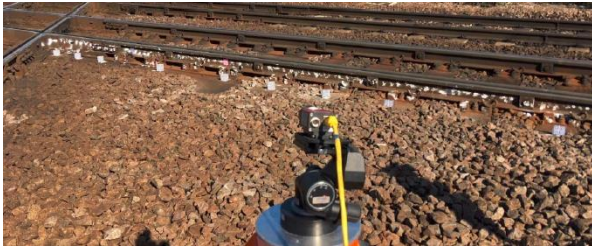
The track system at Newark is a ballasted track system, the design recommendation aims to reduce ballast settlement, future maintenance interventions and the development of significant track geometry faults.

Track Bed Investigation, on site deflection measurements, and FEM undertaken.

Results have determined:

- Poor track quality caused by high dynamic forces and ballast attrition.
- Existing geocells in good condition.

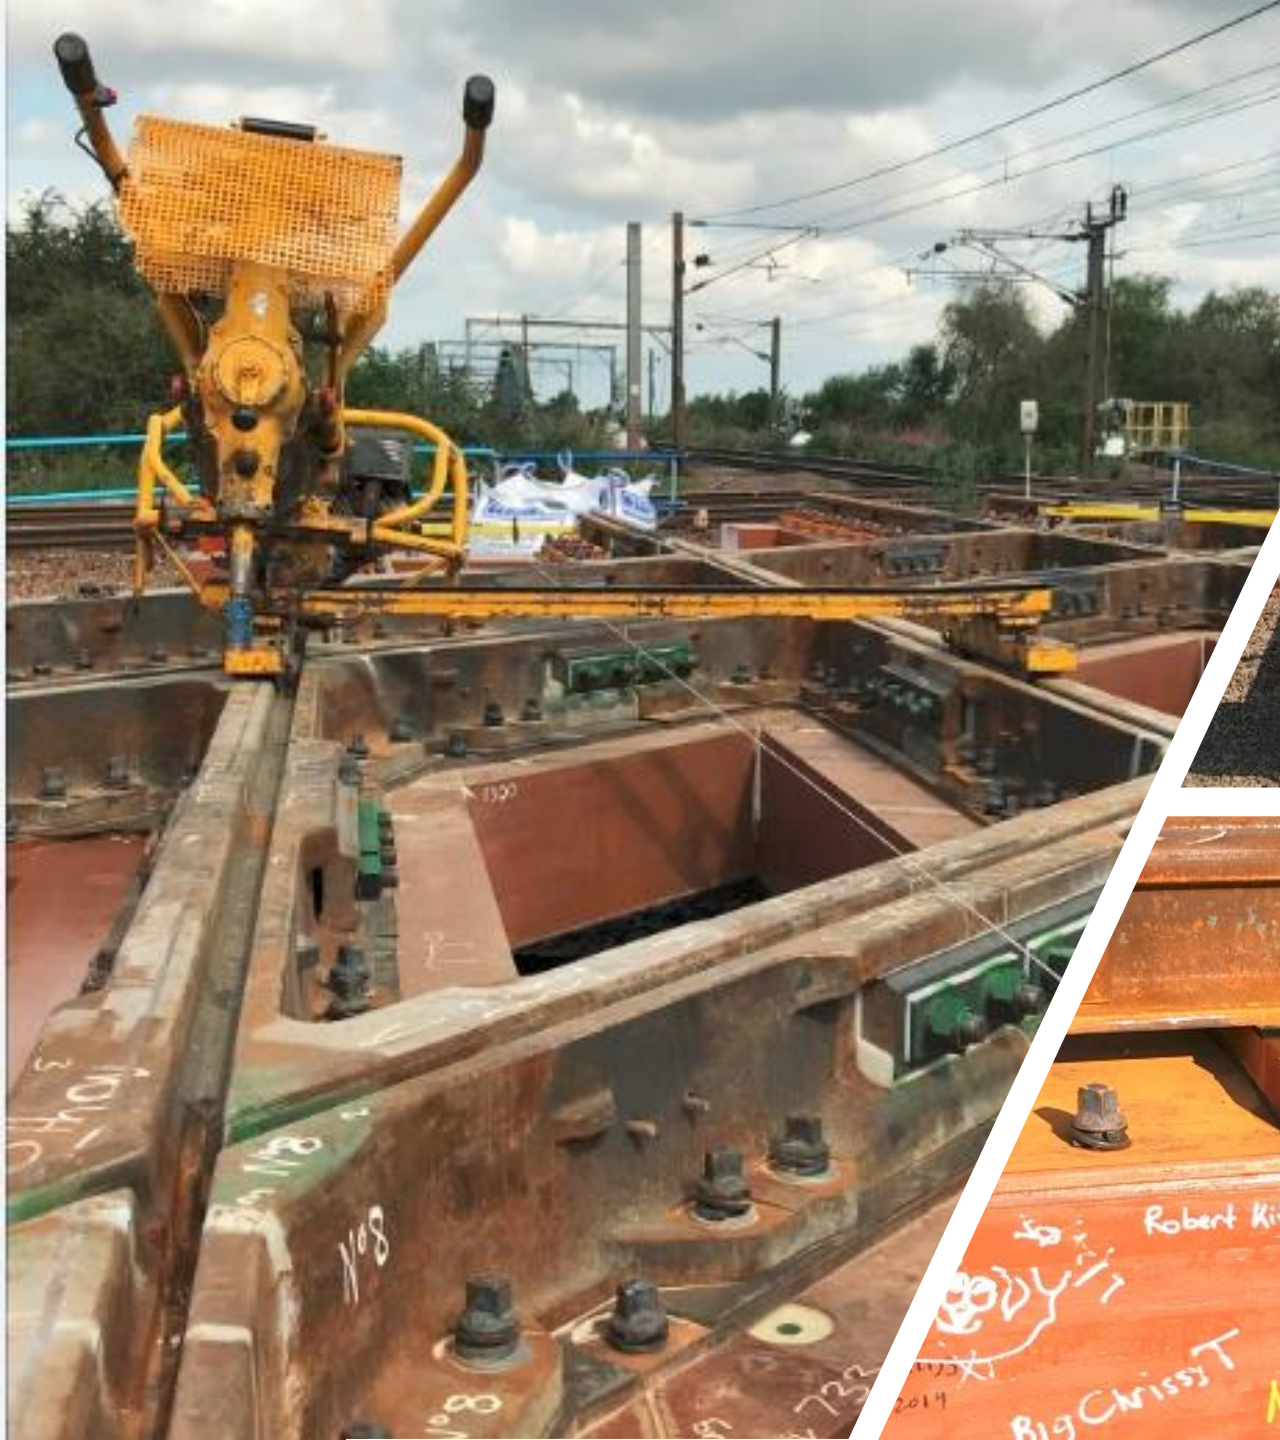
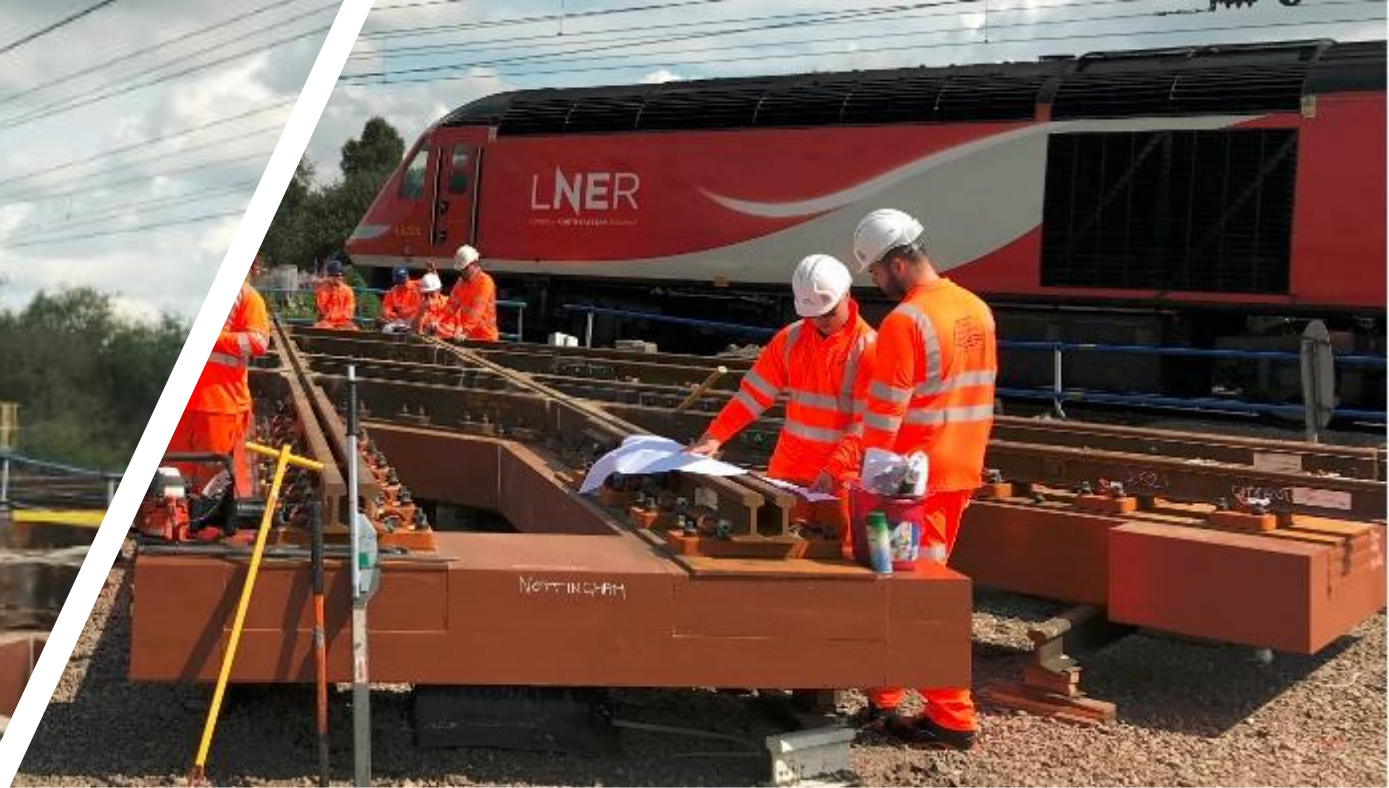
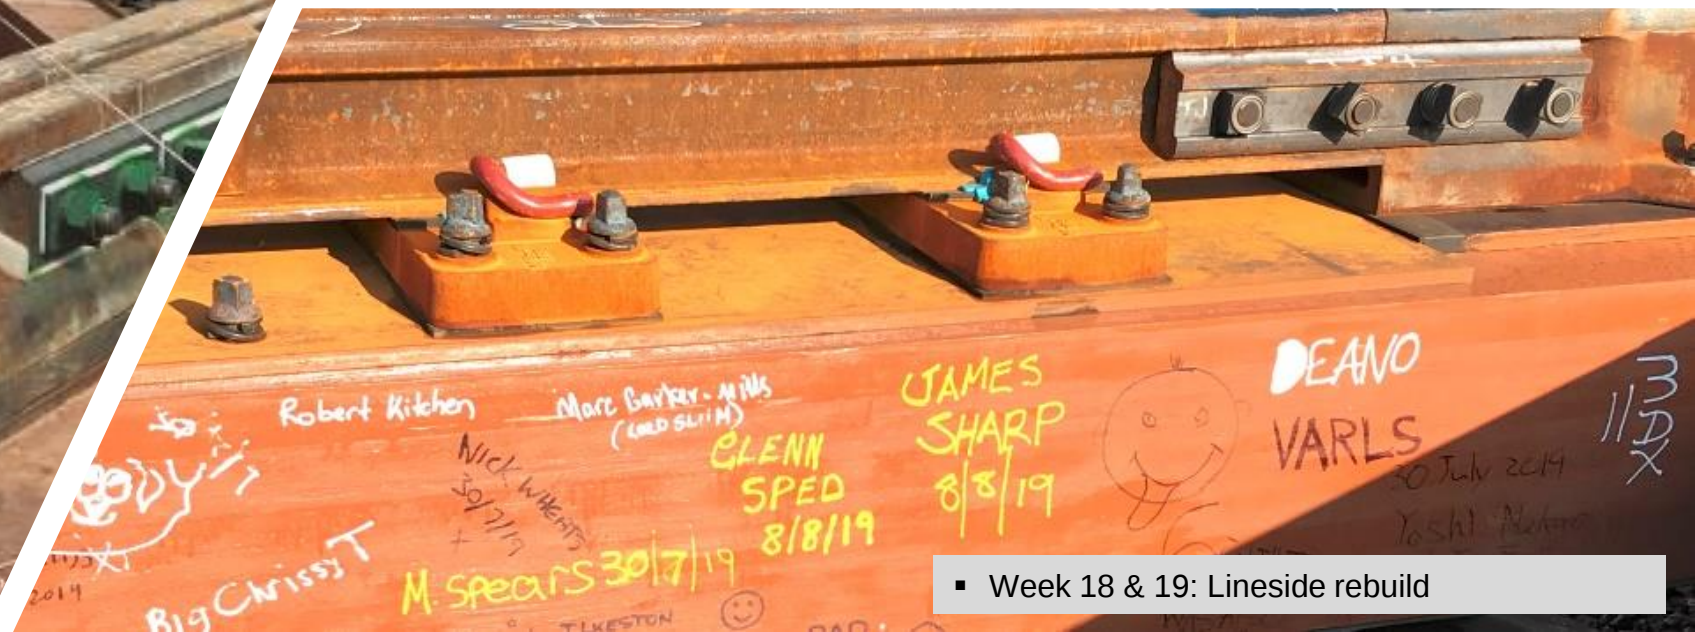
■ Week 18: Offload bearers on site

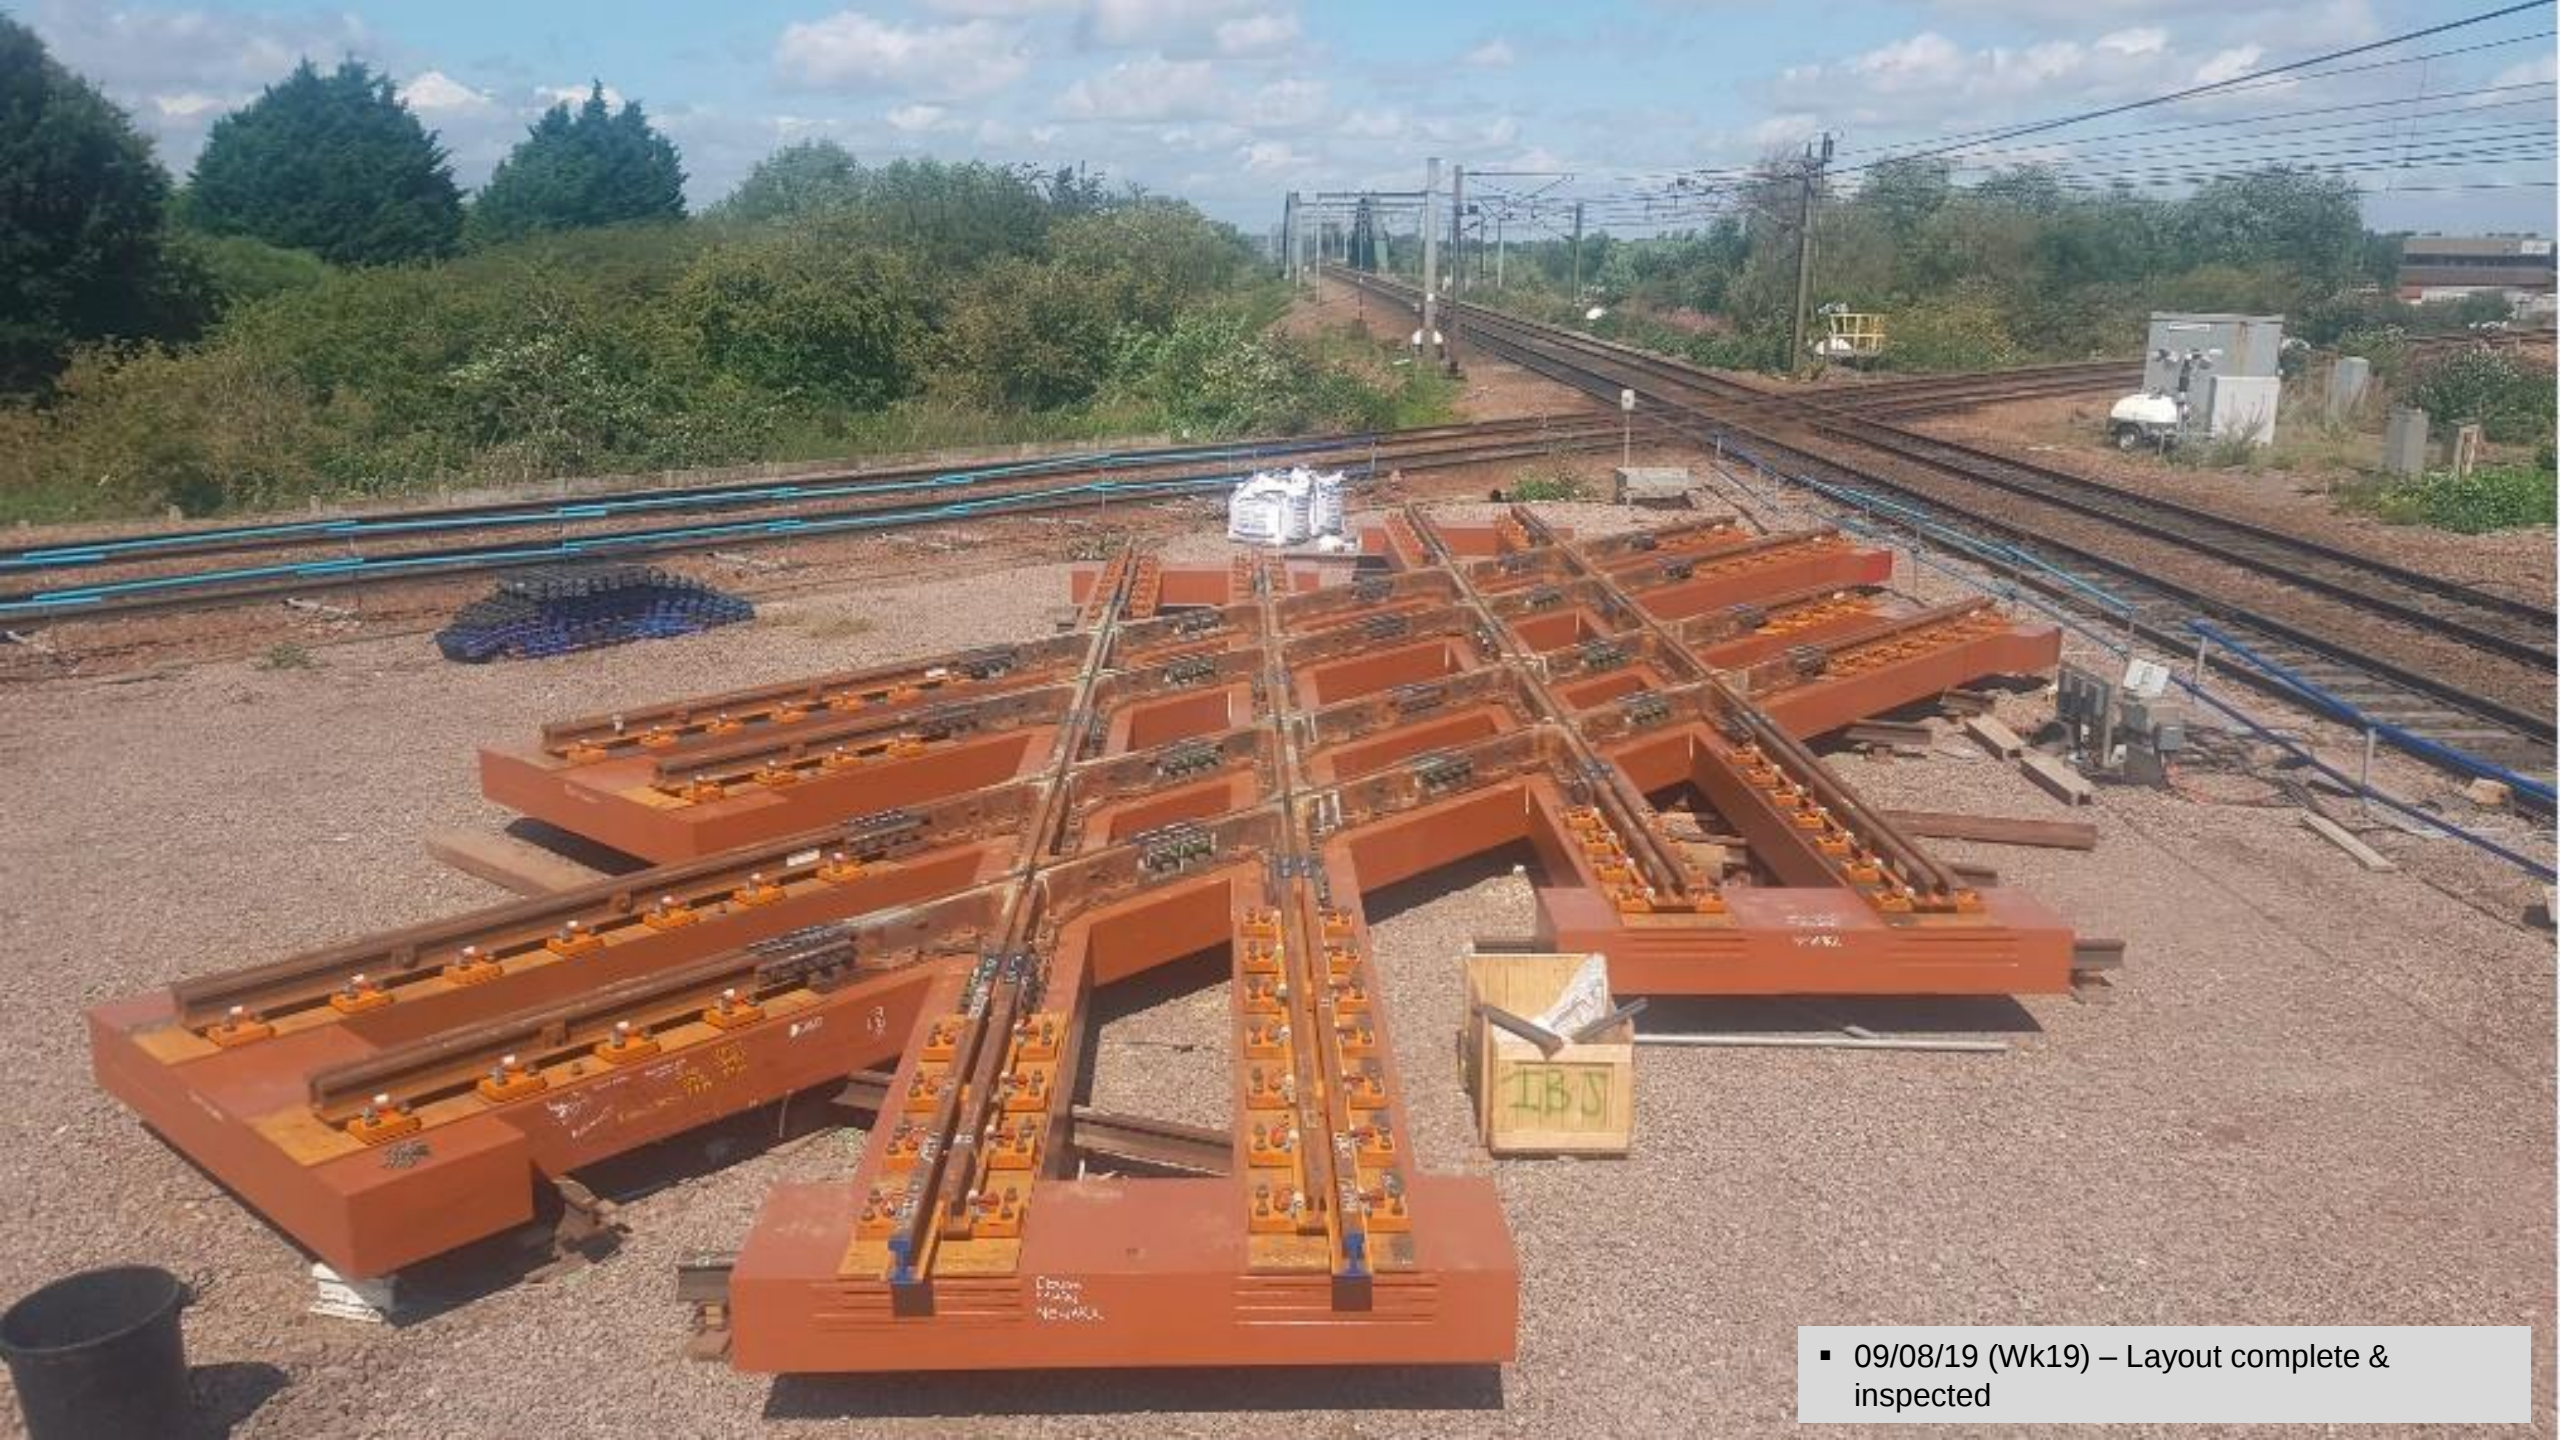
■ Week 18 & 19: Lineside rebuild

- 09/08/19 (Wk19) – Layout complete & inspected

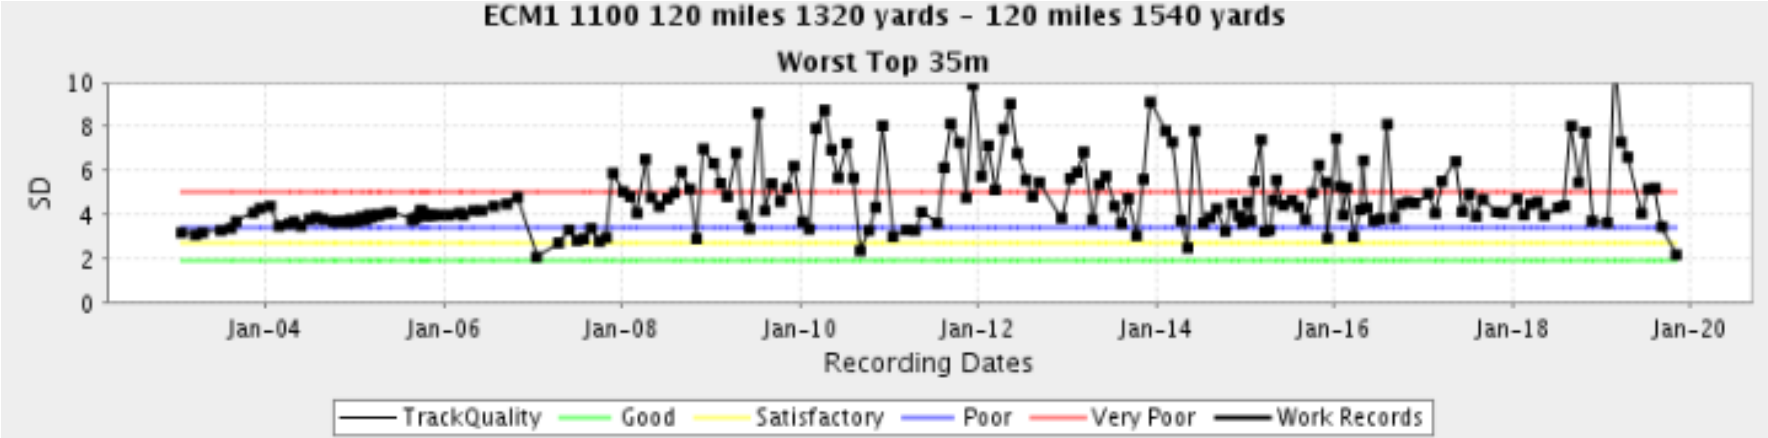
Historic TQ trend

- Renewal / major intervention every 15 to 20 years.
- Track quality in the poor / very poor band soon after each renewal.
- Ballast degraded below sleeper base (Trackbed Investigation).
- Timbers now life expired / visual inspection not easy (ballast glued) and cannot be maintained – risk of CoT TSR/ESR if not renewed.

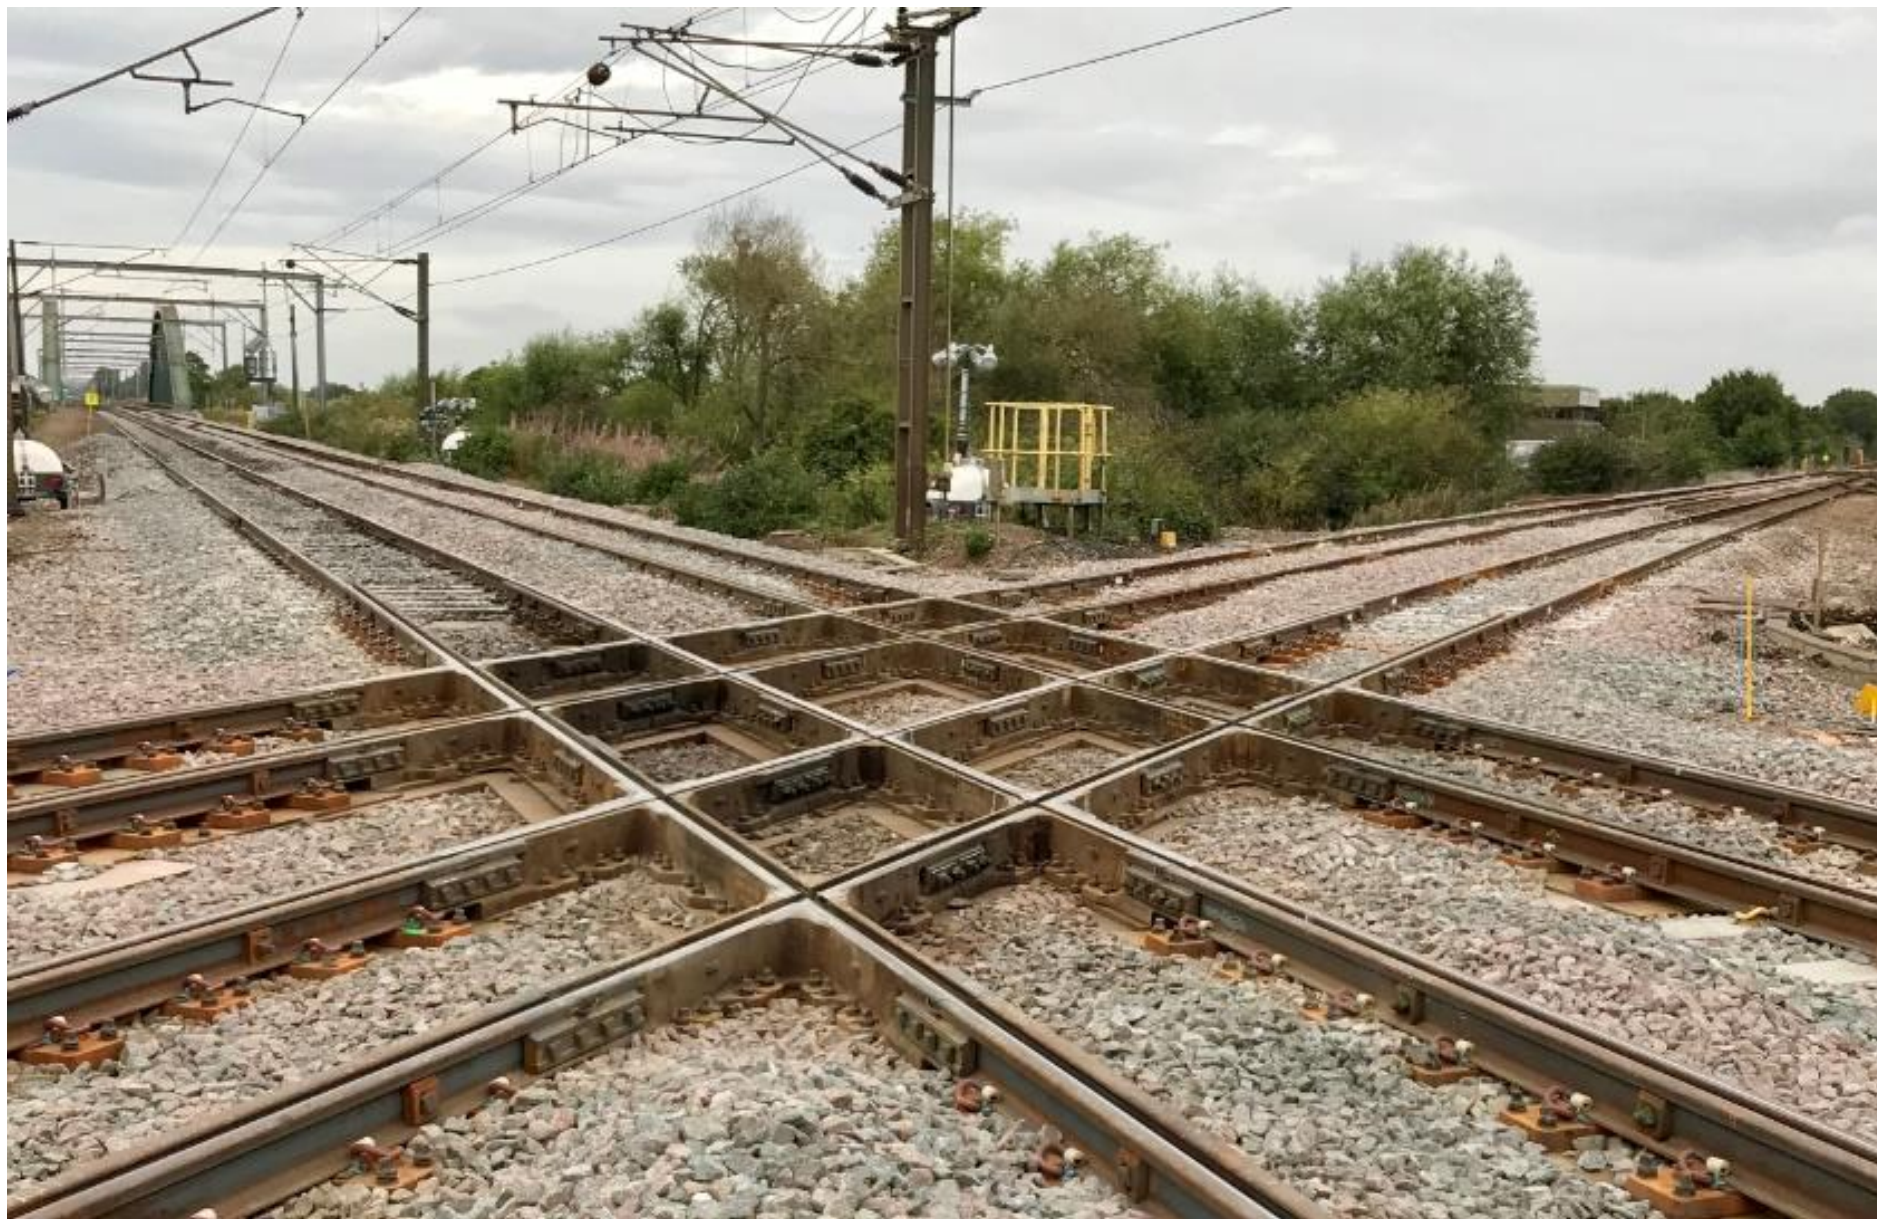
After

# Spot the difference.....
