# PWI Winter Seminar

## Crossings

# Crossings – the challenge ahead

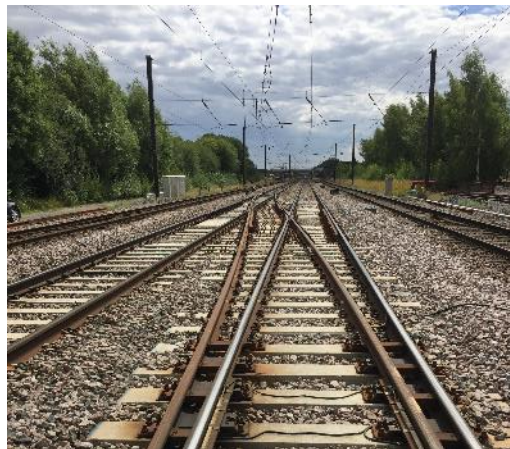
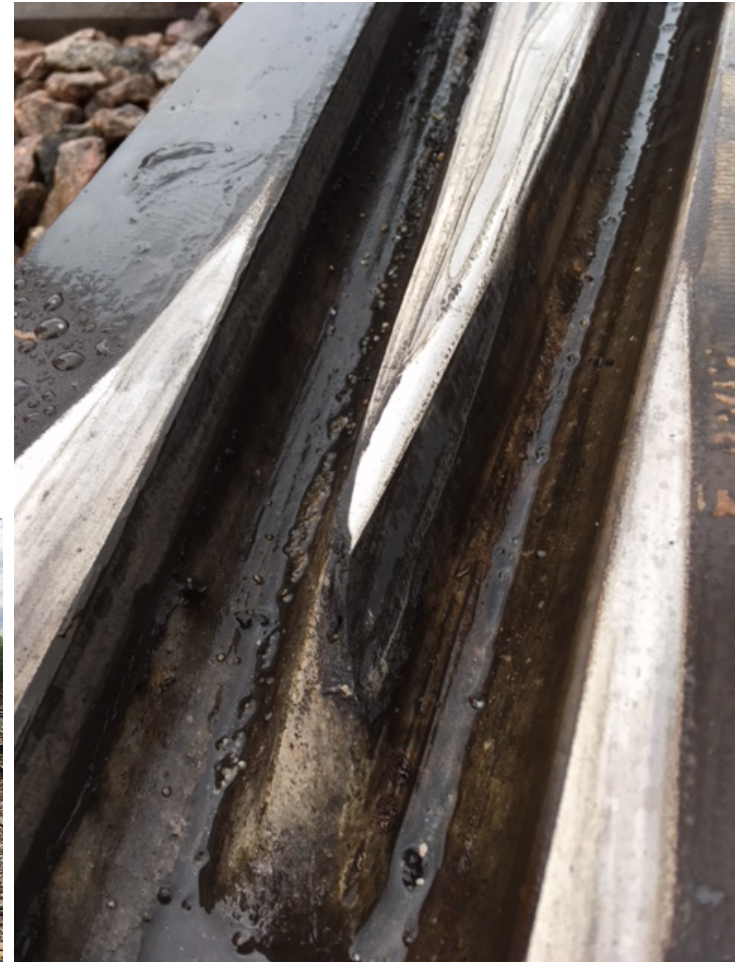
In essence, move towards NR56 Mk2 design

NR60 Mk2 success

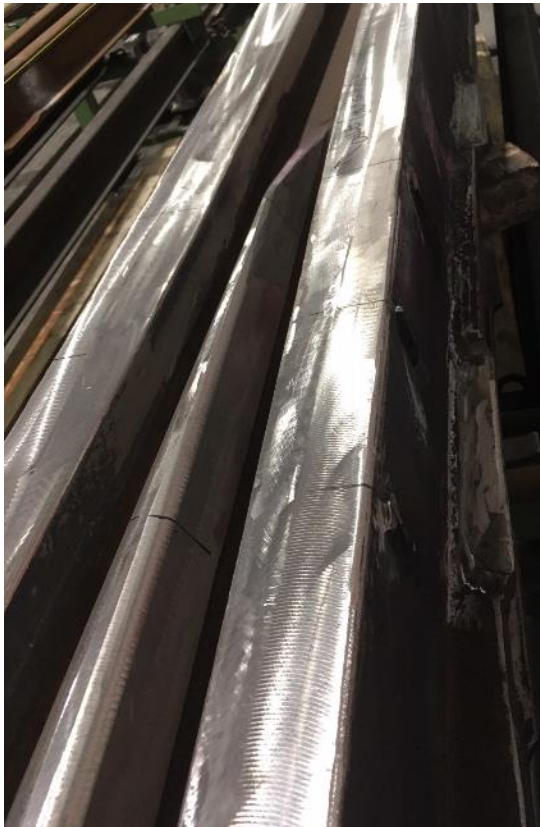
R&D funding to explore options and optimise wheel rail interface  
Estimated £24m a year on crossings (replacement and delay penalties)
