# Runcorn Viaduct

Refurbishment 2017-2018

# Introduction

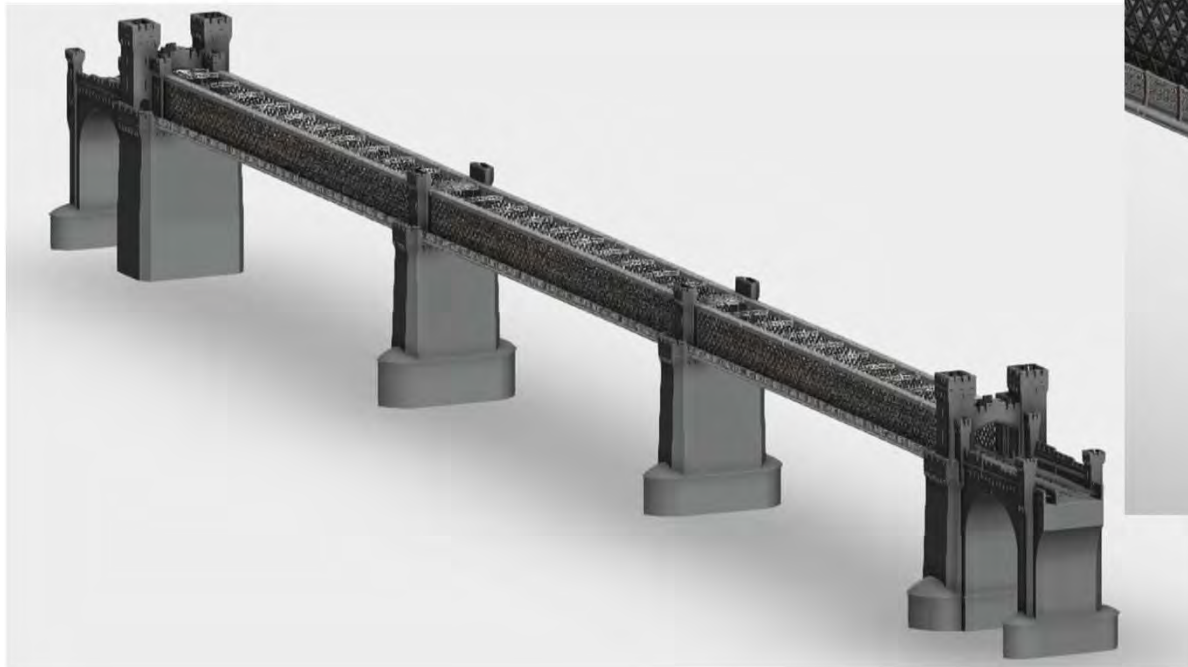
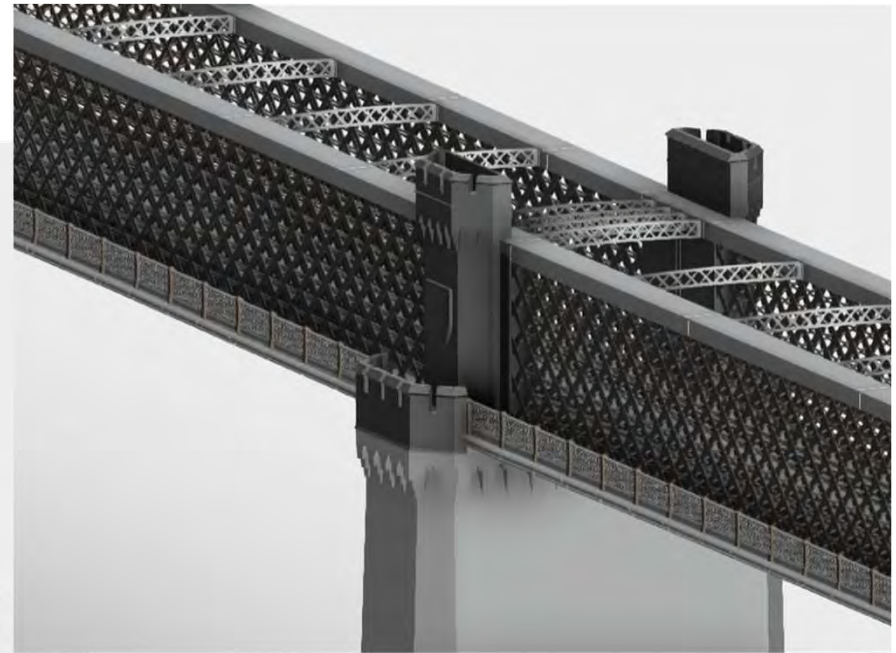
# 3D Survey and Model

- Bridge condition inspection by roped access
- 3D survey using combination of drone and ground measurements
- Intrusive works in the piers
- Structural assessment using 3D FEA models
- Initial feasibility of bearing replacement
- Identified urgent maintenance required to East Walkway, Fenders and drainage system. Historic navigation bell at risk of being lost

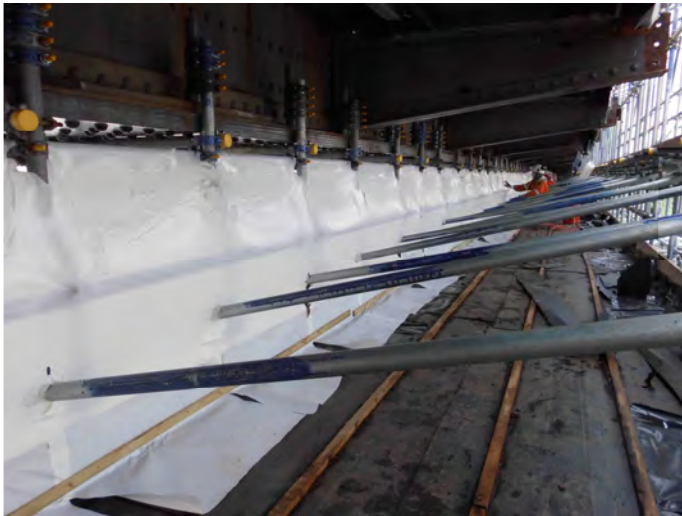
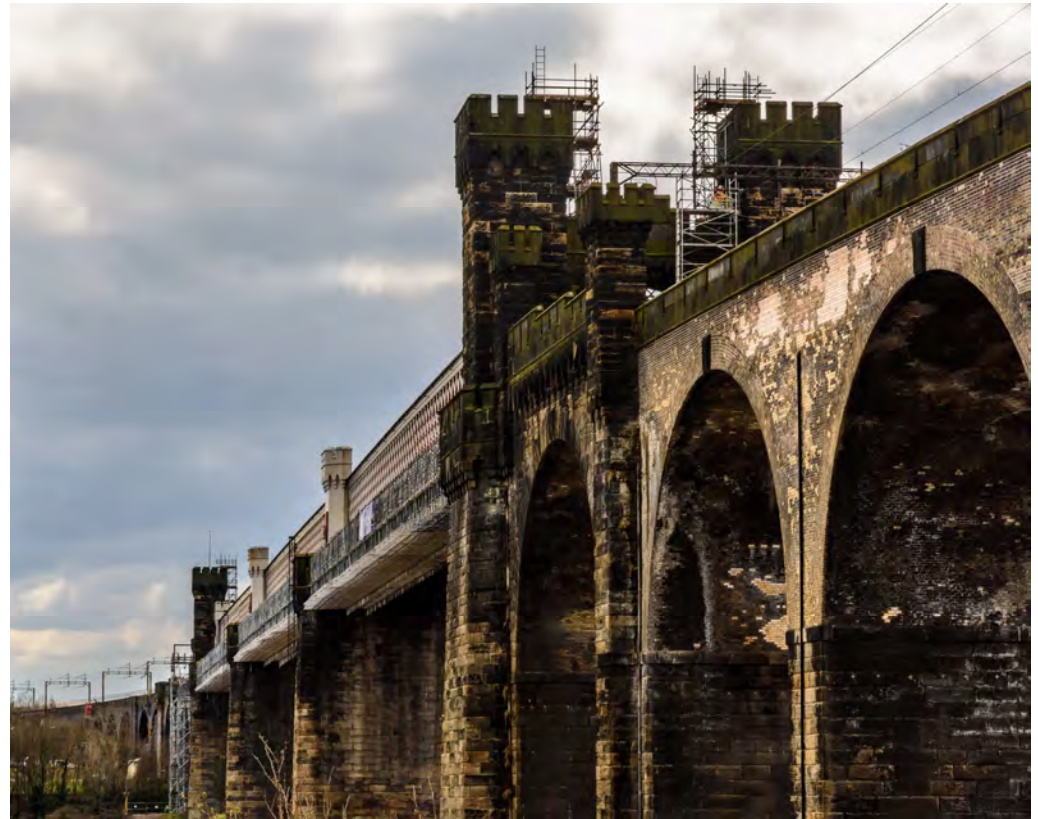
# Temporary Works

- 3no. 90m length suspended scaffolds with full encapsulation for grit blast and paint.
- Load assessment by Arcadis.

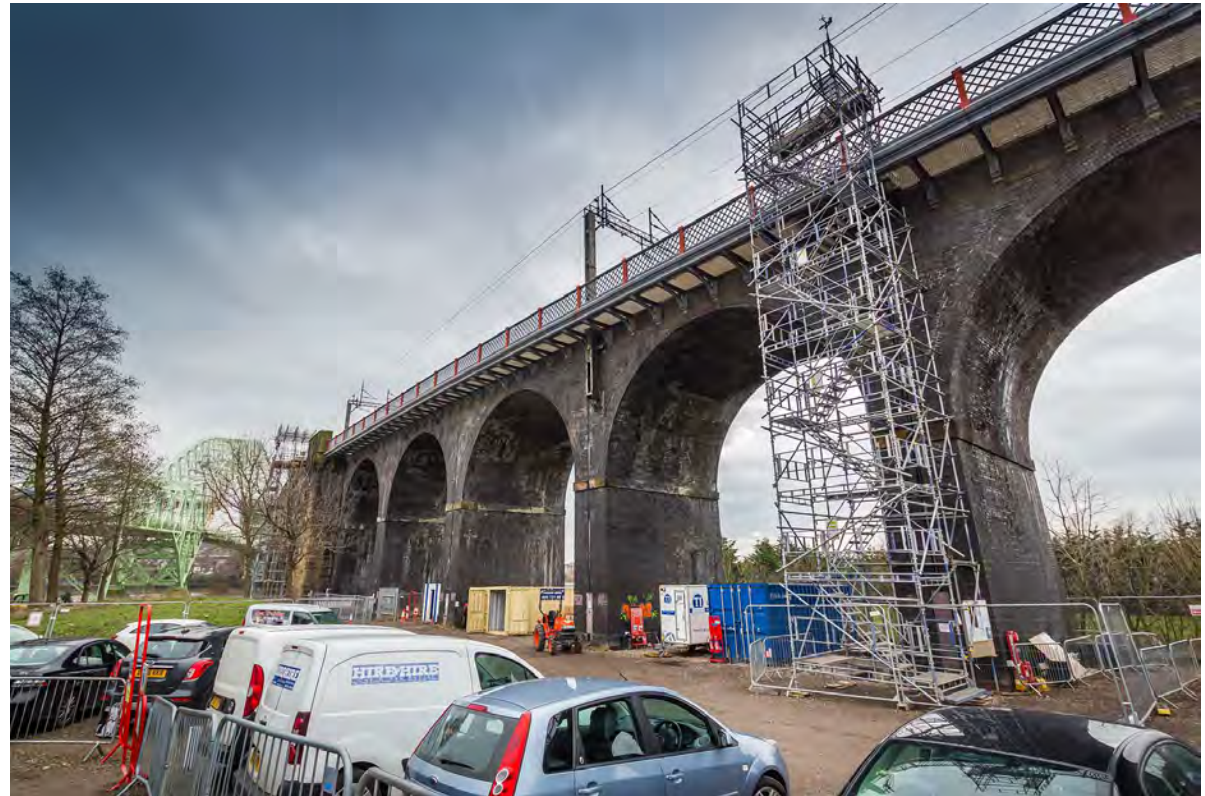
# Temporary Works

- 2no. 20m high Loading bays (one each end of structure) and 'Haki' staircases.
- Scaffold jetties in the estuary and ship canal for safety boat
- Turret access scaffolds

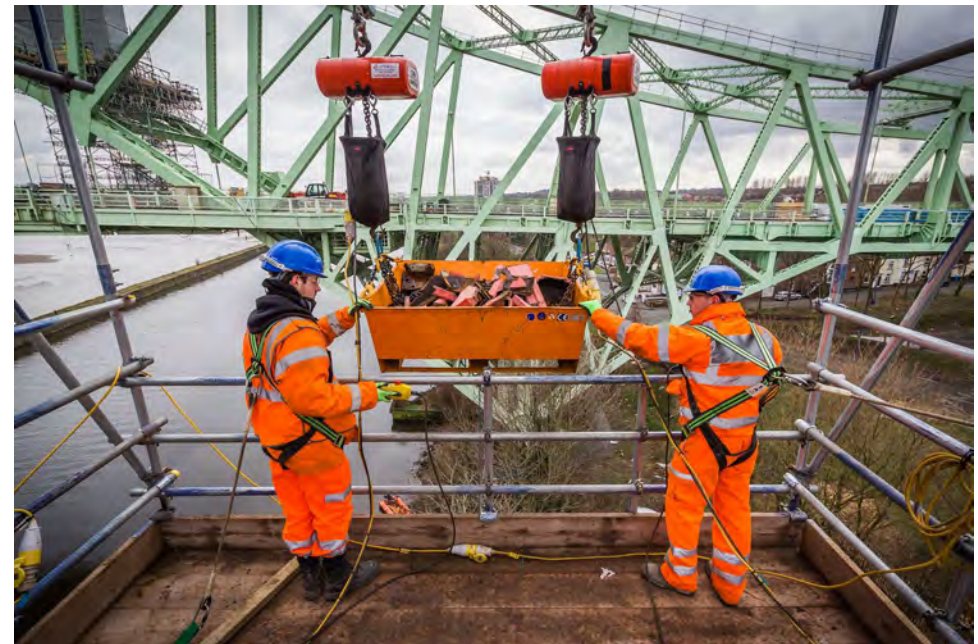
# Design Close Call

- During works a risk was identified where personnel were leaning out to move the cast iron elements due to limited clearance between hoists and scaffold handrails
- Scaffold design revised to increase clearance and provide attachment points for inertia reel harnesses
- Longer 'Niko Rail' with longer projections to avoid manual effort
- Alternative hoists used to reduce clearance required

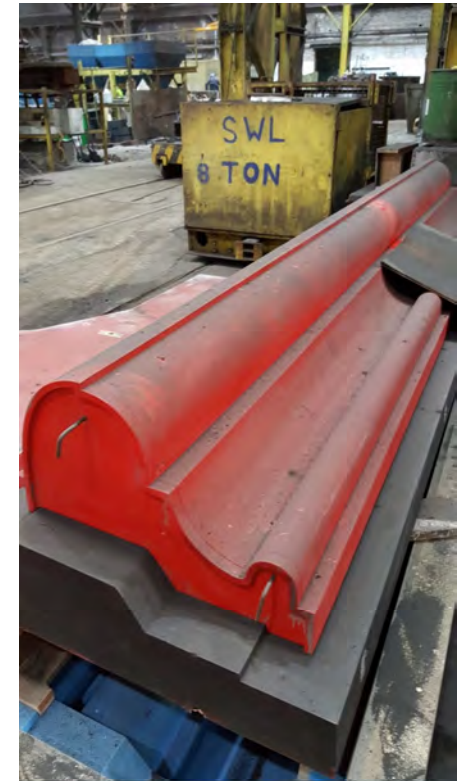
# Parapets - Casting

- November 2017 – initial elements removed from the structure to start production of ‘pattern’ at Shakespeare Foundry, Preston
- Pattern is a reusable timber replica of the element to be cast. The replica has to be around 2% larger than the final element to allow for heat shrinkage
- Pattern making is a skilled carpentry task and takes several weeks

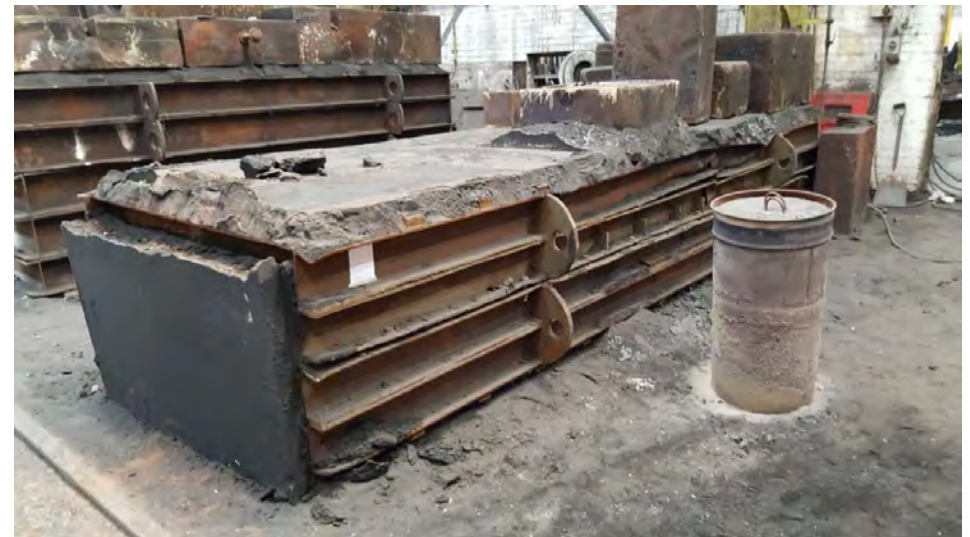
# Parapets – Casting

- Pattern is used to make sand moulds, these can be 'boxed' or 'boxless' ('boxless' requires less floor space but is more expensive)
- 'Sand Core' used for creating internal voids
- A new mould is made for each individual component

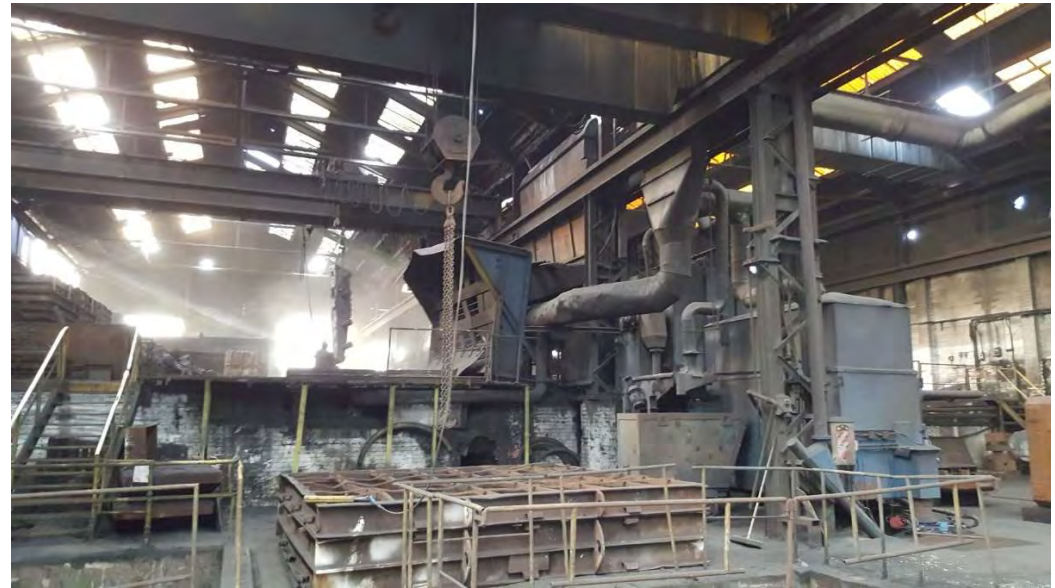
# Parapets – Casting

- Molten iron temperature carefully controlled to prevent 'blow out' of mould (too hot) or internal voids (too cold)
- Casting left in mould for hours/days/weeks depending on volume to prevent warping or fracture
- Bullnose cooling time was 36 hours and was the most difficult to cast
- Concerns over warping of intricate lattice panels

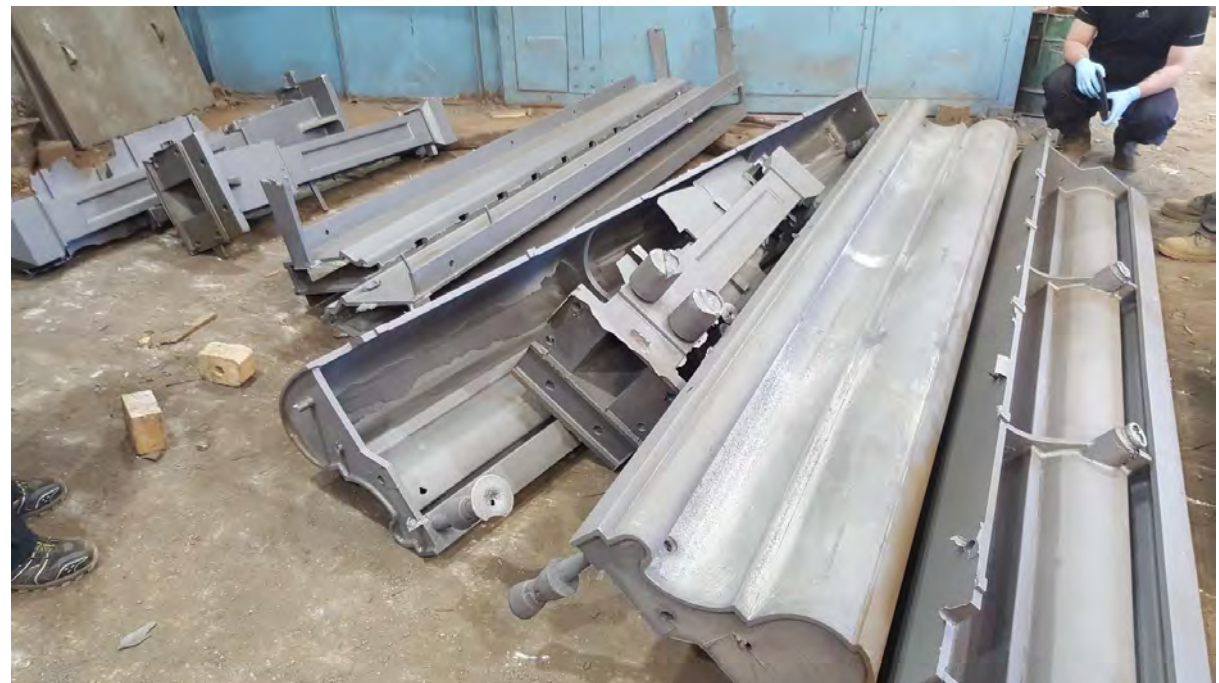
# Parapets - Casting

- Once removed from the mould, the elements require 'fettling' to remove runners and create a surface finish
- Need to define surface finish standard at start of contract using BS EN 1370:2011.

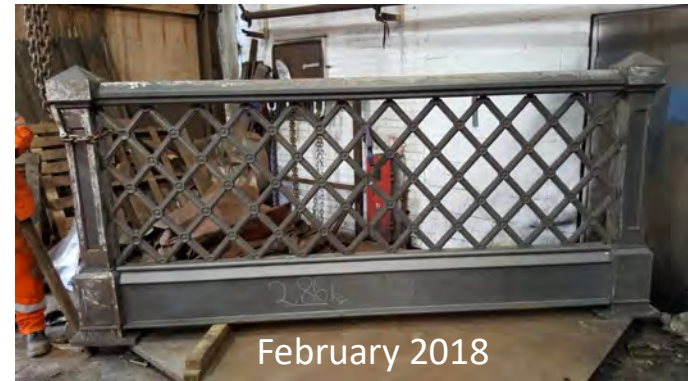
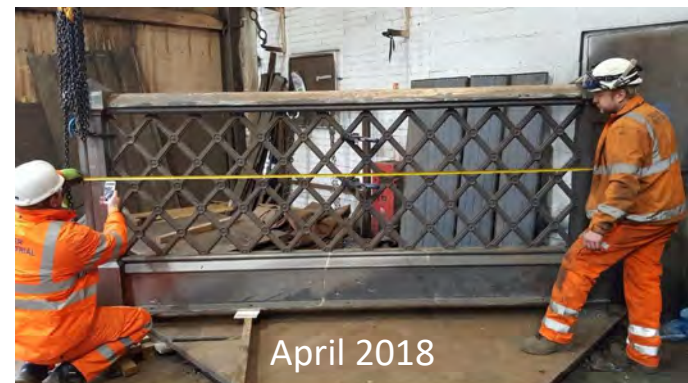
# Parapets- Casting

- First trial erection in Feb 2018, second trial in April 2018 before full production run
- Large area of floor space required for elements limits production rate
- Typically produced 25 elements per week, limited by floor space

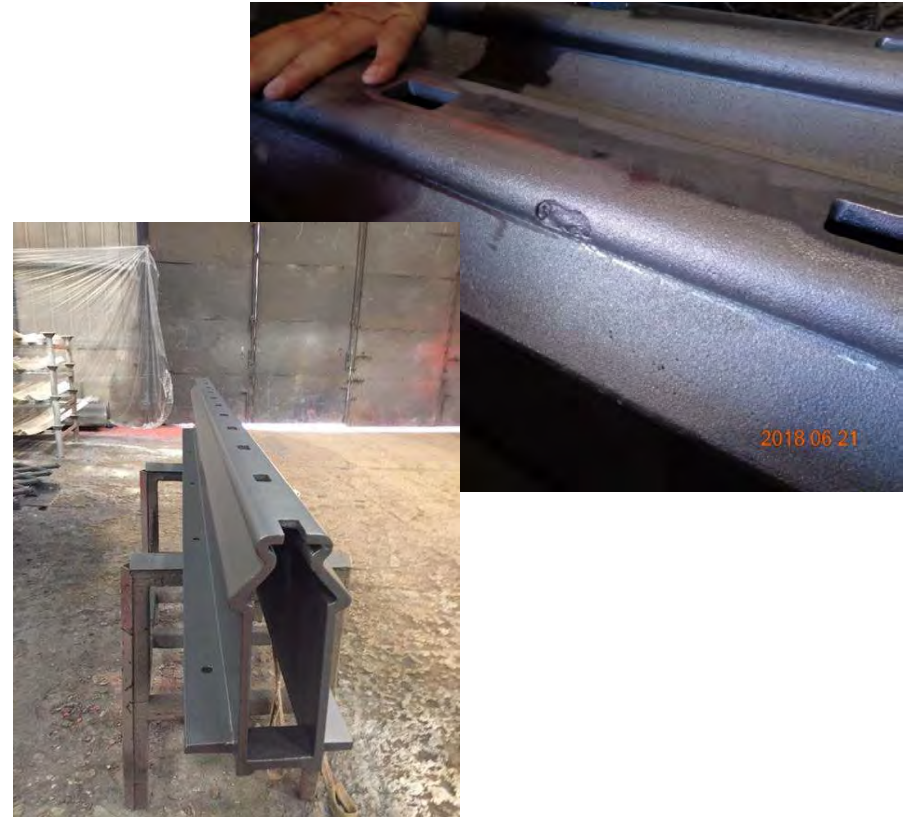
# Parapets- Finishing

- Elements transferred from Foundry to Painters (NL Williams in St Helens)
- Local filling required to rectify minor defects such as blow holes
- Initial issues with surface finish resolved by changing paint setup
- Full M24 paint system required 1 week per item (completed in batches of up to 30)

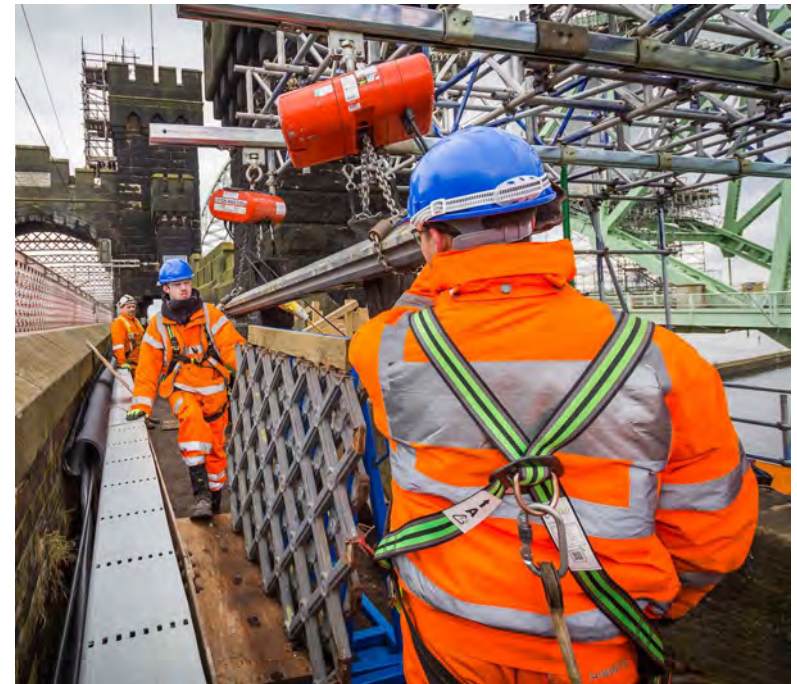
# Parapet Removal / Installation

- Steelwork repairs/painting to the cantilevered support beams before reinstating parapets
- All items individually lifted around 15m using loading bay hoists
- Transported over 200m on trolleys by hand (500kg total weight)
- Able to install up to 6 bays (30 elements) per day but limited by production rate of foundry.
- High risk activities with detailed planning and regular reviews

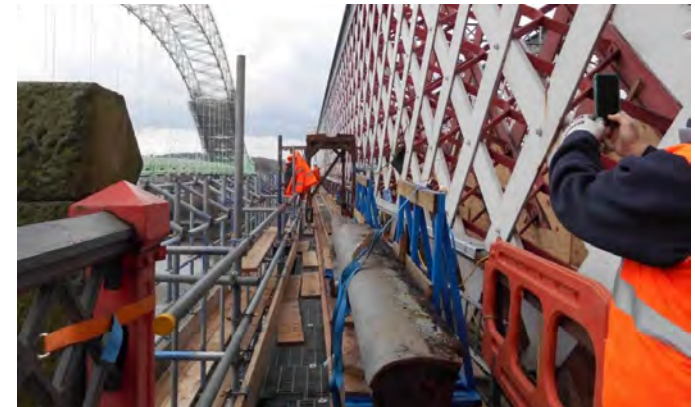
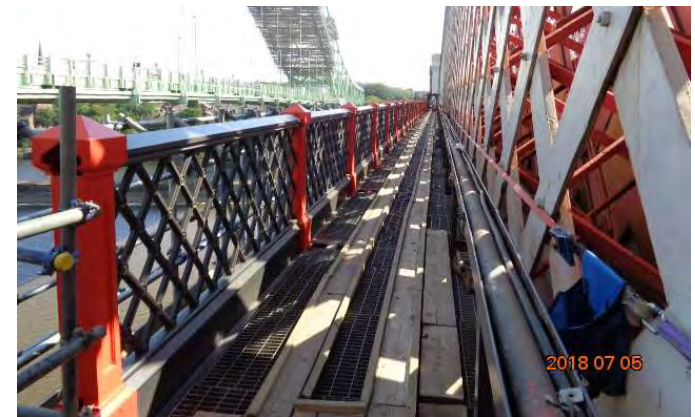
# Parapet Installation

- Bespoke lifting frames critical to successful implementation
- Trolleys and runways used to transport elements from loading bay to working area.
- Challenging logistics to avoid working above the fender refurbishment works.

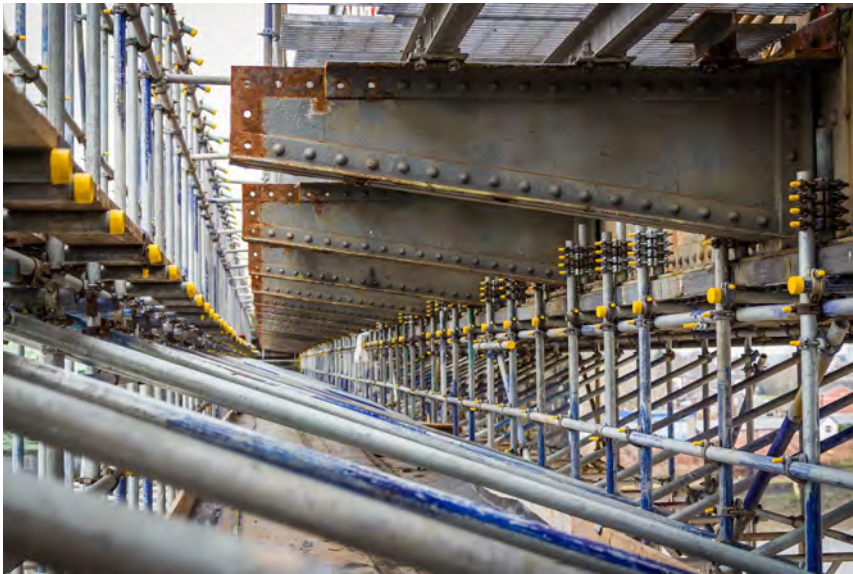
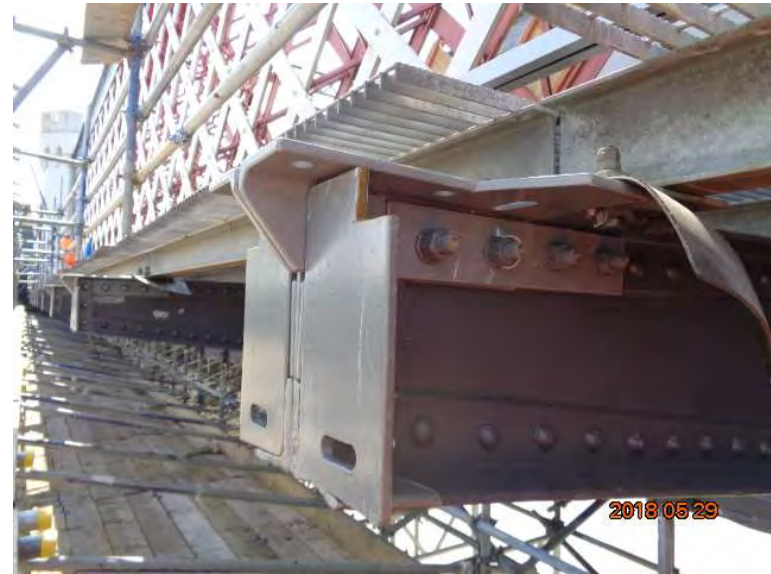
# Steelwork Repairs

- Modifications to cantilever beam ends to allow tolerance for fixed size castings
- Steelwork repairs to beam ends for parapet fixings

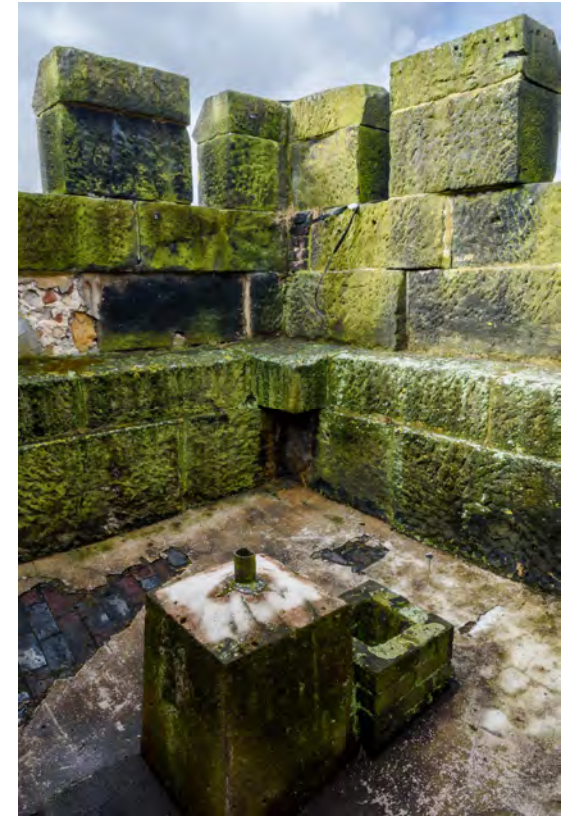
# Runcorn Viaduct – Navigation Bell

- Inaccessible location made repair difficult and expensive
- Future maintenance challenging
- Removed using helicopter organised via NR Air Operations

- After removal, the bell was refurbished and donated to Halton Borough Council by Network Rail
- Listed Building Consent Condition required the Bell to be put on public display if removed.
- Bell exhibition unveiled at Brindley Theatre, Runcorn in October 2018 to coincide with 150 year anniversary of bridge opening

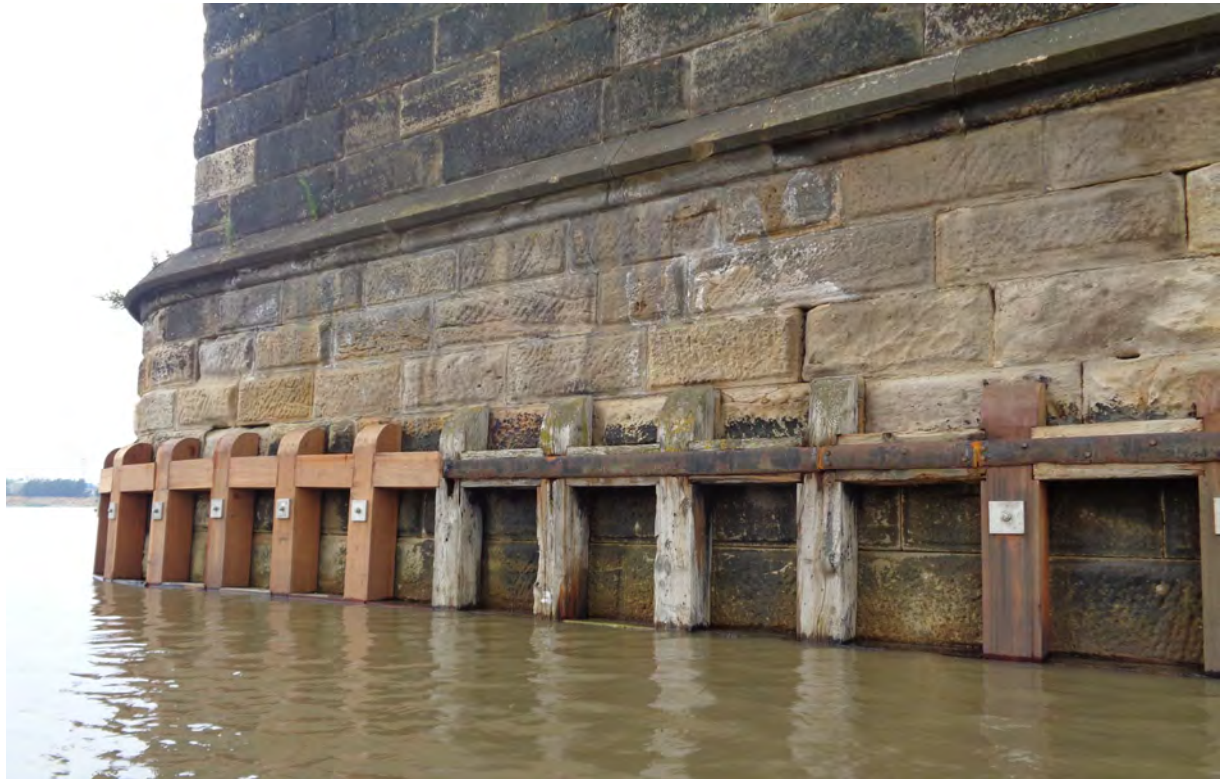
# Pier Fenders

- Refurbishment of Fenders
  - New Sustainably Sourced Ekki Hardwood – 350kg for largest pieces
  - Each piece cut to suit
  - Stainless Steel Anchors
  - Steel bands

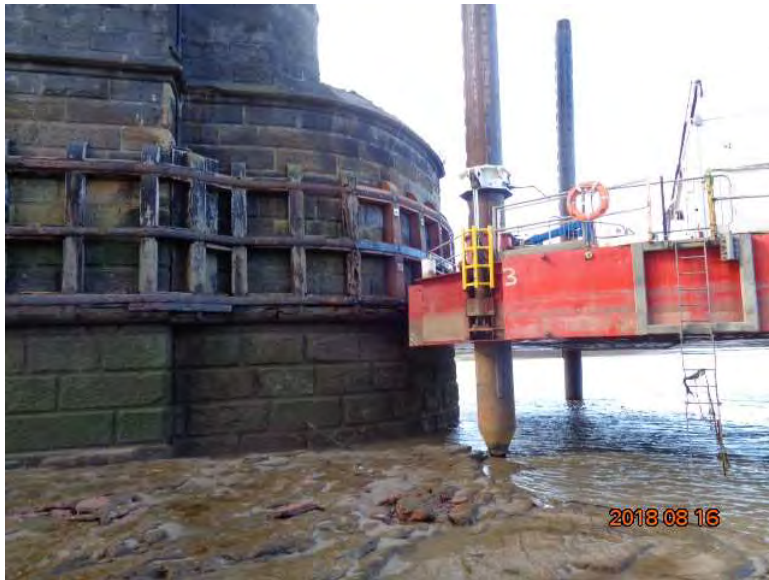
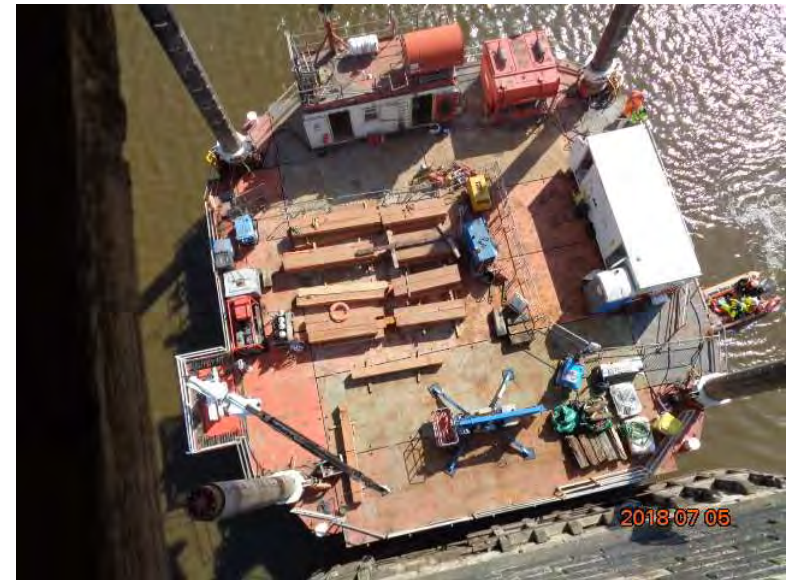
- Challenging marine environment with high flow rates (incoming tide 2 hours, outgoing tide 10 hours)
- Dry river bed for 6 hours every 12 hours

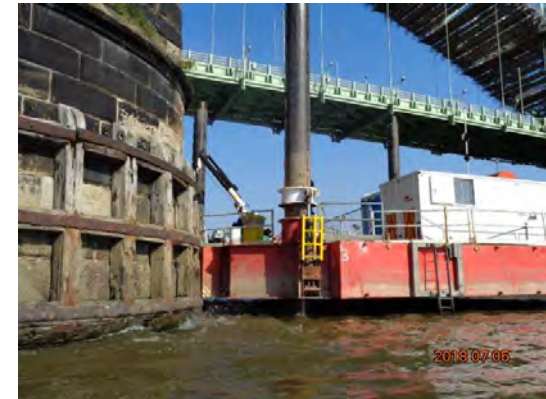
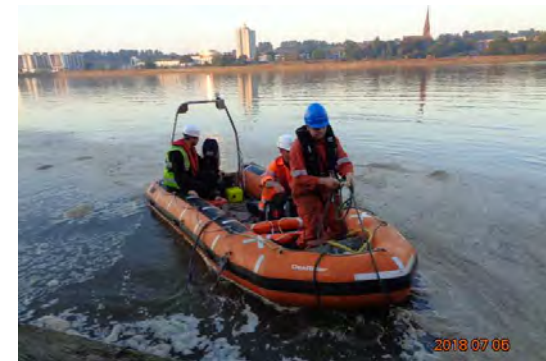
# Pier Fenders

- 18m x 18m modular jack-up barge with hydraulic legs to allow working surface level to be partially independent of tides
- Full welfare facilities on board
- 12 hour shifts to suit the tides. Barge manned 24 hours a day, 7 days a week for 7 weeks
- Only accessible at high tide by boat from Widnes 'Public Jetty'
- Fatigue management

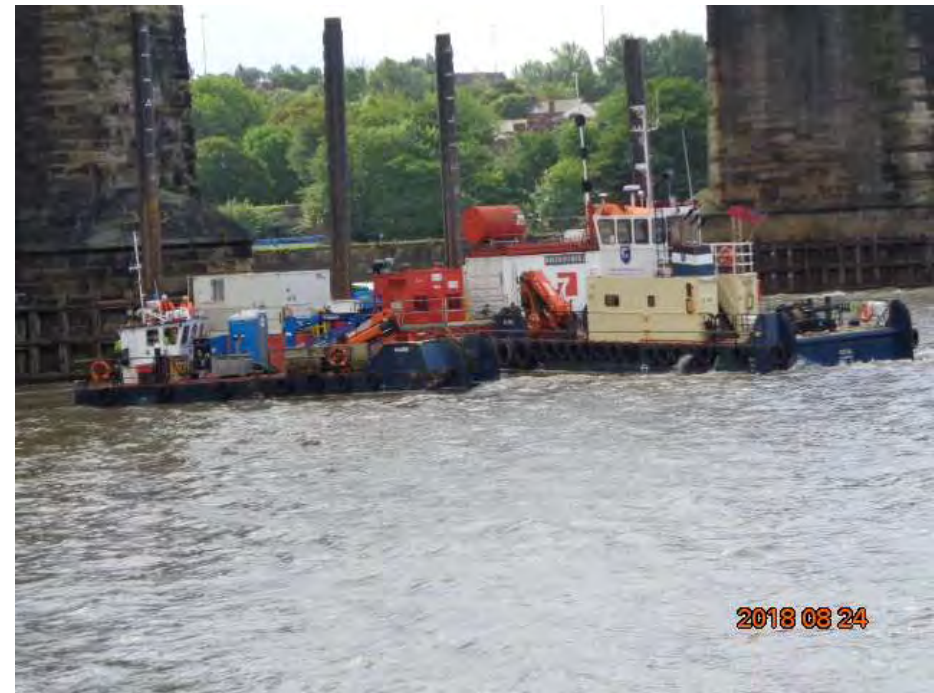
# Pier Fenders

- Jack-up rig could only be moved and re-supplied at high tide
- Tug boat follows the high tide to the bridge bringing new materials
- Tug pushes the barge against the incoming/outgoing tide to maintain control
- At least one leg of the barge in the river bed at all times to prevent barge drifting
- Tug boat leaves site on outgoing tide with waste materials

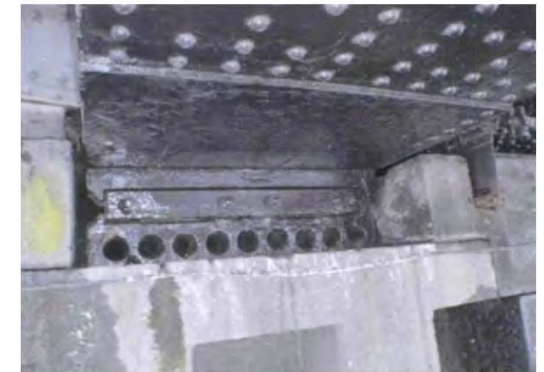
# Bearing Replacement

- Roller bearings comprise a series of iron rollers which appear to have seized and may have deformed
- Seized bearings are causing the piers and adjacent viaduct spans to deflect.
- Large cracks in the piers appear to vary seasonally with temperature

- Bridge inspections and monitoring has found large cracks in the pier masonry which appear to vary seasonally with temperature
- The cracking in the substructure is a long standing issue
- The bridge has been assessed as adequate for current and future loading in present state despite the seized bearings
- Bearing replacement would be high cost, high risk operation
- Alternative, lower cost/risk option, would be to repair the substructure damage and carry out additional ongoing maintenance

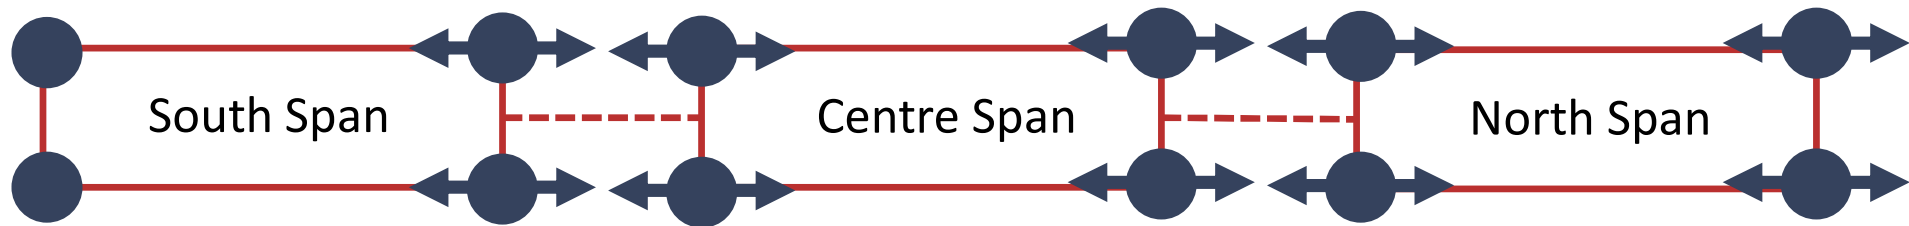
Existing

# Articulation

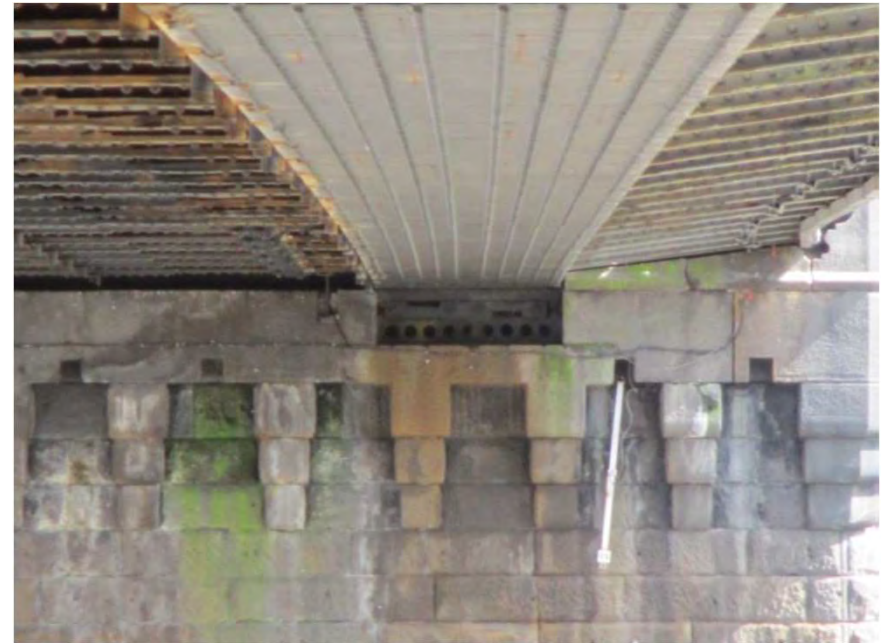
# Bearing Replacement Options

- Hydraulic Jacking with modifications to existing bearing shelf

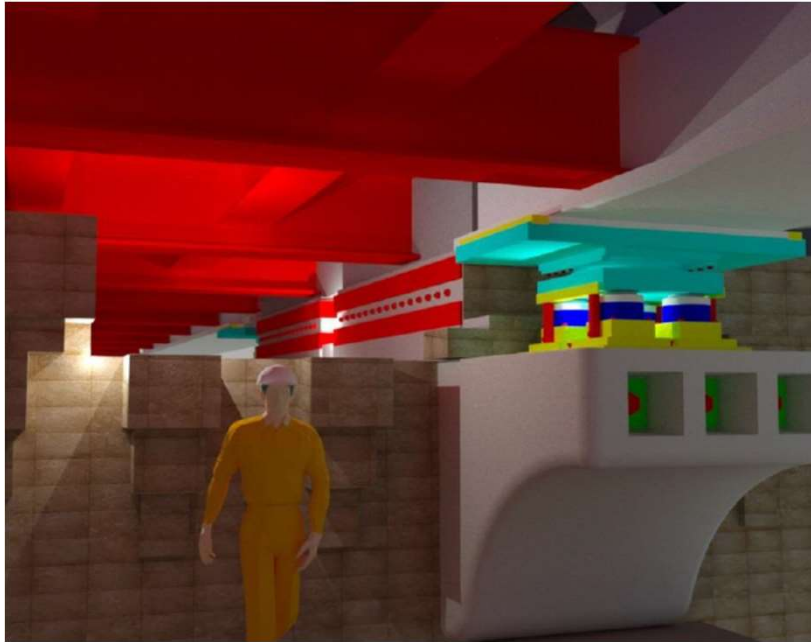
# Bearing Replacement Options

- High Performance Concrete (HPC) corbels

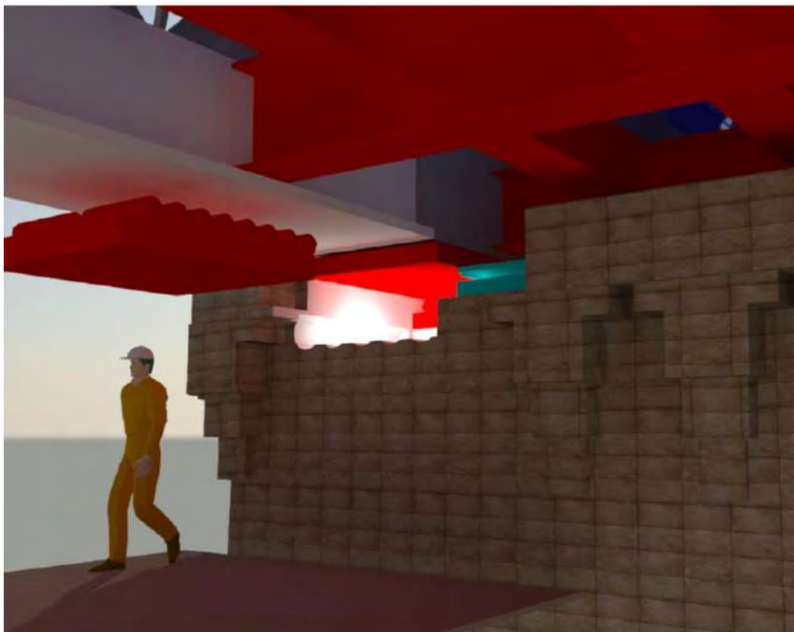
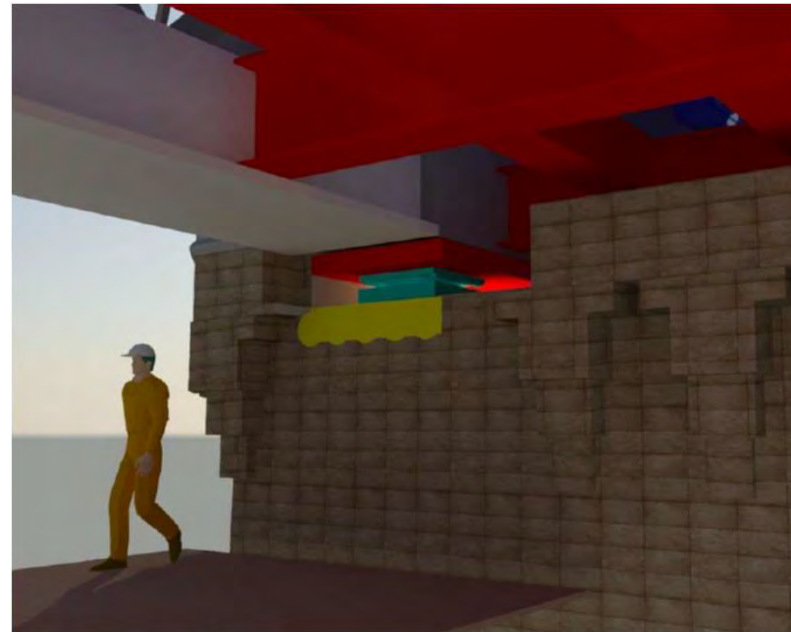
# Bearing Replacement Options

- Progressive bearing replacement (“mining”)
