*PWI Lunch and Learn - March 2022*

## *Rail Management Hot Topics and Developments*

Engineering Expert [Track and S&C] – Network Rail

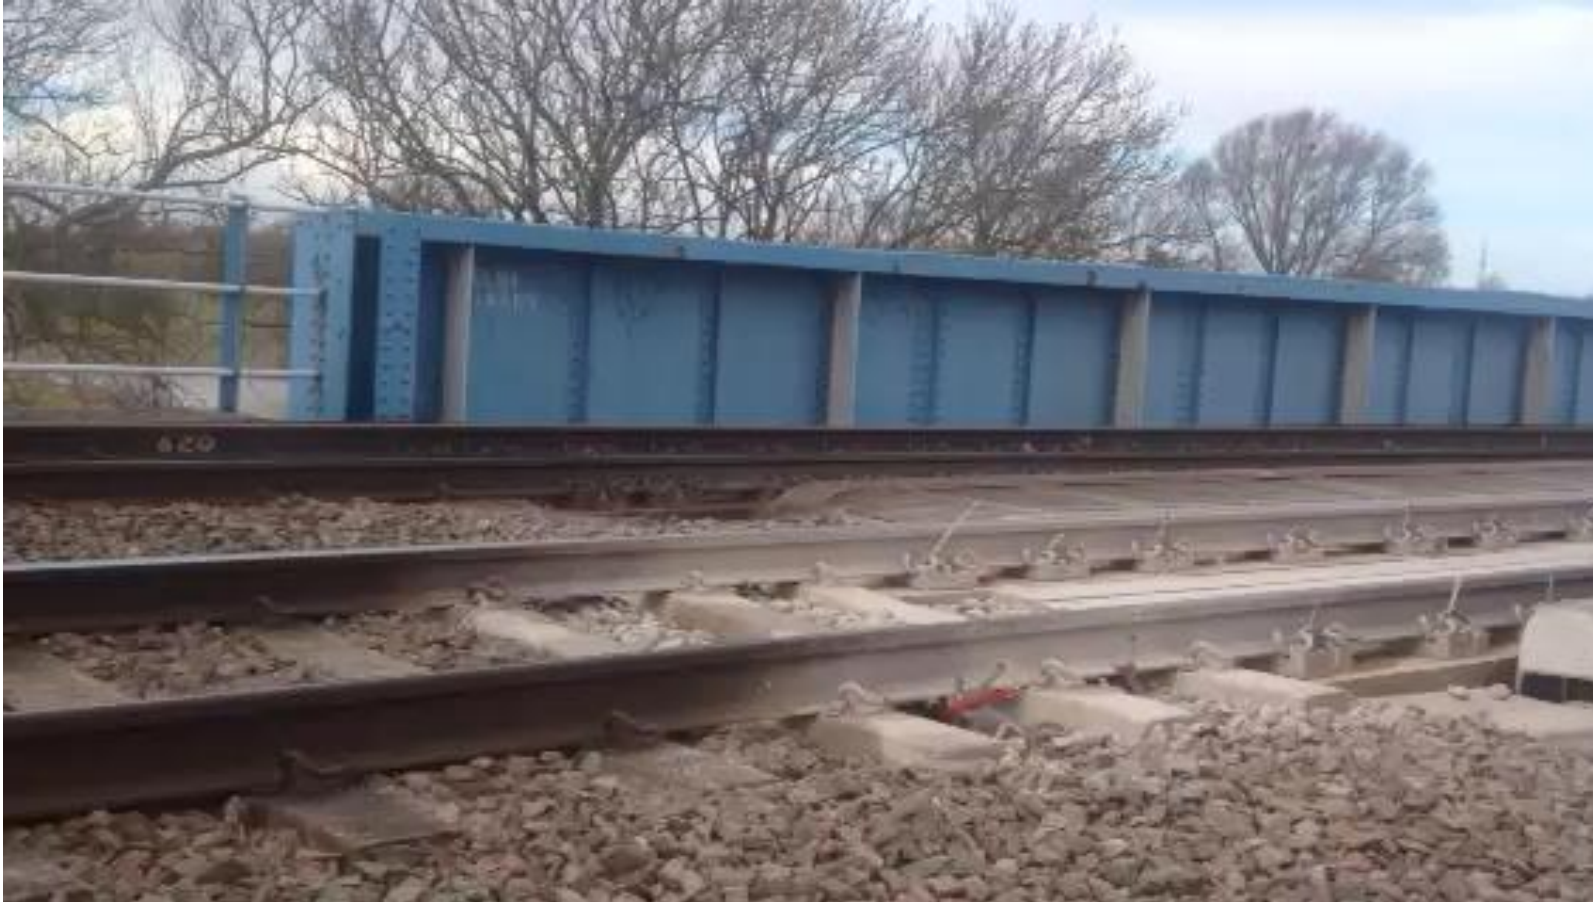
# Rail Foot Failures Account For Around 30% Of Annual Breaks

There has been a previous rail break at this location and the majority of rail breaks in the rail foot are caused by poor support conditions

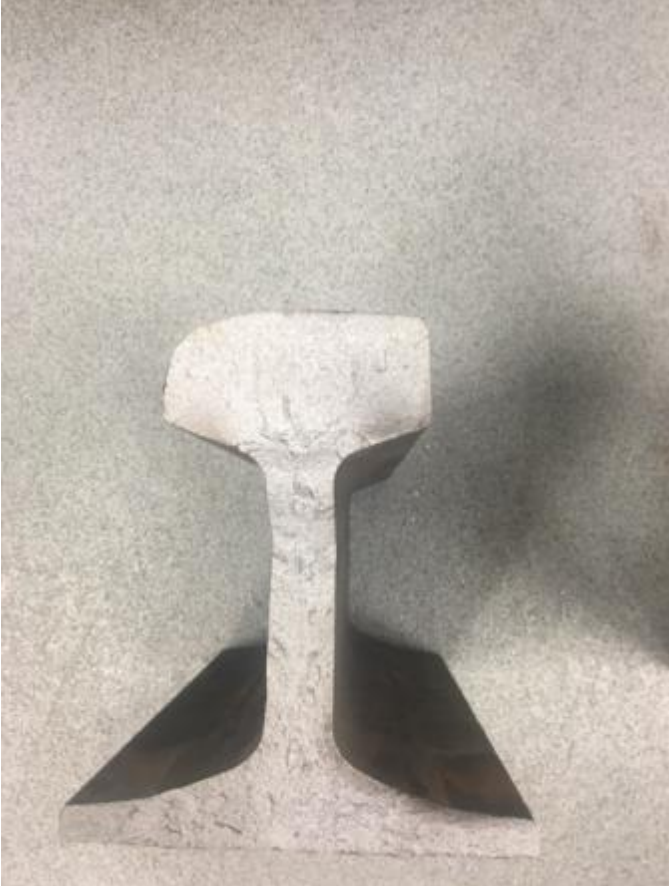
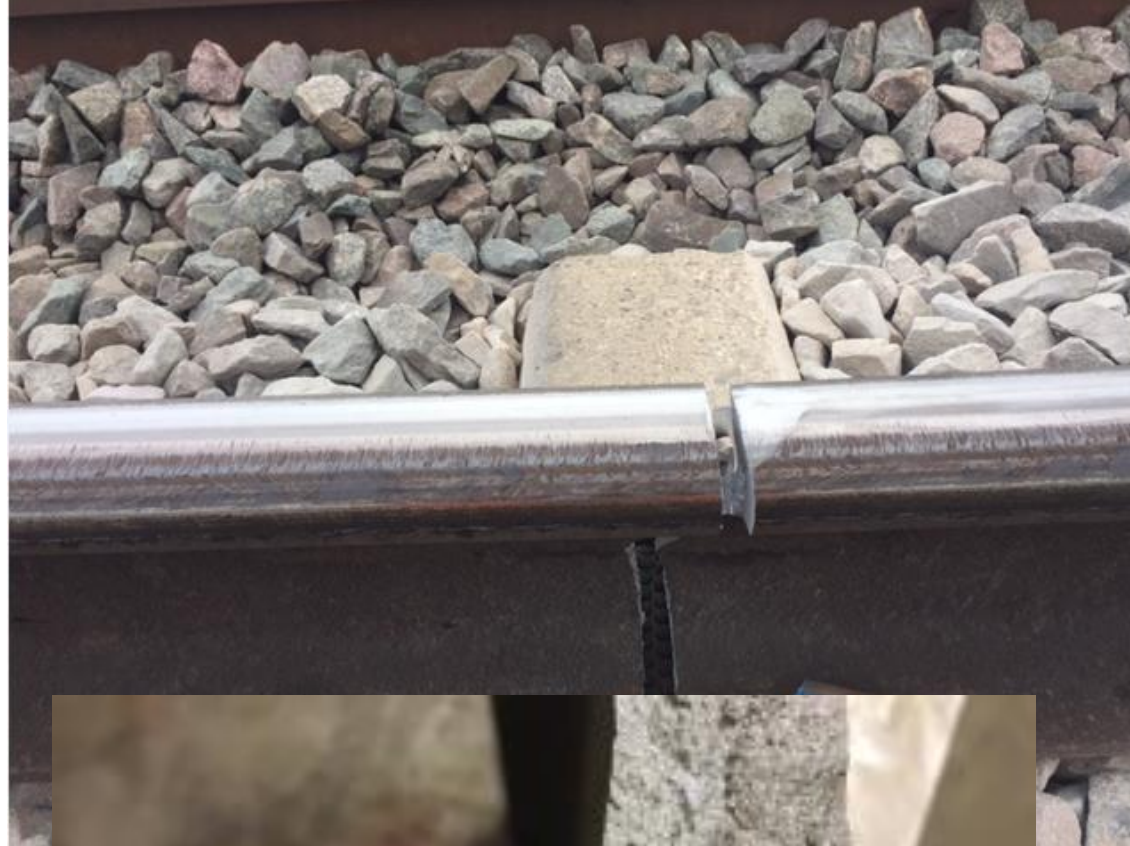
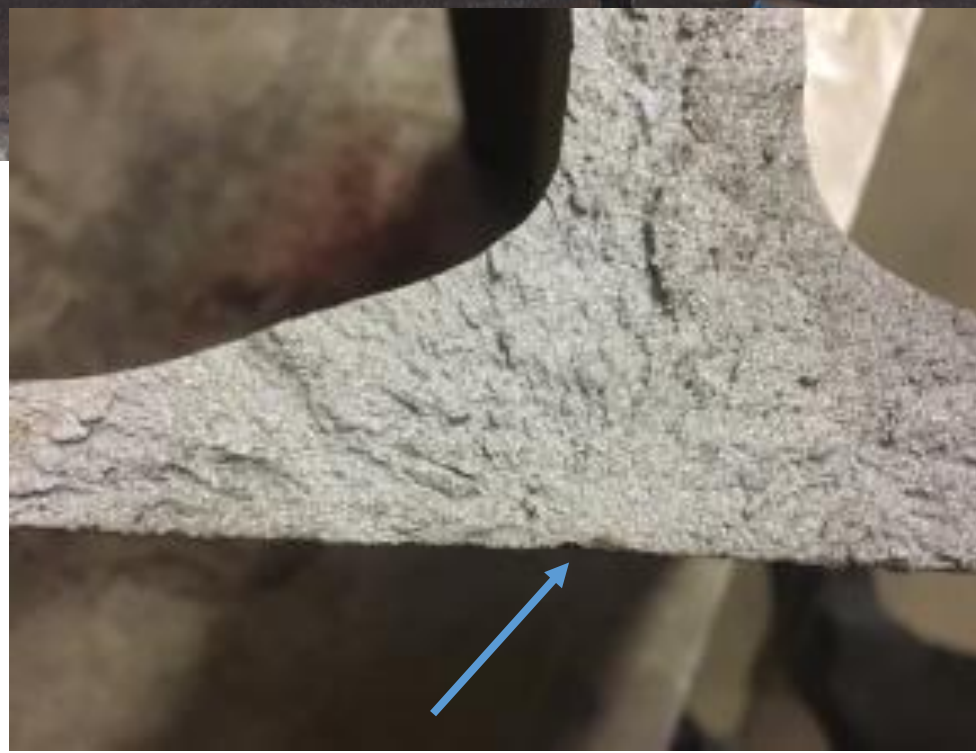
20-04-17, LEC1 1100, 29m 700yds  
 Northchurch, 1980, 113A rail.  
 Break initiated from the rail foot due to high  
 dynamic loading from voiding sleepers and  
 poor support conditions  
 No significant defect to detect by inspection.  
 Need to manage the conditions where this  
 risk exists  
 40 years WCML 1500 MGT  
 Small Dip Angle in Plain Line

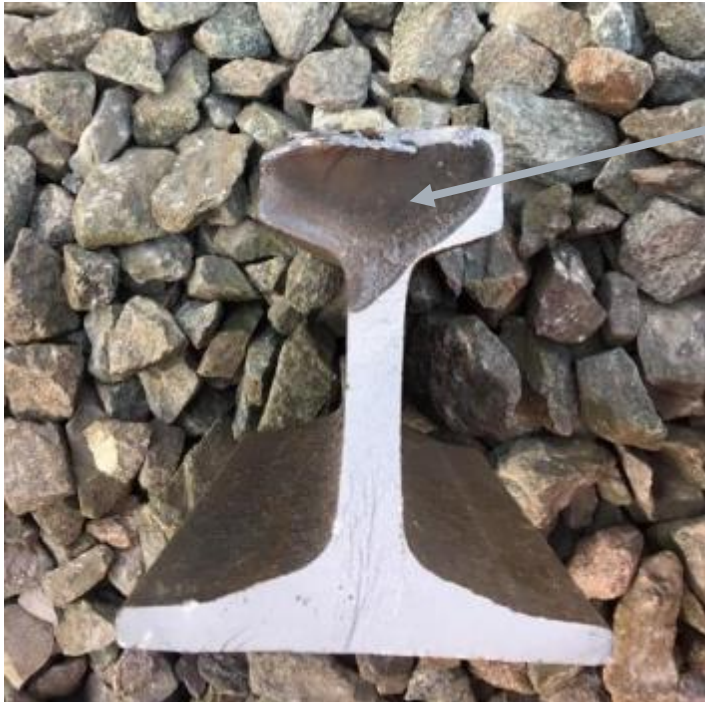
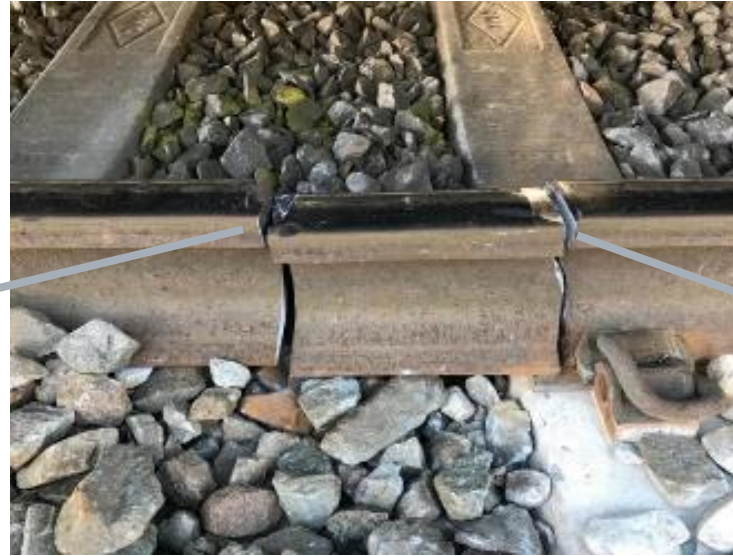
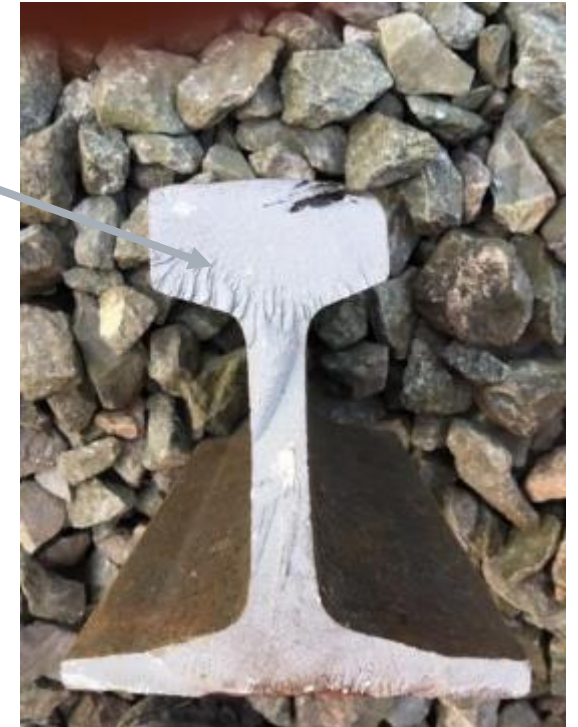
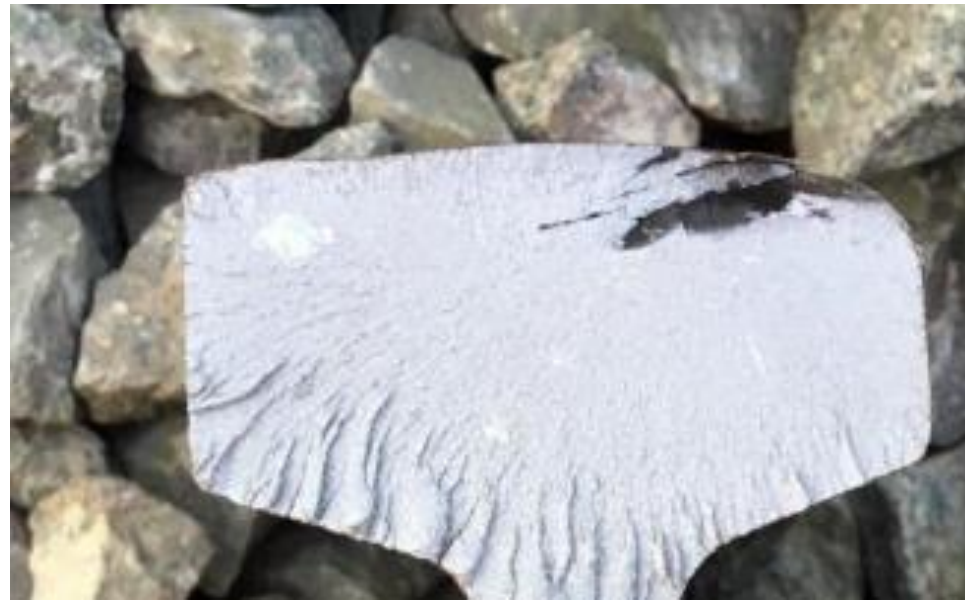
# Sandy North Double Broken Rails 17/01/2022

The rail was a CEN 56 rail section from 1988 supported by F27 sleepers and Pandrol clips. Up Fast line on plain line at 44 miles 63 chains. At the broken rail location, there is a small dip angle of between 10 to 15mrad, 1000 MGT

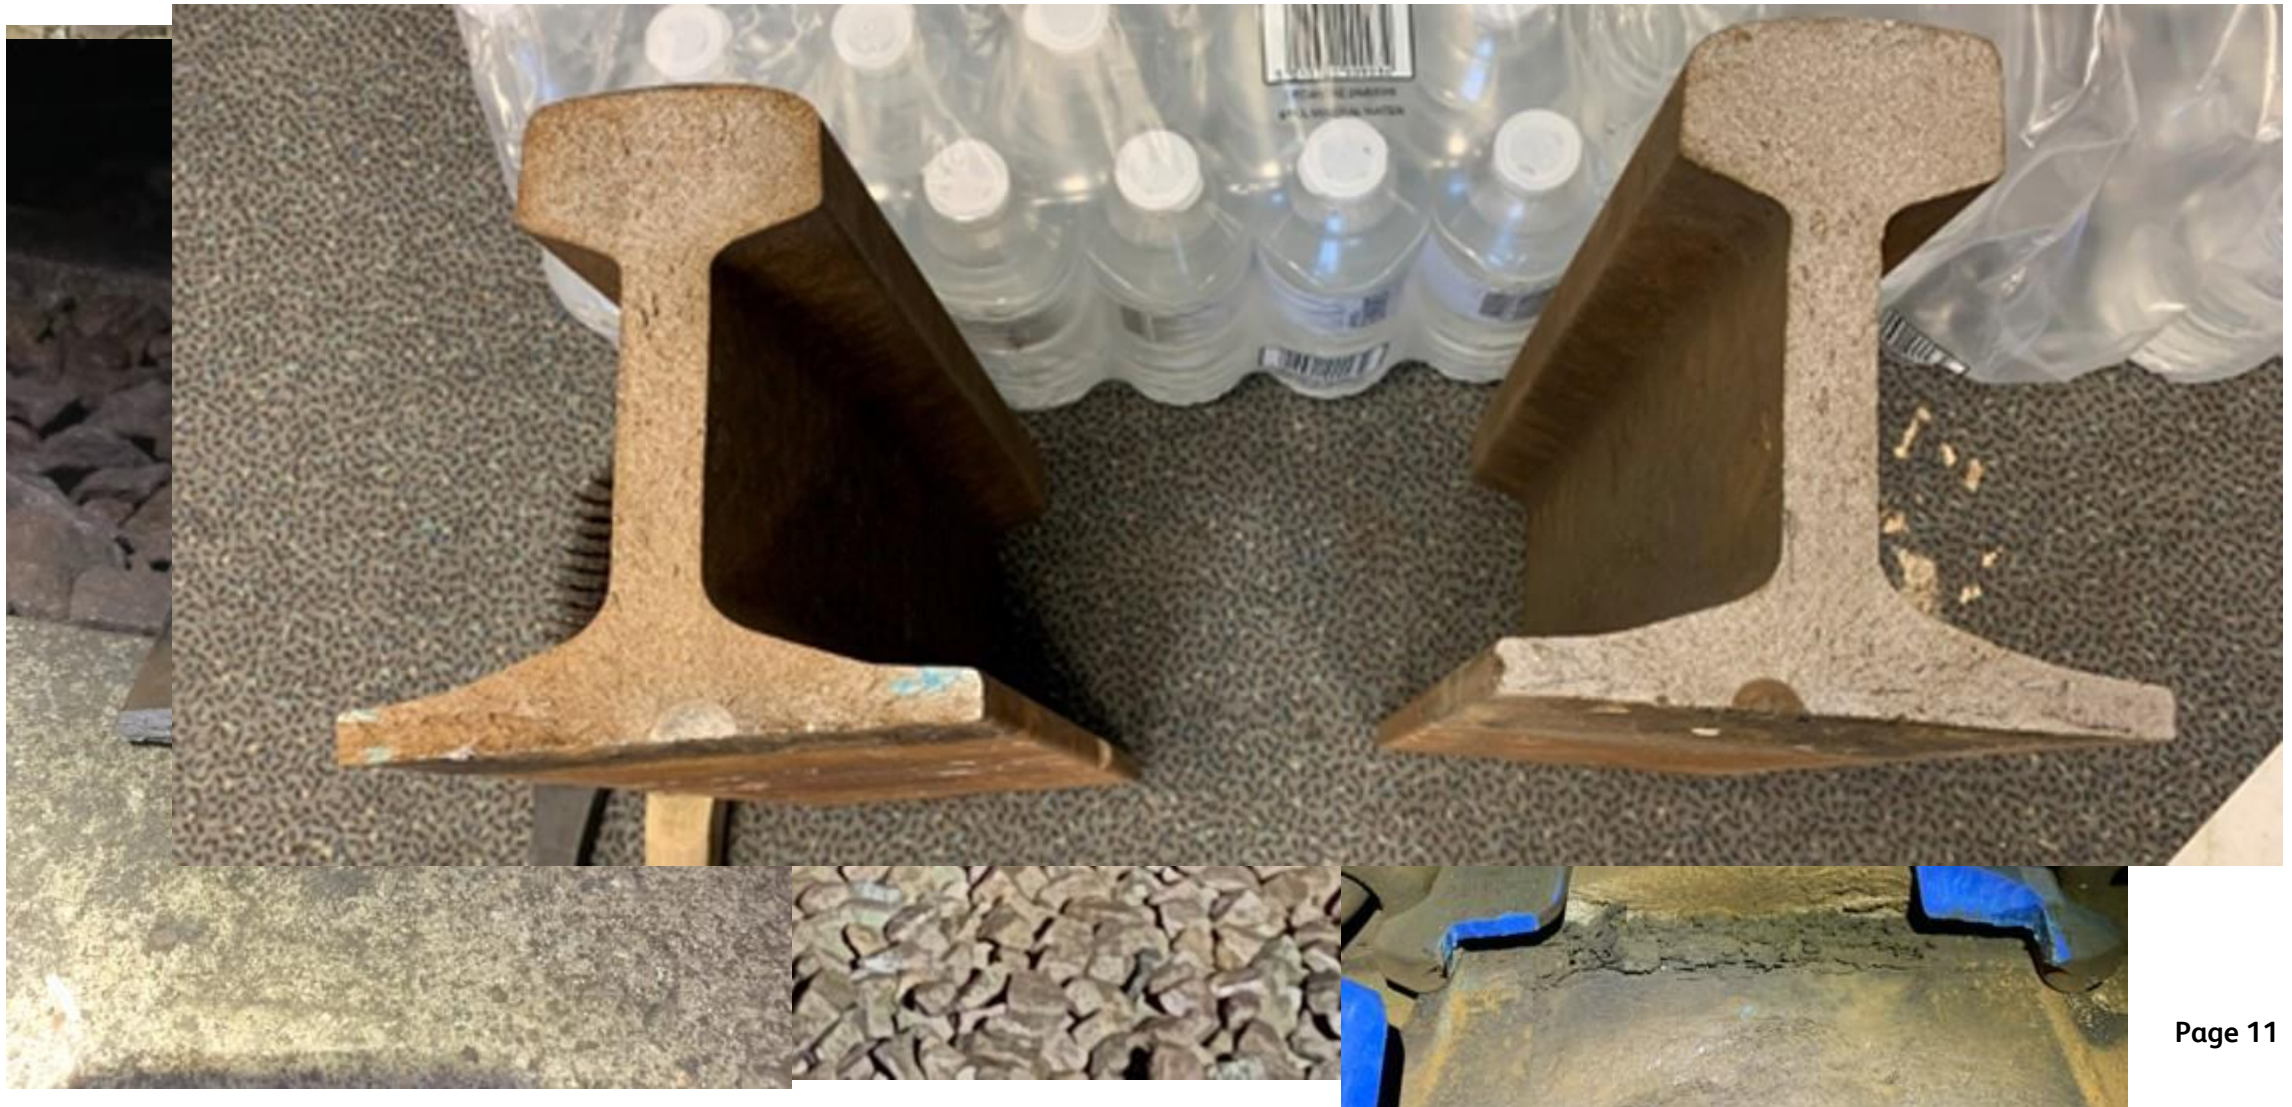
# Sandy North Double Broken Rails 17/01/2022

The rail was a CEN 56 rail section from 1988 supported by F27 sleepers and Pandrol clips. Up Fast line on plain line at 44 miles 63 chains. At the broken rail location, there is a small dip angle of between 10 to 15mrad, 1000 MGT

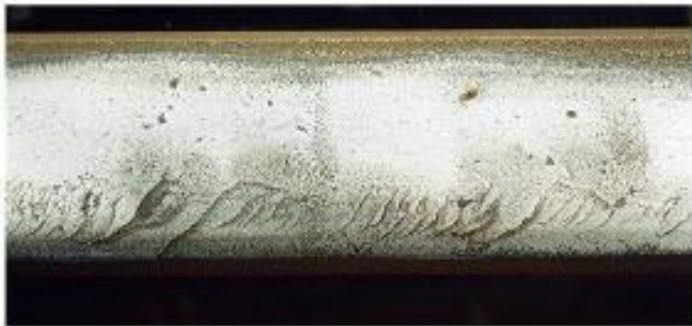
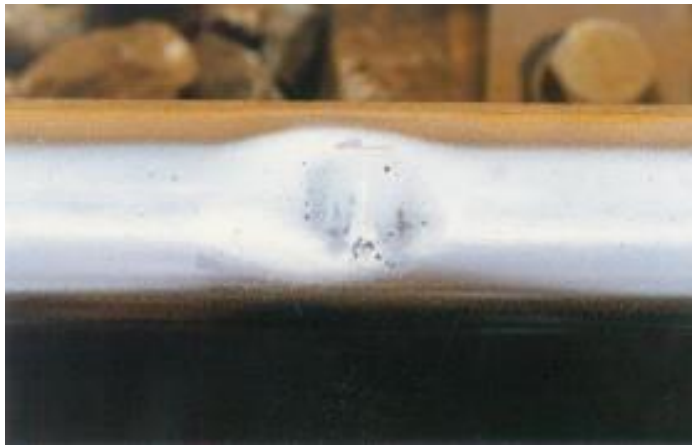
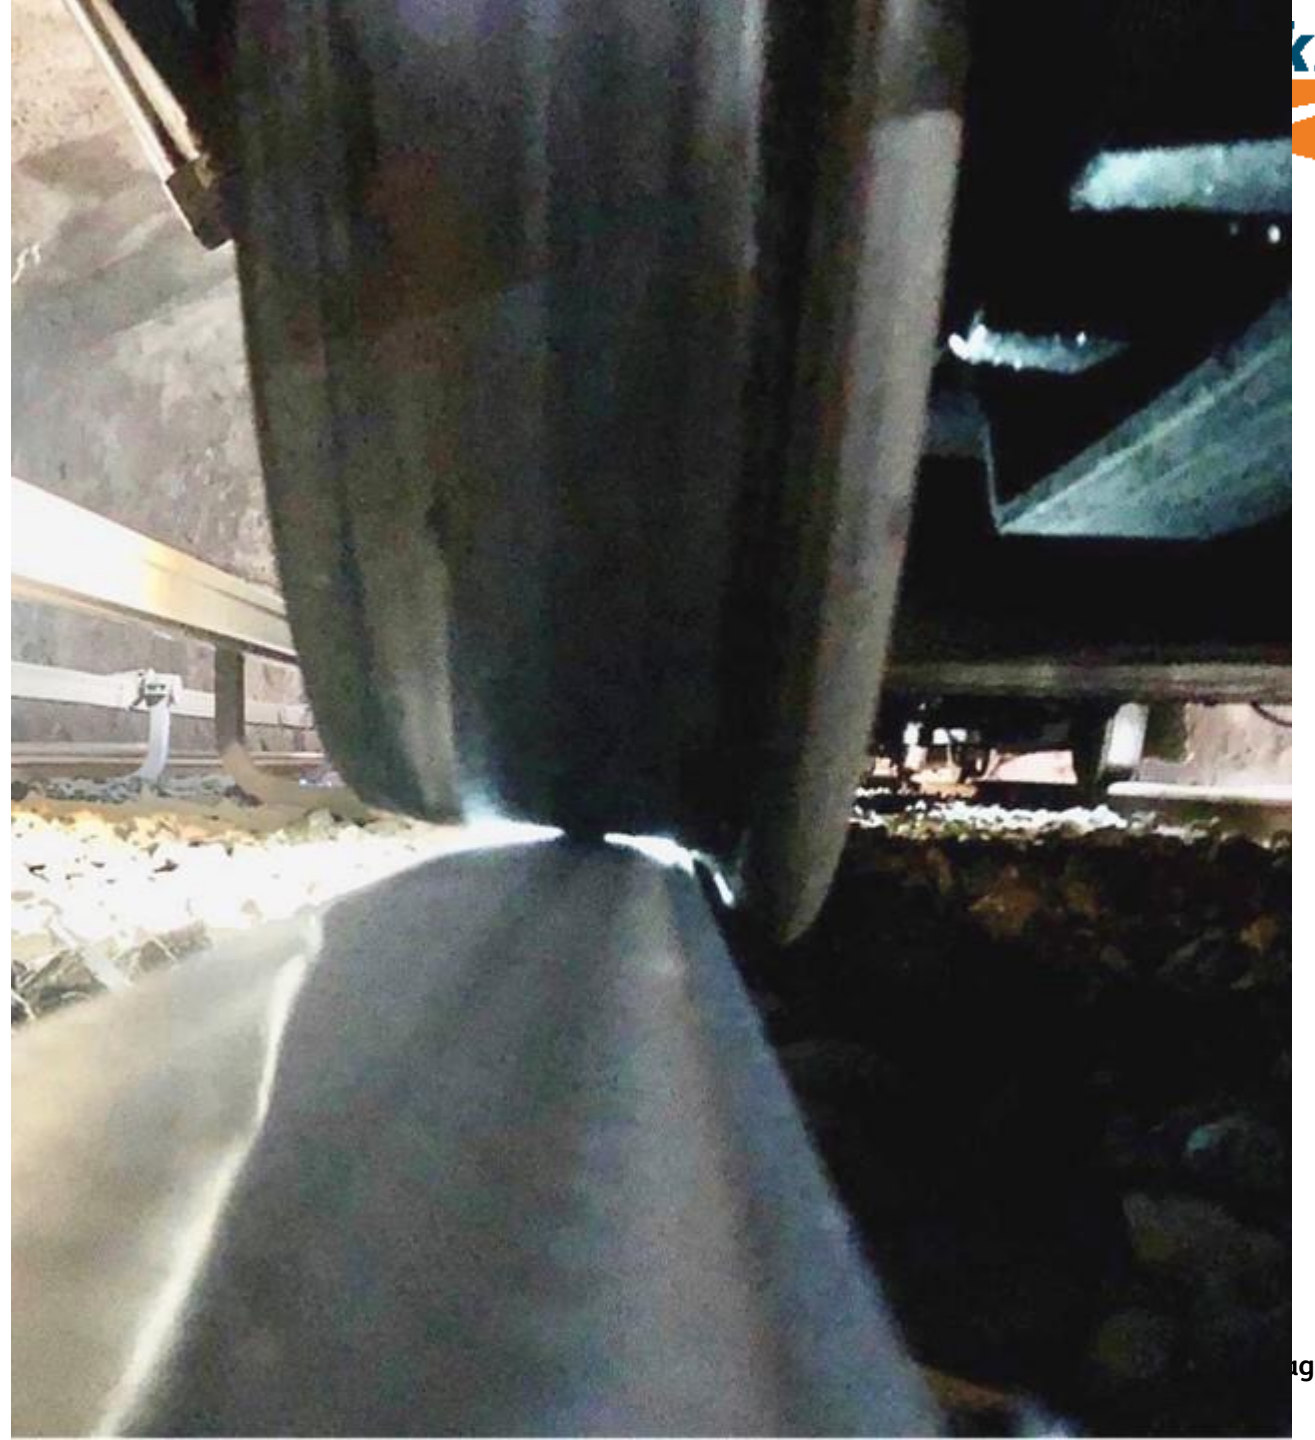
# The contact patch

The contact patch between wheel and rail must transmit all the forces needed to support and guide the vehicle. It must also transmit all the forces from the train accelerating and braking.

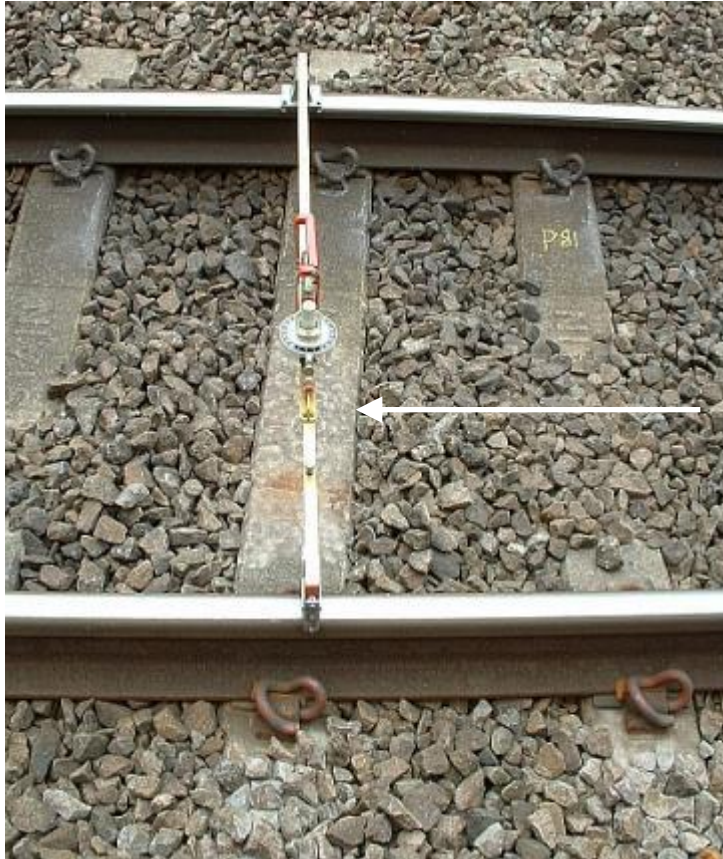
Outside of curve  
(‘high’ rail)

Traffic Flow

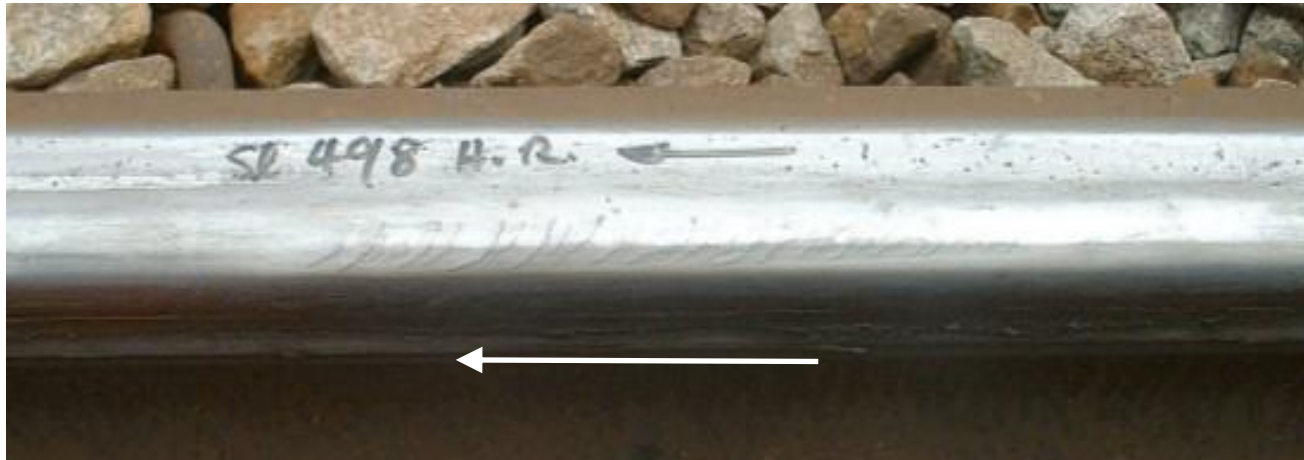
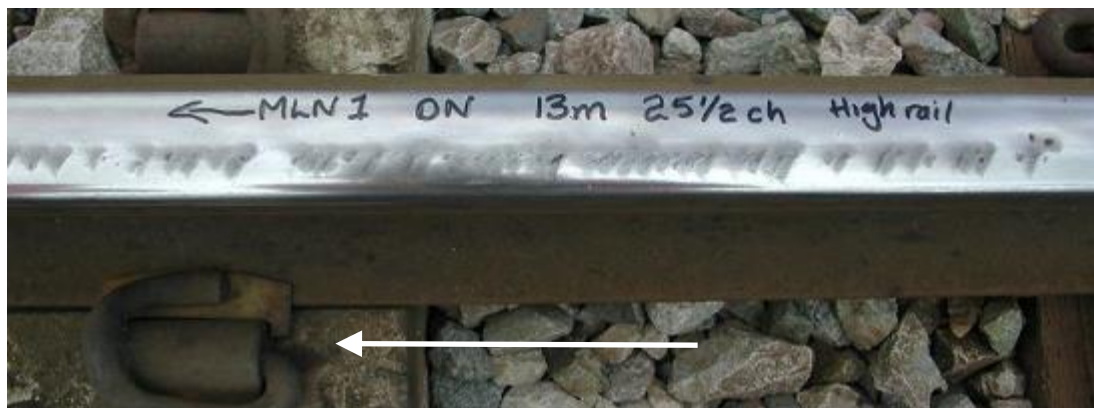
# Damage caused by steering forces

Rolling contact fatigue (high rail)

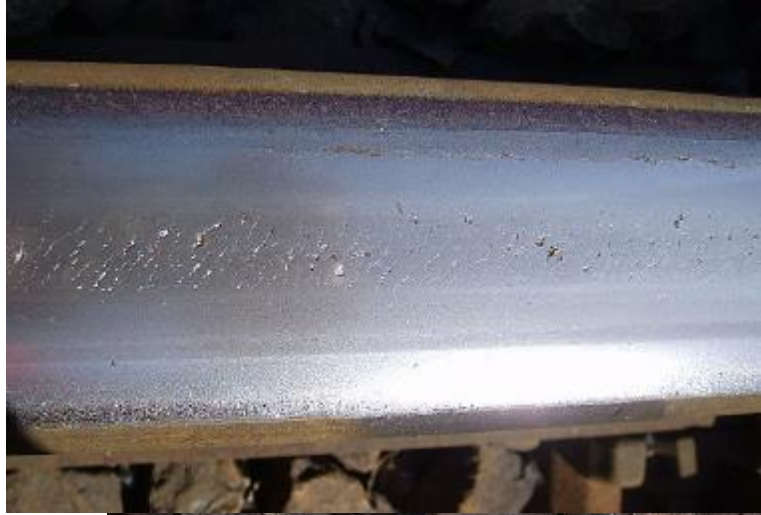
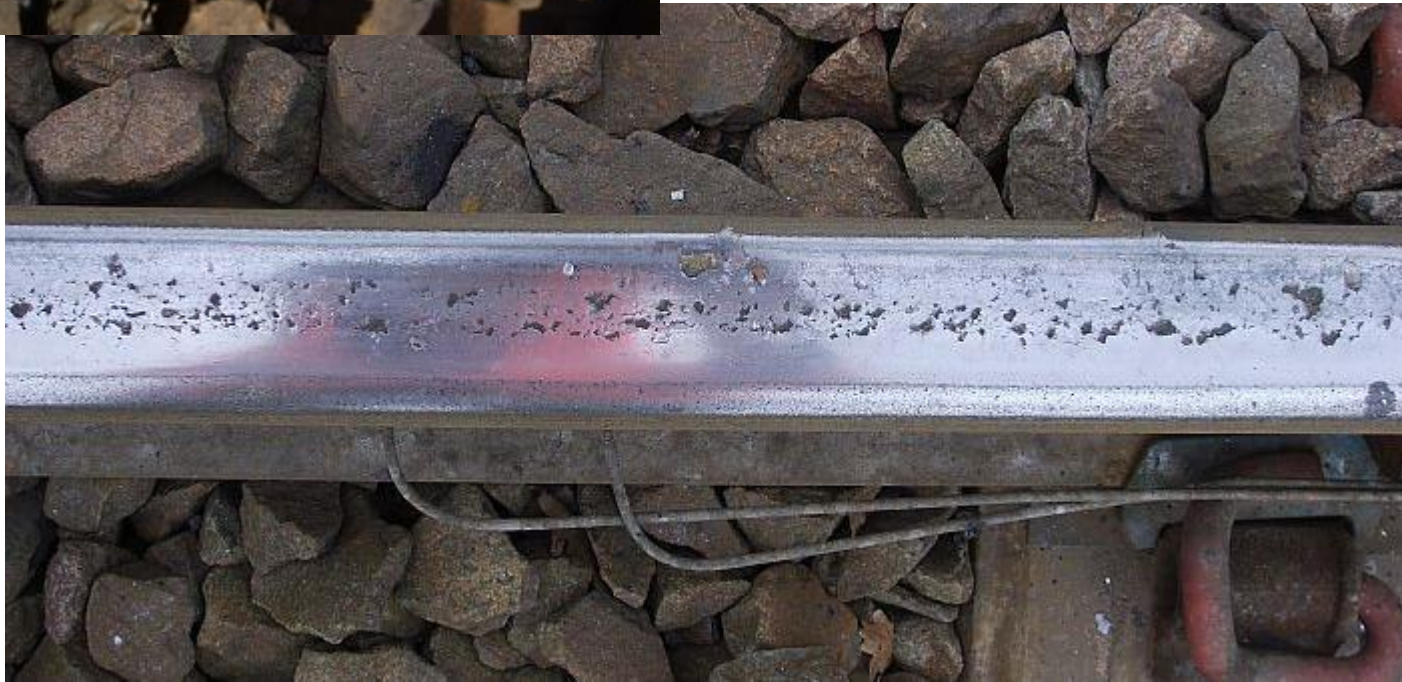
# Damage caused by steering forces

Rolling contact fatigue (low rail)

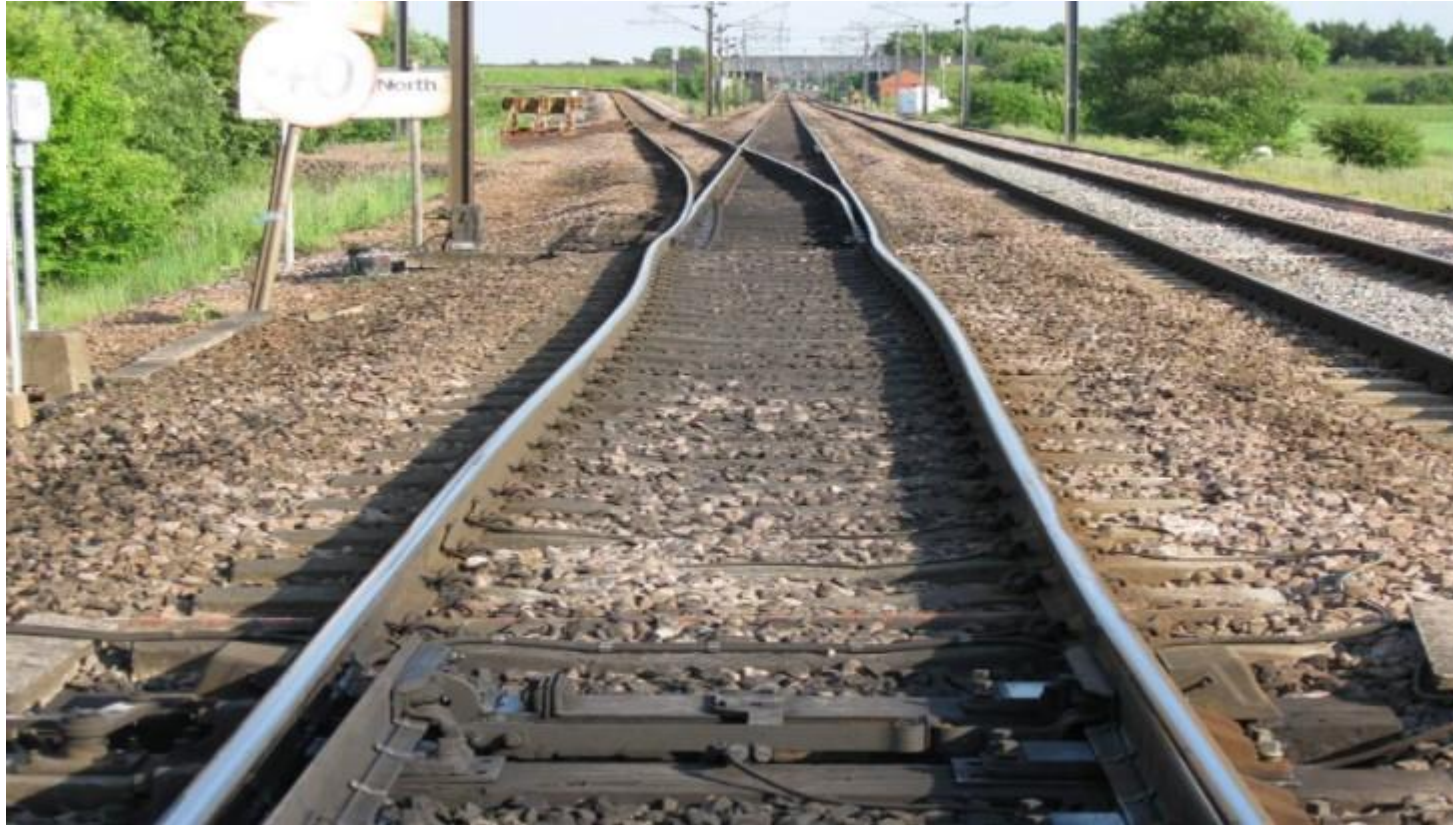
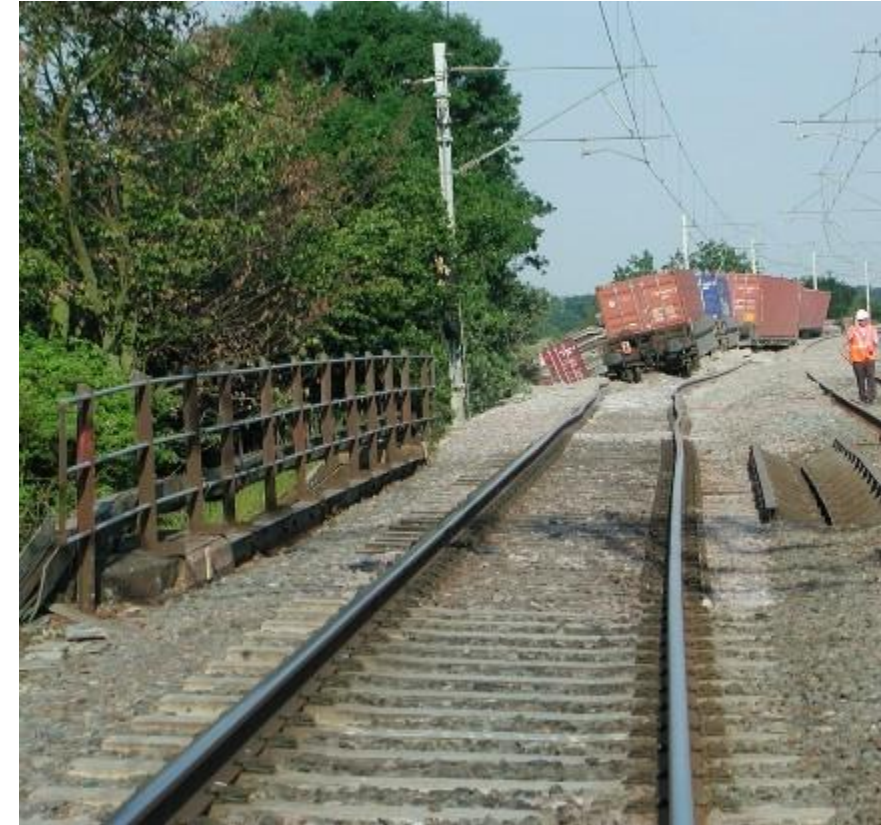
Huddlesford July 2003

*Its not just broken rails in colder weather. Too hot can be equally risky.*  
*Track Buckles*

35 to 40% of all buckles in or within 100m of S&C, 70% of high speed buckles in or within 100m of S&C

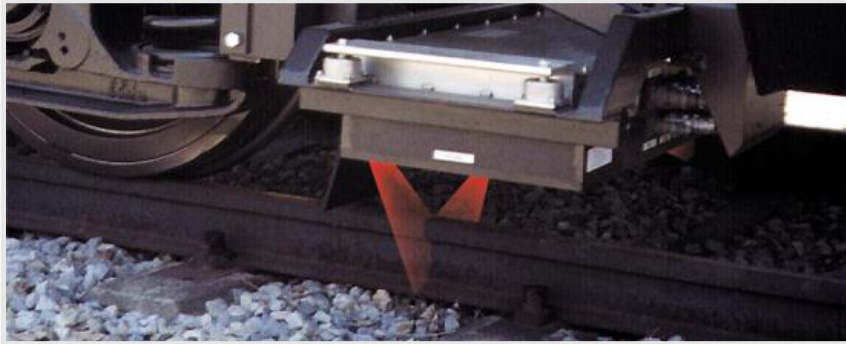
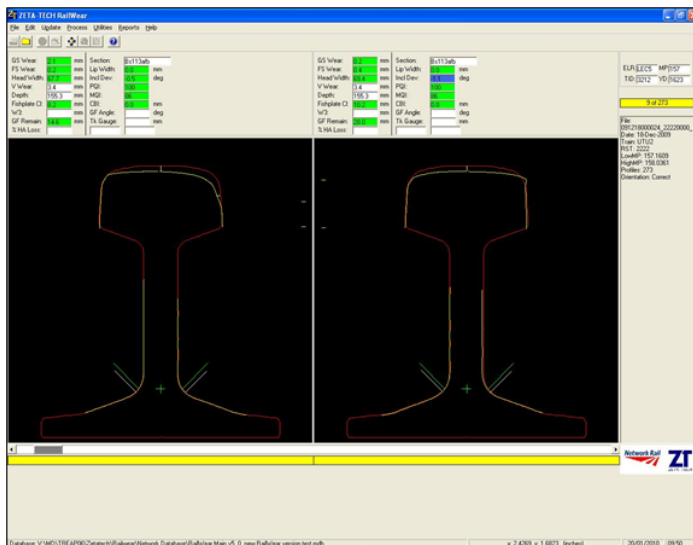
# Insight – Combining Data - Rail Wear

- Uses Laser Light Source and CCD cameras
- Records at track speeds
- Full profile i.e gauge plus field side
- Operational on all UTU's
- Accurate profiles at around 2m intervals
- Matched to standard "as new" rail templates by software
- Remove/ reduce requirement for manual inspection.
- Safer
- Significant time saving for maintenance staff
- Advantages in 'Red Zone' areas.
- Improved rail management.

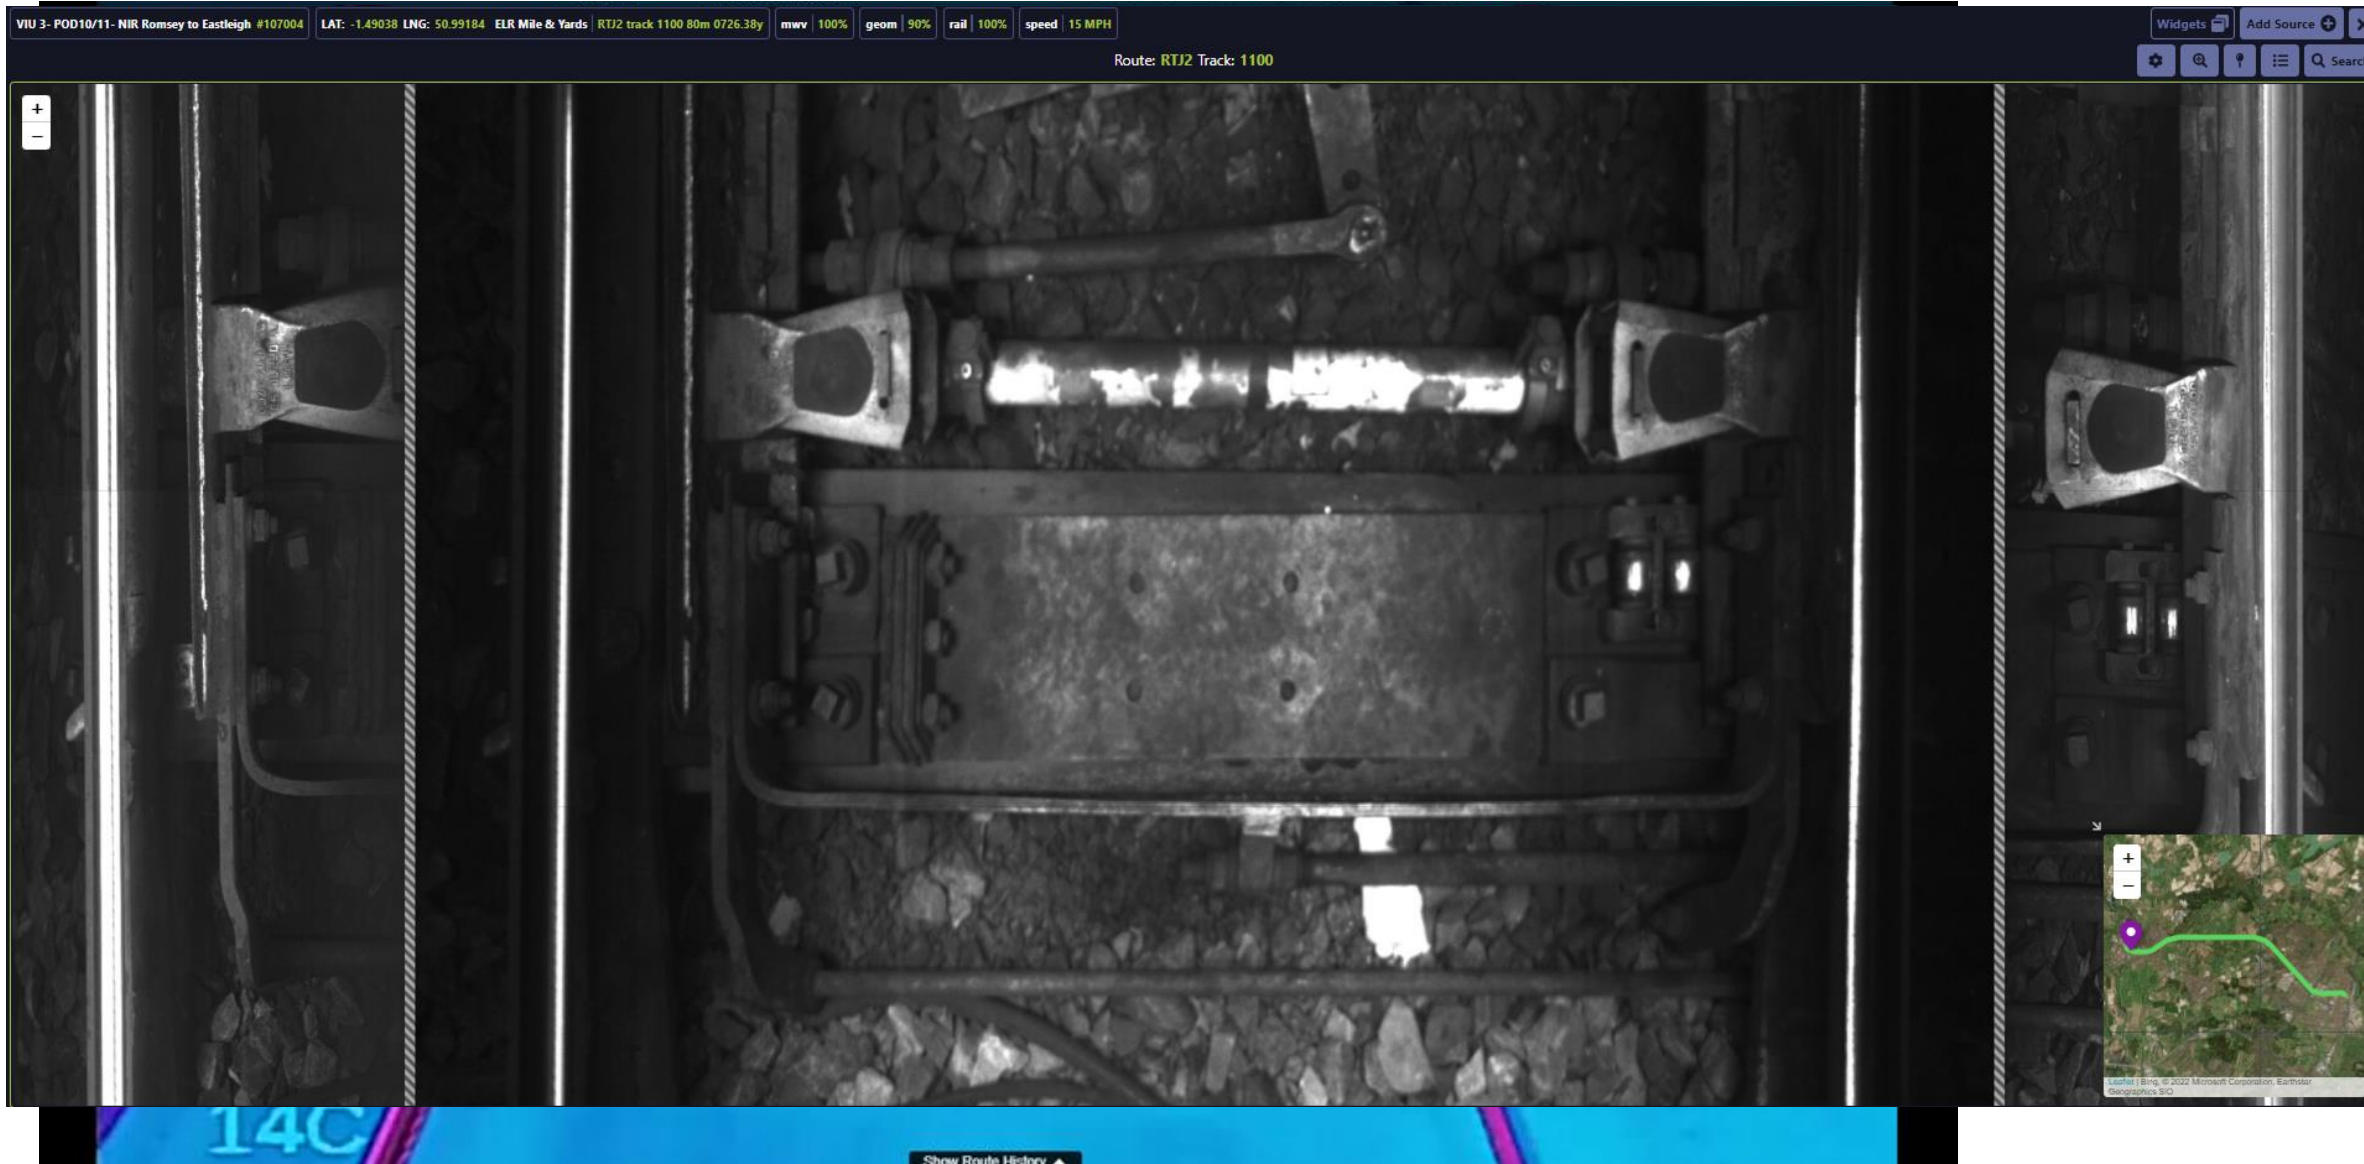
# AIVR Automated Intelligent Video Review – One Big Circle

VIU 3- POD10/11- NIR Romsey to Eastleigh #107004 LAT: -1.49038 LNG: 50.99184 ELR Mile & Yards RTJ2 track 1100 80m 0726.39y mwv 100% geom 90% rail 100% speed 15 MPH
