# Seeing What You Need to See.

## How AIVR is supporting Rail Safety through Innovation and Integration.

# What is AIVR (Automated Intelligent Video Review)

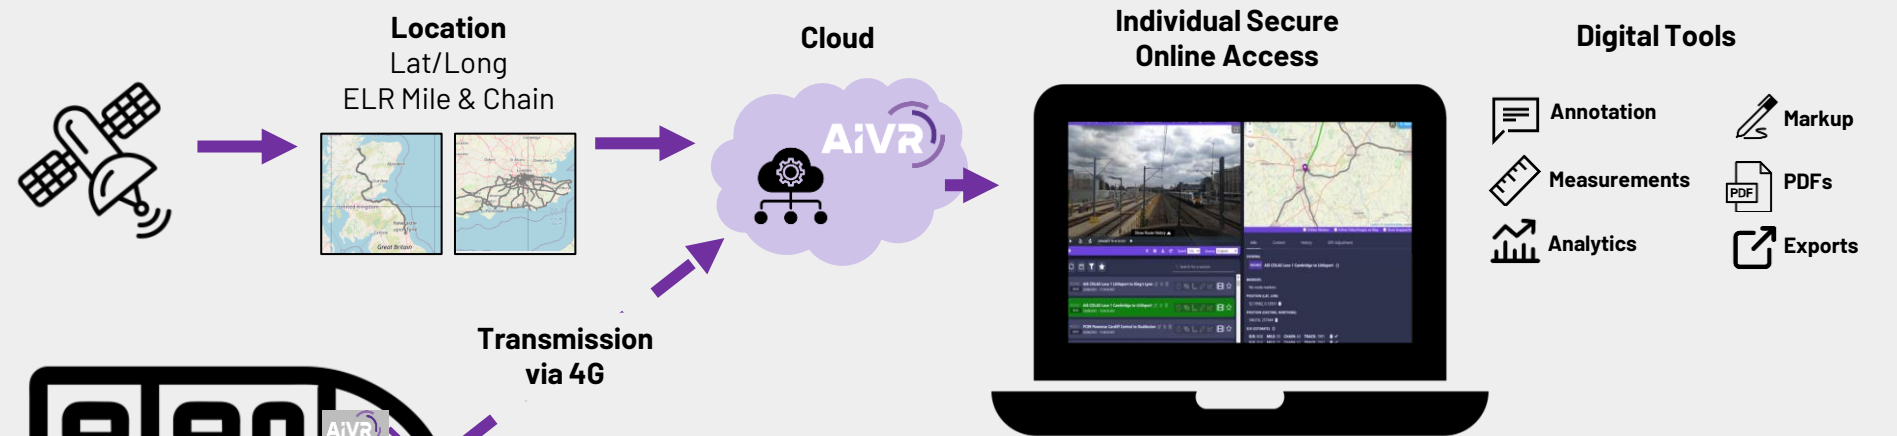
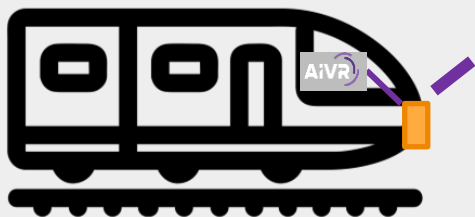
External SIG housing  
that fits temporarily on  
Tail Lamp Bracket  
(mounted by hand)

Integrated  
permanently with FFV  
on Measurement or  
in-service train

Line scanning  
cameras on  
automated class 153's

Mounted  
temporarily inside  
windscreen

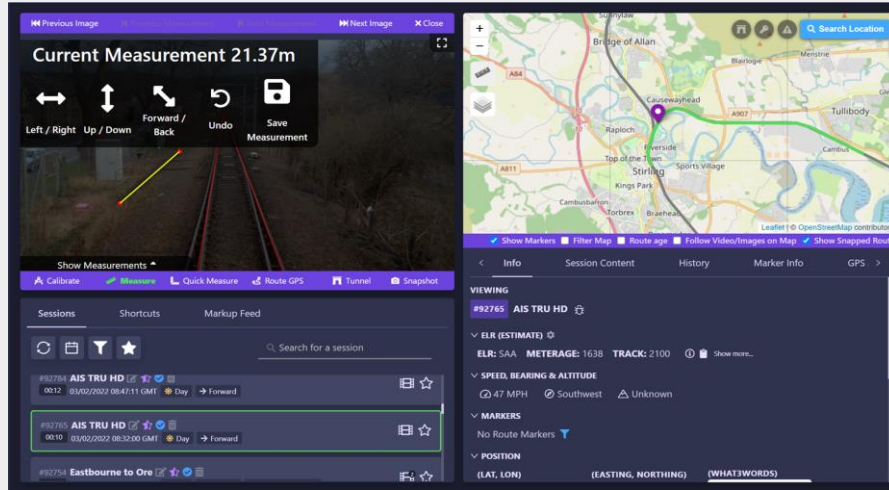
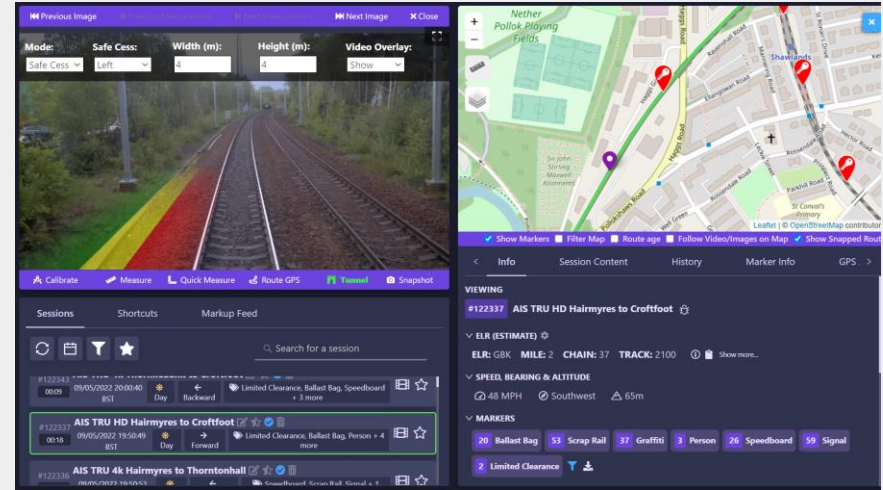
# Online access and digital tools

Online digital tools available to all users for measurement, annotation, reporting, planning and sighting and sharing of data rapidly in an accessible manner.  
Safe cess overlay developed in response to Track Worker Safety requirements.

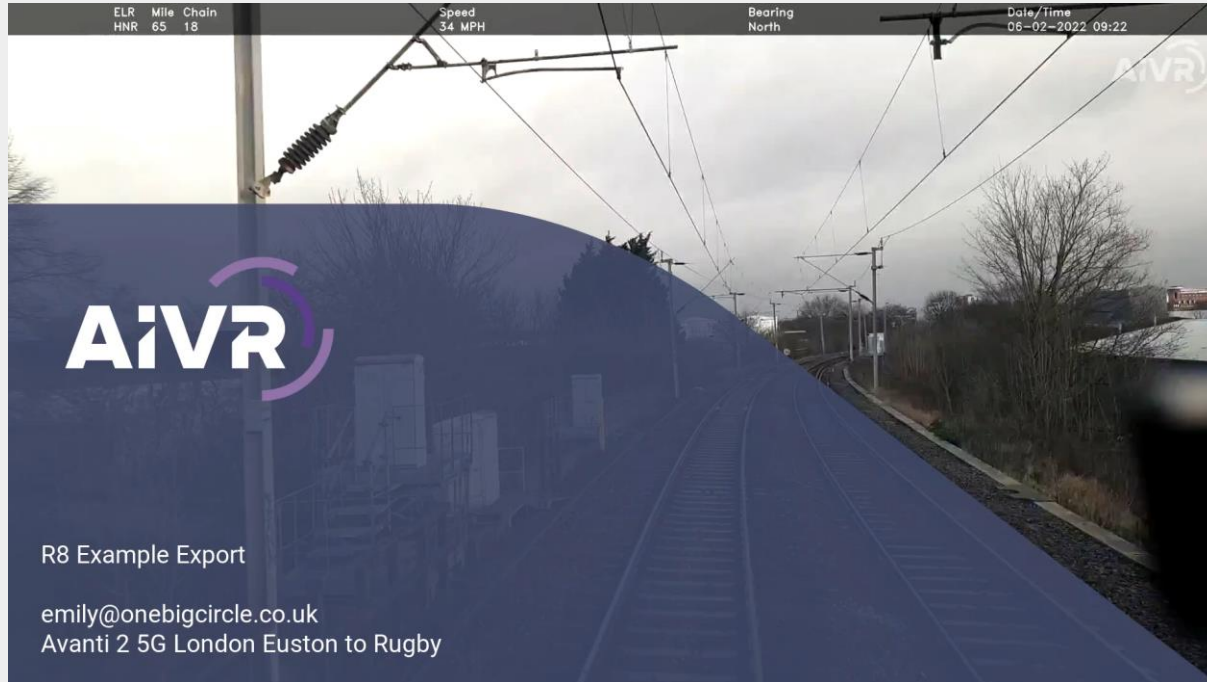
# Red zone working video example

Data from ellipse enables users to assess area based on R8 reporting

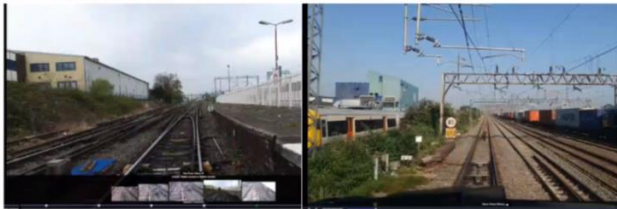
## S&TINCs Review - Points Inspection

We had an Outstanding SINC file on this that had issues with a broken front stretcher, this was a historic file and originally showed as changed to a yellow stretcher, we needed a fair amount of evidence but with the attached picture we could see a TSB White bar at the bottom of picture this mitigated most if not all of the outstanding actions and meant that we could progress the file.
