TME Conference  
Birmingham

# Innovation on Eastern

## Doncaster Visualisation Map

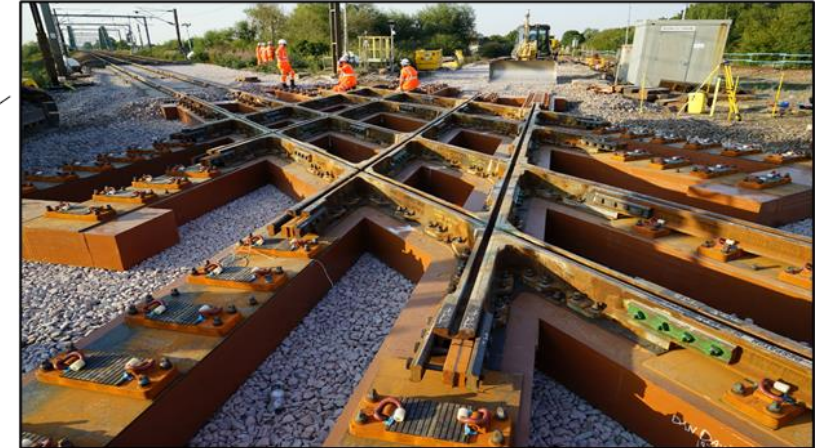
# Track Inspection

Visualisation of full patch for TME Doncaster

- PLPR Runs with IDs
  - Track inspected in Darkness
  - Track inspected in Daylight
- Assurance with full coverage (all boundary plates are highlighted on the diagram includes out of use track layer).
  - Identifies S&C units which could be reviewed from a P.O.S on the daylight patrols. (2179A/B & 2187A/B 125mph Inspected in darkness).

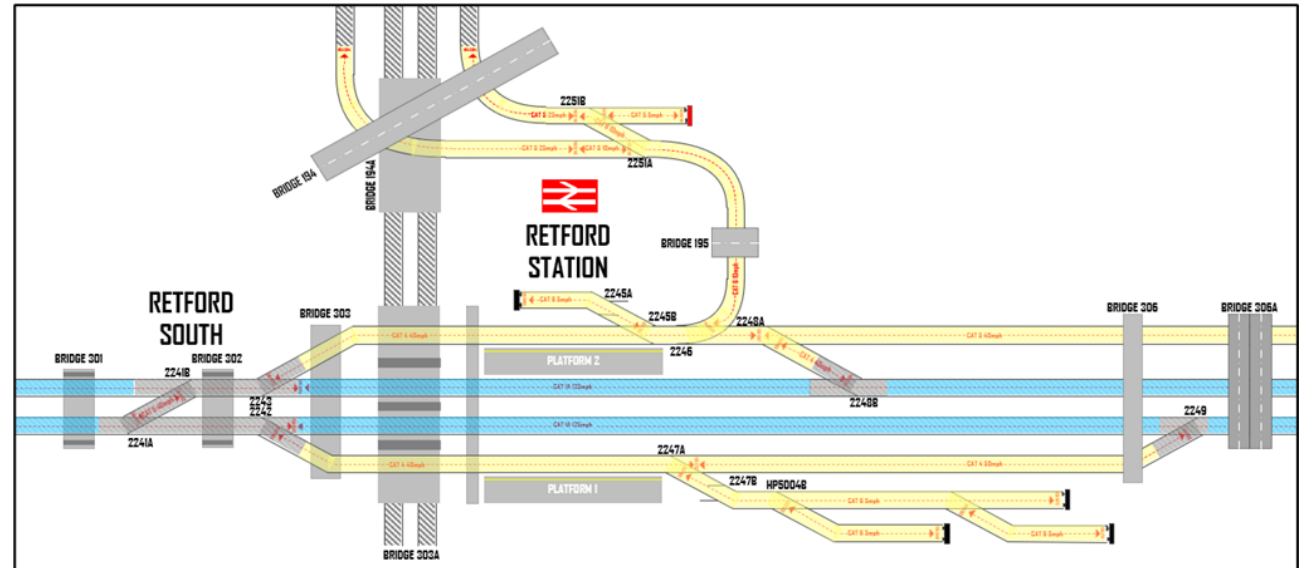
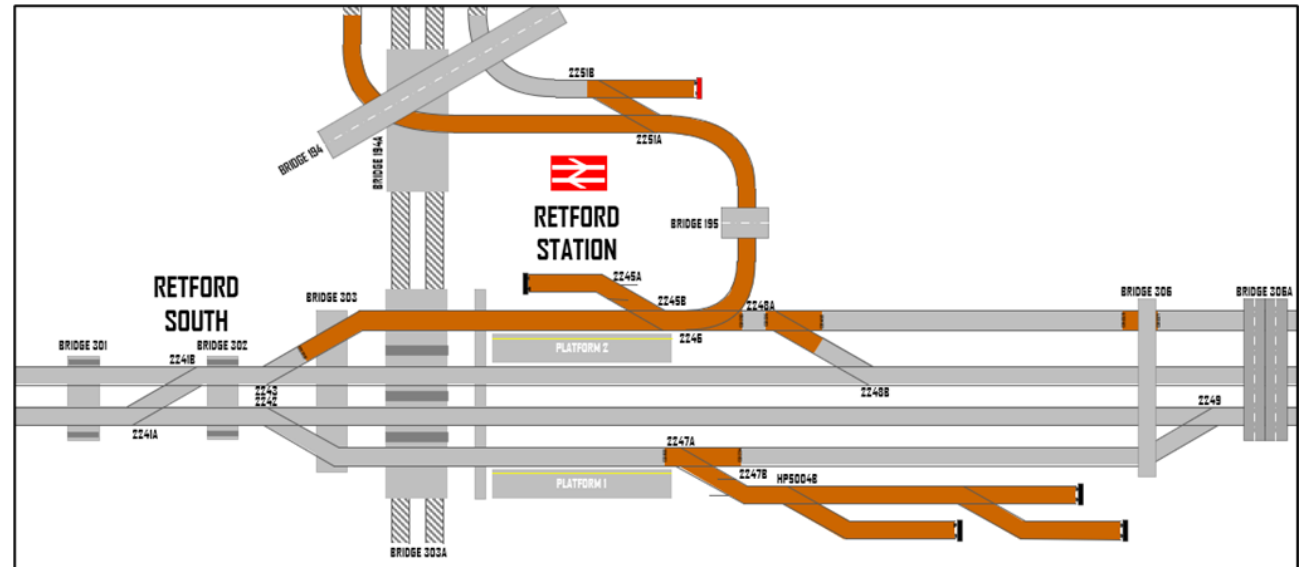
## Track Inspection Review / Management

Track inspection frequencies reviewed using the layers – allowing full visibility of the asset.

**Retford Station** – Timber assets inspected during daylight also allowing the look across at S&C inspected in the dark.

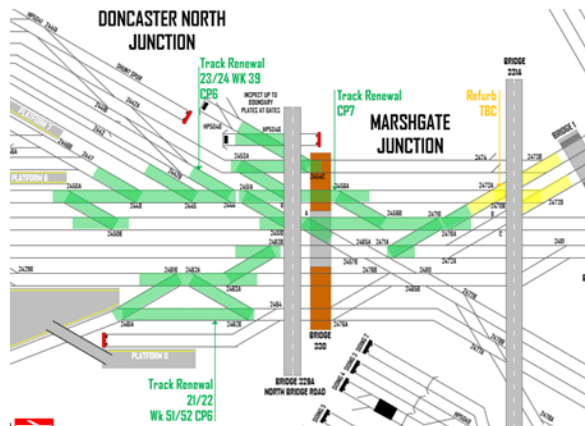
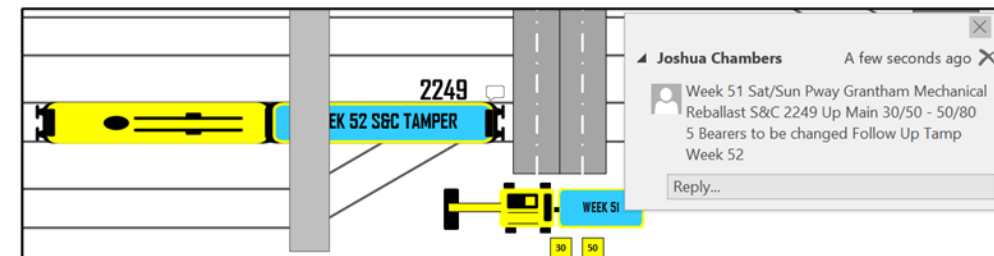
Maintenance and renewal plans integrated under one layer. Identifies key works and locations with currently no plan.

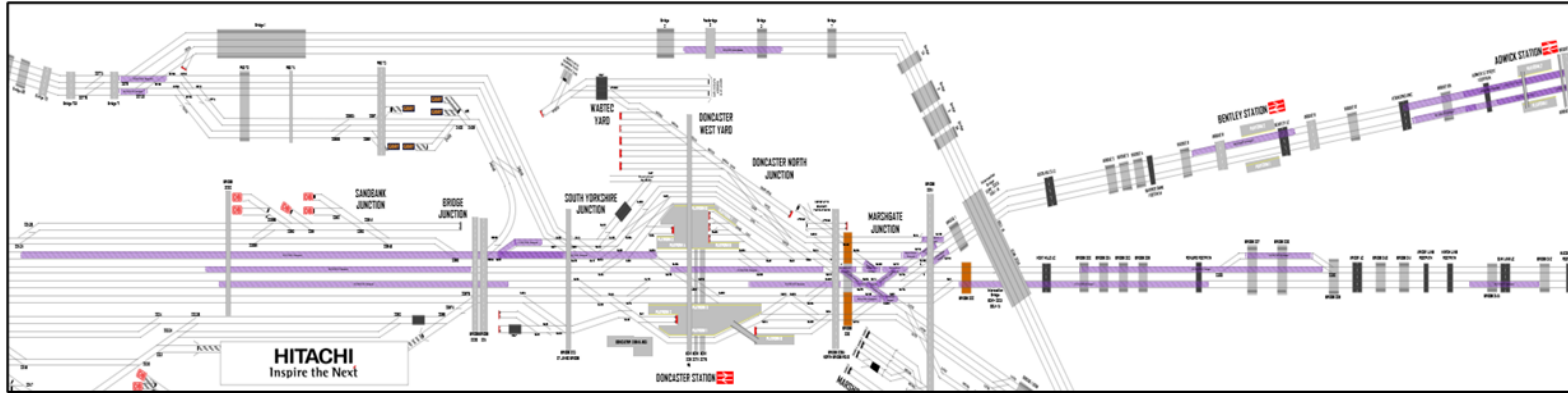
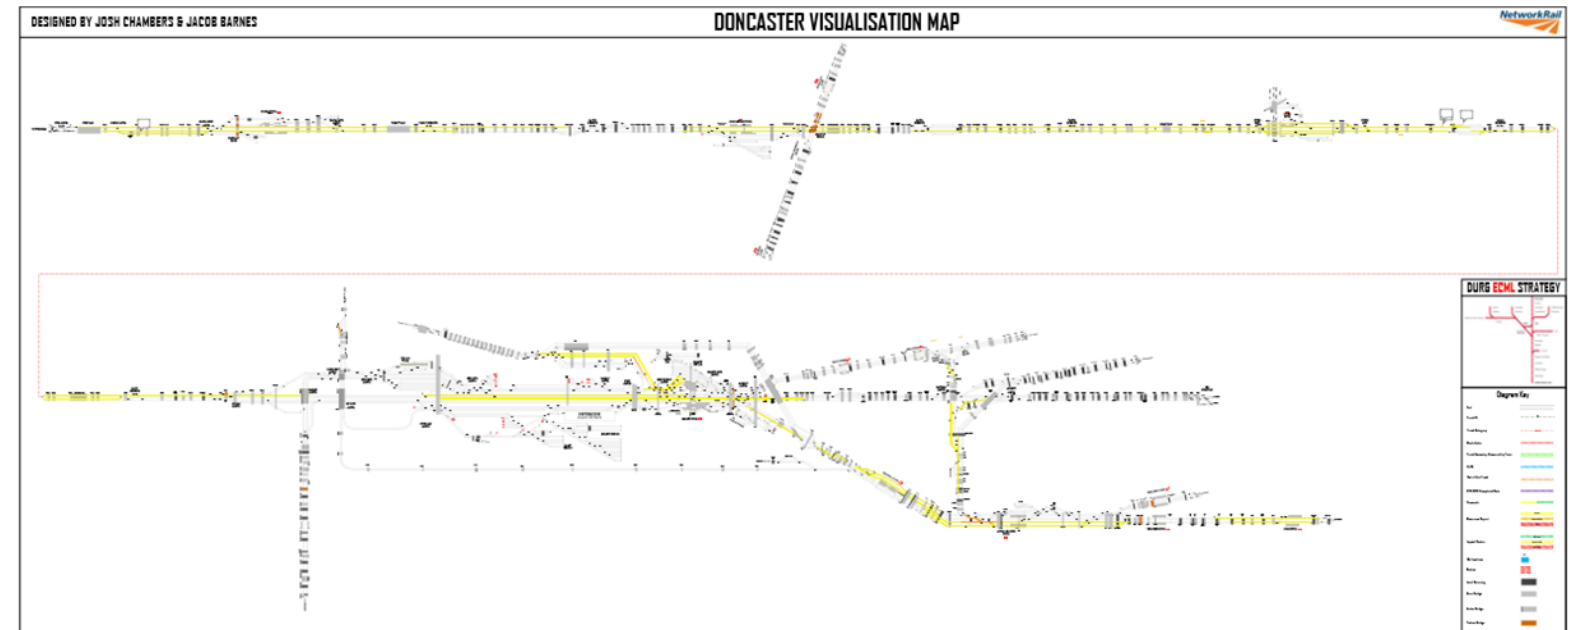
## Asset Performance

### OTM Management

- Full Year completed OTM shifts mapped, visually see treated and untreated areas.
- Highlights locations treated twice prompting alternative methods – Scheme / Stoneblower / Scope Renewal.

### Lubrication

- All TOR / Solar / Hydraulic lubricators mapped for TME Doncaster.
- Yellow – Assets covered by lubrication.
- White – Currently no lubrication regime.
- Diagram utilised by RME department to plan new lubrication locations showing predicted coverage to improve asset life at key junctions.

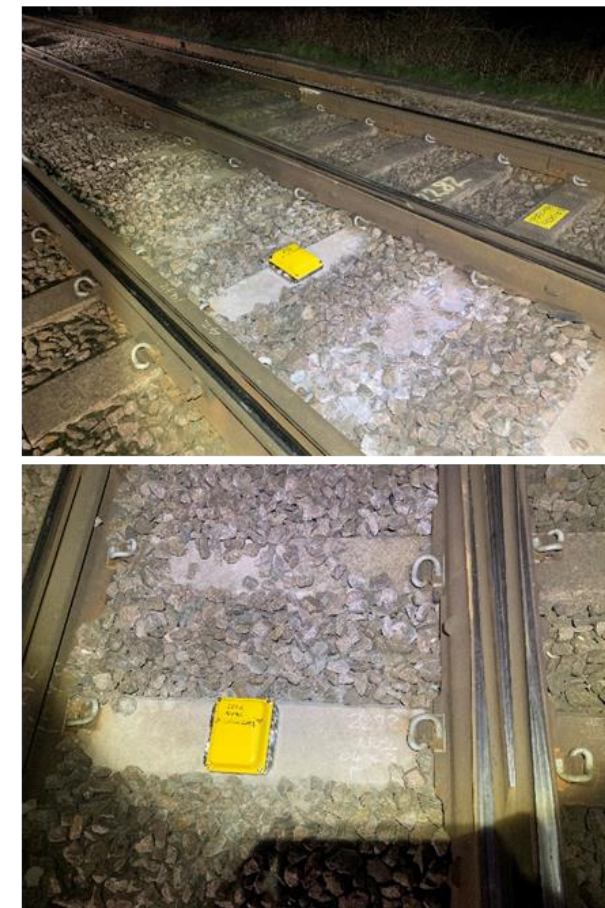
LA 2282

VERTICAL DISPLACEMENT

At Frog - in mm

THRESHOLD 3.00MM

The scatter plot displays vertical displacement data points (blue dots) over a period from May 8 to May 16. The y-axis represents displacement in millimeters, ranging from 0 to 3. A horizontal threshold line is drawn at 3.00 mm. The data points are clustered between approximately 0.2 mm and 0.9 mm, with most values falling between 0.4 mm and 0.8 mm. The x-axis is labeled with dates and times, showing a repeating pattern of data points every day.

### What Good looks like (Vertical Displacement)

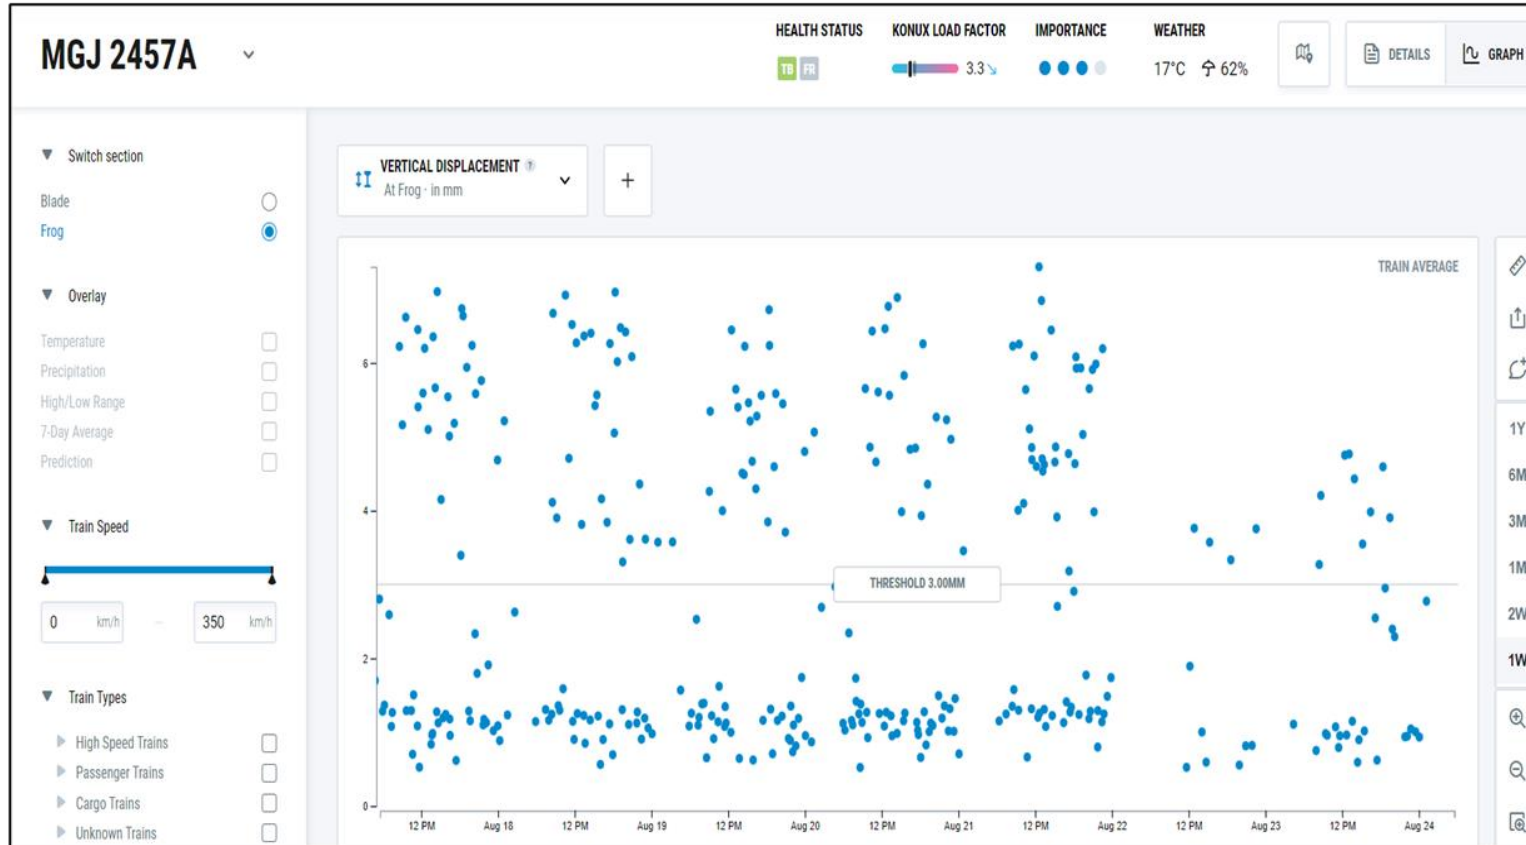
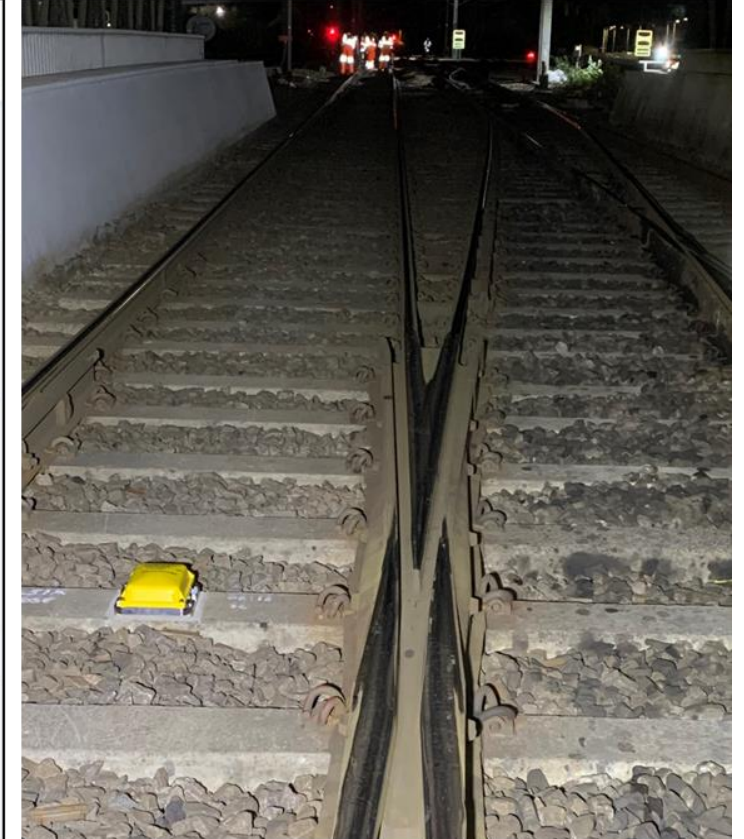
## Marshgate Junction 2457A

### What poor looks like (Vertical Displacement)

2 Devices fitted Unable to review under traffic due to location and complexity 1 in 13 EA (Located on bridge restricted with wire heights)

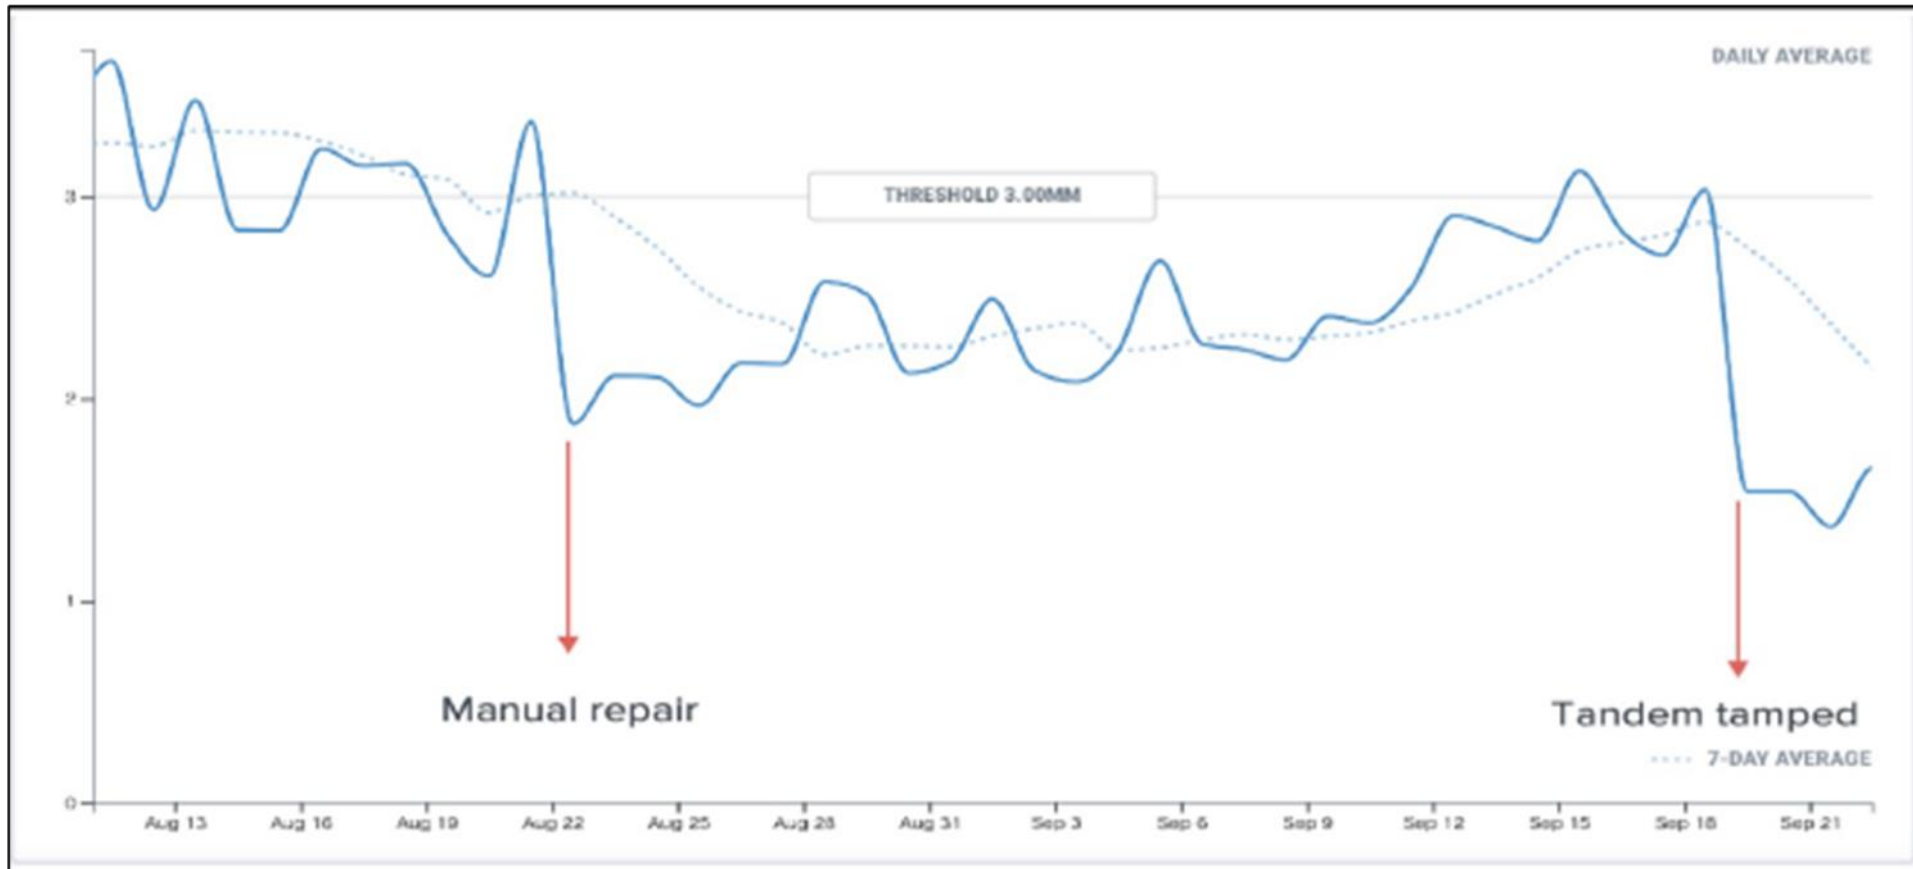
### 2457A Following Maintenance Activities

- Initial Robel – No Impact
- Lifted throughout with Duff Jacks – Vertical Displacement dropped significantly
- Parallel Tamped through Junction – Vertical Displacement less than 2mm with a predicted downward trend.

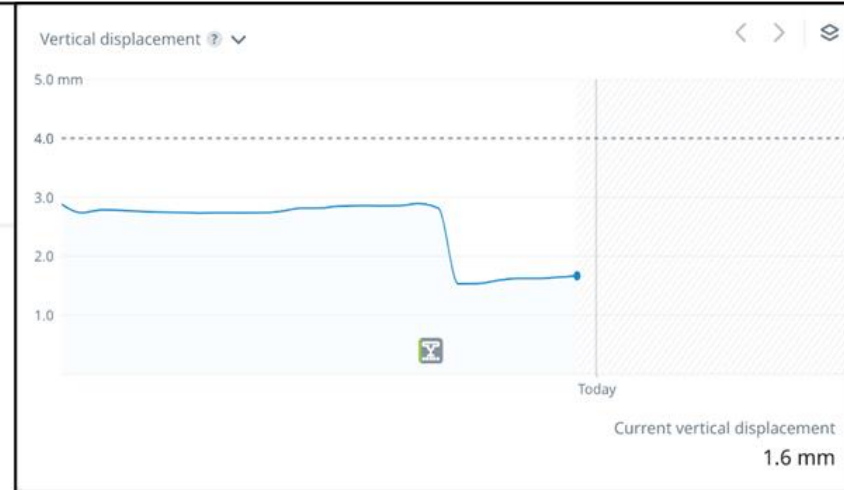
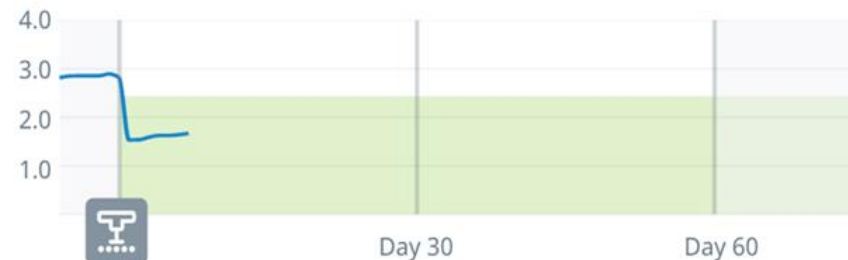
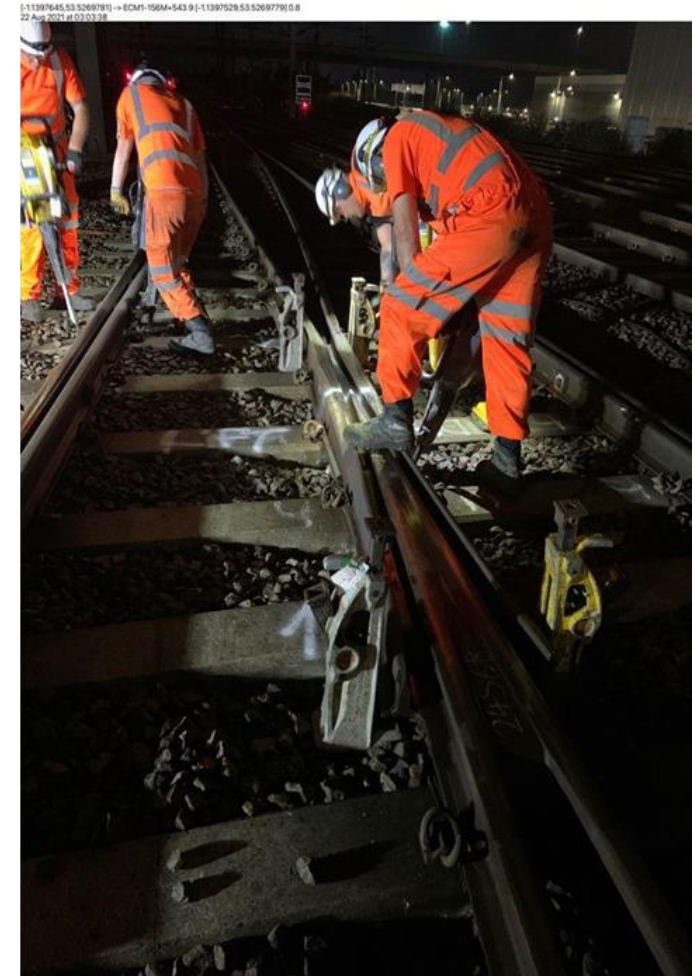
Maintenance quality check following weekend work – 2457B Marshgate Junction.

2457B | Marshgate Jn.

7 of 60 days evaluated...

The maintenance activity appears to be effective so far.

Vertical displacement at Switch

| Before | 2.8 mm |
| After 1 day | 1.5 mm -46 % |
| Current (after 7 days) | 1.6 mm -42 % |

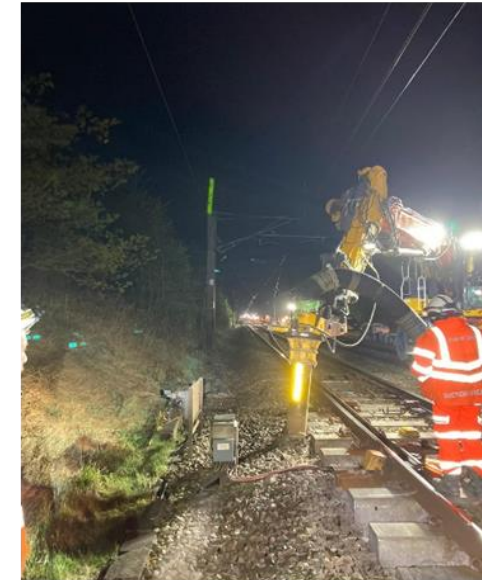
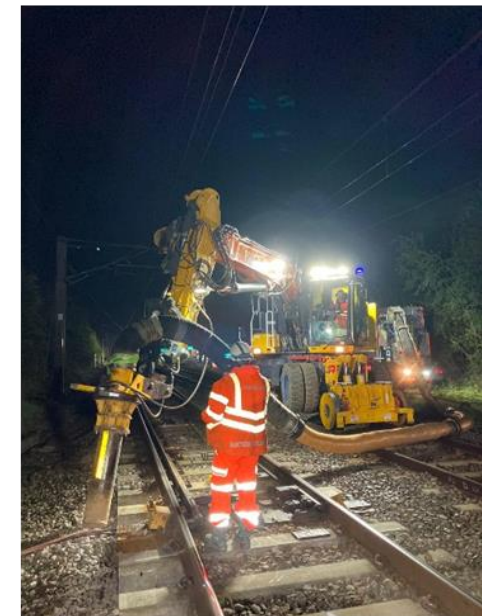
# KONUX – TME Doncaster

2221 2A following Reballast

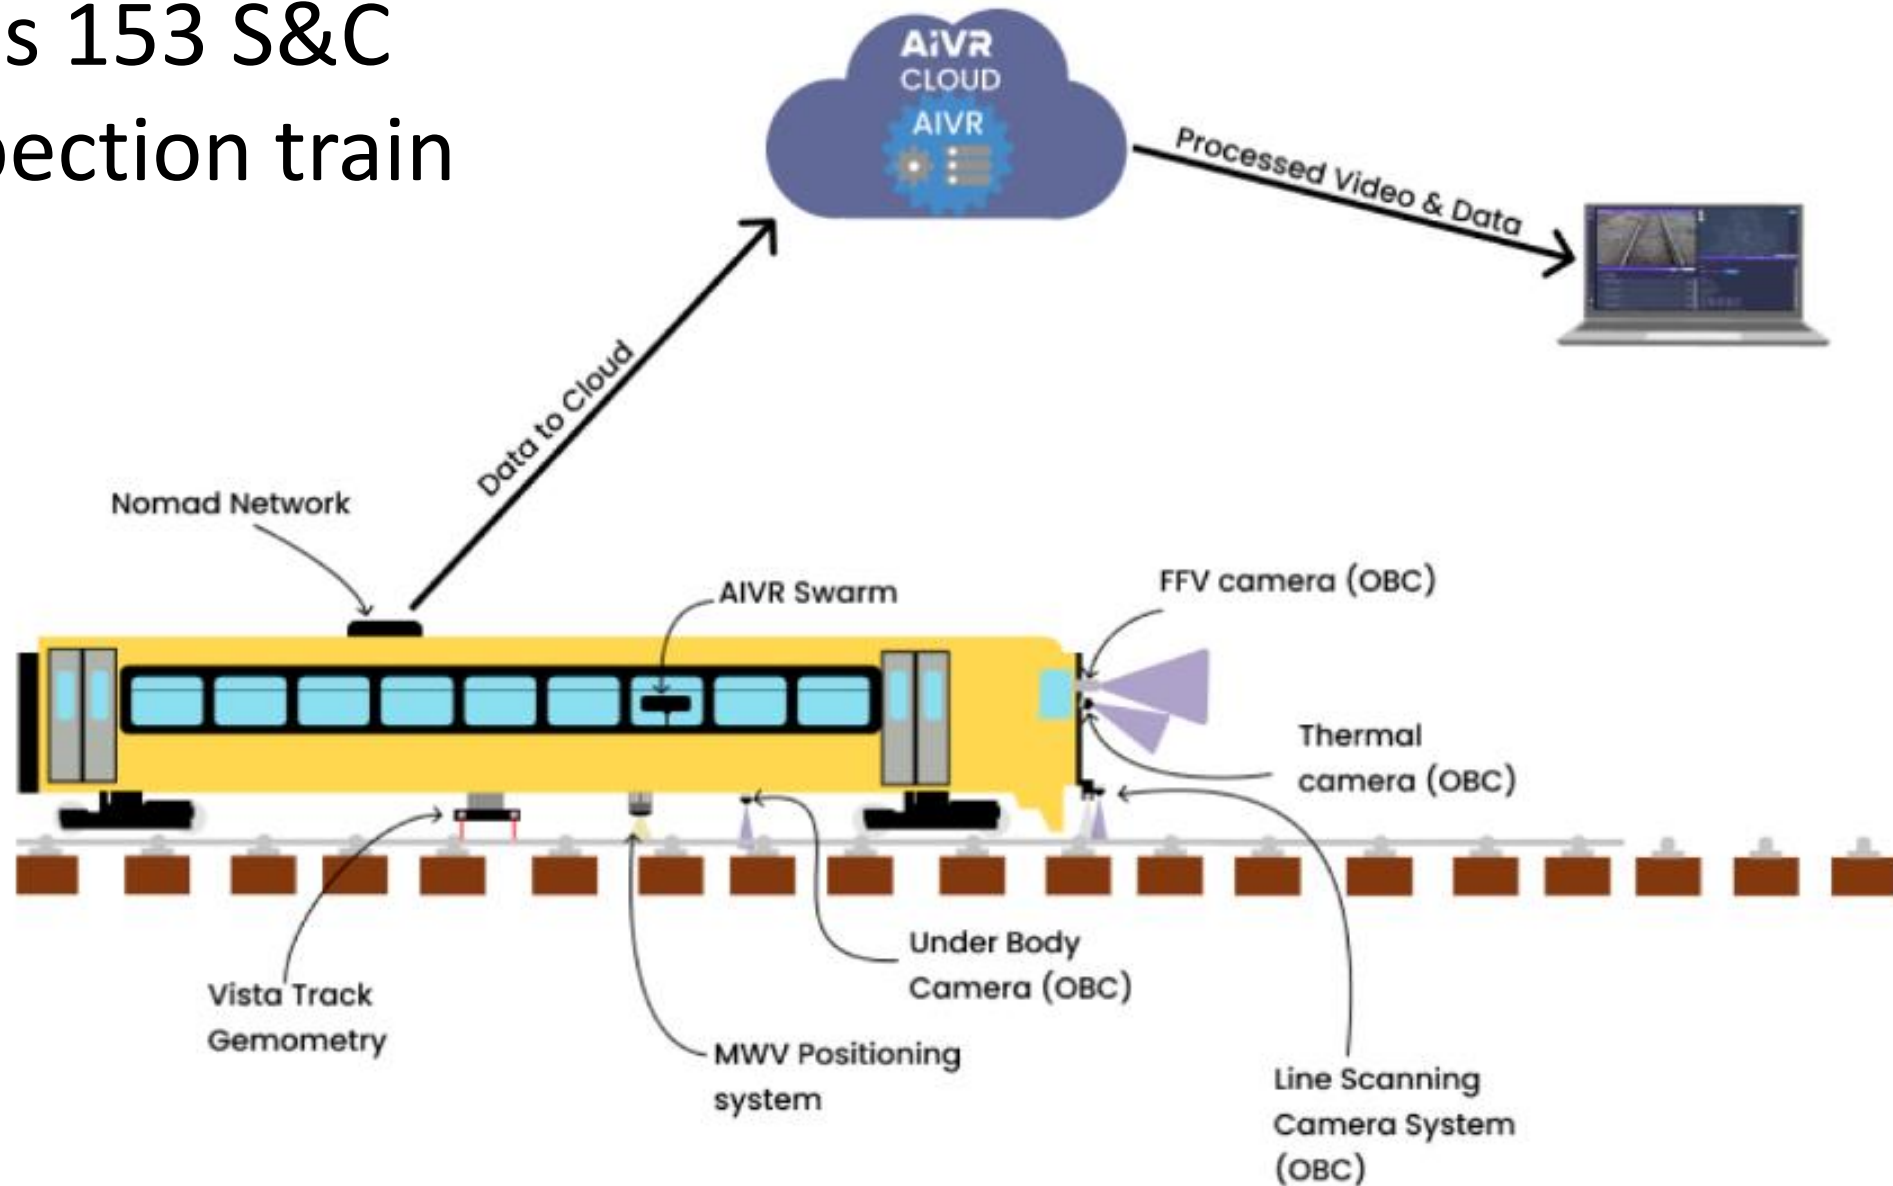
# Class 153 S&C Inspection train

Session: VIU 3- POD 9- Thermal/NIR Micheldever to Reading

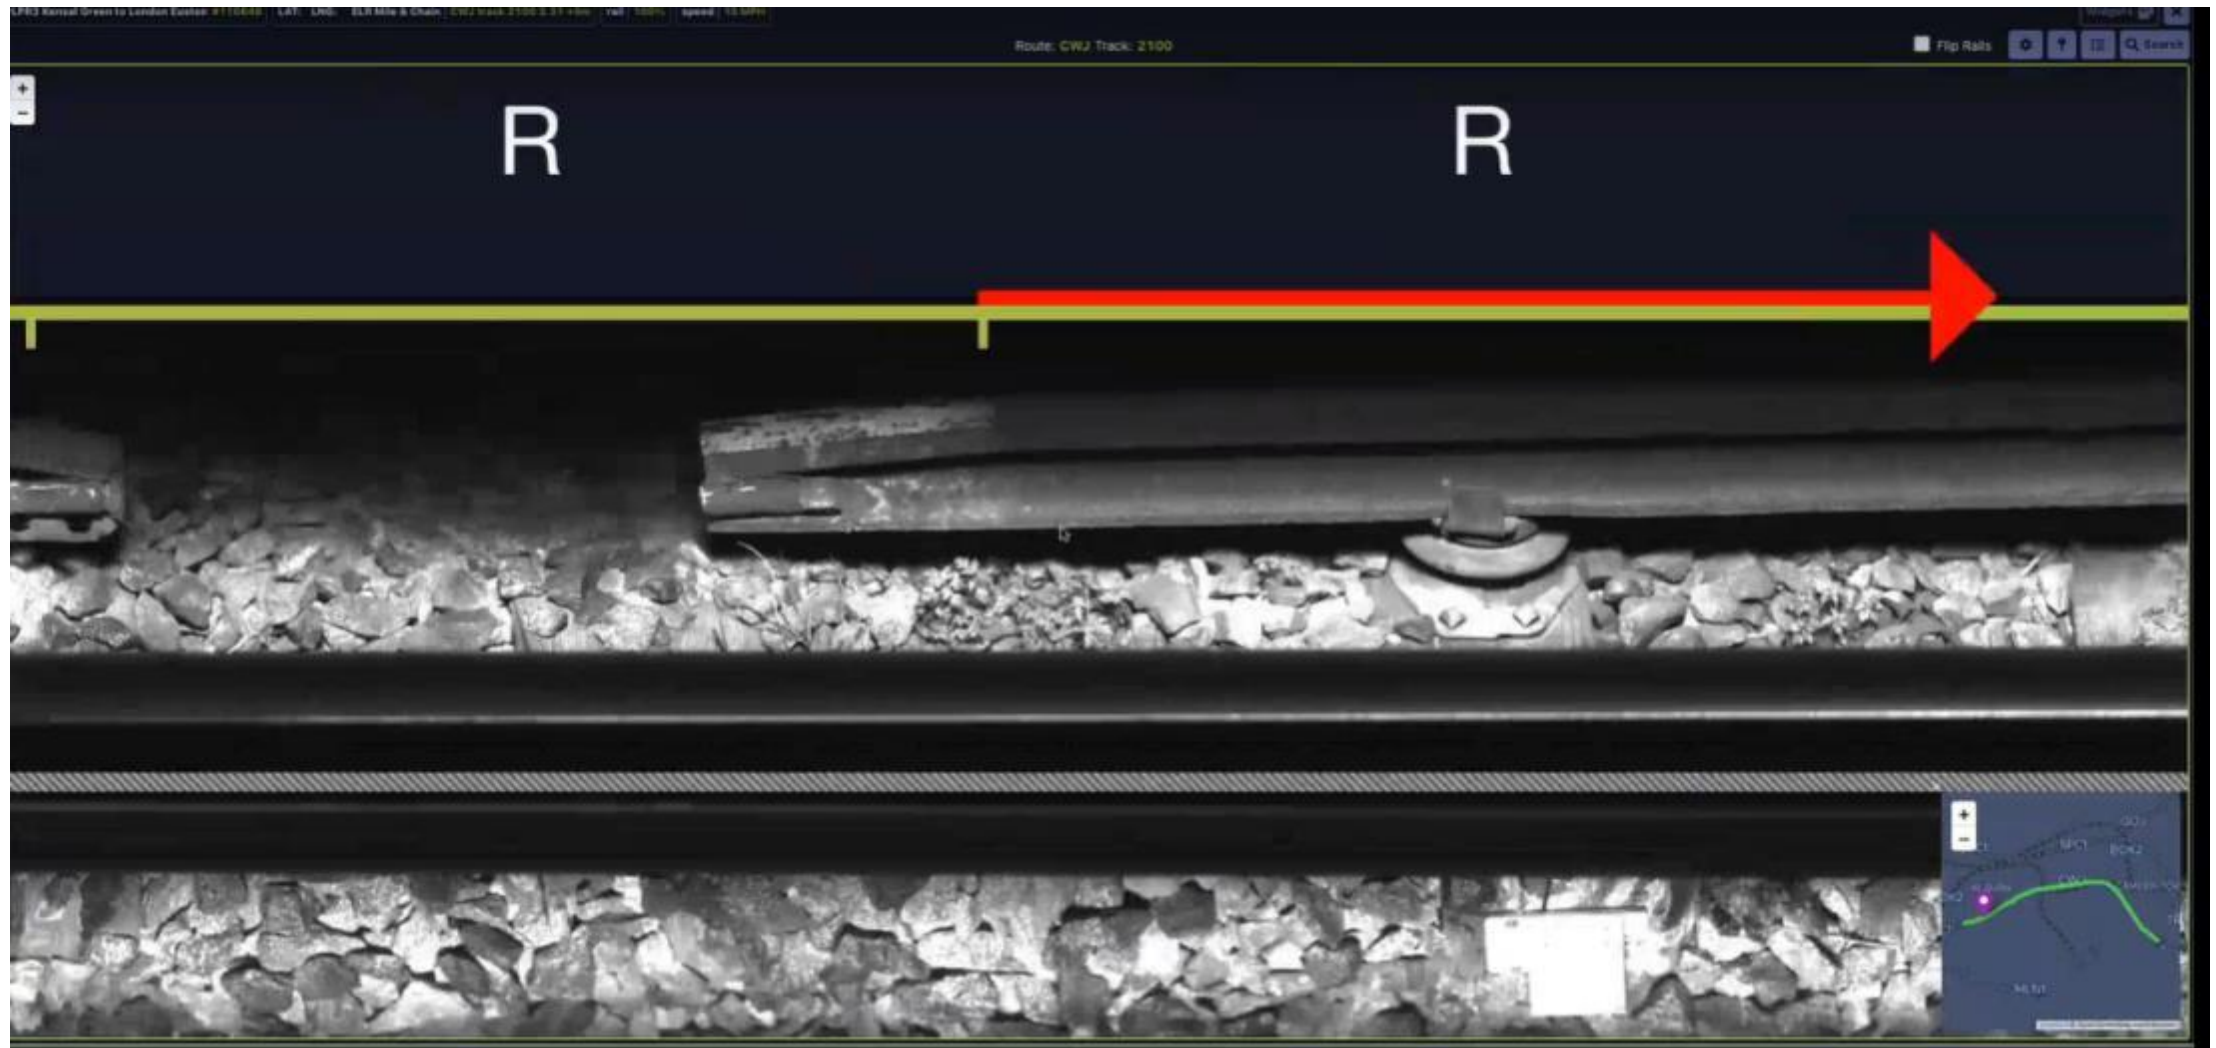
### Basic Visual Inspection Report 5.1%

| ELR | Track ID | Position | Defect Type | Description | Urgent | View | Delete |
| RTJ2 | 2100 | 80m 773.62y | Broken Rail | Extra notes | <input type="checkbox"/> | <a href="#">View</a> | |
