# The Challenges of Maintaining a High Speed Railway

Head of Track Engineering

Network Rail High Speed Ltd

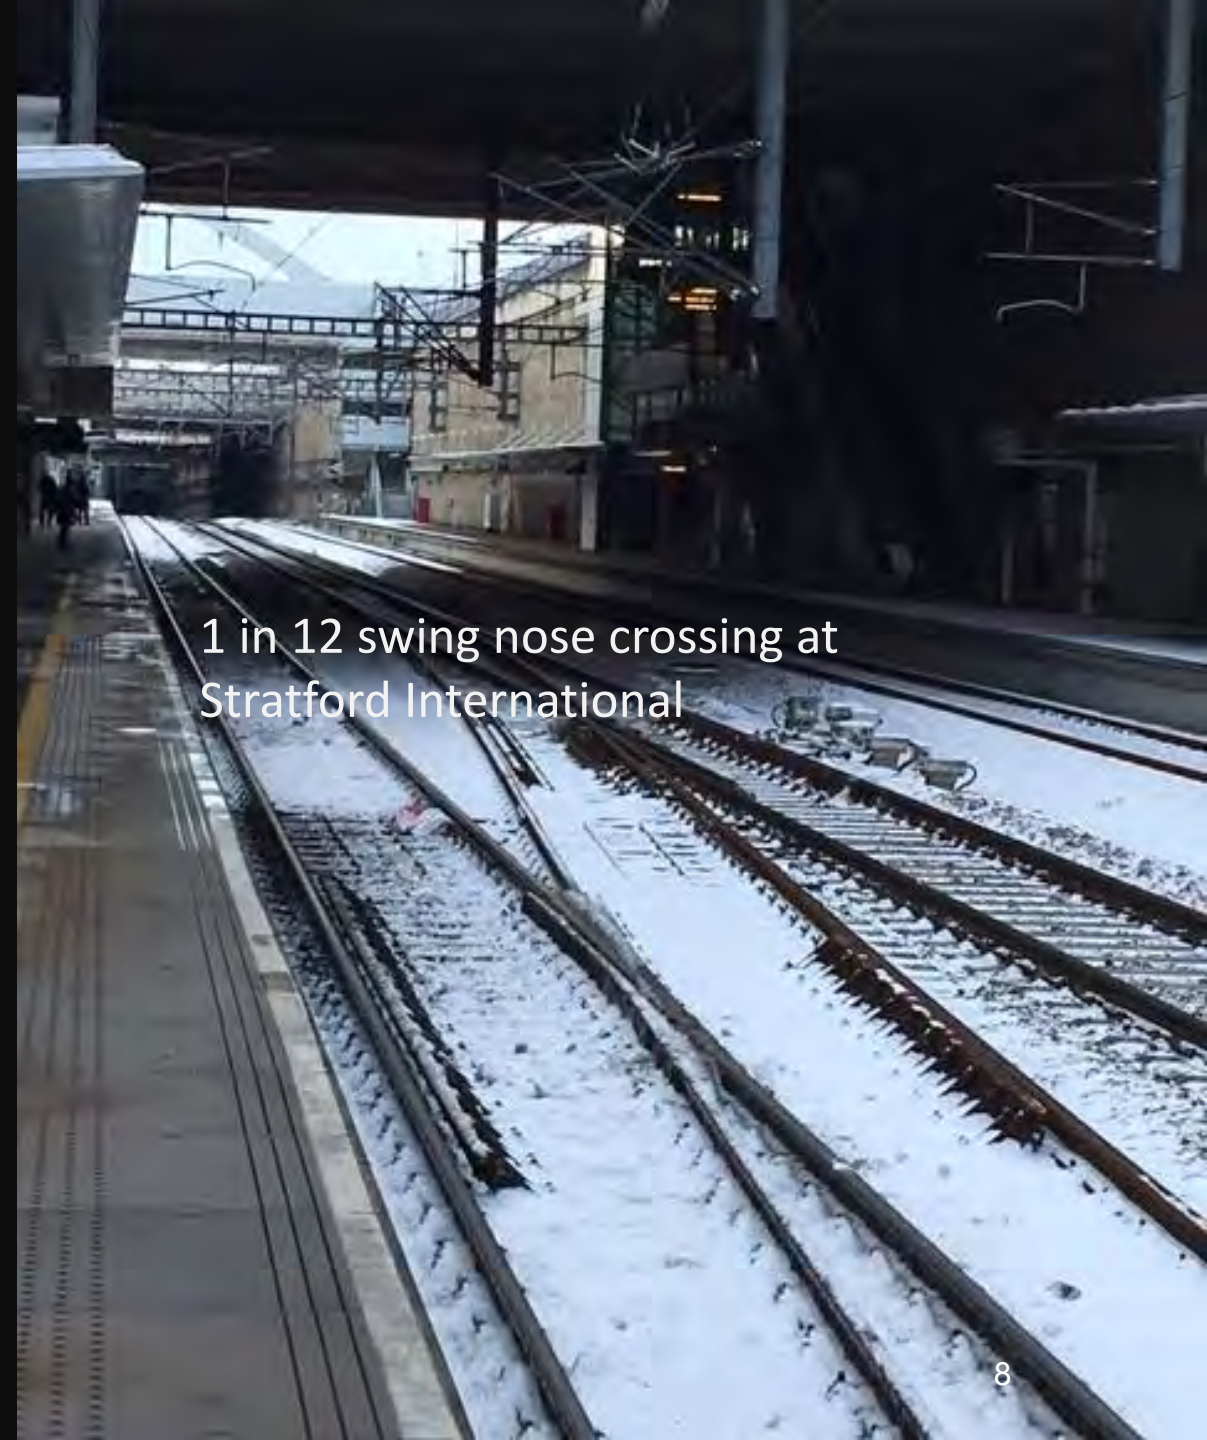
1 in 12 swing nose crossing at  
Stratford International

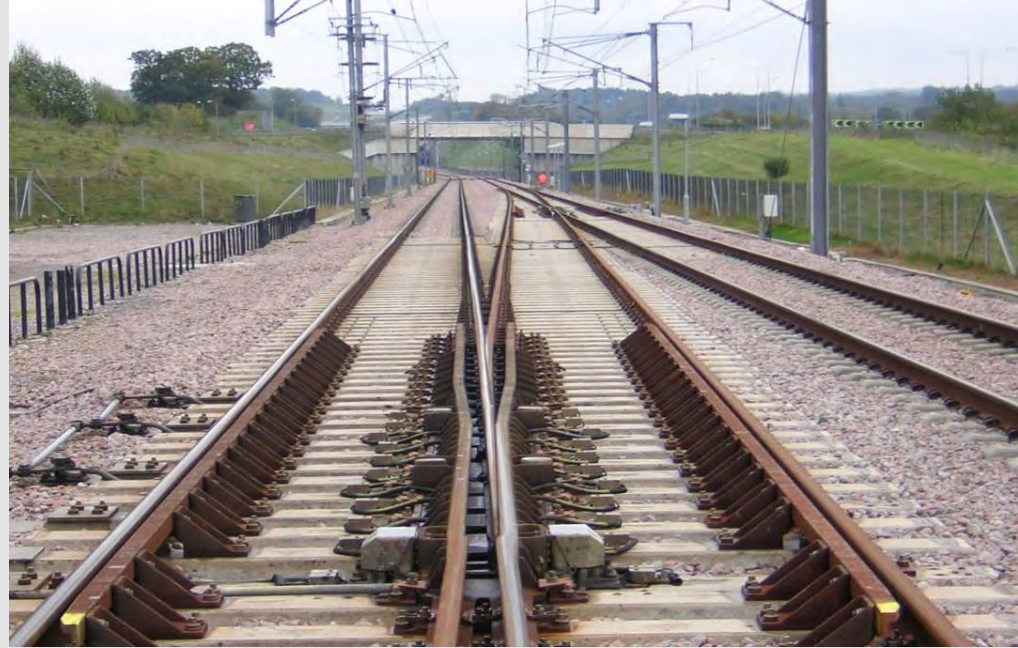
# Vossloh Cogifer 1 in 46 Swing Nose Crossing

- Toe to heel length 43m
- Tip to tip 300m
- Concrete bearers
- Nabla fastenings
- MCEM91 points machines
- All on straight track

- Tangential, double radius
- Cant deficiency of up to 100mm for up to 160km/h; 85mm for above 160km/h
- Manganese cast steel cradle, normal grade point and splice rail

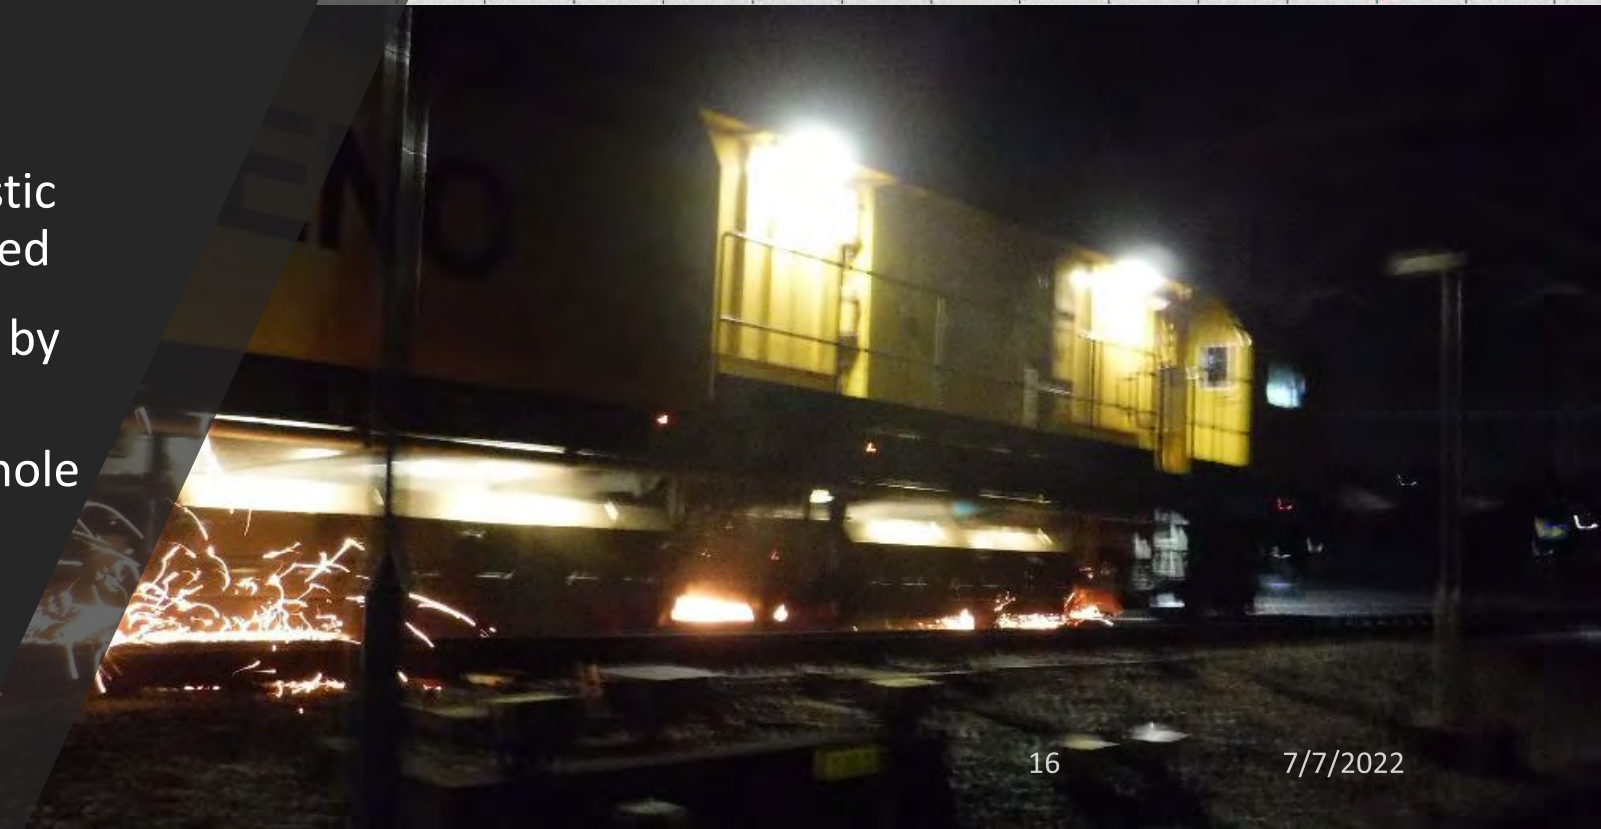
Switch rail sat higher than worn stock rail

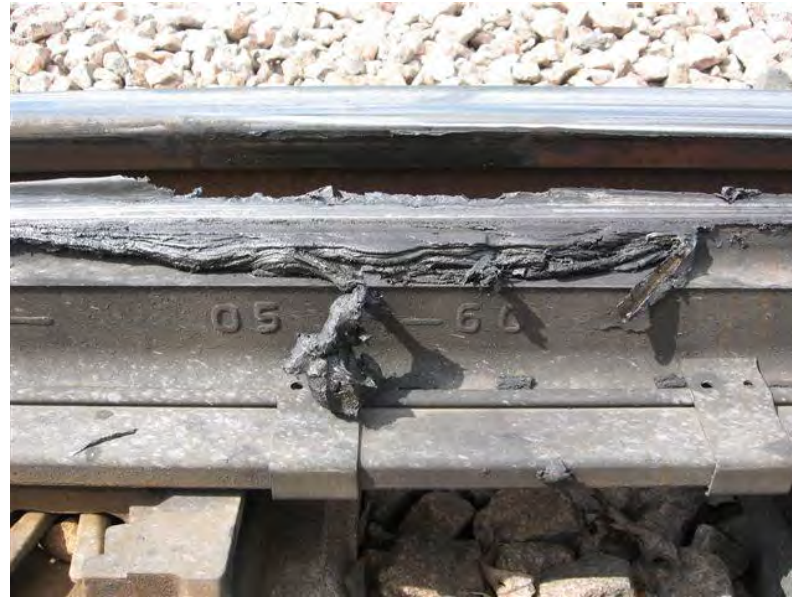
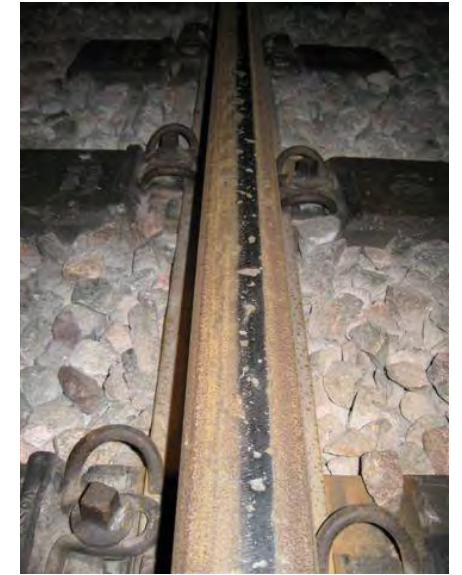
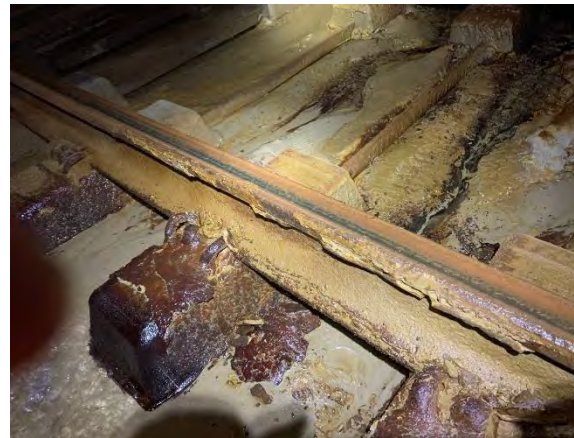
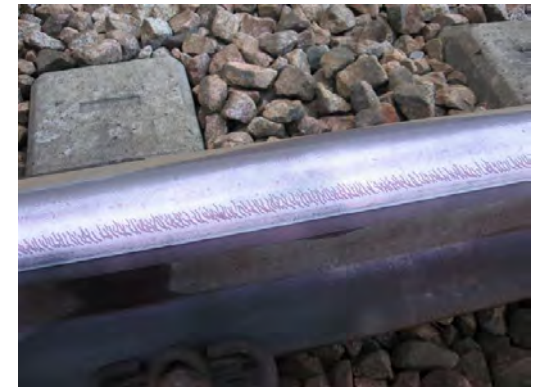
# Track Defects on HS1

- RCF
- Switch rail damage
- Corrosion
- Ballast and Ice pitting
- Cracked crossings
- Cracked/broken fishplates

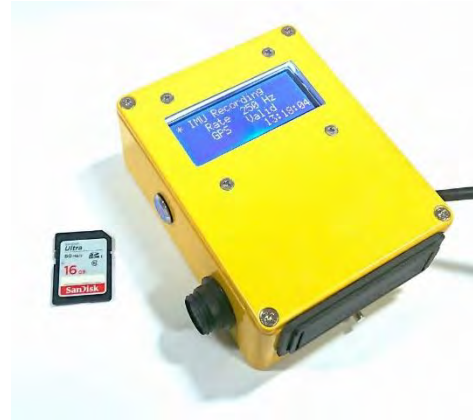
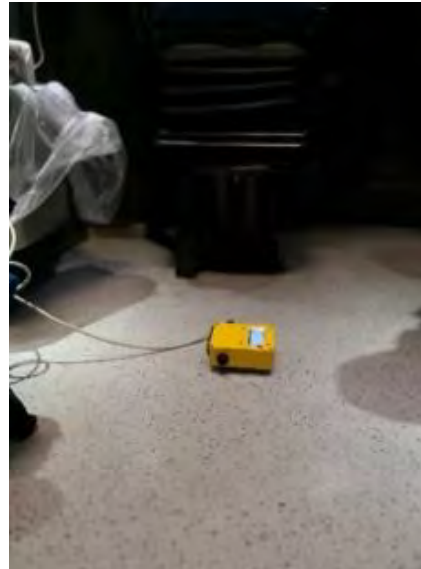
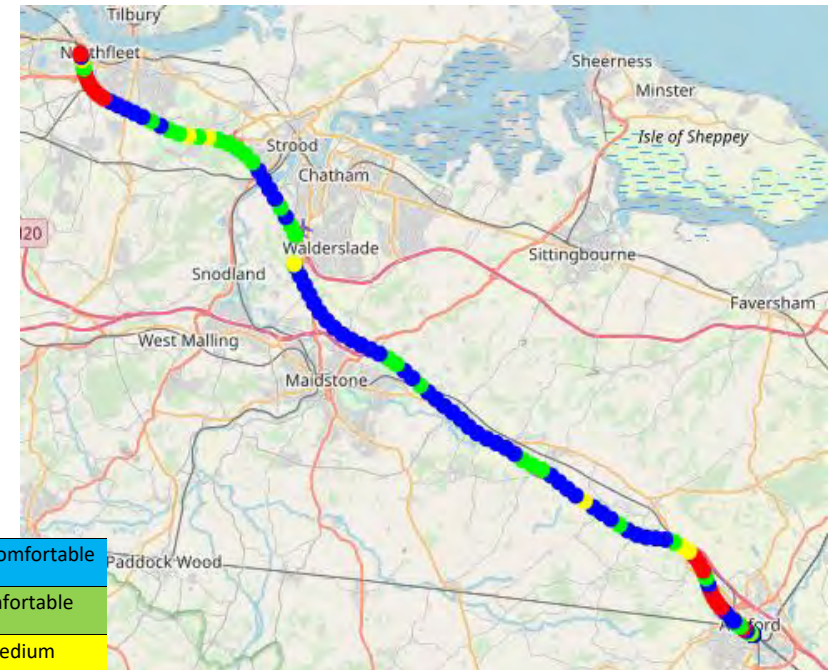
# Ride monitoring on in-service trains

- Ride monitoring using a handheld IMU (inertia monitoring unit) for developing a preventative maintenance regime – manual or train-borne tamping.
- Demonstrated potential for in-service monitoring

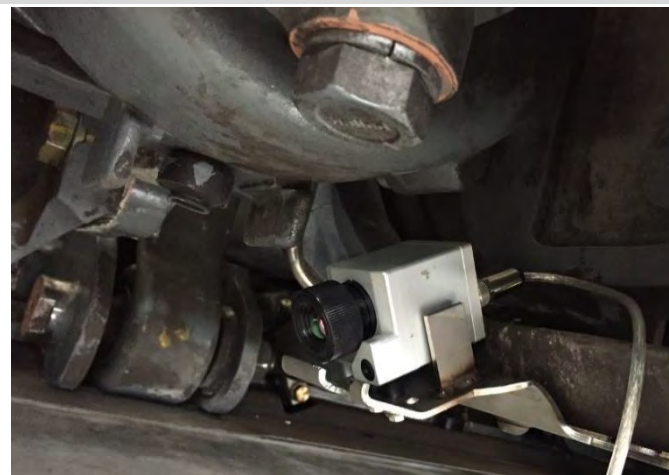
# Wheel/Rail interface monitoring on in-service trains

Using a Thermal camera on the Eurostar directed at the WRI to detect high impact forces as a means of preventative maintenance for both Train Operator and Infrastructure Maintainer

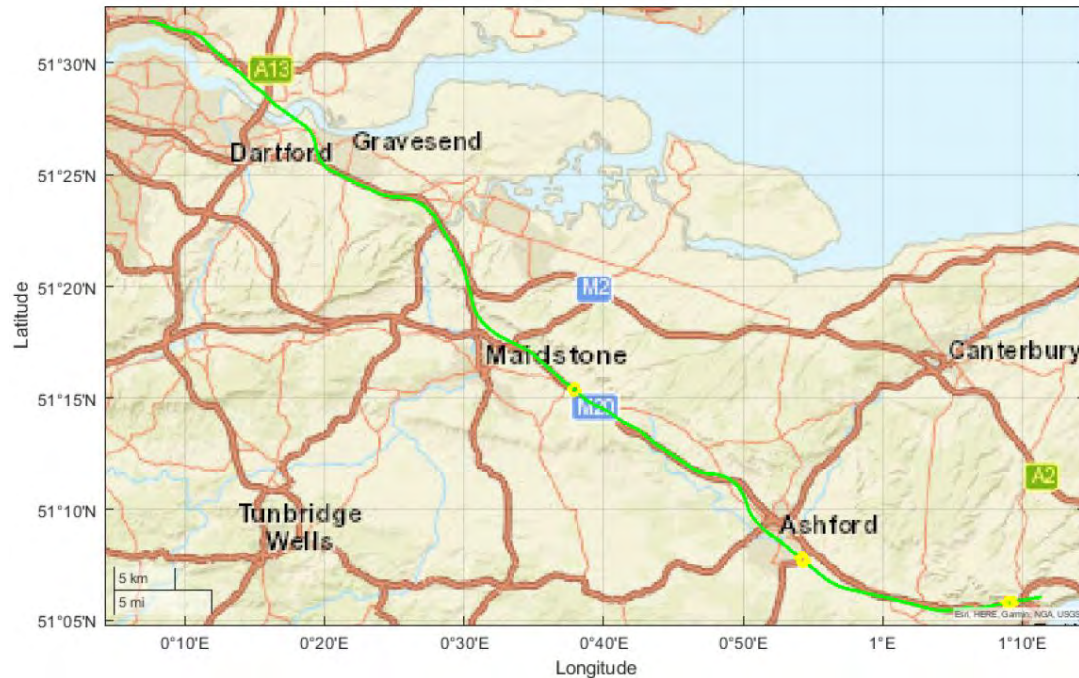
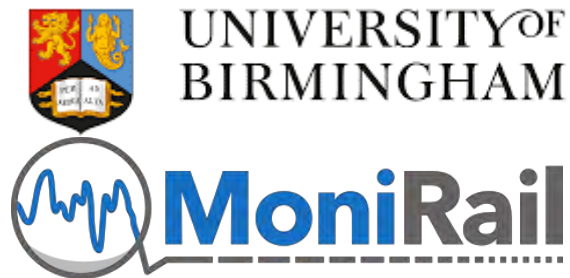
# In-Service Monitoring

Semi-permanent installation of axle box and vehicle body acceleration monitors to correlate acceleration with measured track geometry and observed defects
