# Sea defences - friend or foe?

AUTHOR: John Parker

## TECHNICAL ARTICLE

### The PWI Journal July 2022

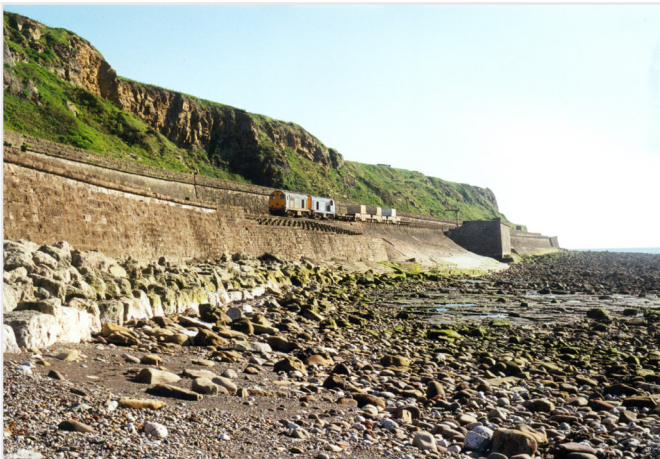
Figure 1: Nuclear flask train passing along the sea wall at Parton, Cumbria.

**1. Sea Walls:** Built usually to form a bench for the railway between the sea and adjacent cliffs which are typically weathered and unstable. Constructed of masonry or concrete and either built vertically, inclined or concave to deflect waves. (See figure 1).

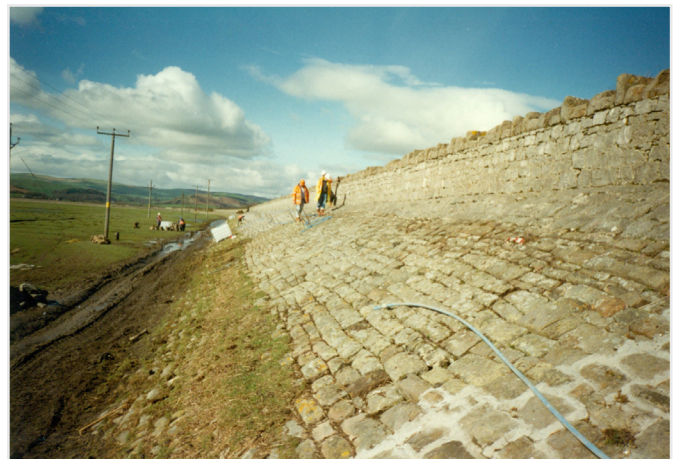
Figure 2: Revetment at Capes Head embankment.

**2. Revetments:** Embankments, usually alongside estuaries that are protected from wave action erosion by stone pitching placed on the seaward side. An example of a revetment is the Capes Head embankment on the approach to Leven Viaduct in Cumbria, which was built by James Brunlees in 1855 and varies in height from 4.5 - 7.6 metres (15ft to 25ft). The viaduct carries the Carnforth to Barrow section of railway over the Leven river estuary. (See figure 2).

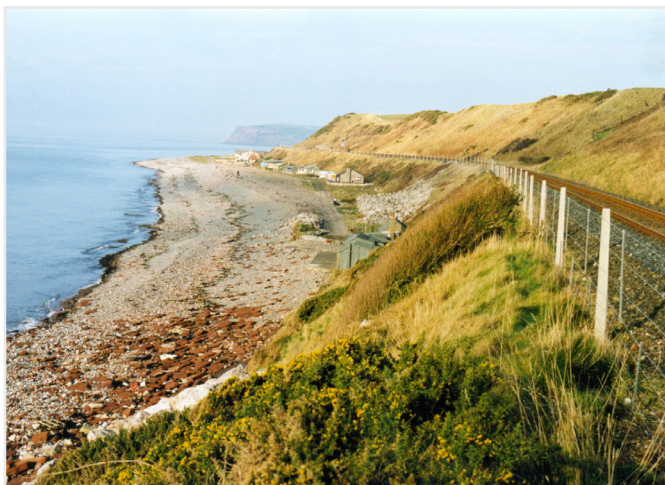
Figure 5: Shingle bank sea defence at Nethertown.

Shingle banks offer one of the best forms of sea defence by absorbing wave energy and reducing the depth of water and hence wave height on the upper beach. However, they do require significant maintenance involving replenishment of stone and reprofiling after severe storms. The residents in the chalets at Nethertown in Cumbria, shown in figure 5, have maintained a shingle bank defence to mainly good effect over many years. This has in turn provided protection to the railway.

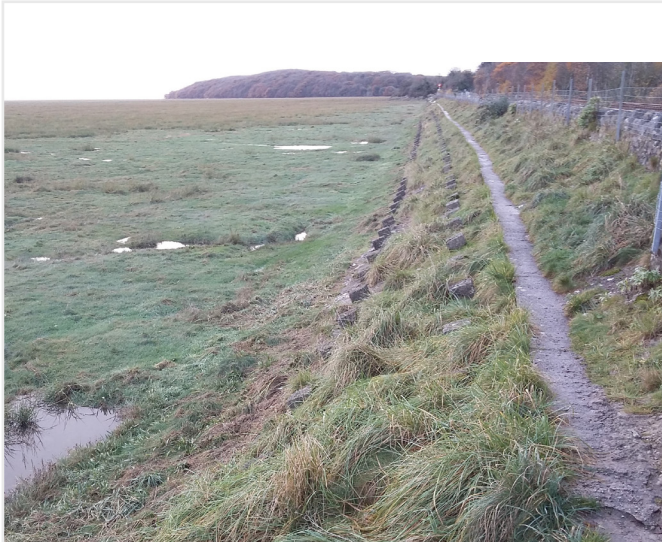
Figure 6: Kent's Bank salt marsh.

**5. Salt Marshes:** Salt marshes form as estuaries alter course over the years ie Kent and Dee. The slower moving water on one side deposit silts and sands and this gradually builds up to force the estuary further away from that side. The mud banks thus exposed are not regularly covered in sea water and hence sea grass establishes itself. These areas form ideal defences as even in storm conditions the water depth on them is shallow hence the wave height is low. They also become very environmentally sensitive areas, usually SSSIs for the bird life they attract. They are, however, very fragile formations and can be quickly eroded when the estuary changes course again as discussed later in this article. Most estuaries oscillate from one side to the other over a period of maybe 100 years. Kents Bank frontage from 1964 to now has changed from a sandy beach to a full salt marsh as shown in figure 6.

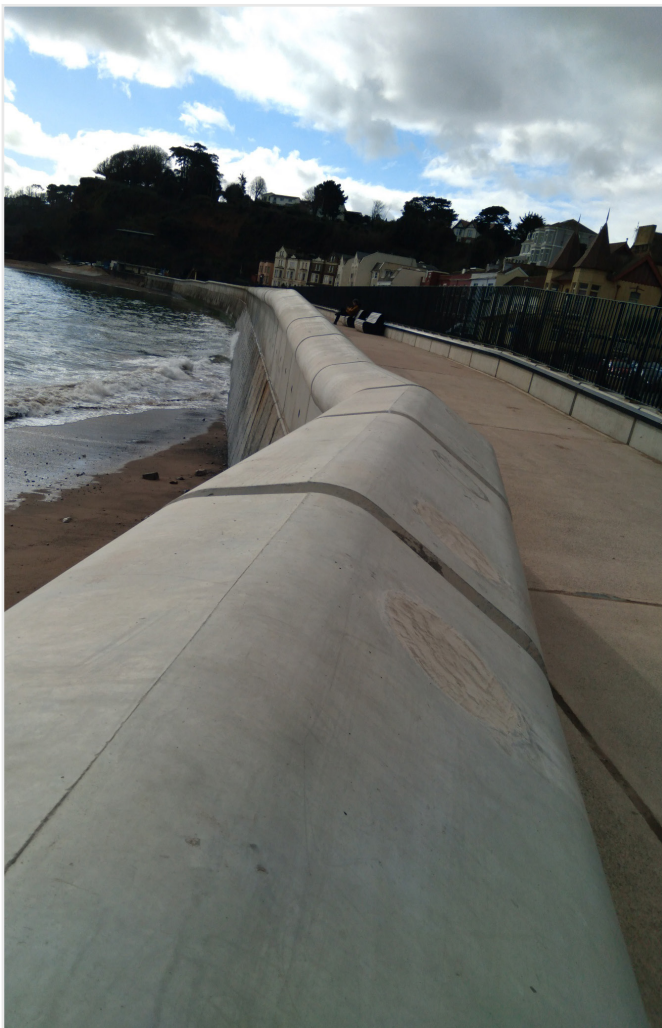
Figure 9: Reconstructed sea wall at Dawlish.

The sea wall is prone to overtopping and is backed by weathered sandstone cliffs, but has the added problem that it is fronted by a popular holiday beach which precludes standard sea defence solutions such as rock armour. The wall is also topped by a public footpath. (See figure 9).

Following a recent feasibility study BAM Nuttall are now on site (Feb 2021) constructing the chosen option which is a partial reconstruction and raising of the sea wall with precast concrete units. Work has progressed from the west end to just beyond Dawlish Station.

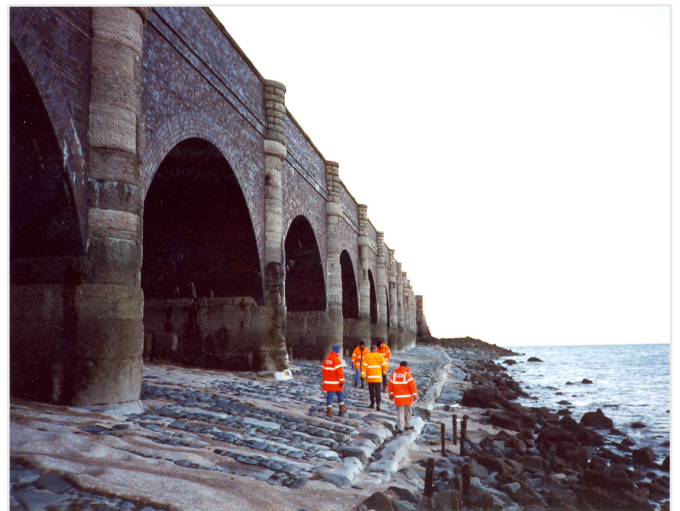
Figure 8: Viaduct at Llanfairfechan.

**Robert Stephenson** In 1846 he was busy with the construction of the Chester – Holyhead Railway and particularly the sea wall at Llanfairfechan, 183 metres, (200 yards), of which failed following a storm in October of that year. He replaced that section with a viaduct initially with CI beams forming the spans. Brick arches were substituted in the late 19th century. (See figure 8). It was also found necessary to drive timber piles 4.5 metres, (15ft), from the wall to prevent scour to the foundations as the work progressed, a problem that exists to this day. It is interesting to reflect on Robert Stephenson's thoughts at this time as recorded in 'Lives of the Stephensons' by Smiles:

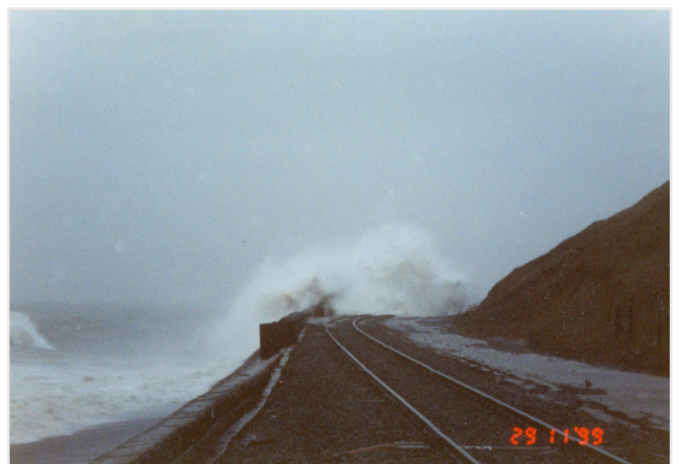
Figure 10: Wave action at Parton Sea Brows.

**Parton Sea Brows:** This section of coast is particularly prone to storm damage as seen from the failures soon after construction. The main causes of failure are wave overtopping forming sink holes in the cess, and erosion of the rock foundation allowing sea water to wash out fill material from behind the wall. (See figure 10). Historically, ad-hoc repairs have been carried out over the years usually involving filling sink holes and pouring concrete to seal the base of the wall.

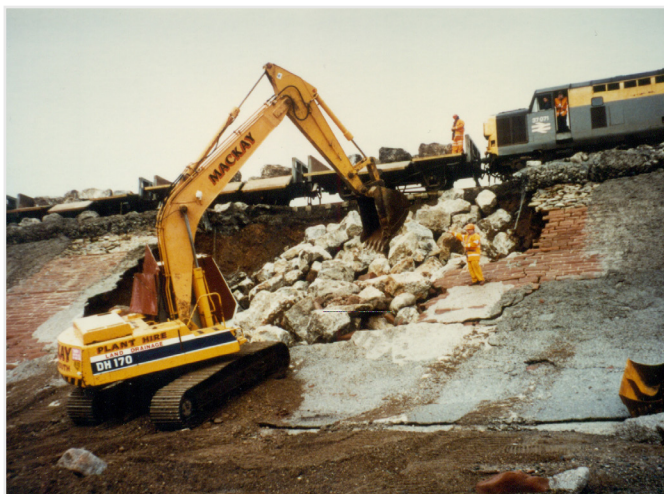
Figure 11: Repairs to the sea wall at St. Bees.

**St Bees:** The St Bees sea defence in Cumbria suffered many failures during the late 20th century. This was due to voiding beneath the stone pitching which had weakened the structure over time. It was always essential to start repairing damage at low tide before further loss of pitching on subsequent tides. In figure 11 the void is being filled with rock armour before sealing with concrete. However the solution was not always that neat, quite often scrap concrete units were used and on one infamous occasion redundant 'brutes' (parcel trolleys) from Carlisle station filled with concrete!

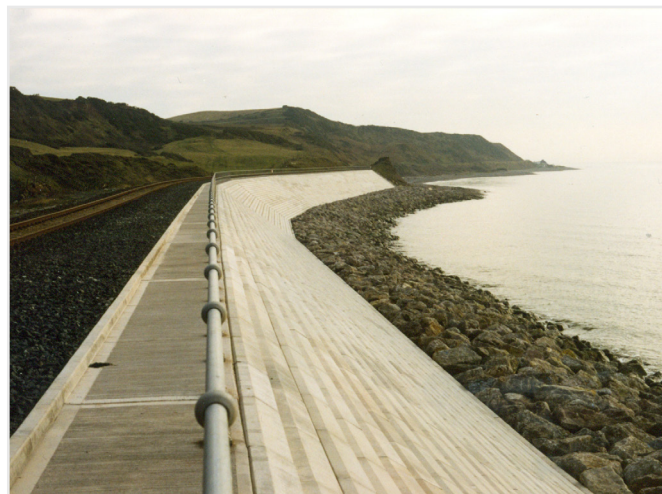
Figure 12: Upgraded sea defences at St. Bees.

With the advent of Railtrack a decision was taken to tackle some of the longer running structural problems such as St Bees. Following a feasibility study a contract was let to Christiani Neilsen to reconstruct the defence with a low level rock armour defence and upper slope erosion protection. Access was naturally required along the beach which had belonged to BR but following privatisation now resided with BR residual who were just in the process of selling it by auction. It was therefore necessary for Railtrack to bid for it, and eventually ownership of the beach was secured for the benefit of the railway.

The rock armour was placed first and used as a platform for the upper works. There may have been a more cost-effective solution than concrete revetment blocks, but they provided a reasonable appearance and will last a very long time. (See figure 12).

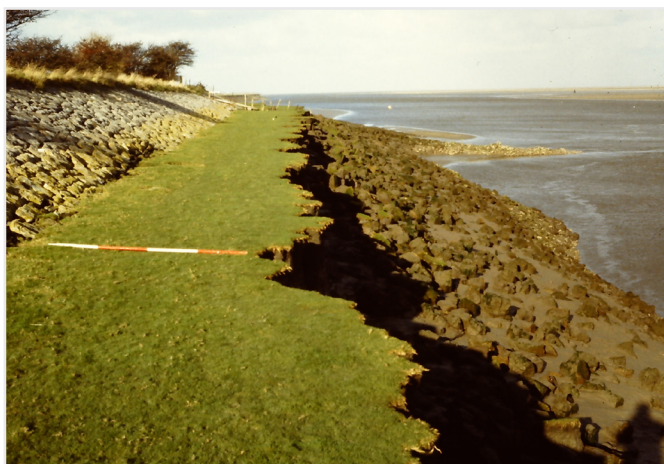
Figure 13: Lord Vivian's Embankment.

Many years ago the salt marsh in front of the revetment was several hundred metres wide but as the River Dee altered course the salt marsh was eroded at an alarming rate. With the main channel so deep there was a serious concern that the estuary would eventually undercut the revetment and collapse it. (See figure 13).

To quantify the risk trial holes were dug to find the toe of the stone pitching, and fortunately the depth of it was such that undermining would be unlikely. This confirmed that the estuary had been hard up against this defence in past times, hence the need to build it. It also shows how fragile a salt marsh is, when accretion is taking place as at Kents Bank it reduces maintenance of sea defences, but erosion on the scale of the Dee at Lord Vivian's Embankment can quickly increase maintenance budgets and risk to railway infrastructure.

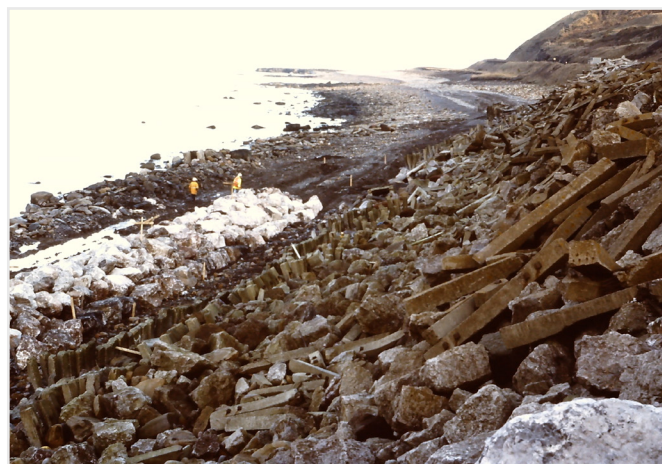
Figure 14: Construction of rock bund at Micklam.

**Micklam Slip:** The deep-seated slip at Micklam in Cumbria has been an on going problem for track engineers, who have frequently had to realign track distorted by ground movement. An historic solution was to weight the toe of the slip with scrap concrete units, mainly sleepers. This was reasonably effective, but the sleepers were not heavy enough to withstand the full force of the Irish Sea and over time ended up spread across the beach. This was undesirable for a number of reasons, being very unsightly and a risk to members of the public as the concrete eroded and exposed reinforcement strands, and the loss of the sleepers obviously weakened the defence.

Work was initially undertaken to contain the sleepers by constructing a rock bund along the frontage. (See figure 14). This proved to have additional benefits by trapping beach material behind it, forming a raised platform in front of the defence which absorbed and reduced the effect of wave action.

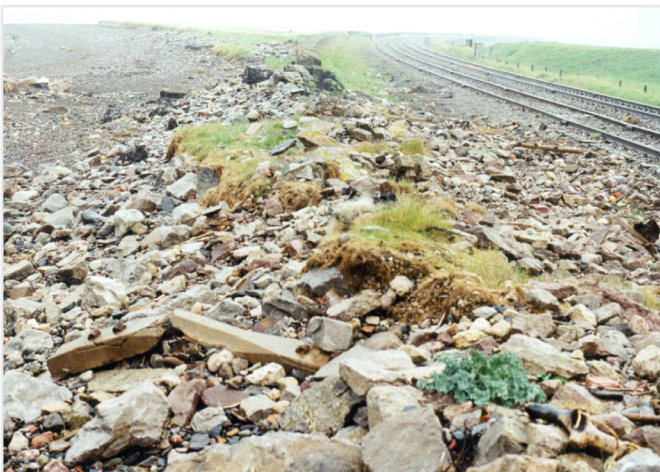
Figure 15: Exposed location at Siddick showing continual erosion.

**Siddick:** The railway here is on a level coastal strip near Workington in Cumbria, and historically no defence was provided. The stony beach was regularly supplemented with waste from coal mining and the steel industry which formed a protection from the sea. With the decline of industry and a more environmentally aware society this practice stopped. (See figure 15).

The frontage was then subject to fairly rapid erosion resulting in the substantial damage in 1977 detailed in Mike Chorley's paper 'The Great Washout', which was published in the PWI Journal in 1984, (Vol 102 part 2). Initially a gabion defence was provided, and as this deteriorated concrete was cast to protect the gabions. In this exposed location the scour effect of the sea undermined the defence and made it necessary to construct a rock defence in early 2000s. However, erosion continues to the north along this very open and level stretch of coast which extends all the way to Flimby. This is an example of a defence growing in a reactive way.

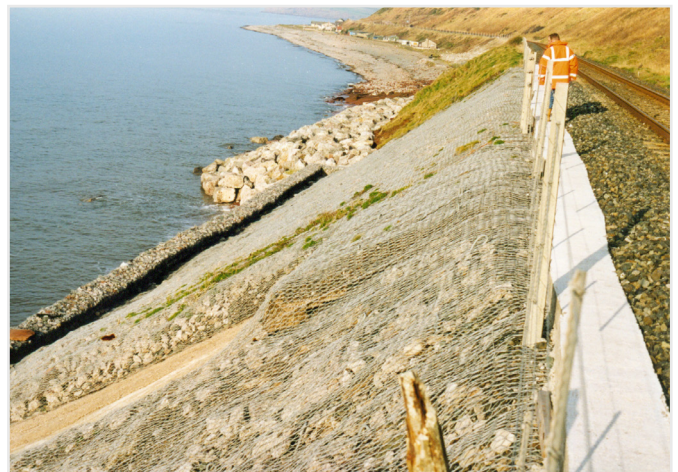
Figure 16: Upper slope with 6G stone and rock netting at Nethertown.

**Nethertown:** The toe of a railway embankment can have adequate protection from coastal erosion provided by rock armour held in place on the rock shelf by steel pins. However the upper slope can still be vulnerable to erosion by wave over topping or run off from the fields on the higher ground inland of the railway. A cost effective solution is to grade the upper slope, place 150mm of Type 6G stone and retain it with rock netting, (See figure 16). This solution could have been used at St Bees but the design life is probably only 30 years due to corrosion of the netting and settlement of the stone.
