# Technology and Asset Management – a Network Rail Perspective

**Dr Sin Sin Hsu**

Regional Engineer [Track], Eastern

Network Rail

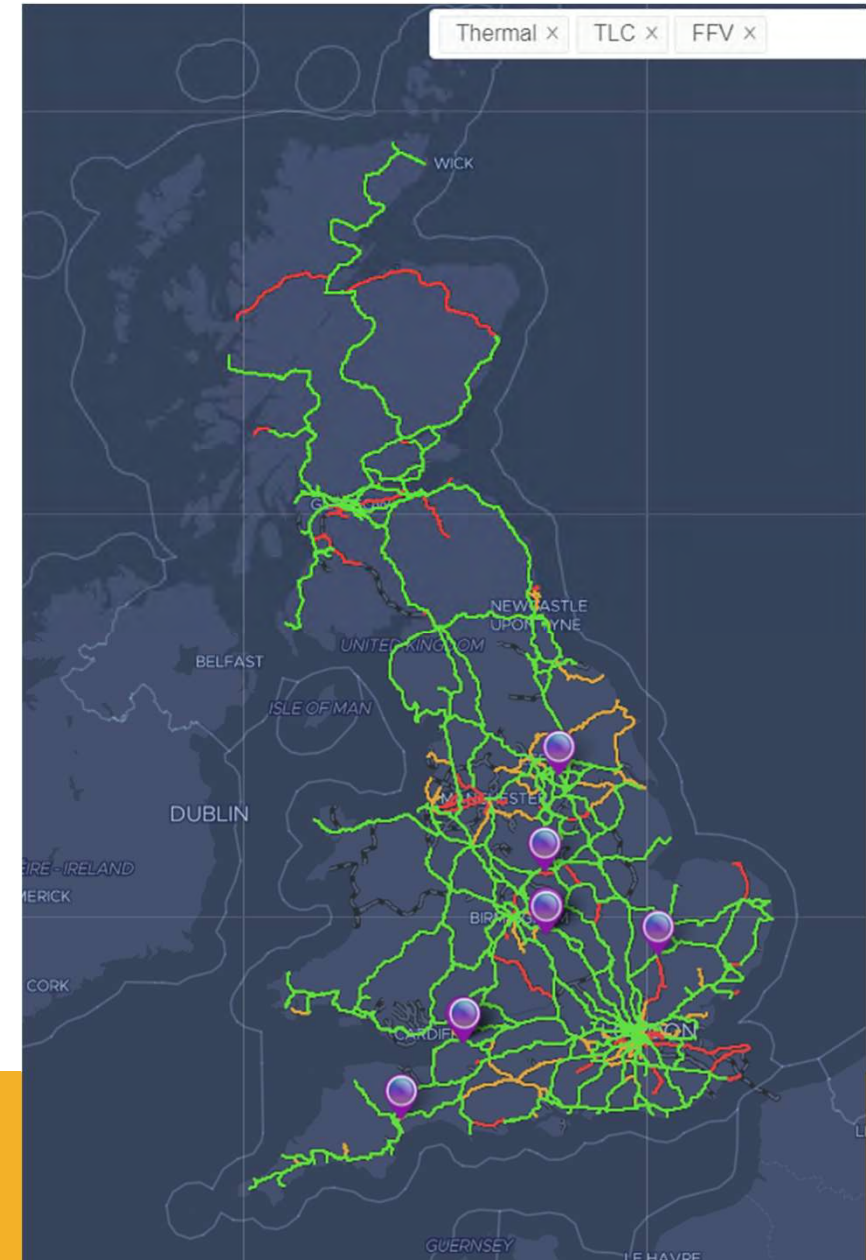
Map of FFV with daylight coverage last year (from IM fleet and portable TLC devices)

Capability of most TOC fleets understood, image quality and operational readiness still WIP – this will inform spec for new installs and determine where upgrades are required

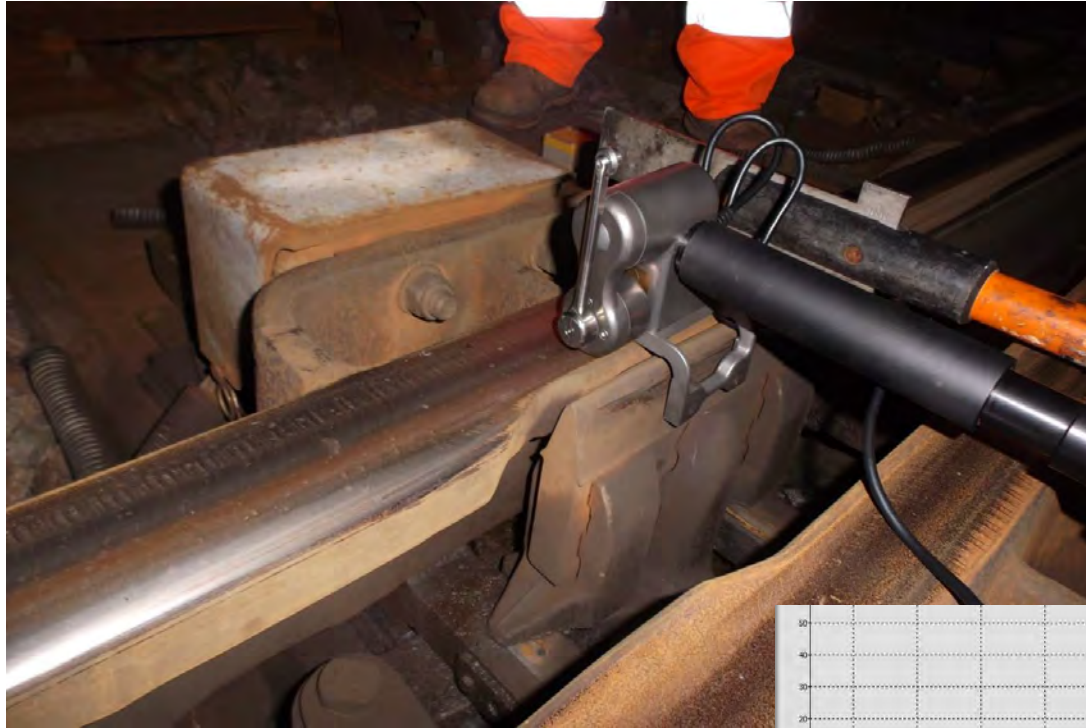
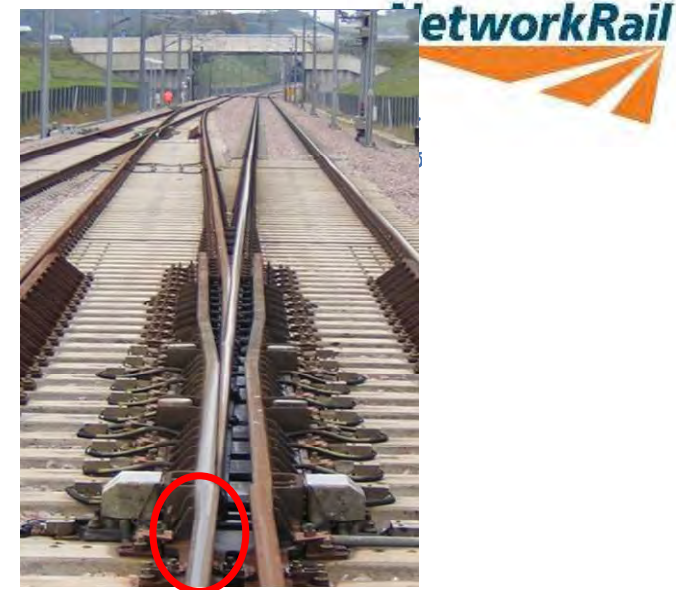
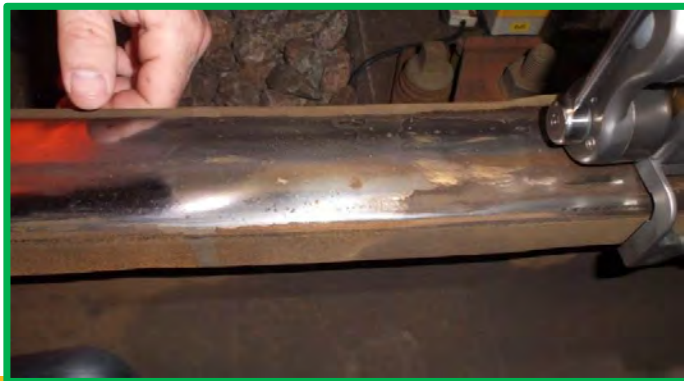
1mm dip in rail profile at the weld repaired section
