Rail Accident Investigation Branch

PWI Earthworks and Drainage Conference, 8 November 2023

## **Learning from Carmont**

Derailment of a passenger train at Carmont near  
Stonehaven, Aberdeenshire, 12 August 2020

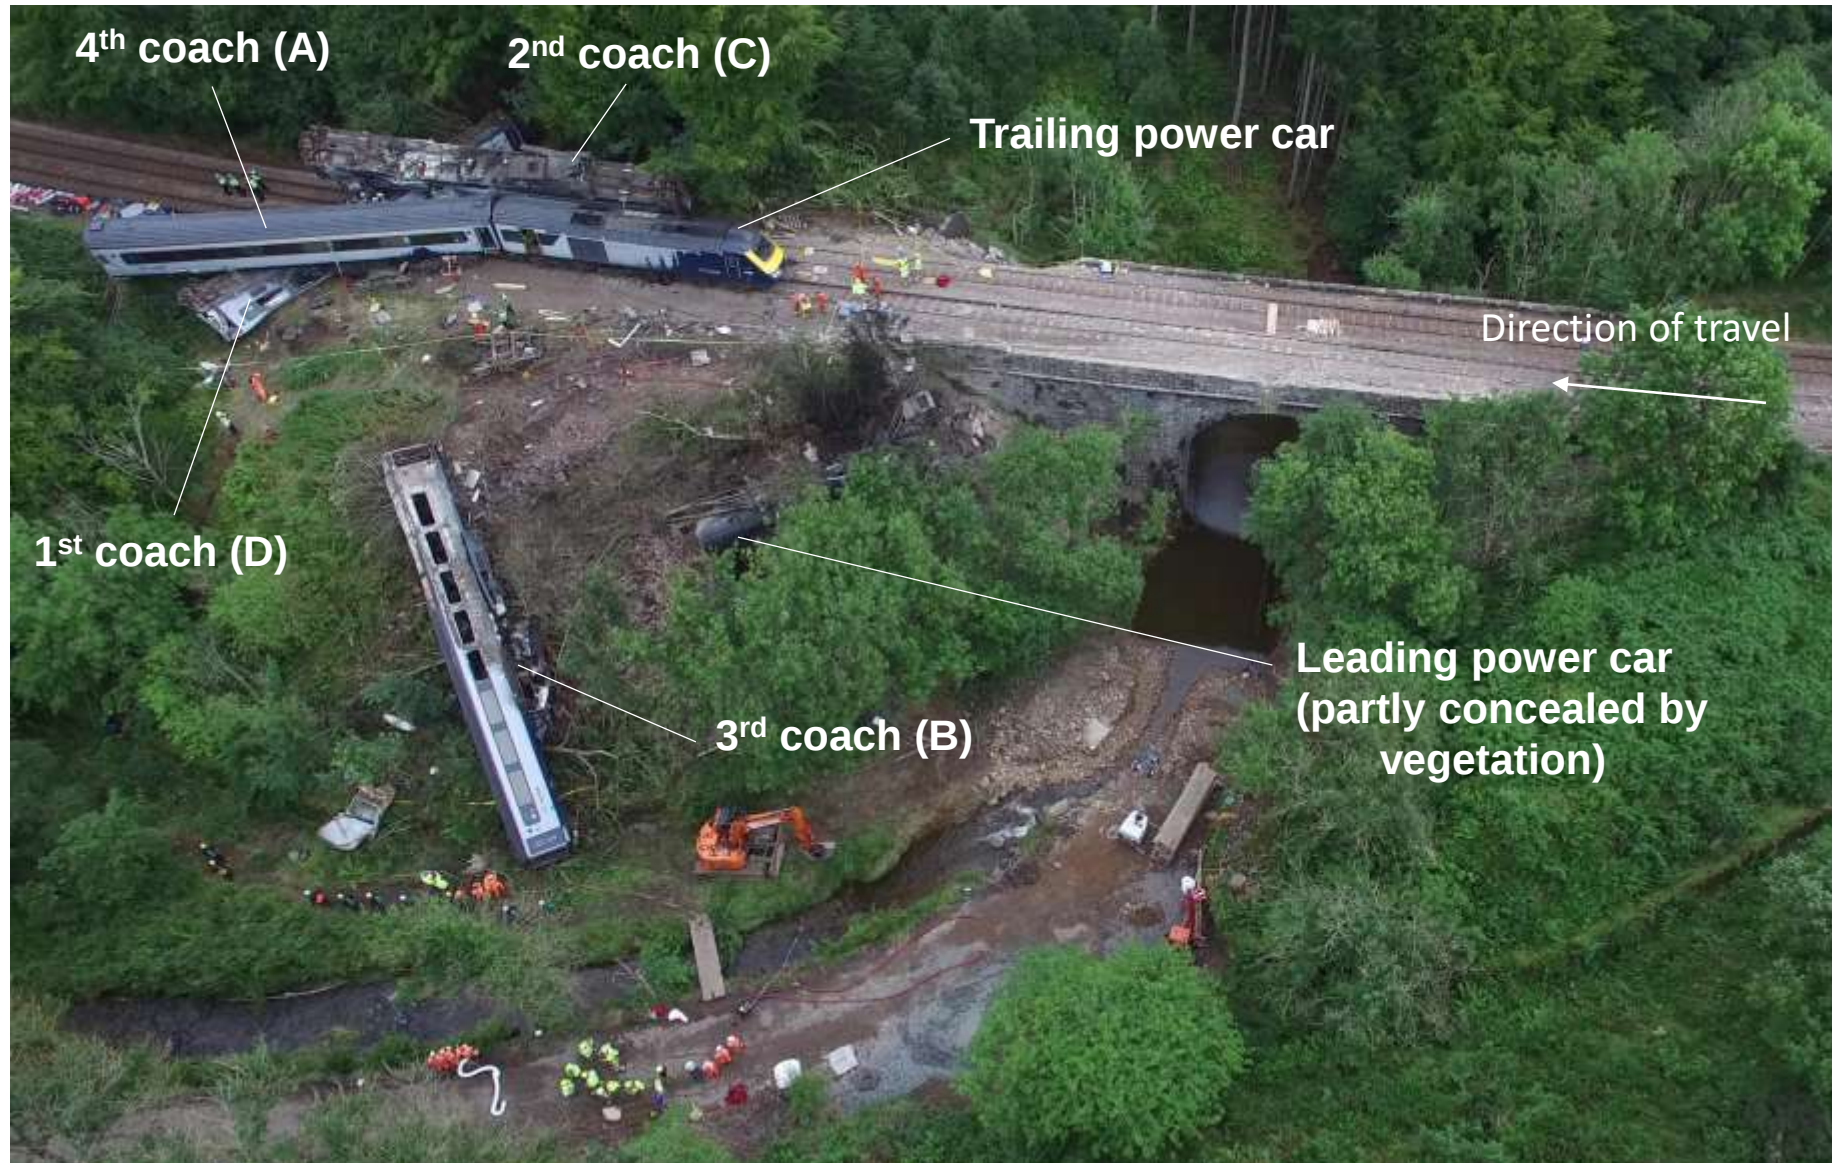
The weather – a rainfall event that could be expected at that location once in 100 years

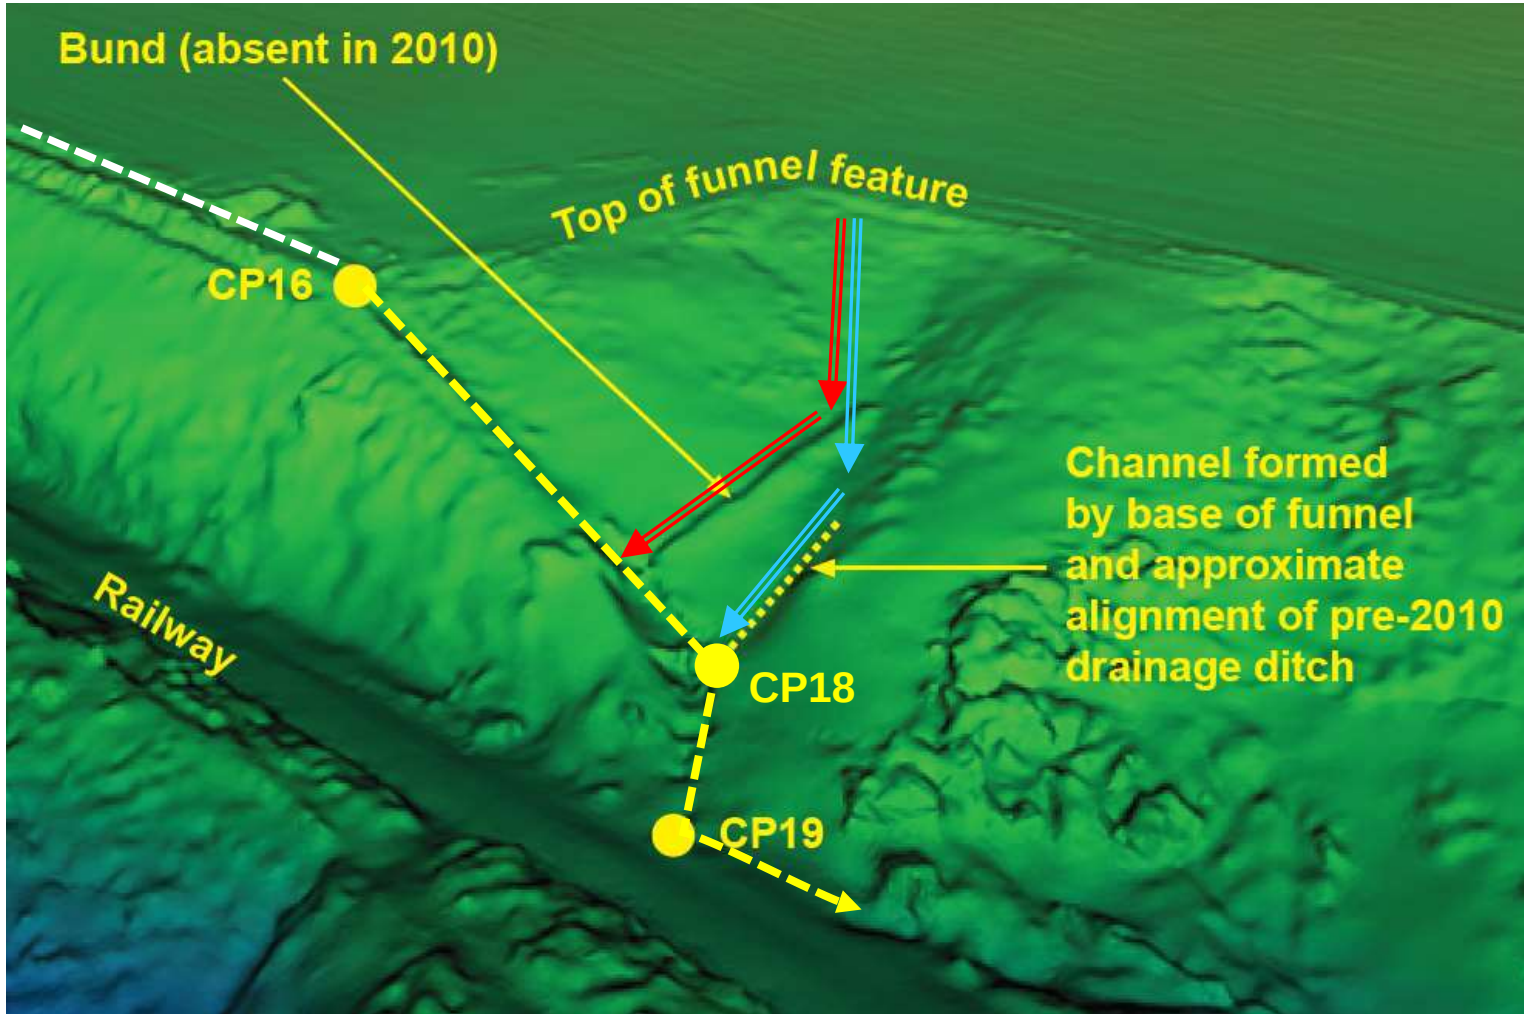
Site topography from LiDAR data

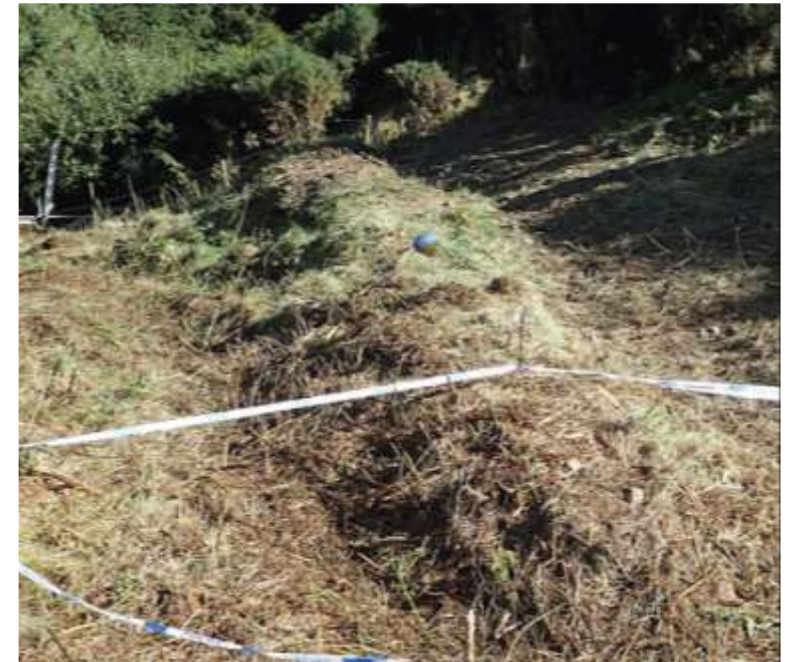
The drain was not installed as designed

Bund (was hidden by gorse)

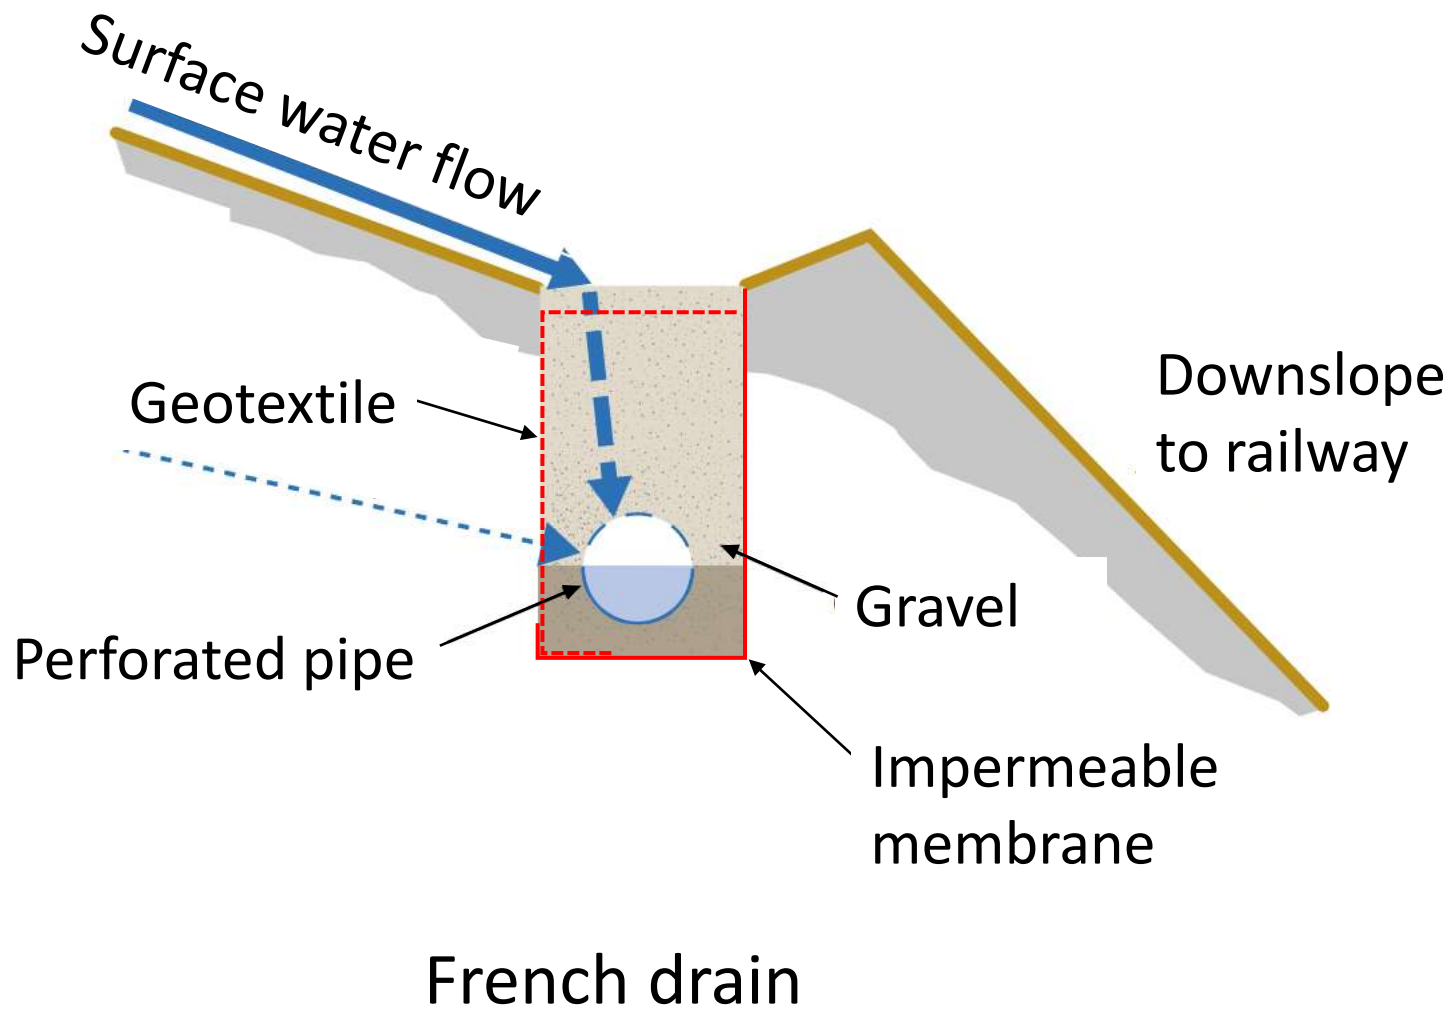
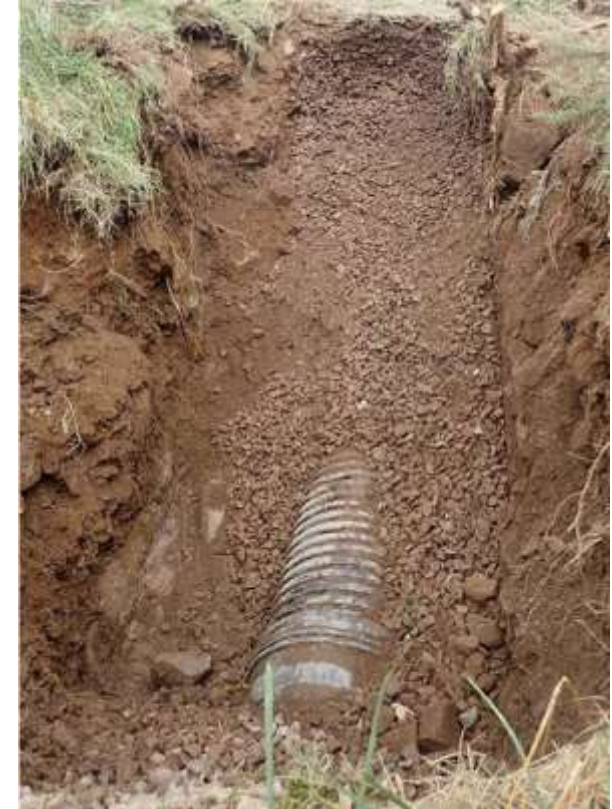
The drain's geotextile lining was omitted in the area of the washout

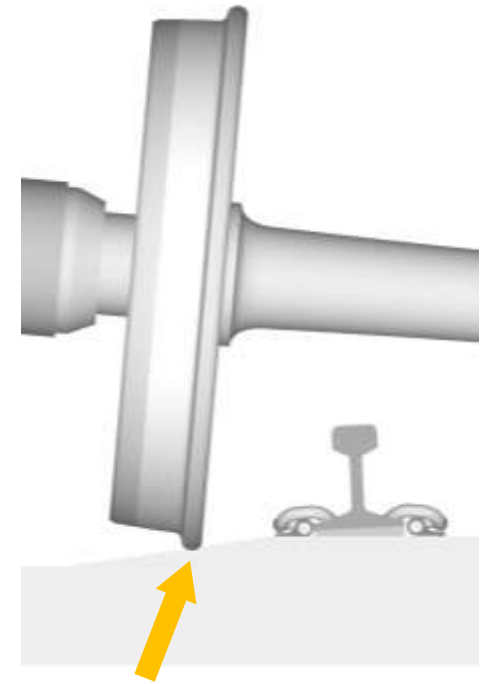
Derailed wheelset

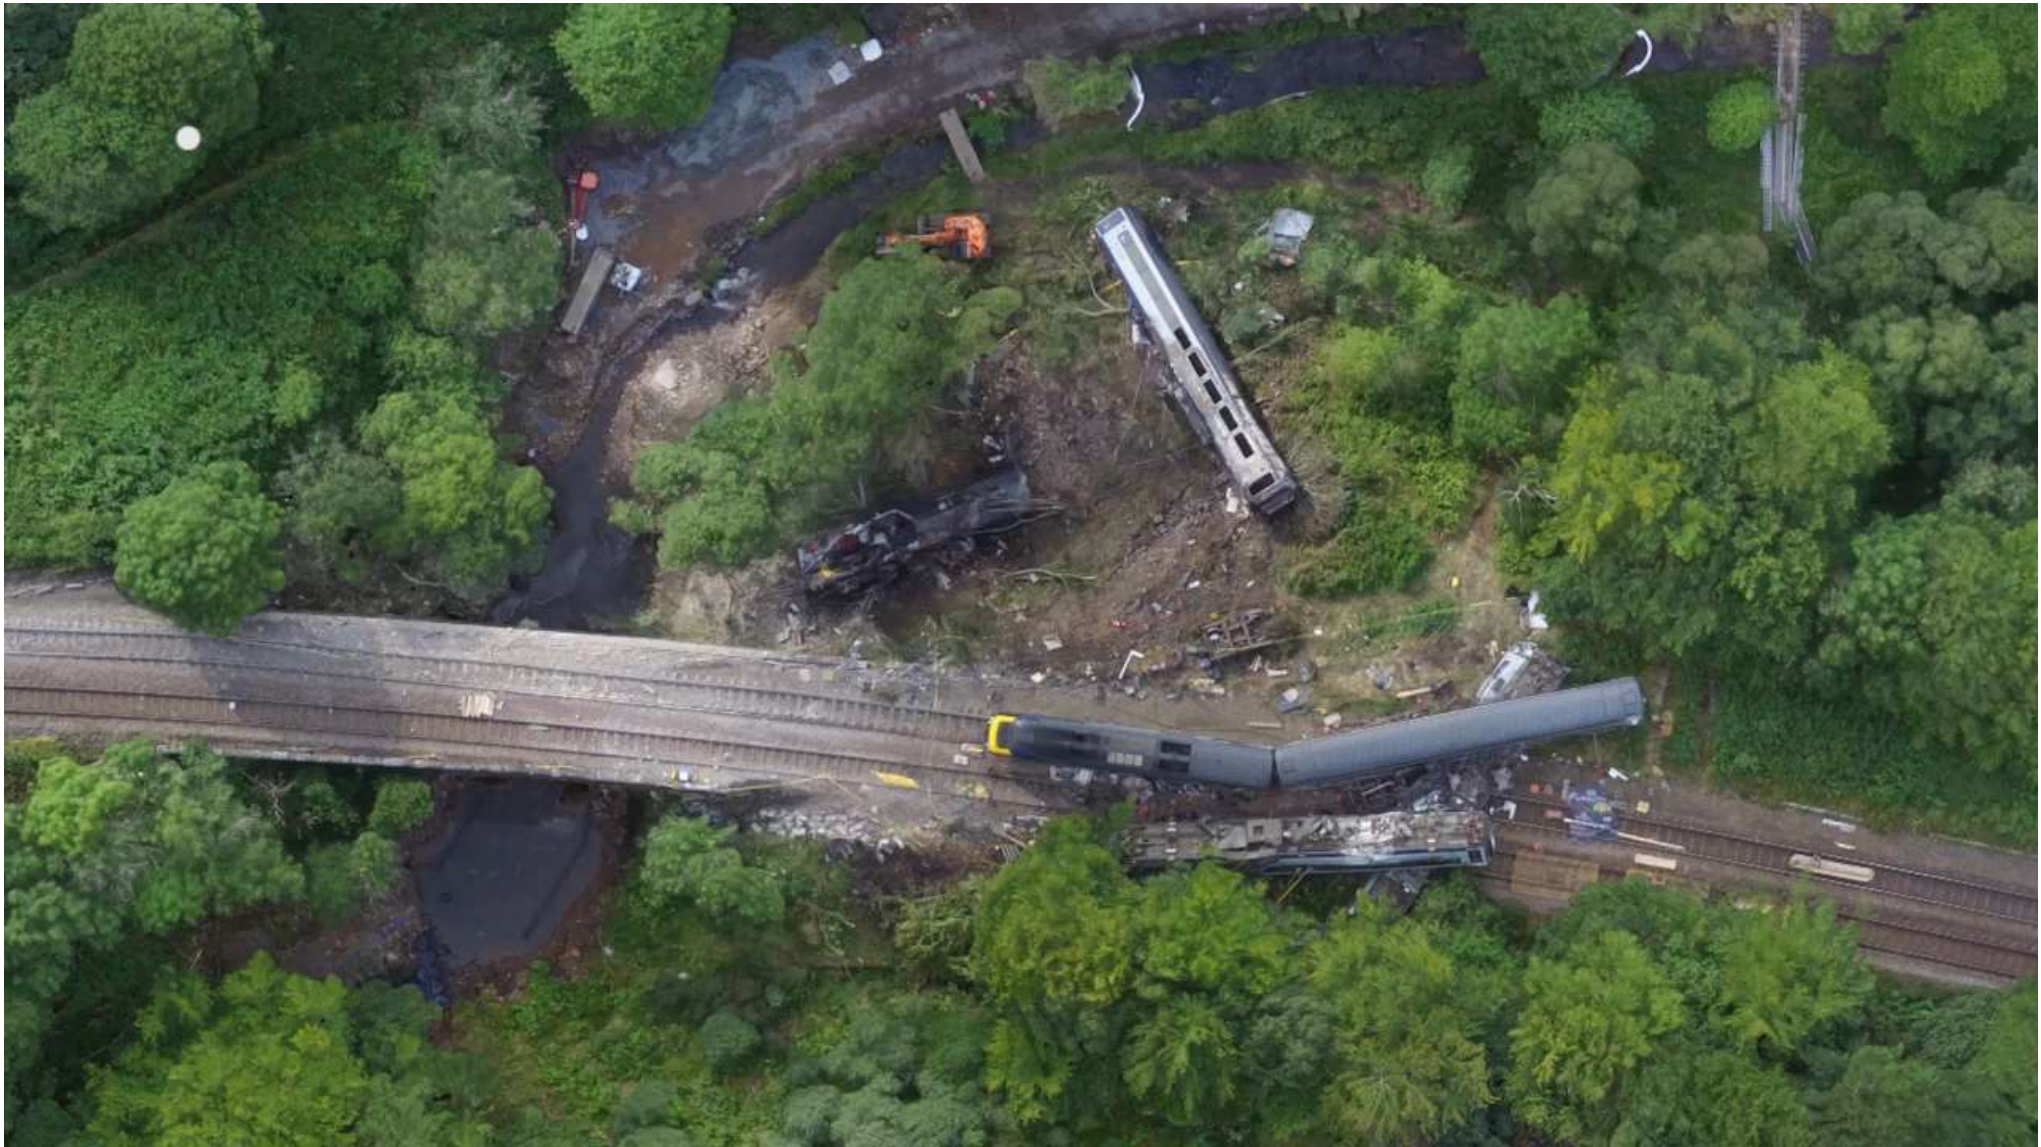
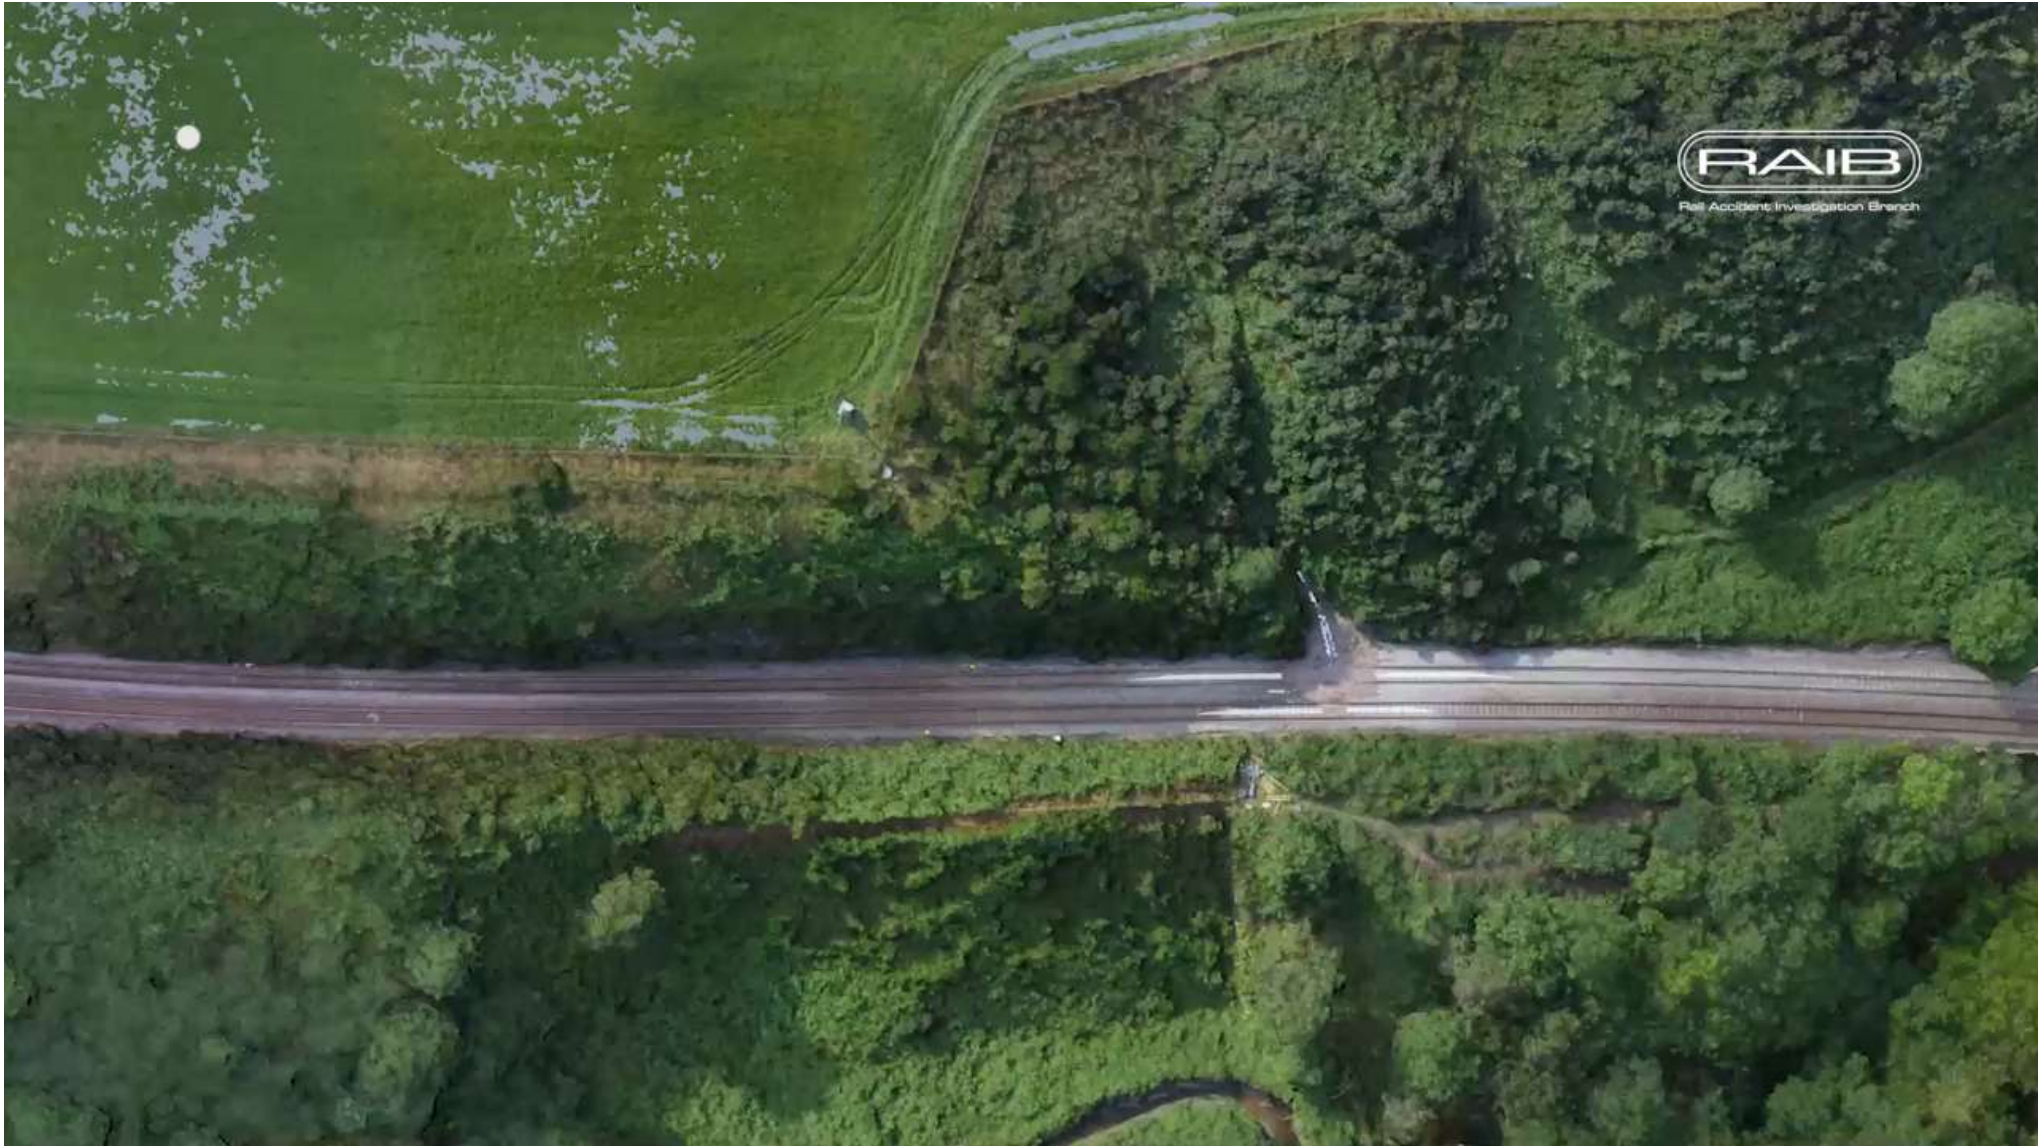
Computer modelling was used to assimilate evidence
