## Geobear's solution to embankment stabilisation: SVR trial

**Dr Mohamed Wehbi, PhD, CEng, FPWI**

Technical Director

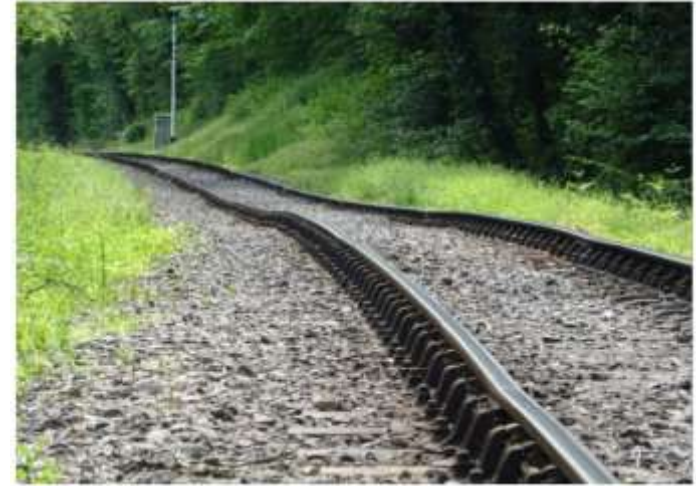
- A section of railway track known as Alveley Wood in Shropshire on the Severn Valley Railway (SVR) is showing signs of distress, which resulted in 300mm deviation from design geometry and the introduction of a speed restriction (10mph)
- The distress, seen typically as a deformation of the track as a result of a slope of instability.
- Track deformation appears along an approximately 80m section of railway line on the western side of the River Severn.

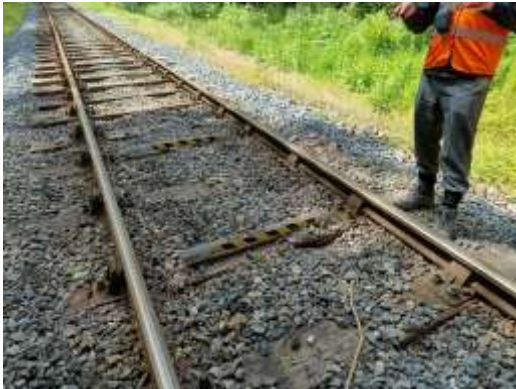
- Tilt sensors were installed in three locations / chainages:
  - 17660 (AW1-AW2)
  - 17684 (AW3-AW4)
  - 17708 (AW5-AW6)

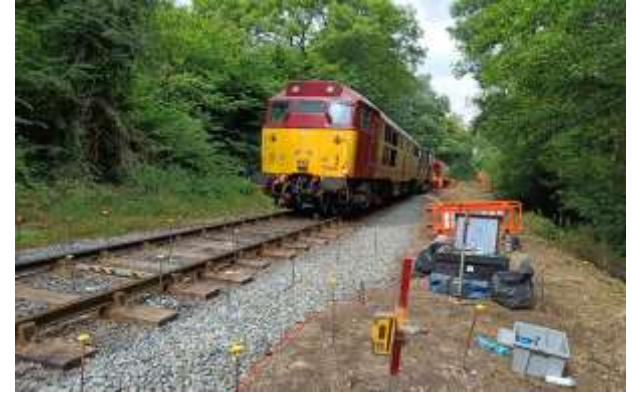
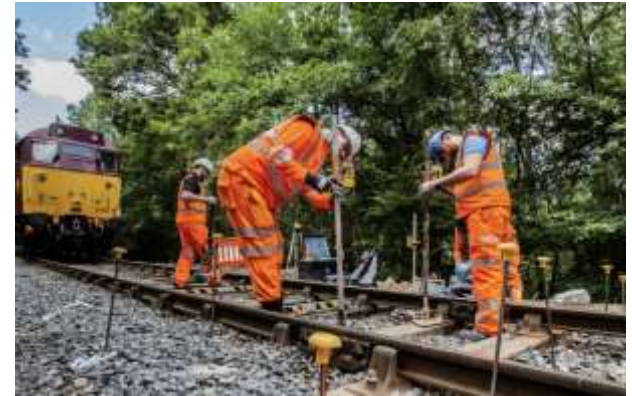
- The work has taken place on the 25th and 26th of July of last year (2022).
- Using injection mobile unit amounted a train wagon.
- 12mm diameter holes were drilled as per the injection plan.
- Injection tubes were be inserted in the drilled holes.
- A total of 136 tubes were installed.
- The injection was carried out using the extraction method.
- Approximately two and half tonnes of material was injected.
- Laser level was used to monitor track lift.
- Pre and post dynamic probing was carried out to validate the improvement in soil strength.
- Tilt sensors measurements were assessed for a period 6 months to verify performance.
- The work was completed in 2x10hr shifts

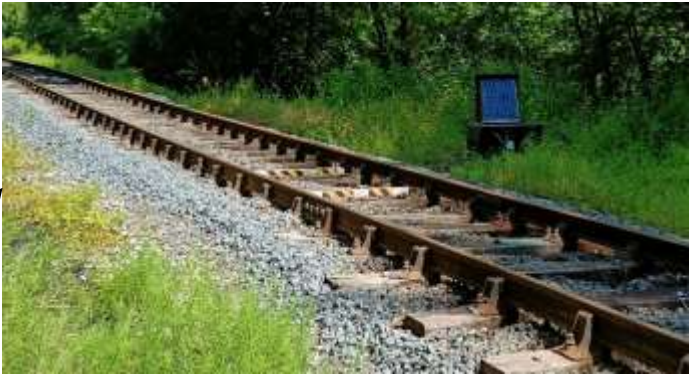
## Alvely Woods

Existing title sensors was utilised to monitor track performance at the treated area and understand the long term impact the treatment

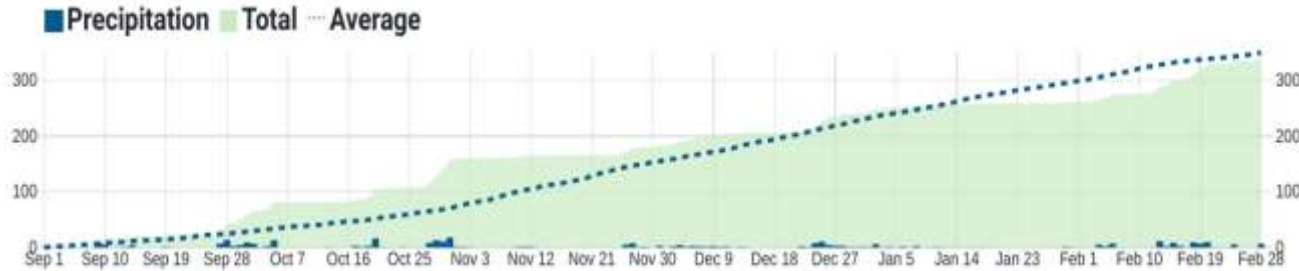
**Before** treatment period  
Sept-2021 to Feb-2022  
Total rainfall = 342mm

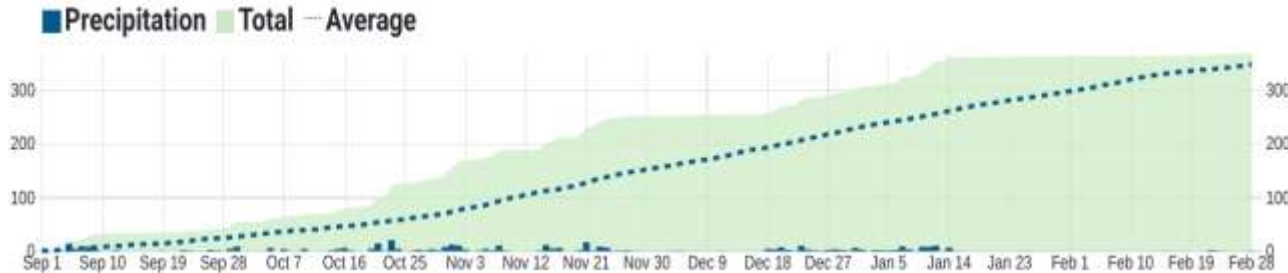
**After** treatment period Sept-  
2022 to Feb-2023  
Total rainfall = 369mm
