# EFFECTS OF CLIMATE CHANGE ON TRANSPORT FOR WALES' CORE VALLEY LINES (CVL)

**This is the first part of a two-part paper looking at the effects of climate change on railway drainage assets.**

## AS PUBLISHED IN THE PWI JOURNAL JANUARY 2024 VOLUME 142 PART 1

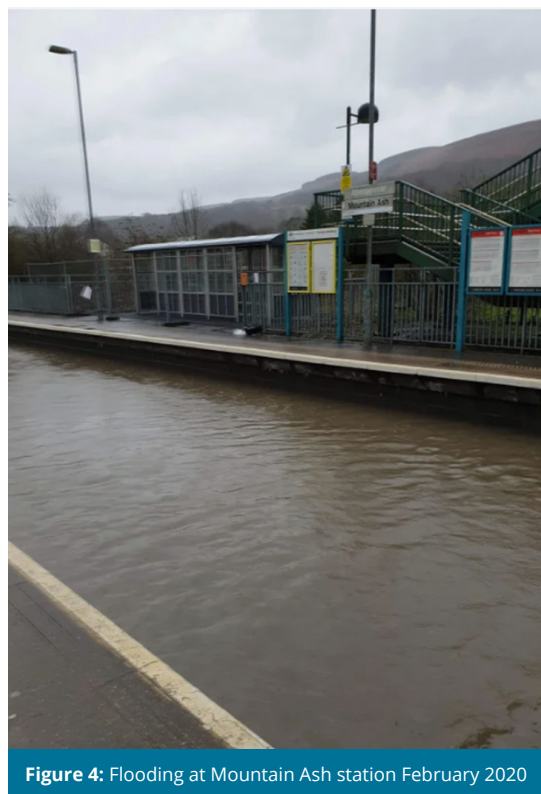
**Figure 4:** Flooding at Mountain Ash station February 2020

Flooding affected Mountain Ash station and Cwmbach on the Aberdare Branch, Trehafod, Britannia Bridge and Llwynipia on the Treherbert branch, Lisvane and Ystrad Mynach on the Rhymney branch, and Llwydcoed on the Aberdare to Hirwaun section. There were also landslips related to the adverse weather at Hirwaun, Mountain Ash, Quakers Yard and Trelewis.

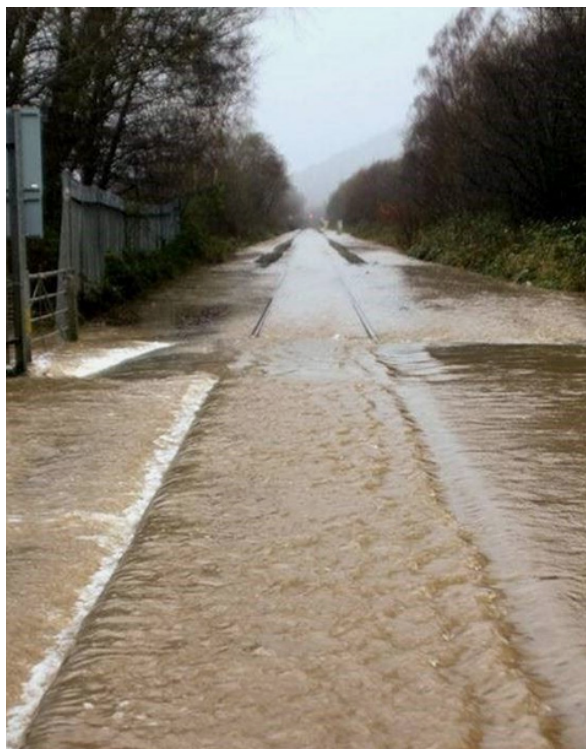
**Figure 5:** Flooding at Cwmbach, a regular occurrence after adverse weather

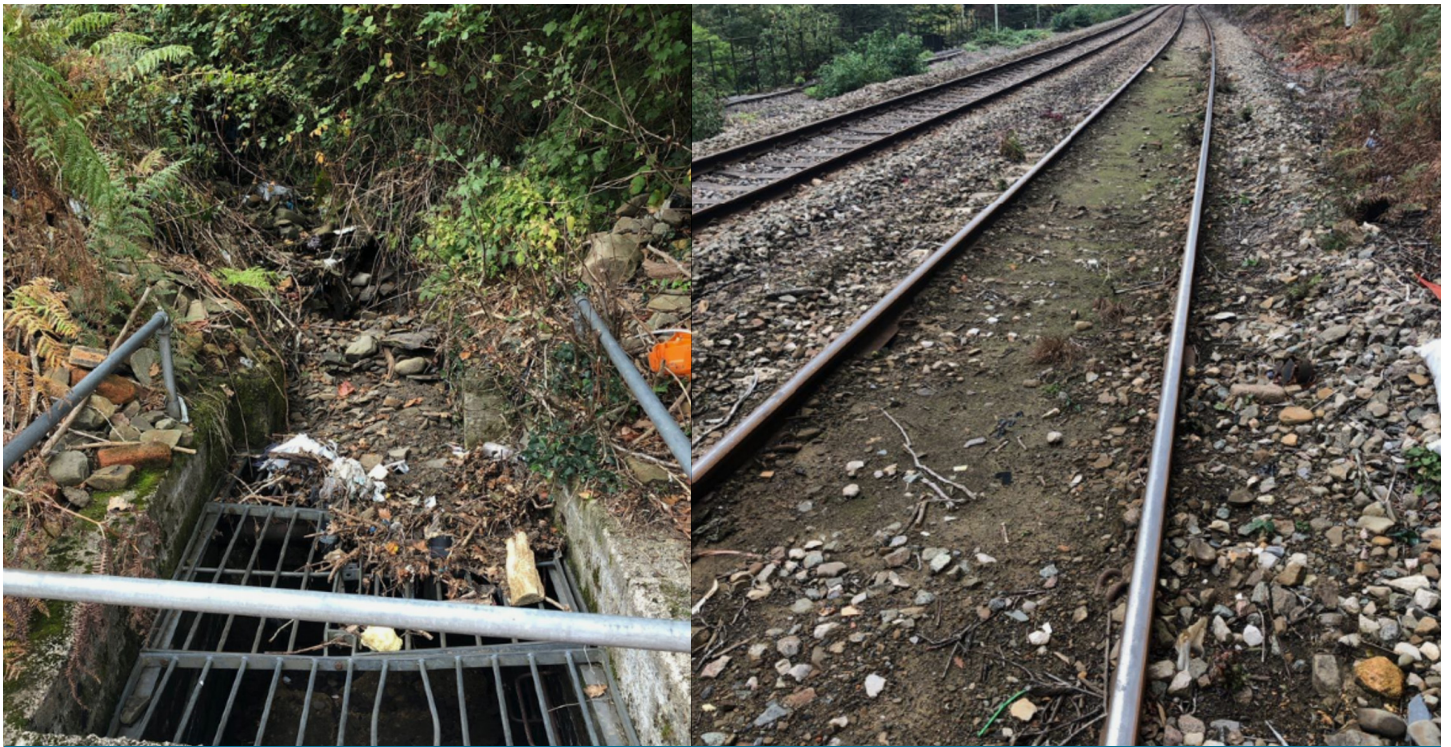
**Figure 8:** Adverse weather debris flow blocking flume to culvert, resulting in overtopping of headwall causing silt contamination of ballast and line closure

Whenever site visits are undertaken, Track Locator is used to photograph drainage assets that are visible so these can be checked against records. If the site visit is to look at drainage flooding issues, then every effort is made to ensure that the wider picture is understood, i.e. what is causing the problem: deficient drainage, blocked drainage, lack of drainage, change of land usage etc? **(Figure 8).**

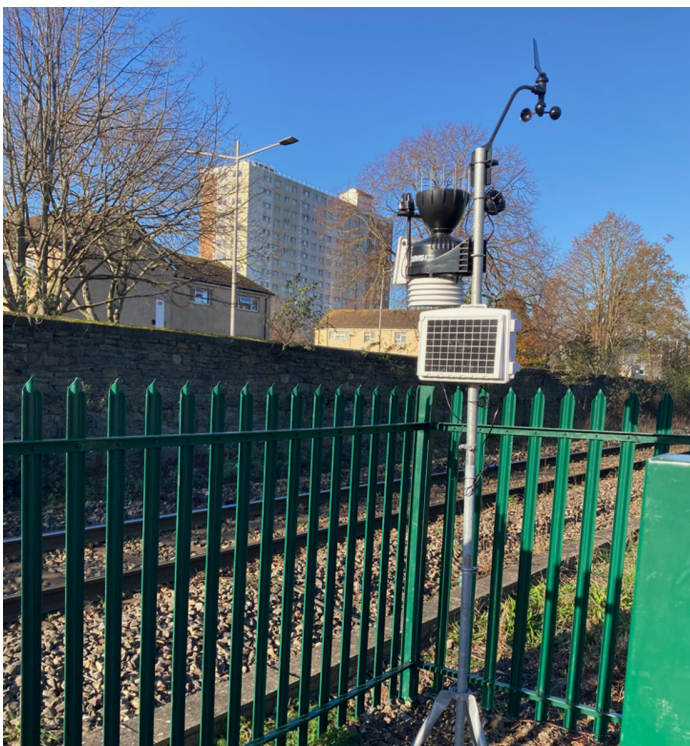
**Figure 9:** Davis Vantage pro 2 plus weather station in Cardiff Bay

speed and direction, precipitation, humidity, barometric pressure, evapotranspiration, temperature, UV and solar radiation. This information is uploaded to the cloud via a 4G Gateway located in the solar panel box. Being fully automatic means that staff attendance is only required when there is a fault, or otherwise monthly to ensure the rain gauge is clear of debris. Battery charge can be checked remotely through the web portal. The system could also be set up with alarm trigger levels, to warn of high precipitation rates, high and low temperatures, high wind speeds etc. (Figure 10).

As previously shown in **Figure 6**, EWAT weather warnings are relatively low resolution, with two sites covering the whole of the CVL area. As weather in the UK is predominantly west to east, it generally follows that a higher proportion of precipitation should fall in the western-most valleys compared to the east, and also on the higher ground. Due to a lack of local weather forecasting stations, this remained an unknown. It was decided to install seven weather stations across the CVL to determine if this thinking was correct. A review of possible locations was carried out, and suitable weather station specifications were reviewed. We needed a system which could operate without mains power and had minimal requirements for attendance to take readings or maintenance. A fully automatic weather station from Davis Instruments, called the Vantage Pro 2 Plus, was chosen for its small footprint, solar powered operation, the ability to upload data to the cloud at 5-minute intervals, and provision of a cloud-based dashboard for the weather stations as part of the package. **(Figure 9).** The Davis Vantage Pro 2 plus measures wind

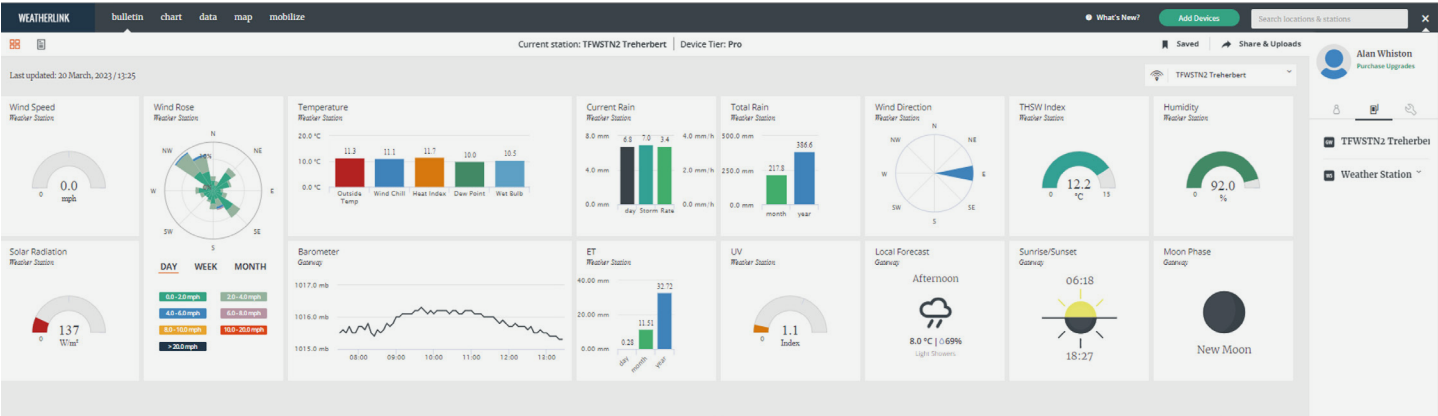
Figure 11 shows the dashboard for the weather station in Treherbert: the benefit of this system is that dashboards from 3rd party weather stations can also be viewed through the portal, (if made public by weather station owners), which gives a live view of developing weather patterns. A mobile app is also available, which shows identical information plus an hourly and weekly forecast.

Figure 11: Davis Instruments, Weatherlink Dashboard for weather stations
