# ADAPTING AN AGEING INFRASTRUCTURE FOR THE CHALLENGES OF THE FUTURE

## - SEVERN ESTUARY EARTHWORKS

## TECHNICAL ARTICLE

AS PUBLISHED IN  
THE PWI JOURNAL **APRIL 2024**  
VOLUME 142 PART 2

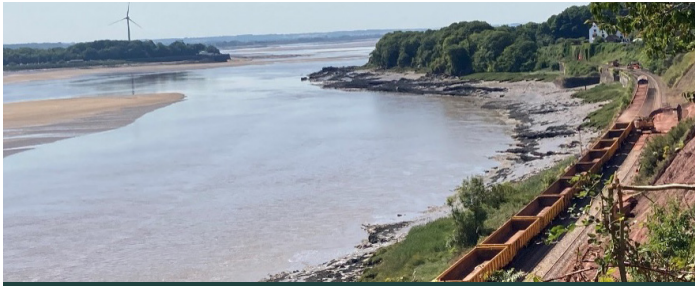
**Figure 2:** Engineering Train stationary on site location while wagons are being loaded by excavators

Phase 1 of the programme was delivered during a temporary closure of the line for seven weeks from 18 July to 3 September 2022. During this blockade the team had to plan, organise, and implement the running of 30 engineering trains. These trains were vital in the removal of more than 15,000 tonnes of material which was removed during regrading works within the two-mile extent of a steep cutting

near Lydney. **(Figure 2).** While thirty engineering trains were planned, the strikes that were occurring during the blockade resulted in a lack of staff to crew them, causing cancellations. This necessitated a reduction in the overall number of engineering trains. The effect of this on the works required the team to think on their feet and change the project plan to ensure that while regrading the topsoil, space was left to temporarily store it prior to the engineering trains arriving on site. Alongside this, the team had to vary the initial plan as the reduced number of trains meant that there was less time to complete the task of regrading all the required sections within the cutting. The many years of knowledge within the team allowed for efficient and swift amendments to the removal of the regraded soil as the number of trains available to the team kept varying due to the strikes.

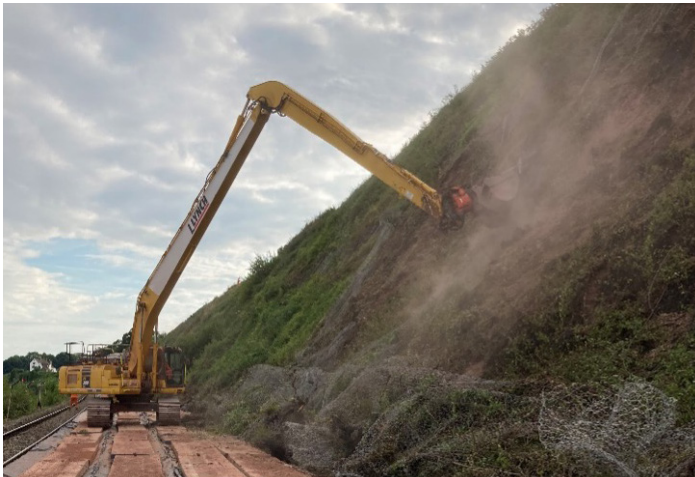
**Figure 3:** Long reach excavator regrading topsoil from cutting face under NRDD guidance

You might be asking yourself, how did the team manage to regrade so much soil, and how were they able to stabilise such a large amount of cutting? Well, for this project the team began by cutting existing mesh on the slope. This mesh was part of an old passive mesh system and was design life expired. This meant that the team had to use rope access trained operatives to cut through the existing layers of mesh on the slope to expose it, to allow for the regrading of the cutting topsoil. As you may already know, geotechnical projects always have a level of uncertainty about them. Unlike most other disciplines, when working on geotechnical projects the geology of the ground can easily vary from what is expected and it may not be possible to find certain details until the area has been excavated. For this project, the team could not be certain of the geology of the cutting until it was exposed, as the vegetation had already overgrown the whole cutting making it impossible to see the top soil. Therefore, for phase 1 while the topsoil was being regraded using excavators and rope access teams, the NR Design Delivery (NRDD) geotechnical team carefully guided the subcontractors to ensure that the final regraded slope was competent. This regrade of the topsoil was needed, as during

landslips some of the most unstable sections of a slope is the topsoil. **(Figure 3).**

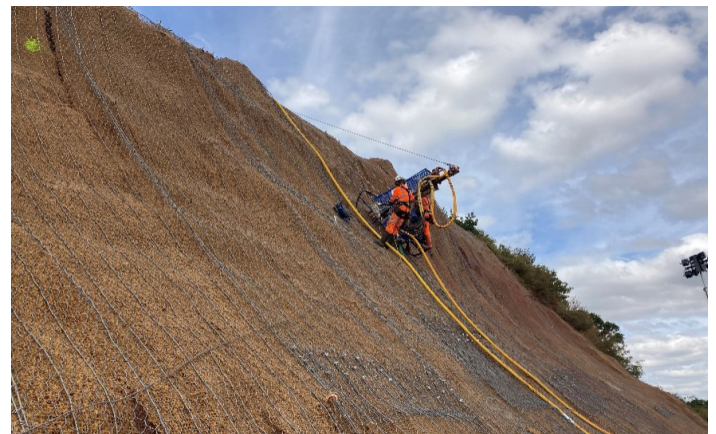
**Figure 4:** Rope trained operative drilling into cutting face using a suspended drilling rig from the top of the cutting.

Once the NRDD team were happy with the competency of the regraded cutting the rope access trained operatives placed the coir erosion control matting. The team installed circa 27,000 square metres of coir matting during phase 1. This was implemented by unravelling the roll from the top of the cutting to the bottom. This matting was then bound to the new competent topsoil using soil pins. This matting improves the stability of the topsoil and reduces the amount of ravelling that would occur following the regrading. Ravelling occurs as the topsoil is fresh and has not been consolidated and therefore, is more likely to ravel down the slope face. Once the coir matting was fully installed the rope access teams began the installation of a galvanised steel mesh and soil nails on the cutting. The steel mesh with the soil nails was installed to create a passive mesh system for the regraded slope sections. A passive mesh system works by pinning the mesh at the top, somewhere near the middle and finally at the bottom of the slope. The passive system works by allowing for larger rocks to ravel down the slope in a controlled manner as any rocks that break off would be contained by the steel mesh. The slack of the steel mesh allows for enough space for small to medium size boulders to move down the slope along the slope face without gathering too much momentum. Then at the toe of the cutting there is also some slack in the mesh which allows for any of the ravelled soil to build up over time. As the name suggests the system is a passive system and its implementation does not actively improve slope stability, however it does reduce the risks posed onto the railways from land slips and other general deterioration of the slope. The engineering team installed circa 27,000 square metres of galvanised steel mesh and over 750 soil nails to create the passive mesh system in the regraded sections. The soil nails at the toe of the slope were installed by using a rotary drilling rig installed on an RRV which drilled up to a depth of 7.5m, following which the soil nails were installed and grouted. The top and intermediate soil nails were installed using a rotary drilling rig which was suspended from the top of the cutting which drilled into the slope face to a depth of 7.5m and then the rope access teams installed the soil nails and grouted the holes to ensure that the system was secure with the slope. **(Figure 4).** Once the grout had set the mesh was laid on top of the slope face and attached to the soil nails which created the passive mesh system.

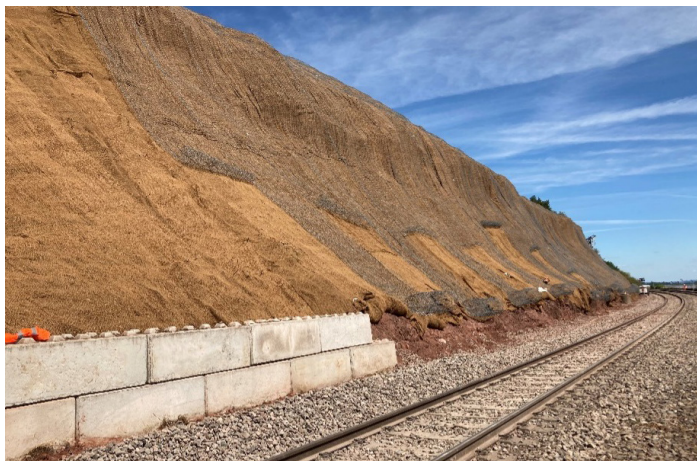
**Figure 5:** Regraded slope with coir erosion control matting installed as well as partly installed galvanised steel mesh

platforms, reusing existing soil nails bolts when possible, and repurposing coir erosion control matting. **(Figure 5).**
