# **Pantograph condition monitoring, and other techniques used to monitor Overhead Line Equipment on Network Rail's Wales & Western region**

**Jai Parhar BEng – Asset Engineer (OLE Mtce support)**

**Darrel Tiddy – IEng IET – Senior Asset Engineer (OLE Mtce support)**

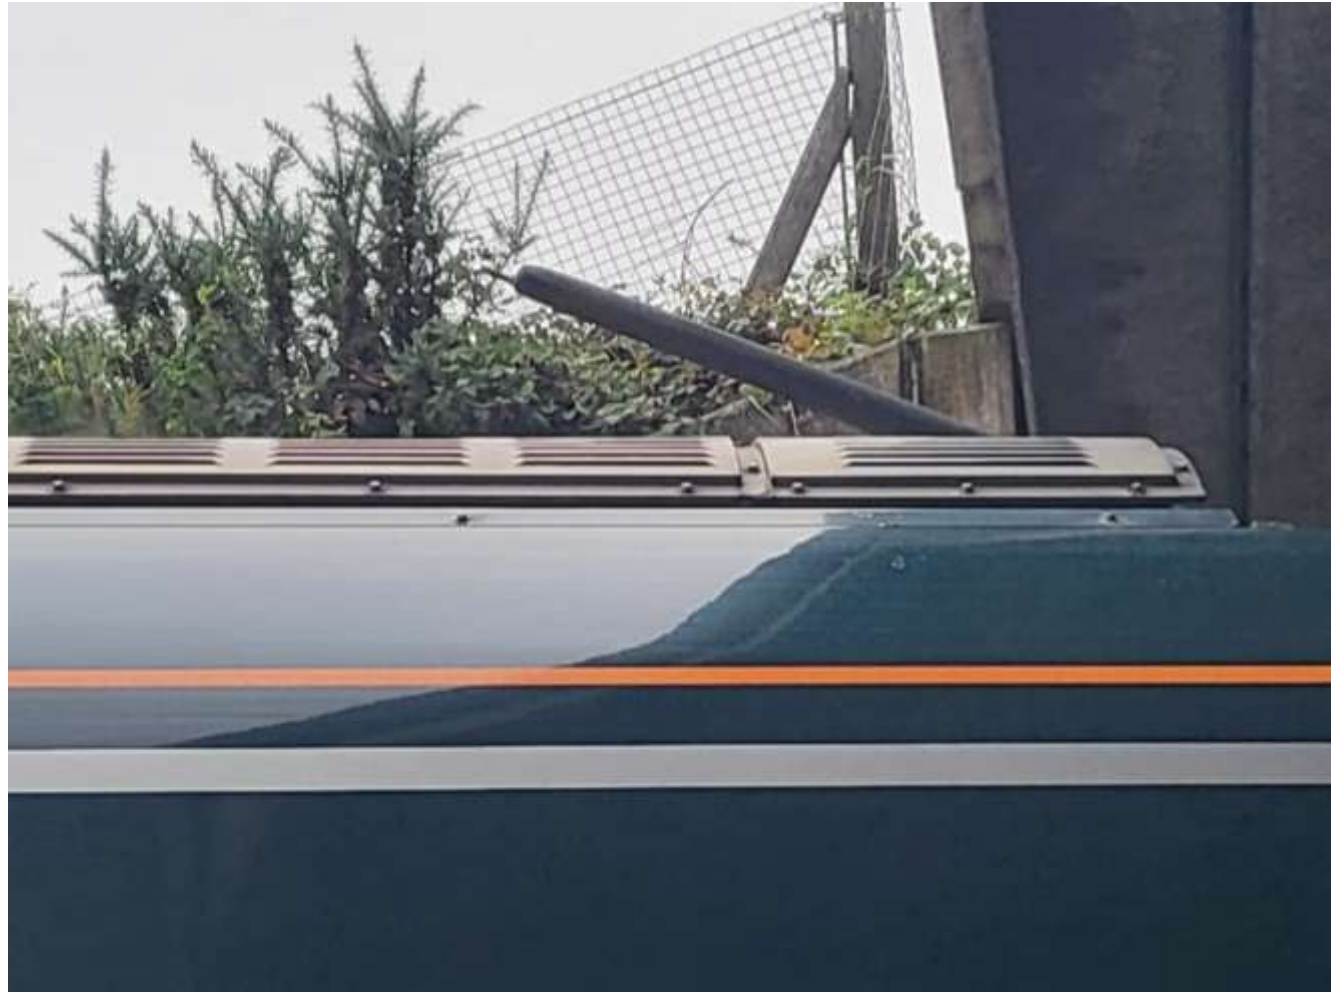
Missing pantograph upper assembly - 2024

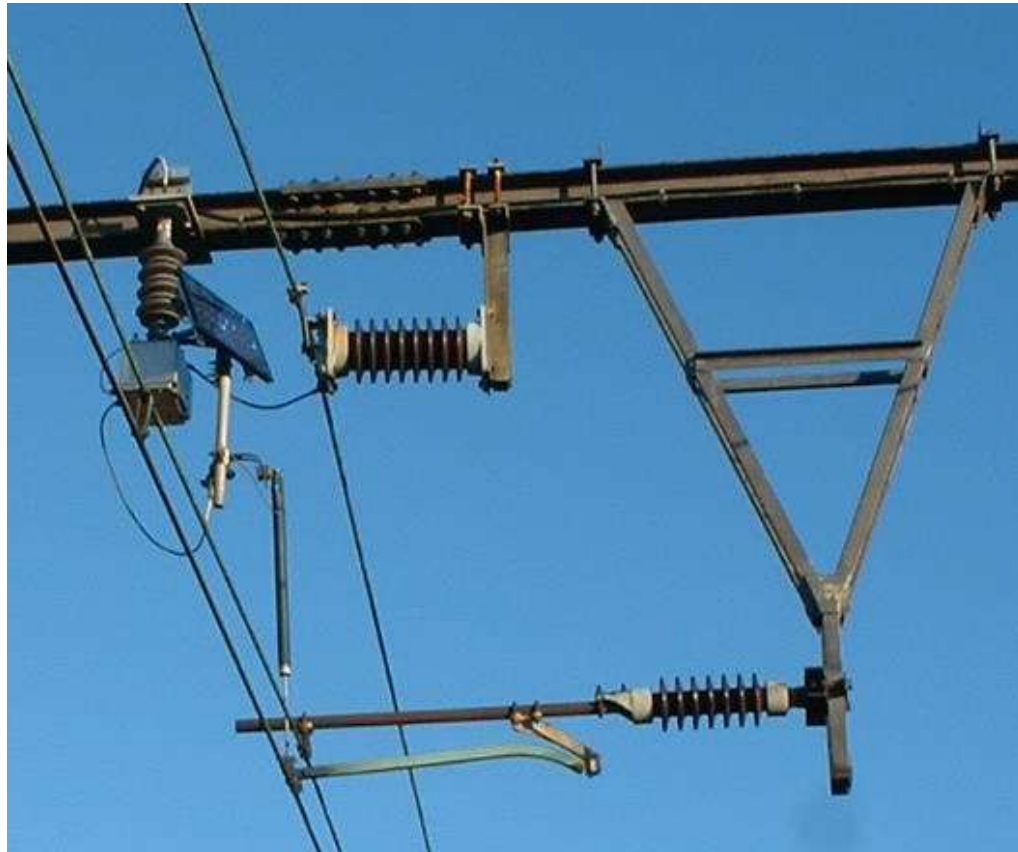
Panchex at Chadwell Heath (courtesy of PWI)

1997 Electrification of Paddington – Heathrow Panchex (Delta Rail system) installed at Southall to measure pantograph up-lift. System went out of use during early 2000s. **Major incident December 2017.**

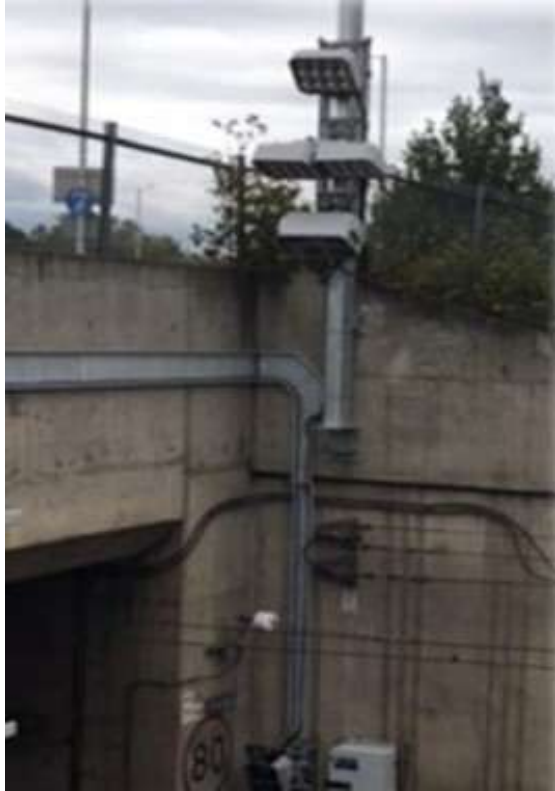
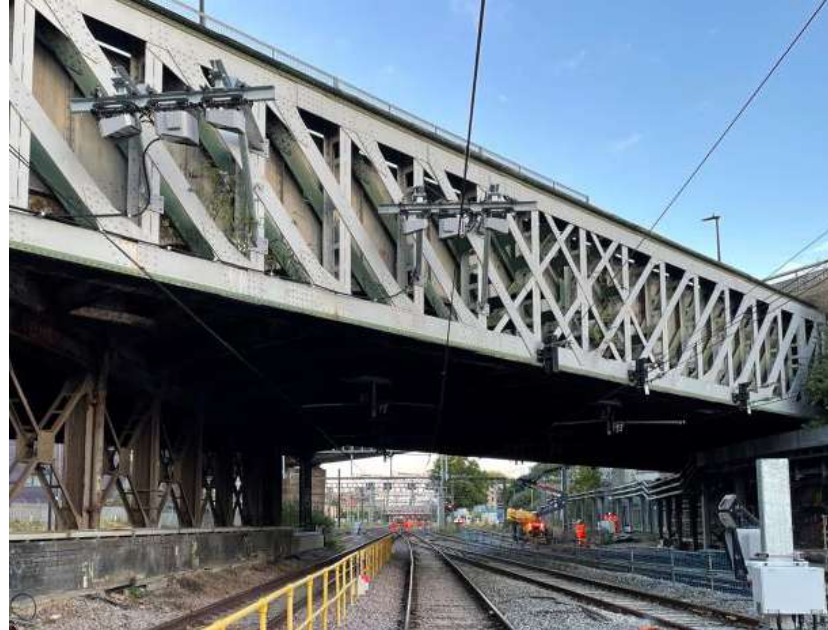
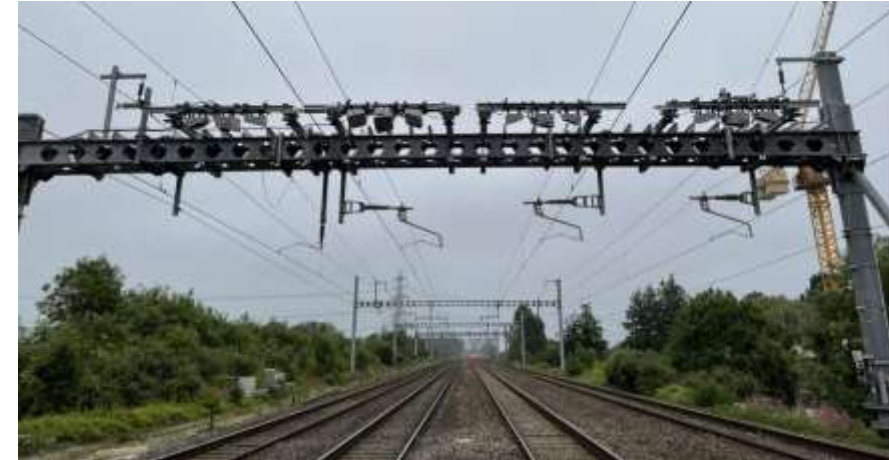
Heathrow Portal (tunnel mouth), Westbourne Park (overbridge) and Didcot (portal) installations

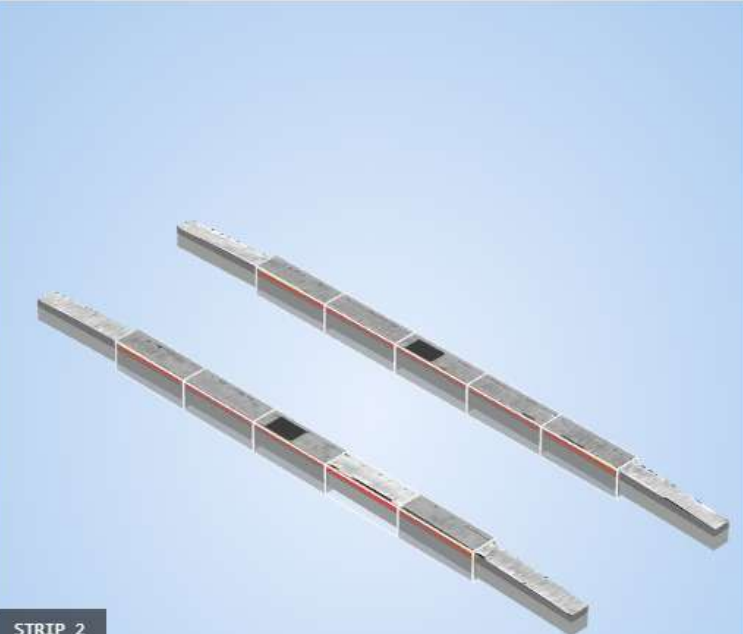
**CAMERA PIC** **DISPARITY MAP**

**Strip 2**

**Strip 1**

**STRIP 2**

| 5 | 4 | 3 | 2 | 1 |
|---|---|---|---|---|
| 35 mm | 34 mm | 33 mm | 34 mm | 35 mm |

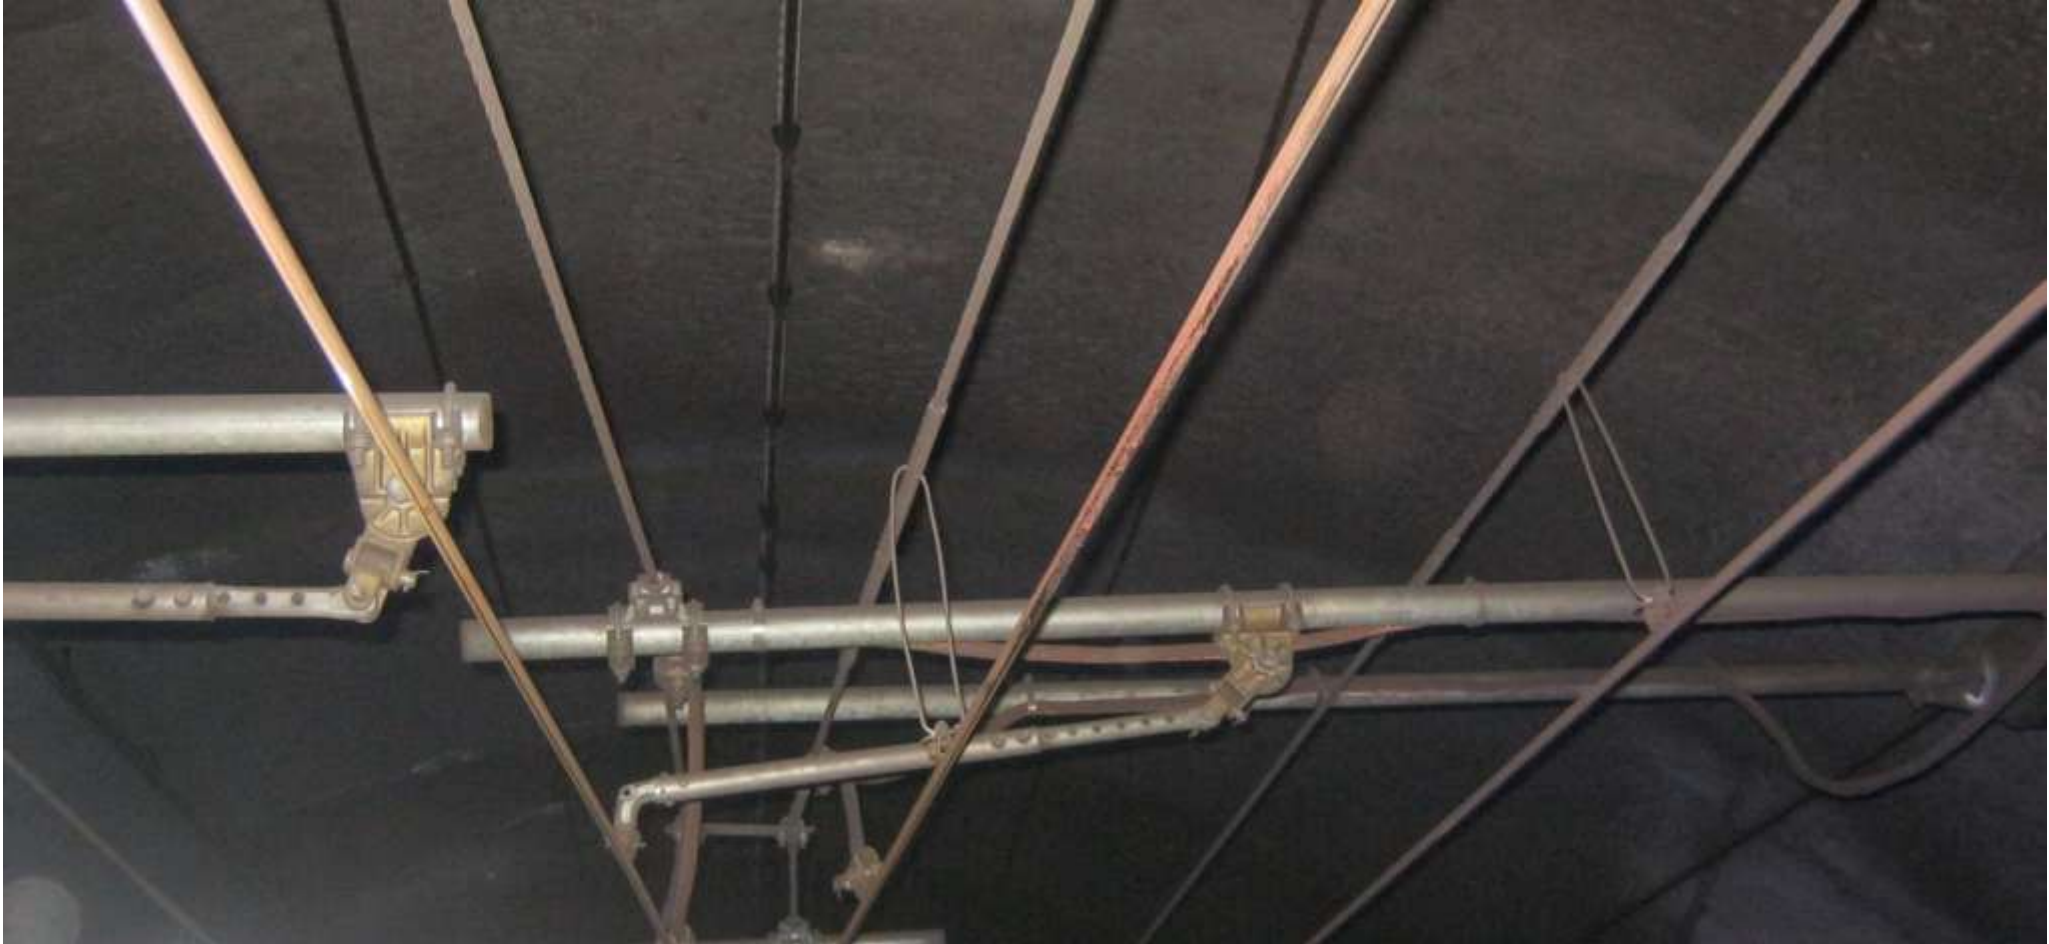
Example of the OLE inside Heathrow tunnels

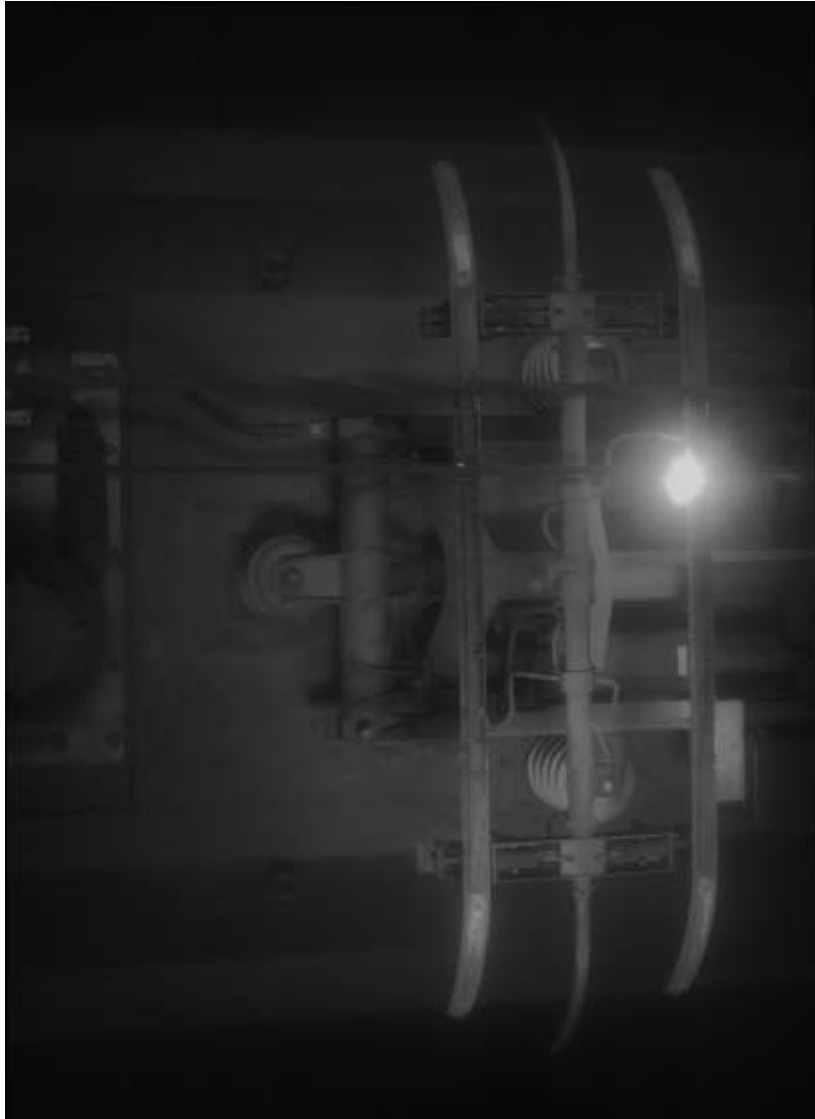
PanVue image - Didcot 2024

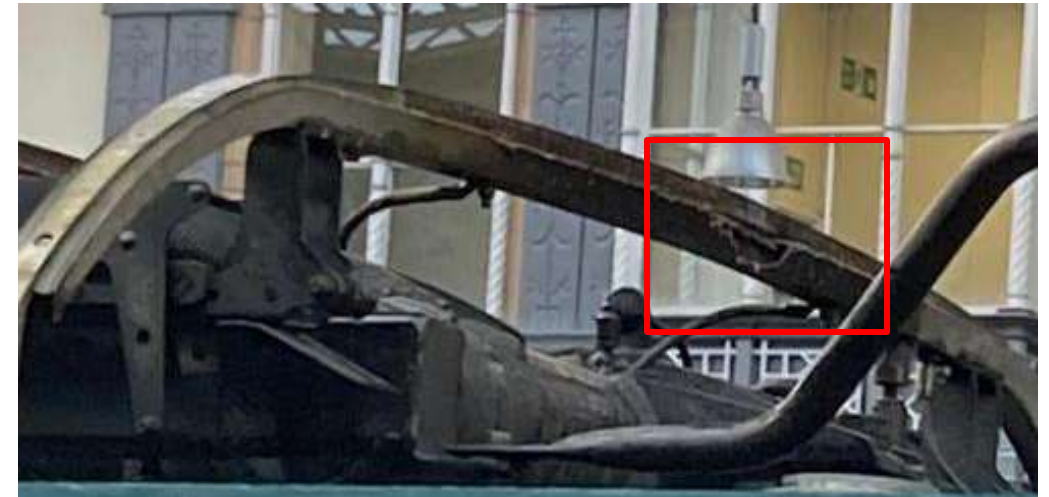
Ice damaged pantograph - 2023

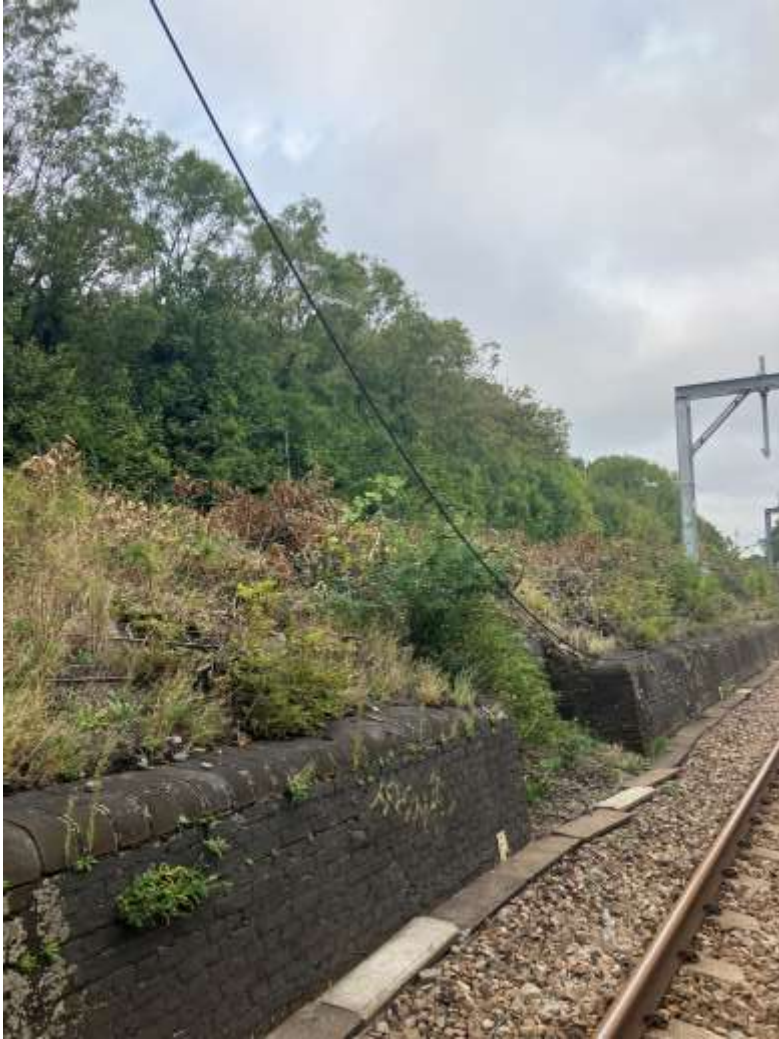
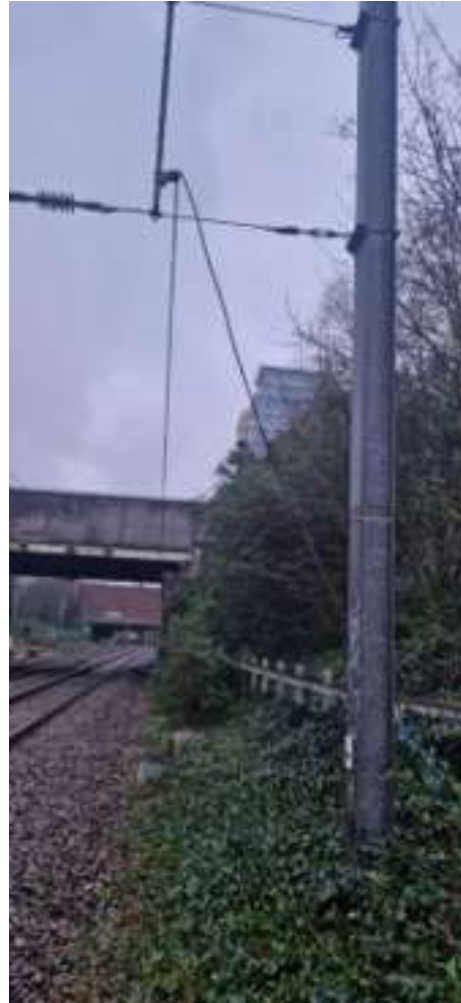
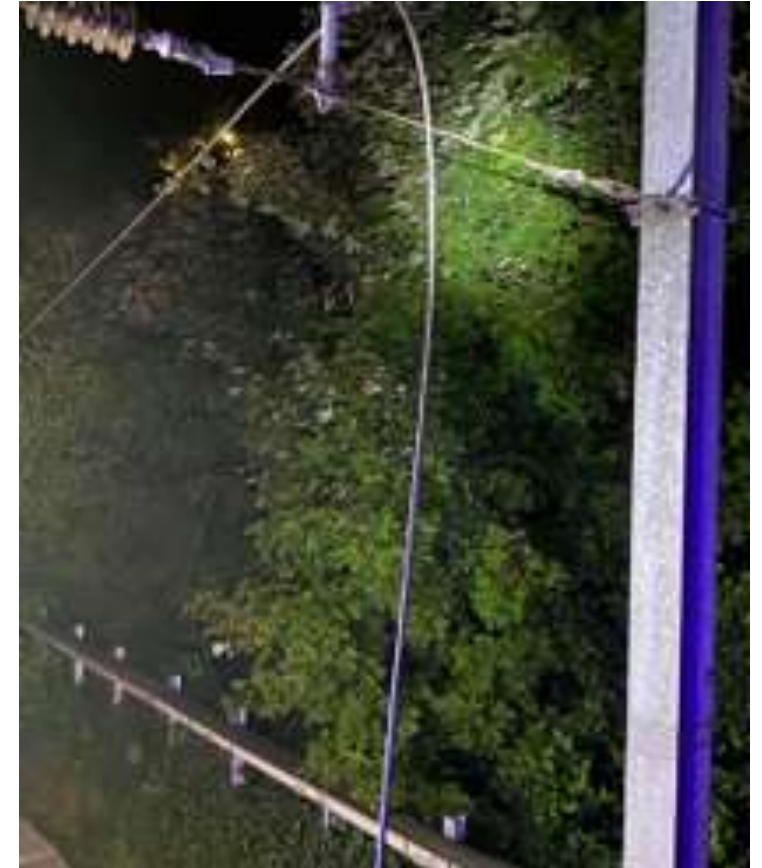
Examples of earth wire failures
