# EXCALIBUR SCREWBOLTS – A MODERN APPROACH TO RAIL FIXINGS

## IMPROVING RAIL PRODUCTIVITY, RELIABILITY & WORKFORCE WELFARE

## TECHNICAL ARTICLE

AS PUBLISHED IN  
THE PWI JOURNAL **APRIL 2025**  
VOLUME 143 PART 2

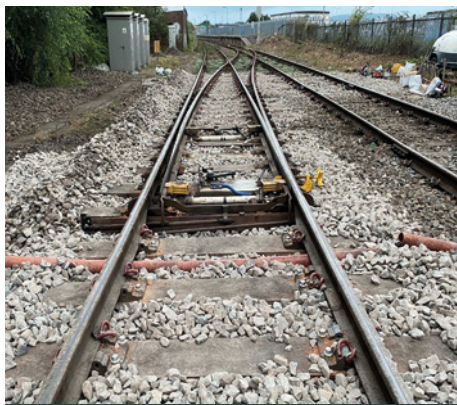
**Figure 7:** Ninian Park installation with Excalibur Screwbolts.

In an effort to find an innovative way to reduce 'boots on ballast', NR / Wales & Western undertook replacement of a large number of AS screwspikes with Excalibur bolts at its Ninian Park (**Figure 7**), and Carmarthen stations (**Figures 8 & 9**).

**Ninian Park:** Approximately 300 AS screwspikes were changed to Excalibur Screwbolts, utilising a battery-operated impact wrench with a high amp hour battery. The job involved renewal of 17 hardwood bearers for 9331b points throughout the switch and crossing, re-gauging of the switch and re-ballasting of the cribs. The time to screw an Excalibur bolt was an average of 7 seconds into a new timber – this compared to 11 seconds with an AS screwspike. Excalibur Screwbolts achieved an average of 80 screws per battery, with little time loss.

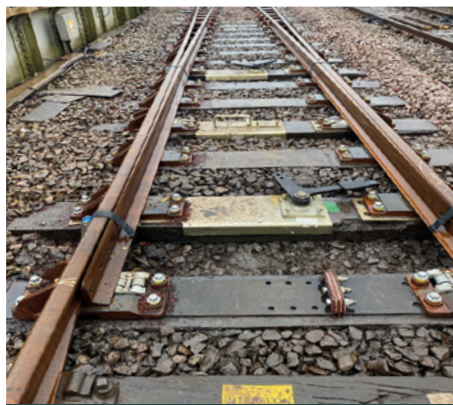
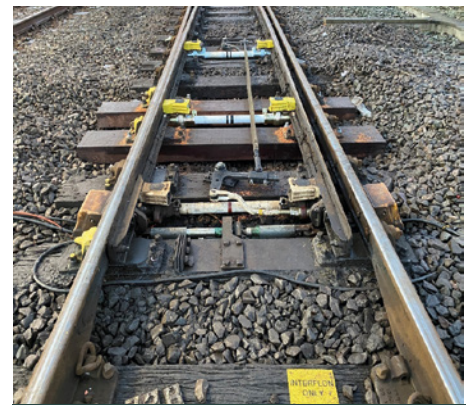
**Figure 8:** Carmarthen installation with Excalibur Screwbolts.

**Figure 9:** Carmarthen installation with Excalibur Screwbolts.

**Carmarthen:** Approximately 2000 AS screwspikes were changed to Excalibur Screwbolts on 74 points, 78 points, 72 a&b points and 71 points.

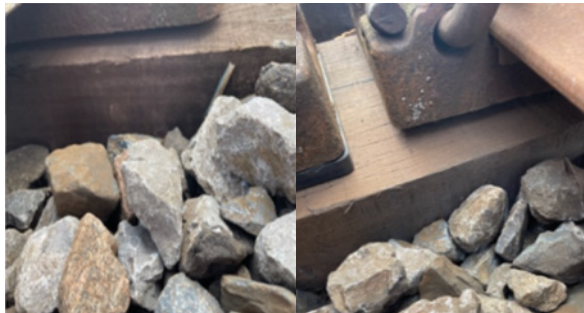
**Figure 10:** Chair lifting is present with AS screwspikes, and it was noted cracks appearing around holes which are failing to maintain a hold on the AS screwspikes.

Charing Cross bridge 648pts uses extra-depth timbers, over 10 metres in length, which are stressed by high vibration with no ballast to absorb the loads. Coupled with water ingress they had degraded, so NR's Swanley Works Delivery team were tasked with installing new chair bolts at the Charing Cross location. This site was particularly noted for failures brought on by the timbers frequently expanding and contracting over and above standard tolerances (**Figure 10**).

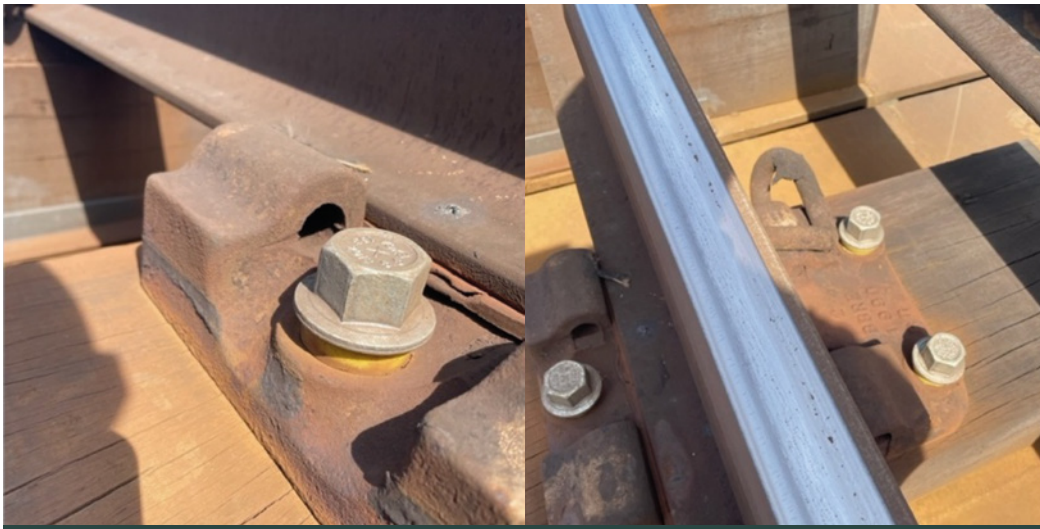
**Figure 13:** Excalibur Screwbolts firmly seated.

In addition, the report noted; Using 19mm drill bits as per standard for timbers, the Excalibur Screwbolts could be initially inserted into the drilled holes very easily. When driven into the timber rather than applying outward pressure at the top of the hole to hold the baseplate like standard AS screwspikes the Excalibur Sleeper Bolts cut their own thread into the timber. As a result, the Excalibur bolts work with the impact wrench to drive bolts into the hole, making installation quicker on each bolt and resulting in time savings that allows an increase in the volume of job scope within a given time. Unlike traditional rail screwspikes there was no lubricant required to aid driving the Excalibur bolts in, and reductions in manual handling and HAVS risk, site tidiness and time saved were recorded. The report concluded that Excalibur Screwbolts would aid in a quicker transition to battery powered tools given how easily they can be inserted, which would have an even greater impact on workforce welfare, HAVS risk, COSHH and environmental impact (**Figure 13**).
