# TMEs - Old Dogs & New Tricks

Paul Furnival - TME (Tonbridge)

Paddy White - TME (Hither Green)

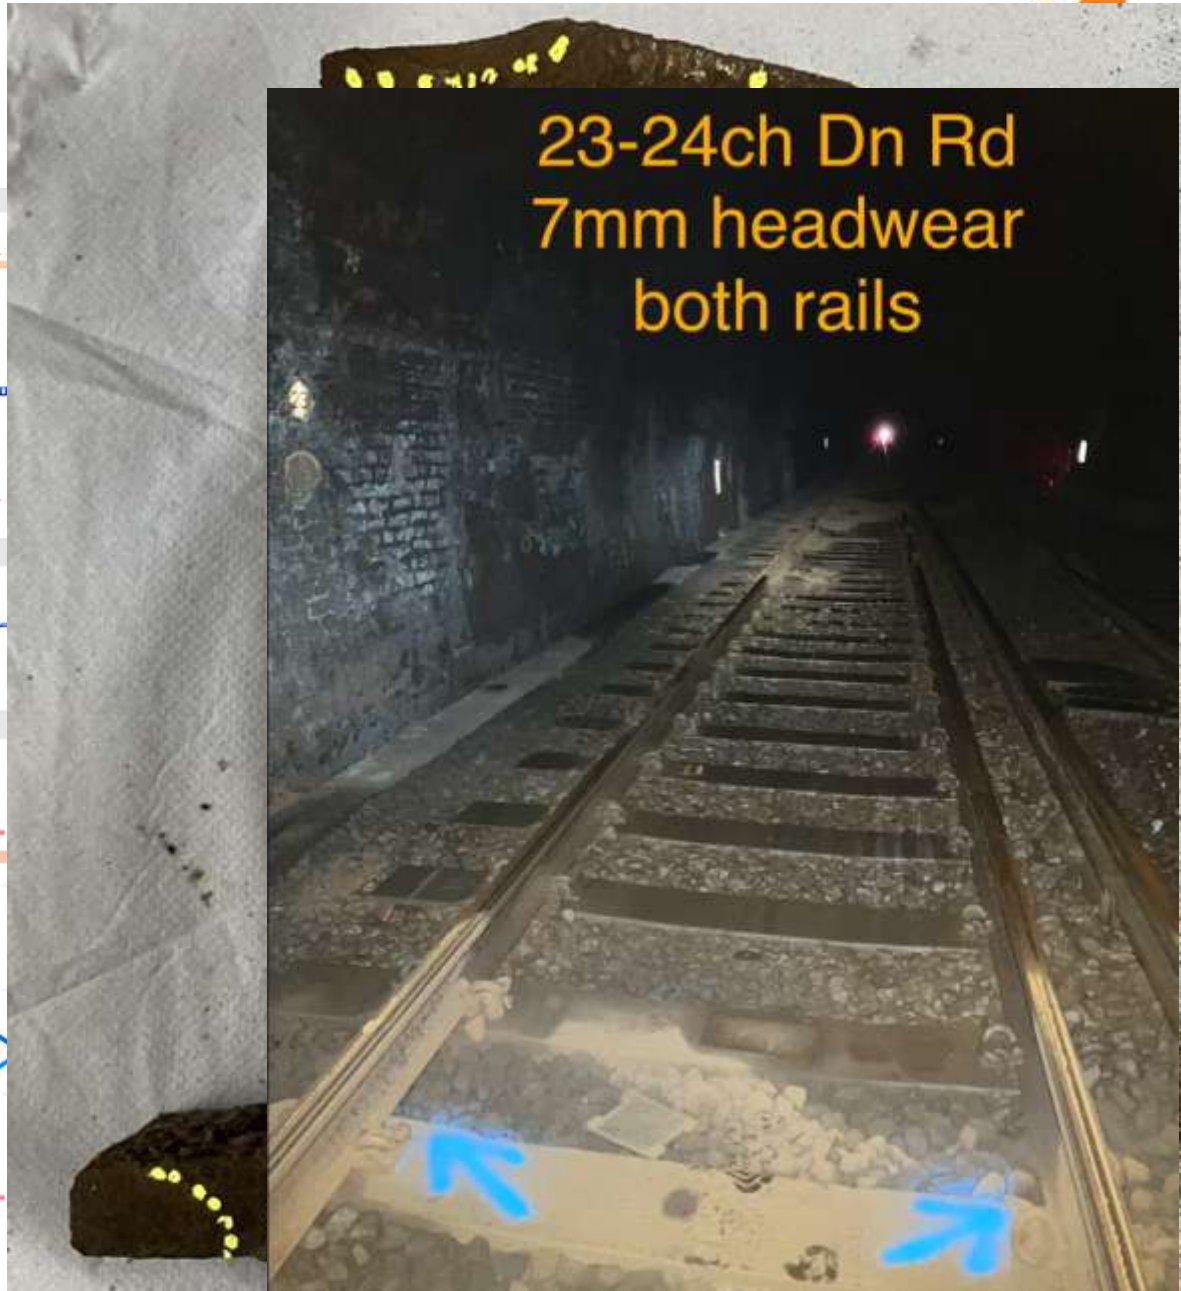
23-24ch Dn Rd  
7mm headwear  
both rails
