# A Day in the Life – Scotland's Maintenance Challenge

*Presentation for PWI – 17<sup>th</sup> September 2025*

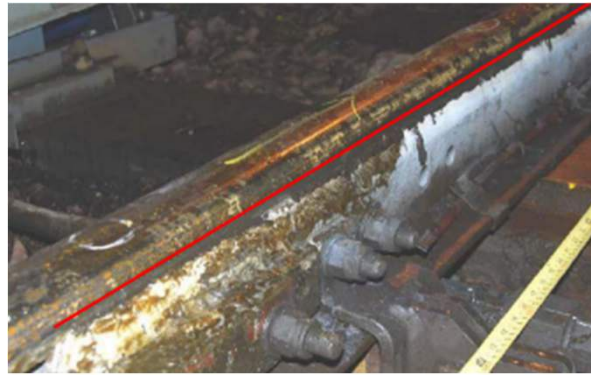
Diagram and photo demonstrating “Switch Topping Height” – taken from NR/BS/LI/284

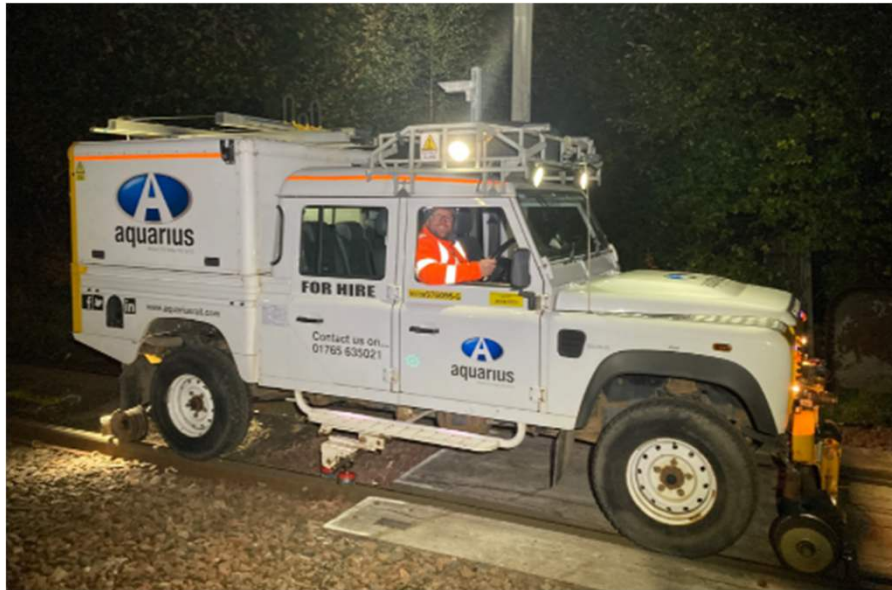
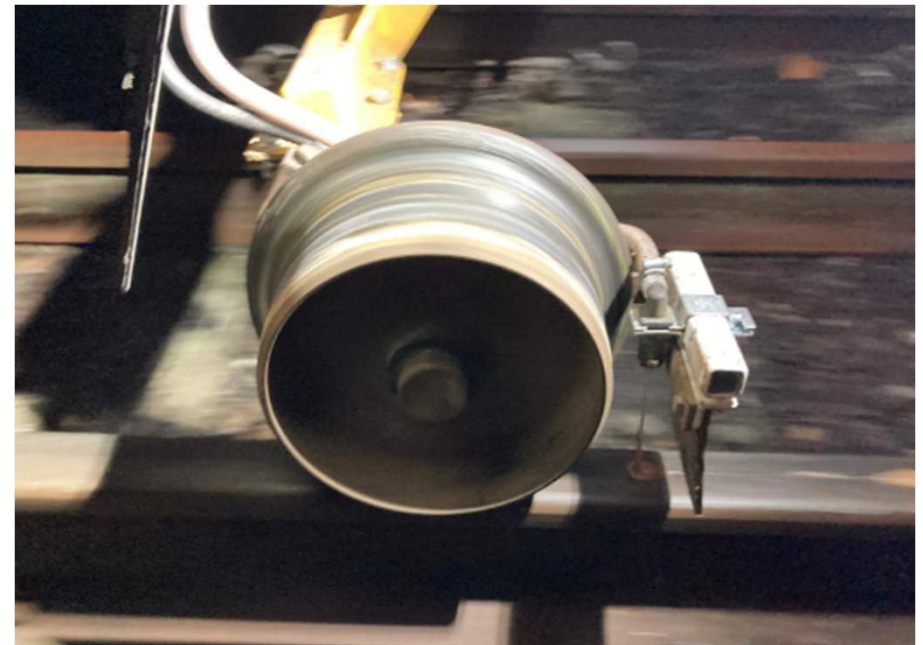
Sand-rover use on the Balloch Branch – Delivered by Maintenance to protect against a potential 65% reduction in track access time

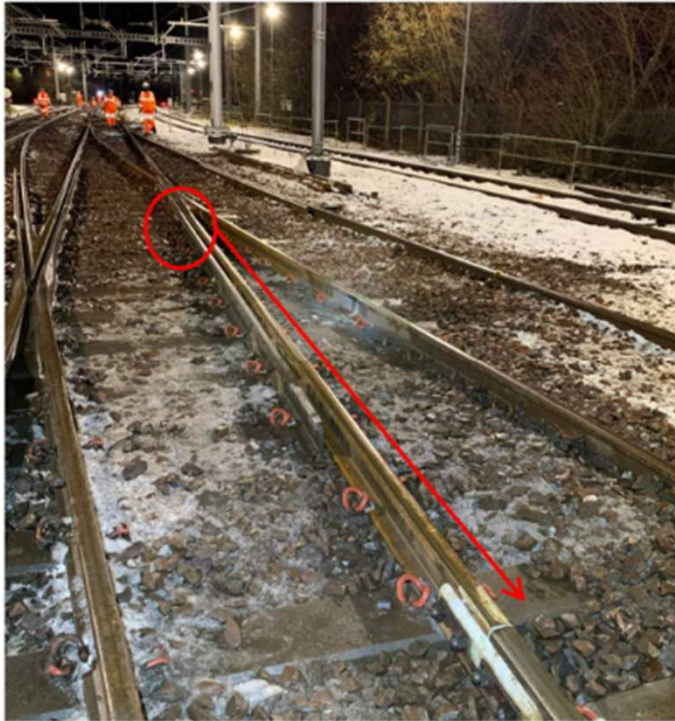
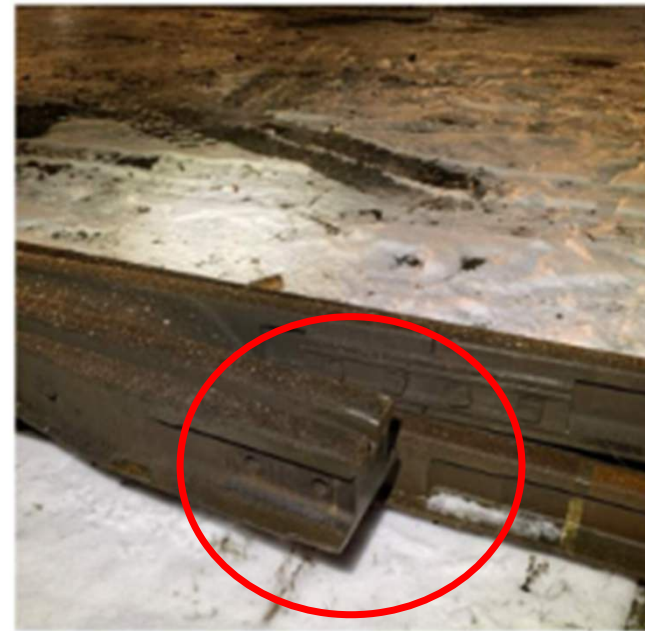
735 Crossing – bespoke crossing ordered to move very high-risk, inherently weak joint
