# Overhead Line Monitoring and Incident Management

# How OLert works

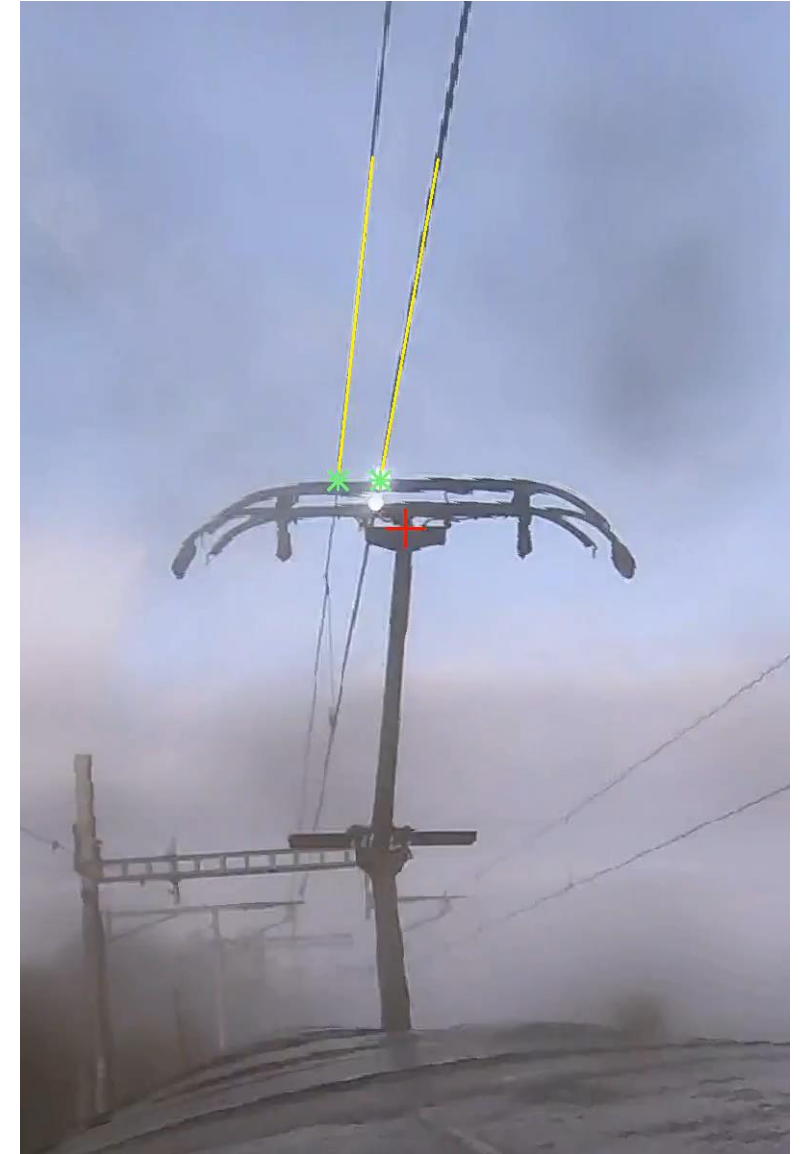
- At OLert's core is a machine vision algorithm developed in partnership with University of Oxford academics.
- This algorithm is key to turning the captured images into meaningful insights in conjunction with the accelerometer data.
- The algorithm & accelerometers identify and calculate height, stagger & contact force through image recognition & impact analysis.
- Any variances to these measurements, outside of the pre-determined tolerances are recorded and alerts are generated to prevent future failures.
- These alerts alongside the video and image capture, provides evidence for maintenance teams to take preventative action.
- OLert clustering highlight's locations with a high number of individual alerts, based on track position, enabling a more targeted approach to engineering maintenance.

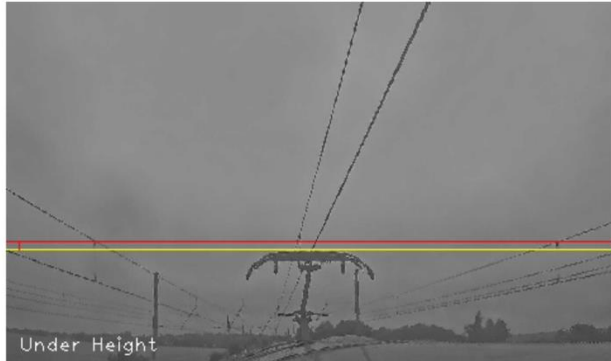
Under Height

Alert detail can show captured video footage or a graphic representation.

Investigating an alert will present users with everything the system has discovered. In this example, the pan was under height.

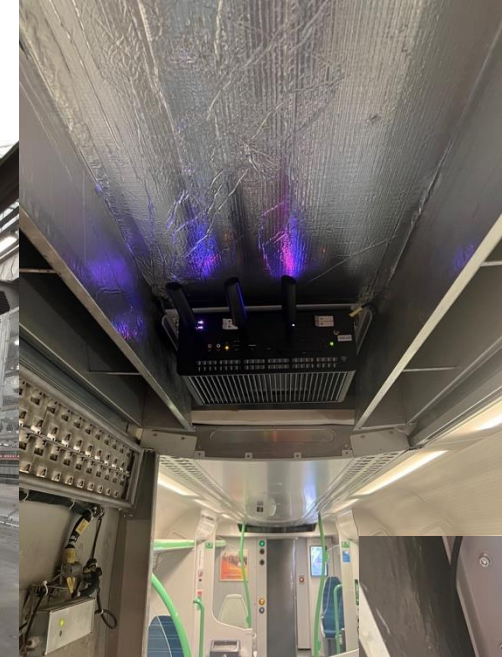
Antenna installed above processor

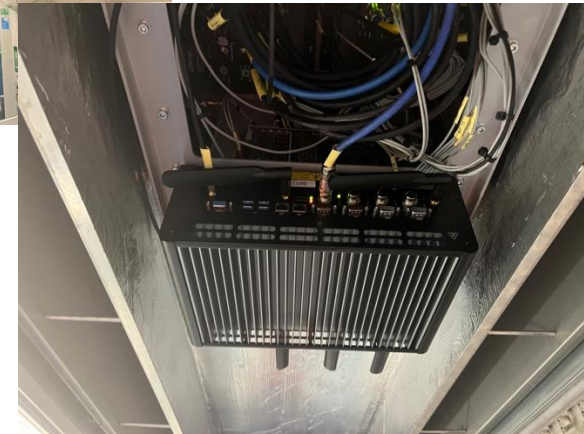
Processor installed in roof cavity of the train

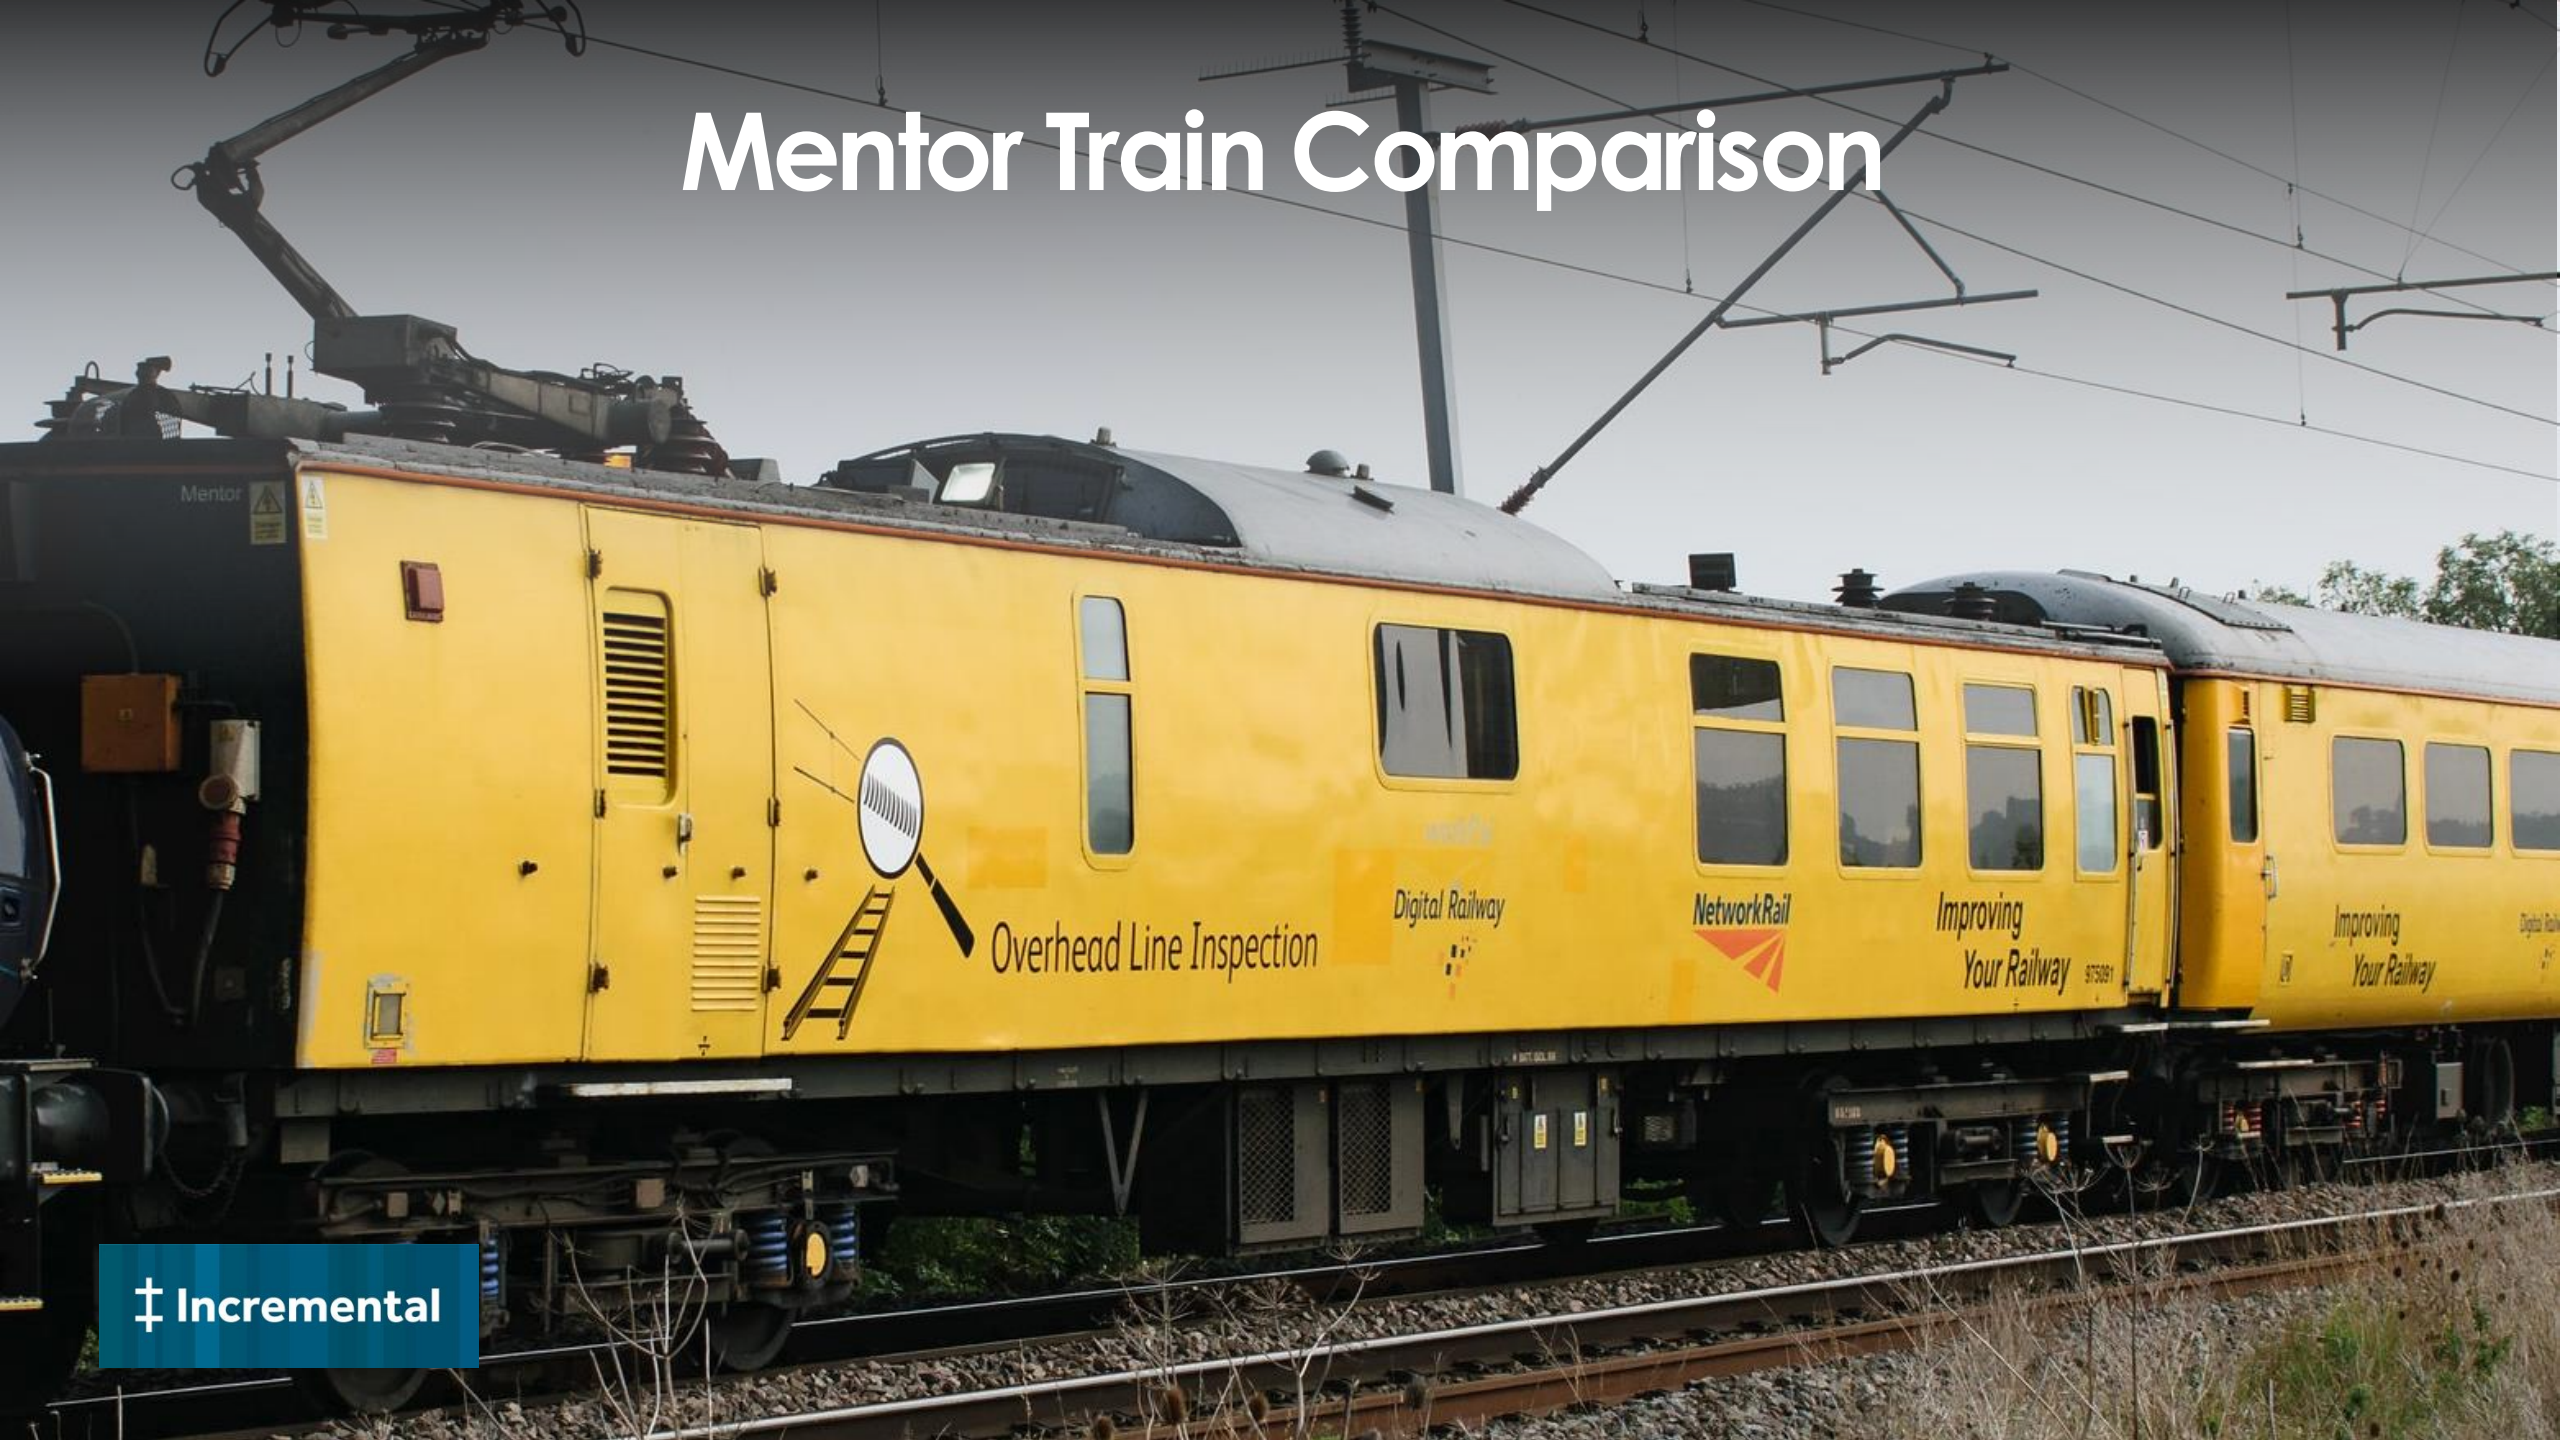
# Mentor Train Comparison

**99.4% of OLert's stagger measurements were within 100mm of MENTOR'S.**

**0.005mm – the mean difference between OLert and MENTOR.**

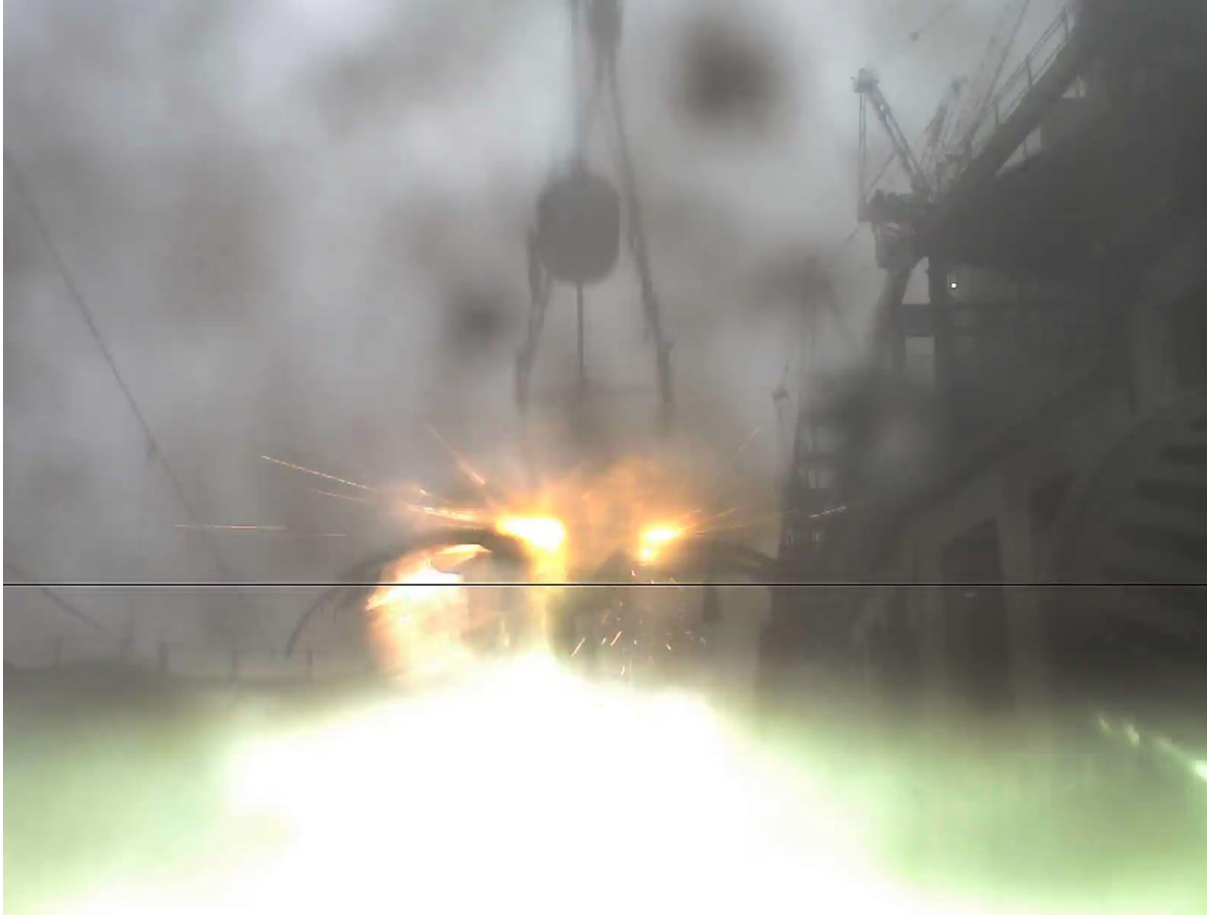
Explosion captured by unit 700011, 45 prior to dewirement

The graphic to the left showed an explosion from the unit involved in the incident around 45 minutes prior to the event.

Further analysis conducted via OLert highlighted that there was no deviation from the “norm” on the OLE profile and therefore the customer was able to target fault identification through panhead inspections and appropriate repairs were made to the panhead.

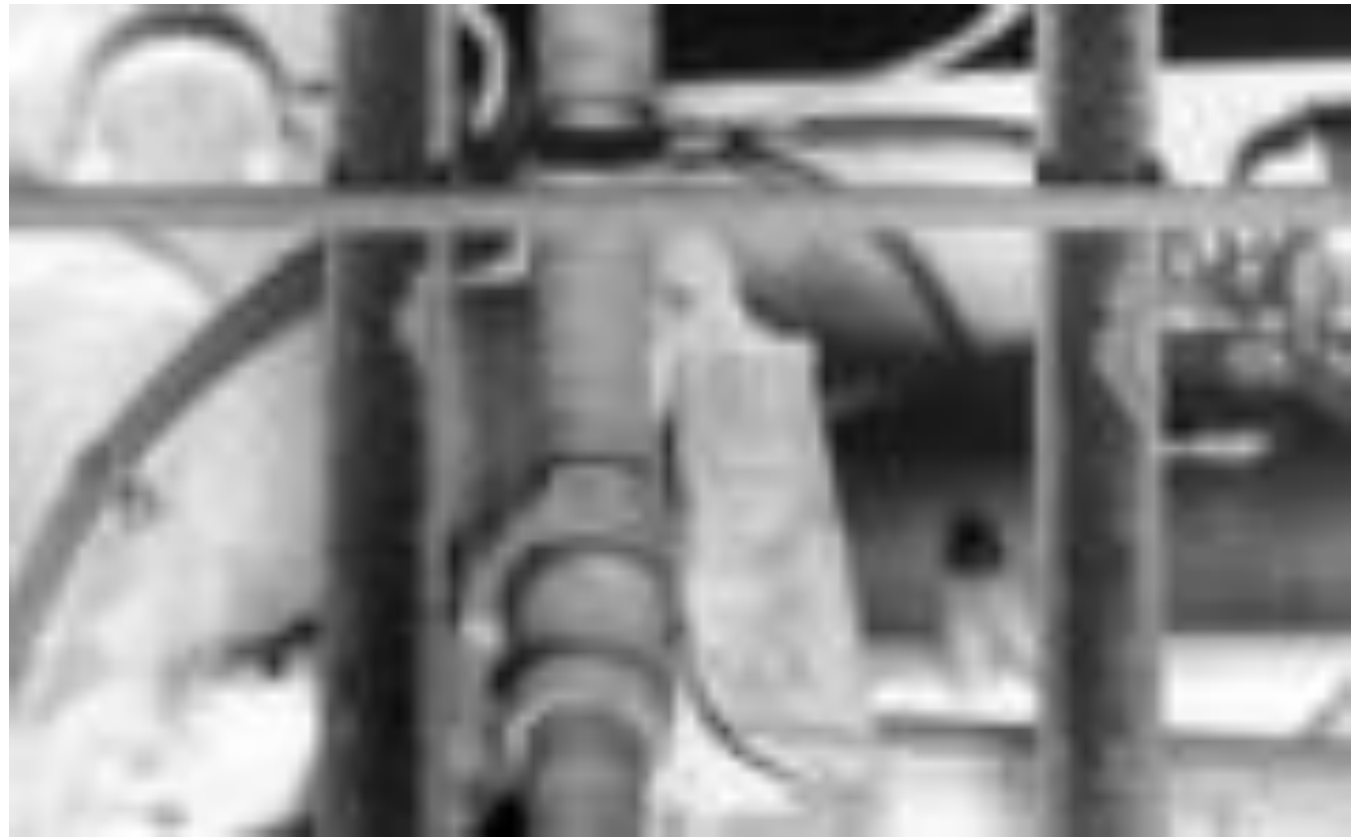
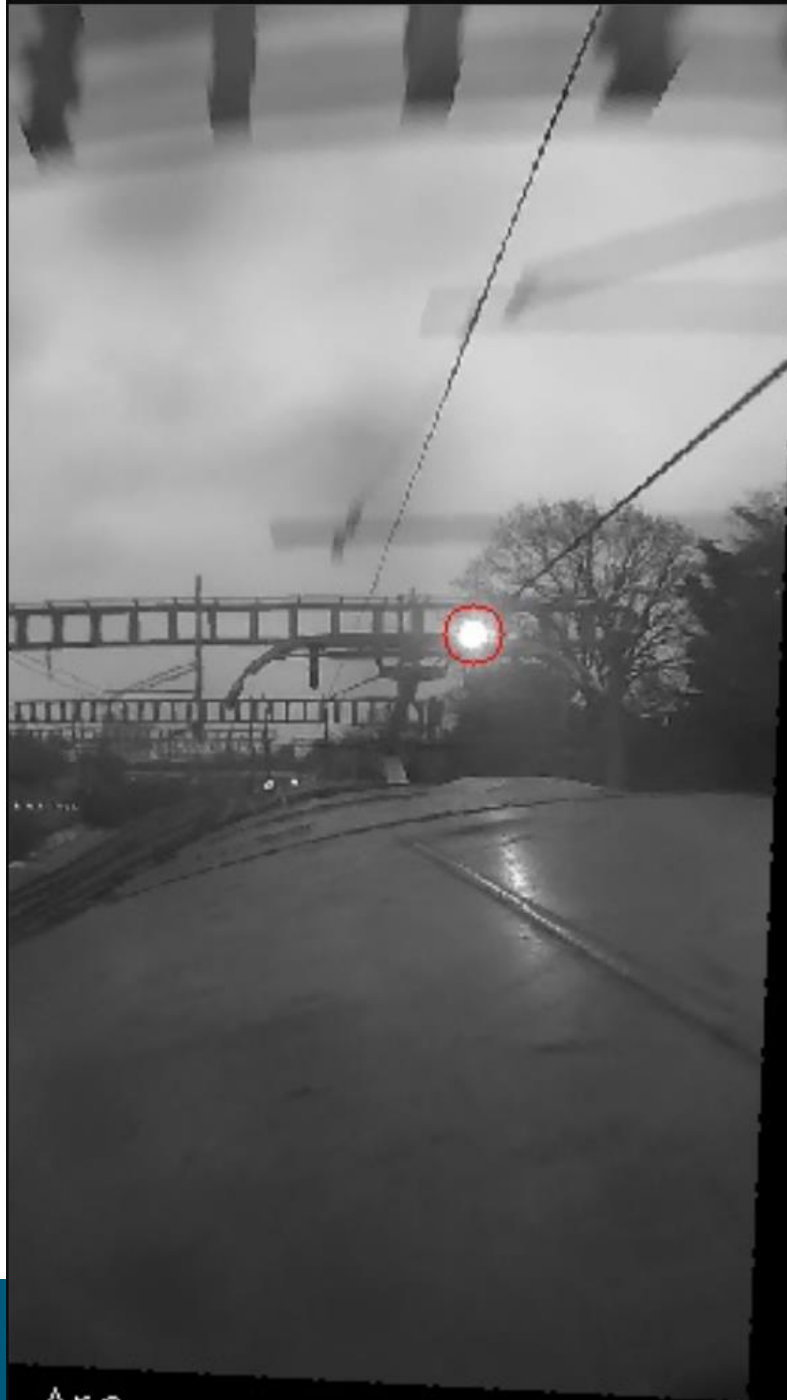
- Lineside cameras (PanVue) identified damage to pantographs between Paddington and Airport Junction but limited means to identify the cause
- OLert consulted and identified several clusters of arc alerts, some of which were at registration arms
- Specific location details provided (W3W, ELR and mileage or lat/long), issue remediated after targeted visual inspection

OLE height profiles mapped

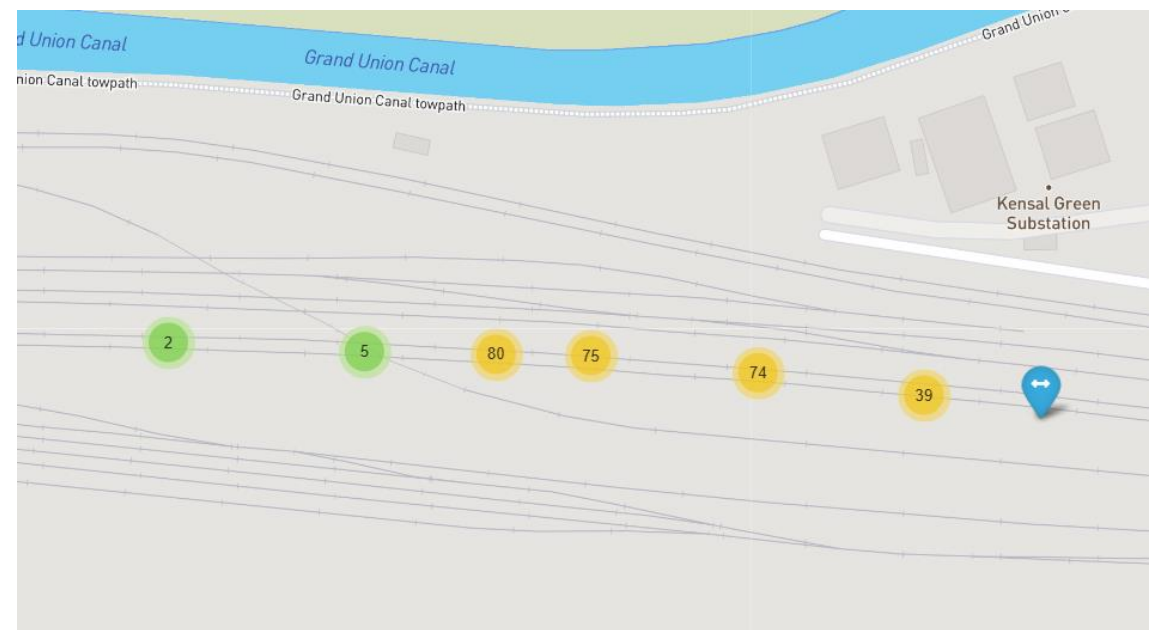
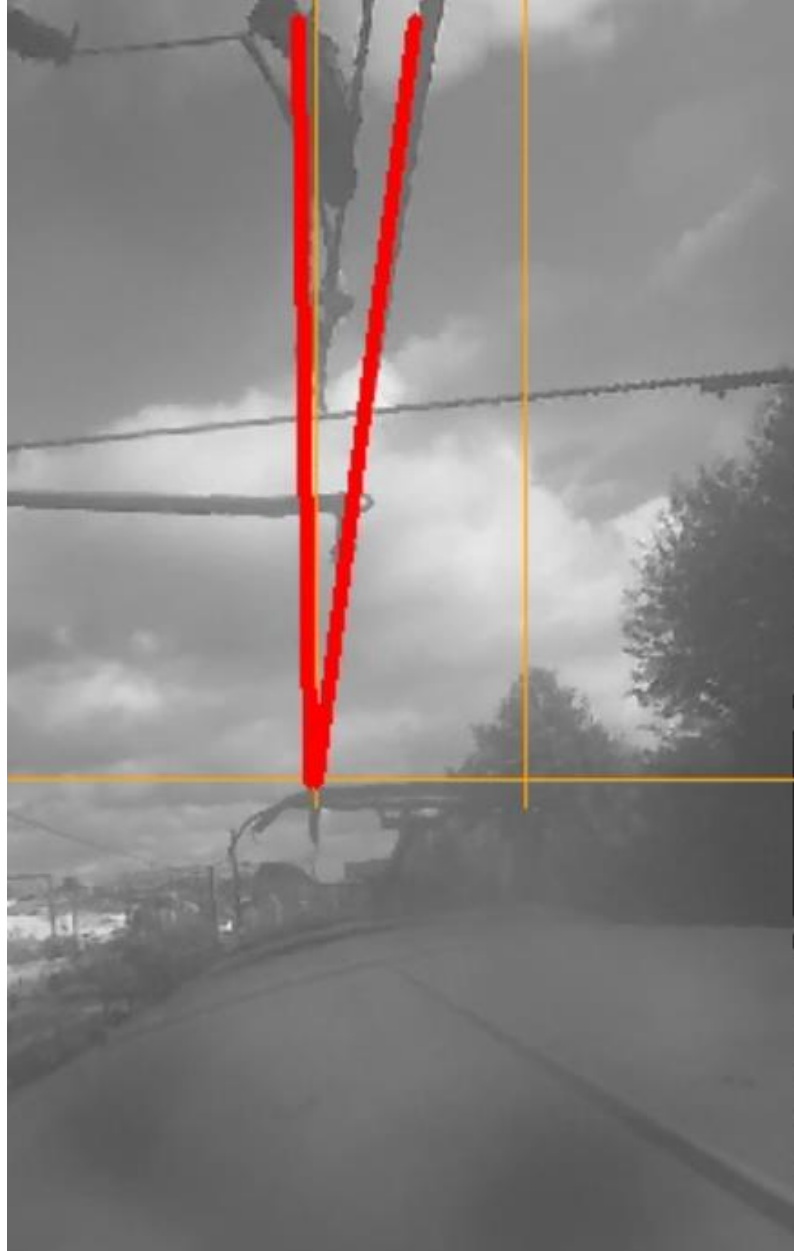
OLE height profiles mapped

Abnormal Stagger
