# RailEI Technical Seminar Current Crossing Issues and Maintenance Solutions

Steve OBrien Principal Engineer S&C

18<sup>th</sup> March 2026

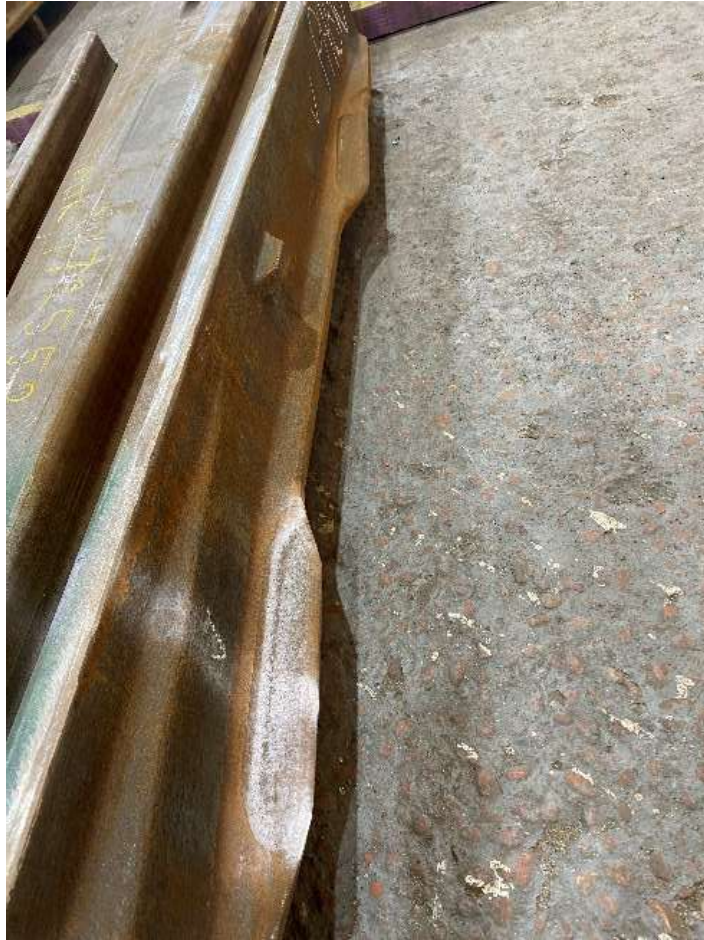
*Scallop radius design pre-2019*

Pre-May 2019 – Foot flange has discontinuities in between bearers which can lead to stress raisers and early propagation of cracks emanating from the foot

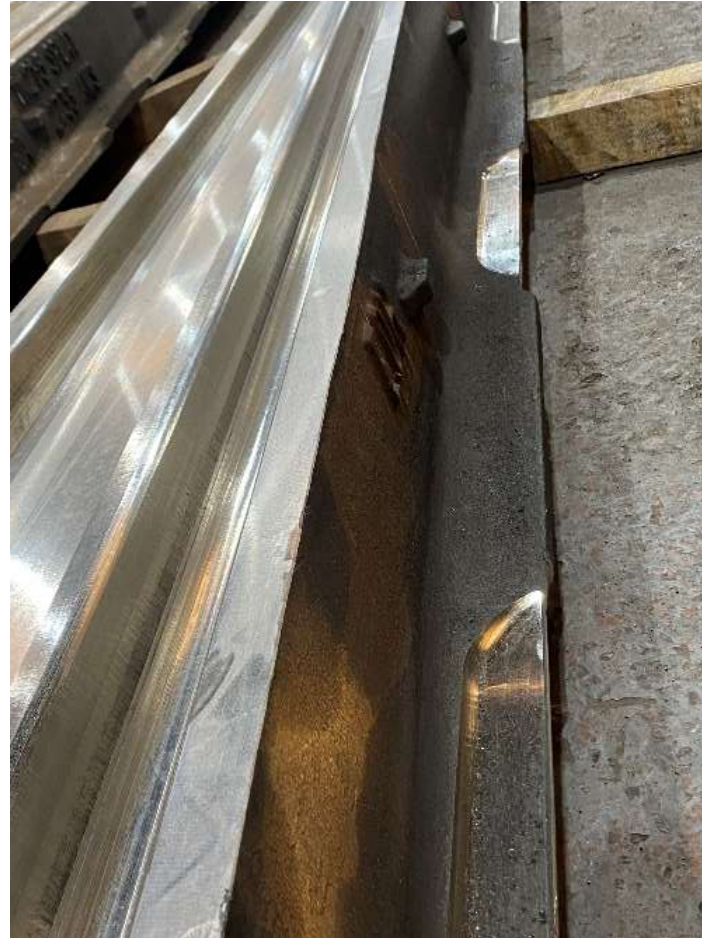
*Continuous foot design post 2019*

Post May 2019 – New pattern with a continuous foot flange where the scallop radius has been removed providing greater resistance to cracks emanating from the foot.

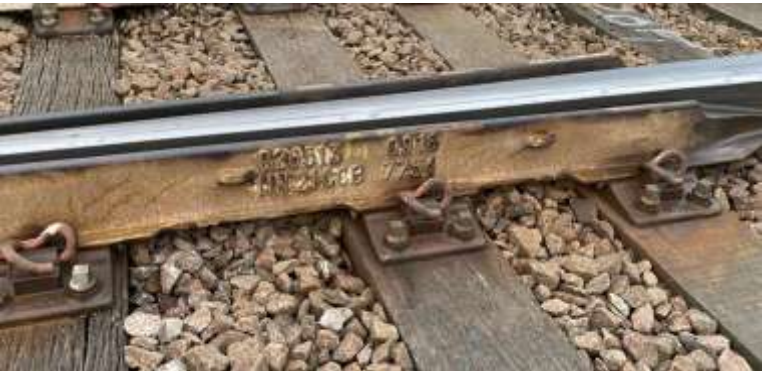
Non- Explosive Depth Hardened (EDH)

Non-EDH crossings from new have a surface hardening of 240 Brinell to 280 Brinell

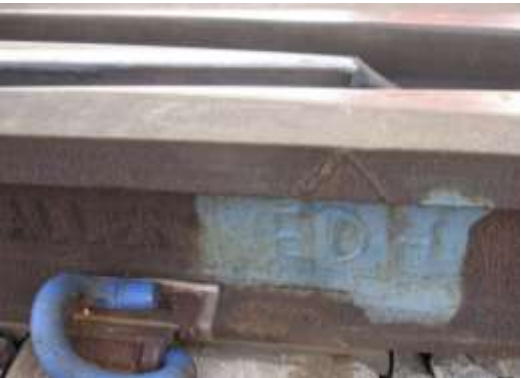
Explosive Depth Hardened (EDH)

EDH is a method using plastic explosives to accelerate hardening of the steel prior to installation. EDH is used to reduce wear and batter and the hardening of the surface transmits to a depth of 25mm

EDH crossings from new have a surface hardening of 321 Brinell to 360 Brinell

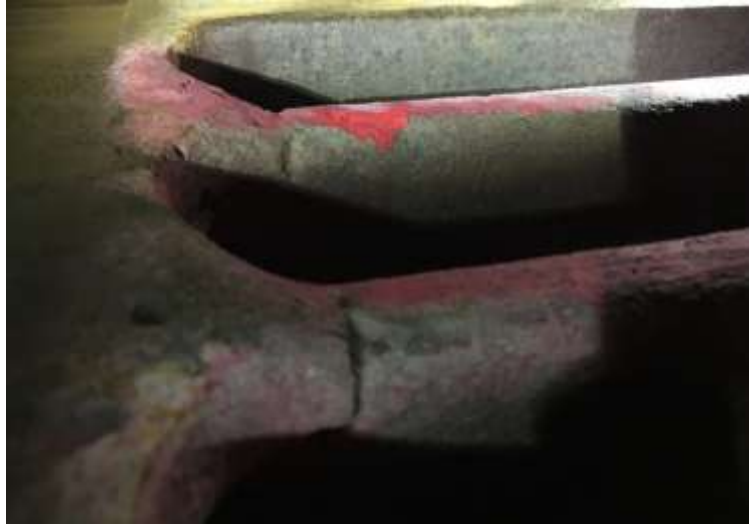
*Shallow depth ribs*

Pre-May 2019 - The internal structure varies by manufacturer, but all contain core pockets and ribs in various configurations where the ribs are upturned 15 degrees into the casting.

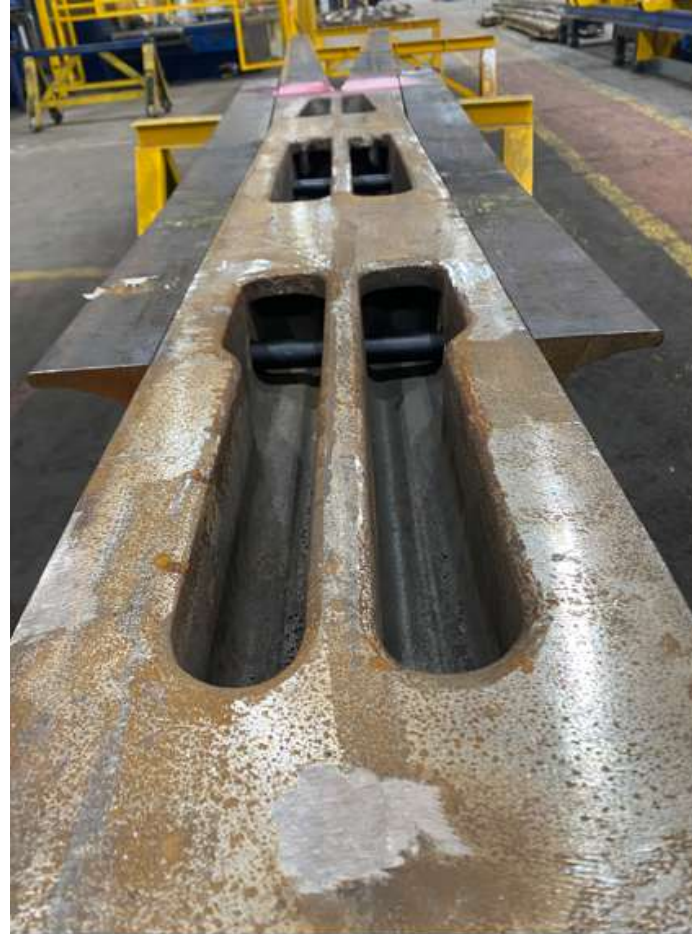
*Full depth ribs*

Post May 2019 –The internal structure varies by manufacturer, but all contain core pockets and ribs in various configurations where the ribs are at the same depth as the casting.

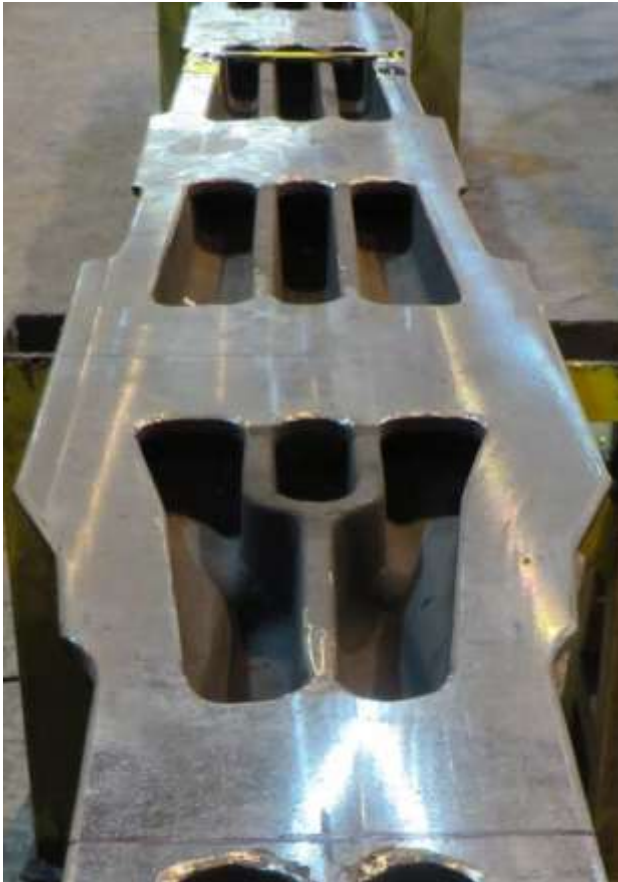
*Straight core pockets*

The traditional design pre-May 2019 had consistent shape core pockets which allowed areas of stress to increase and propagation of cracks

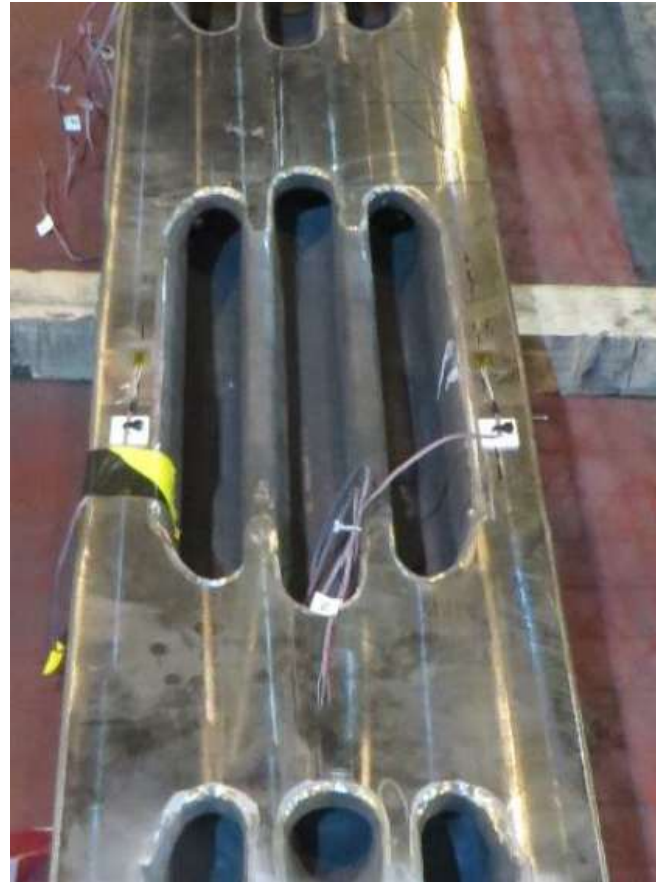
*Staggered core pockets*

Post May 2019 – The outer pockets have been made shorter than the middle pocket. The longitudinal rib helped to distribute the stress experienced from under the running surface and the crossing foot. Staggering the core pockets moves and alleviates a degree of the outer stress concentration.

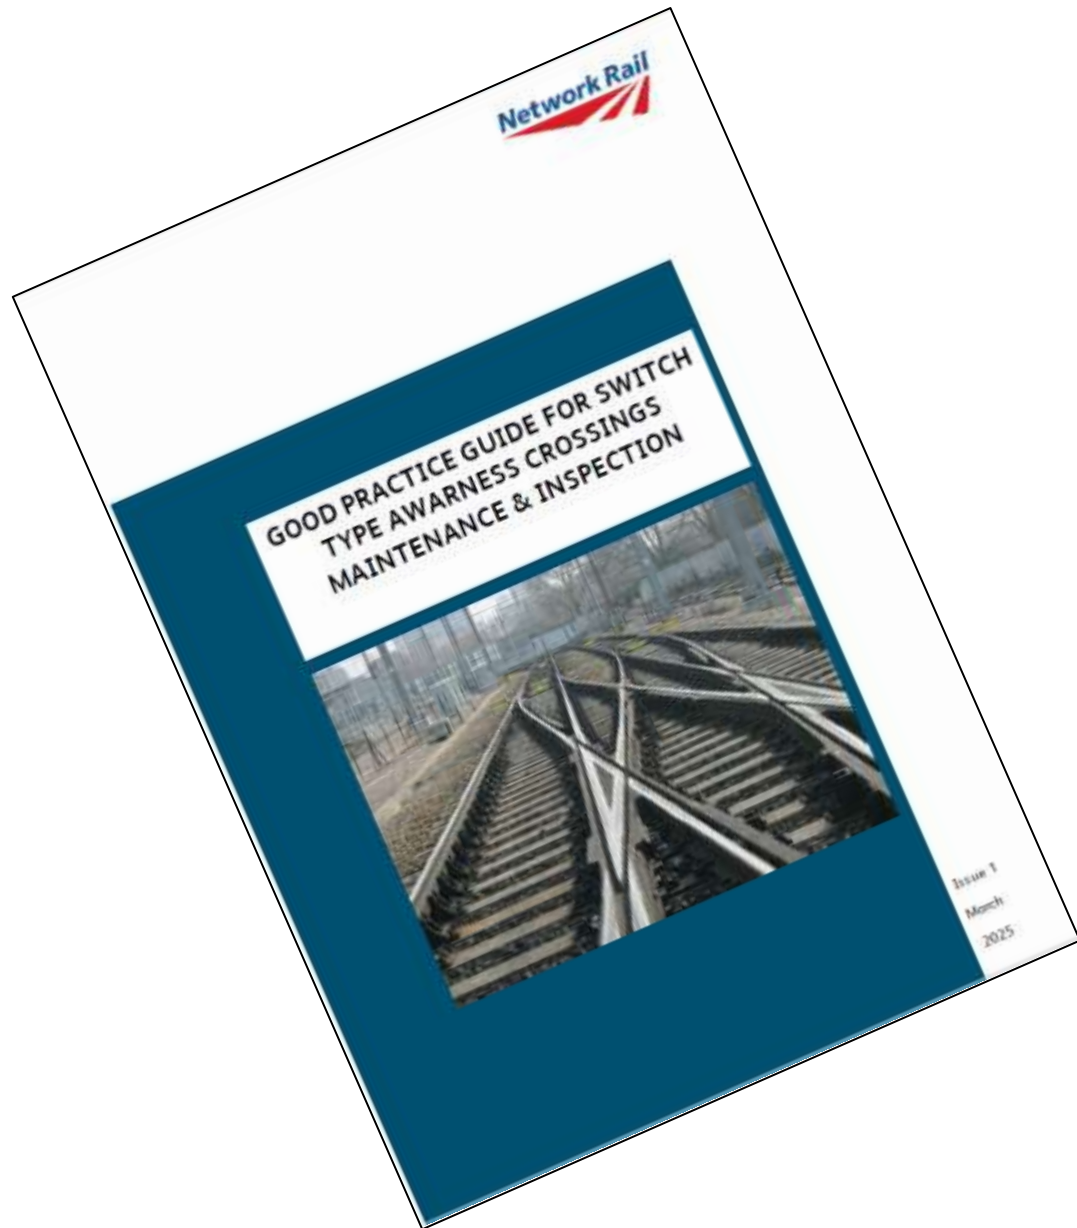
## Blue Book Good Practice Guide

This Good Practice Guide has been written in the format of the original guidance books created by Railtrack & Network Rail as part of the Civil Engineering Conference series between 2000 and 2011.

The Good Practice Guide is less wordy, focusing on the end user with graphs, photographs and illustrations to aid learning.
