## Manufacturing next generation S&C

Developments in S&C design, manufacturing, installation & maintenance

18 March, Manchester

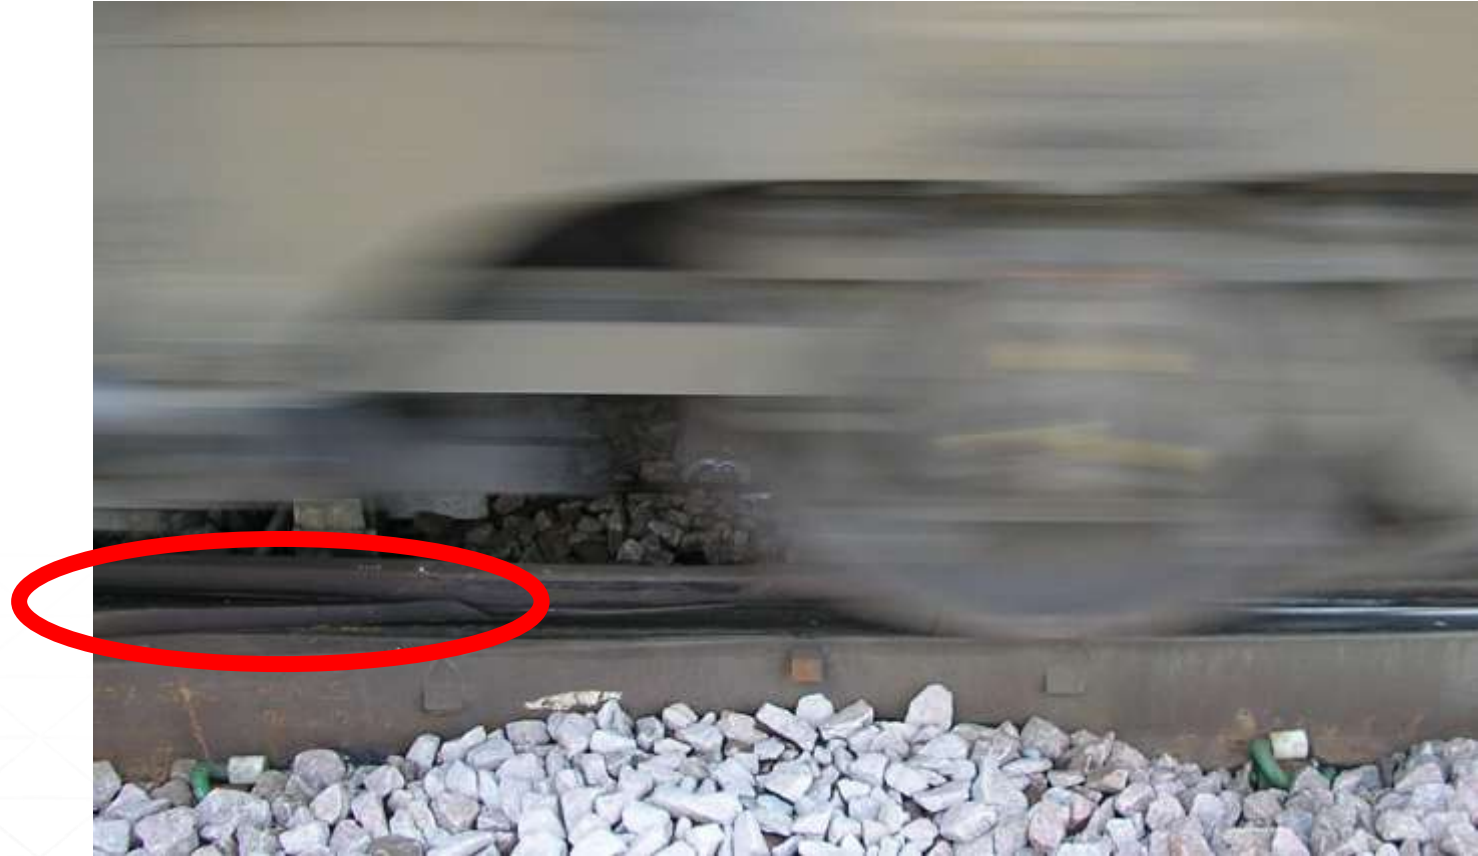
# What is a crossing?

- routinely catches 421 tonnes
- travelling up to 140mph
- & guides it the right way...

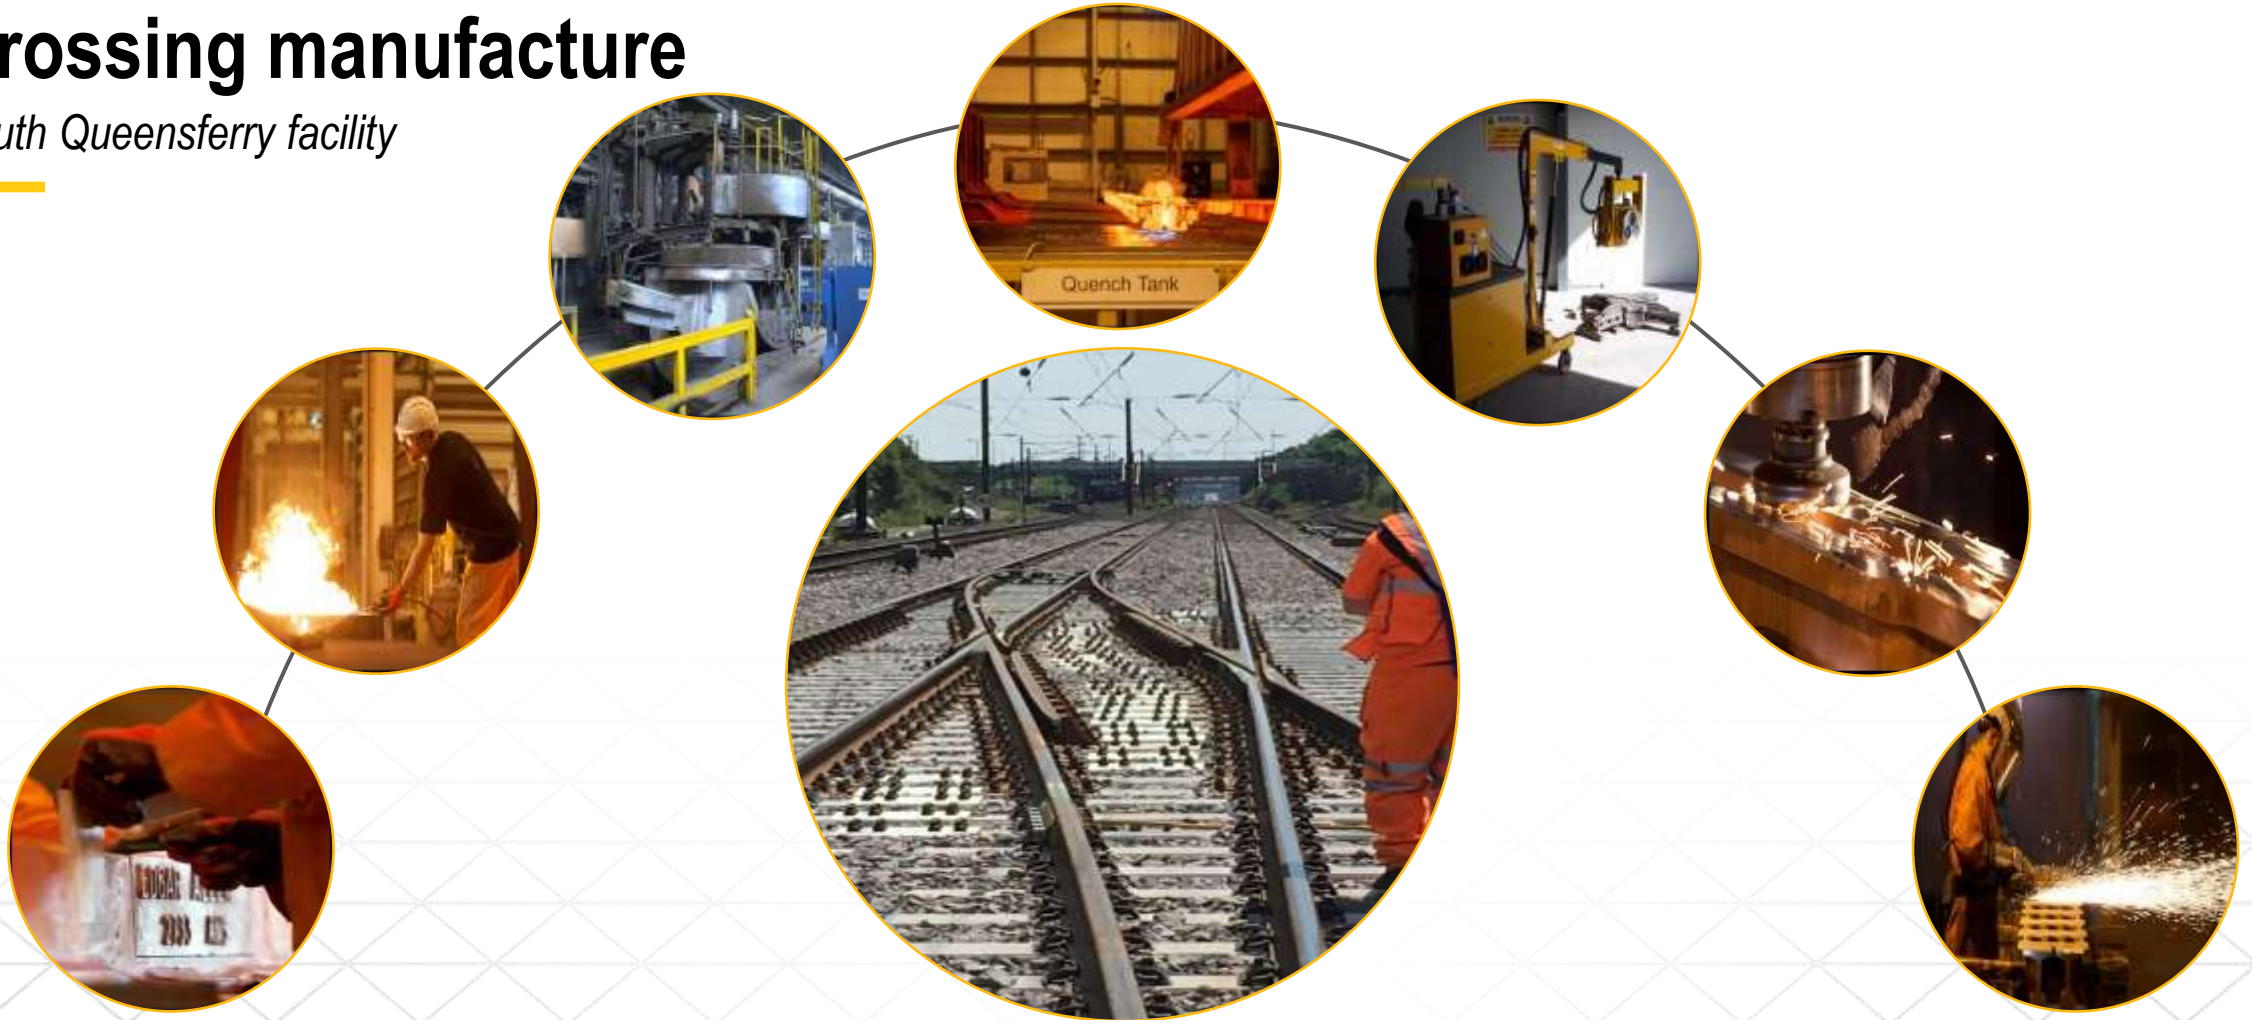
# Crossing manufacture

*South Queensferry facility*

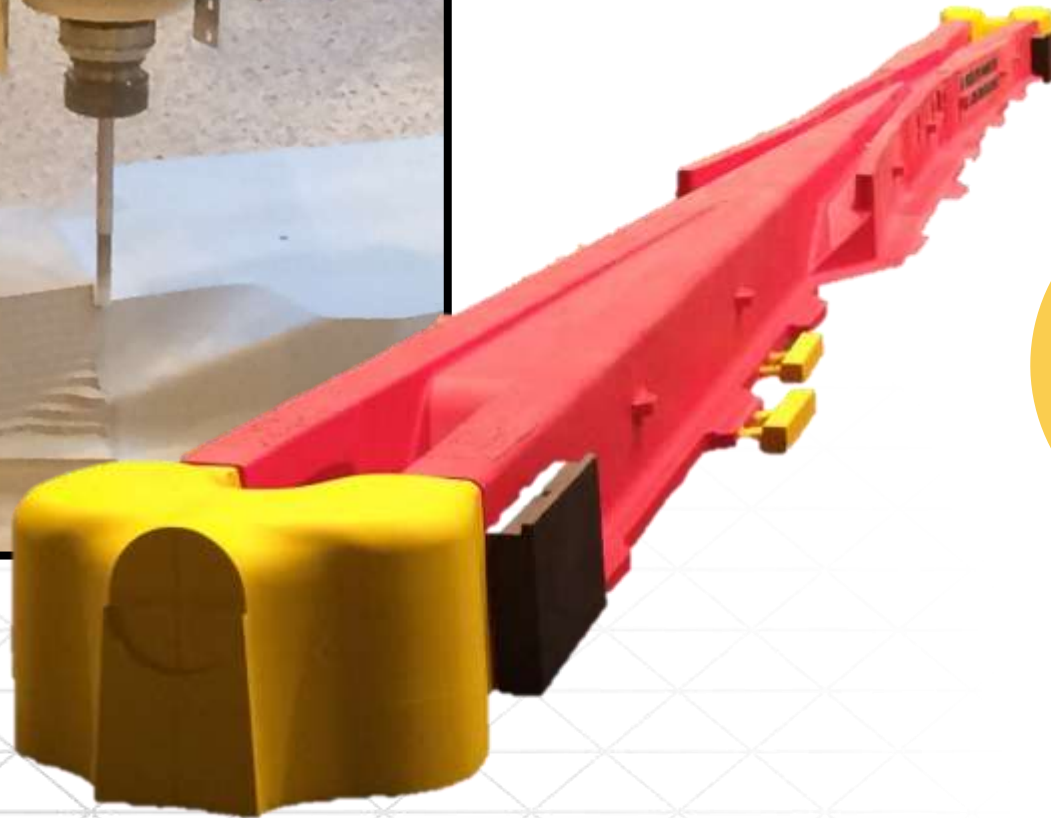
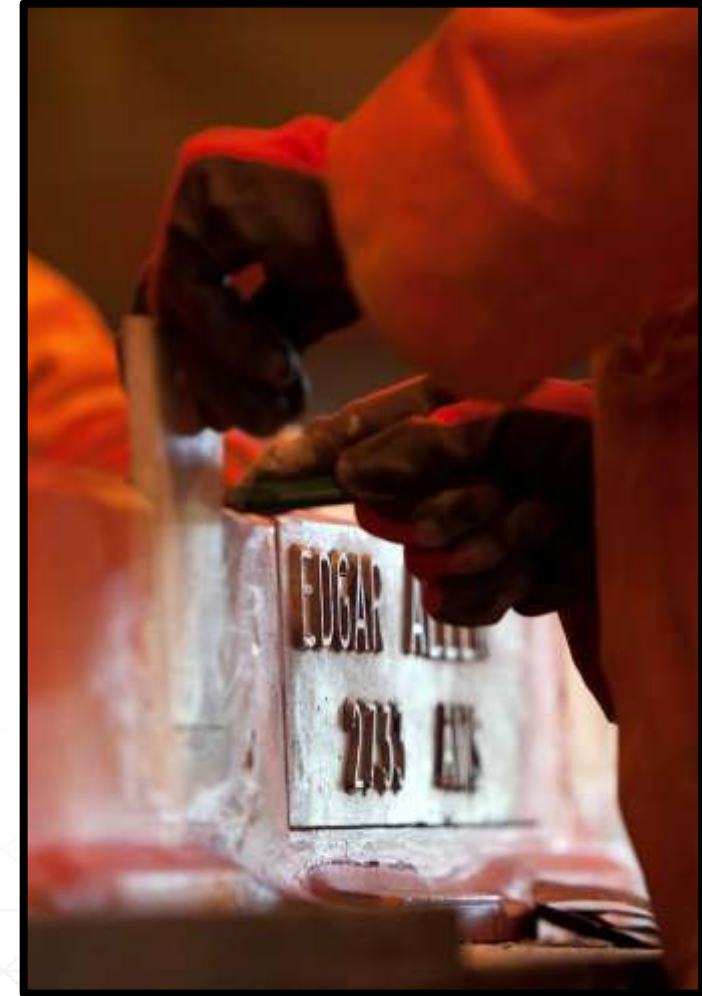
# Pattern making

*In-house pattern manufacture (5-axis) capability*

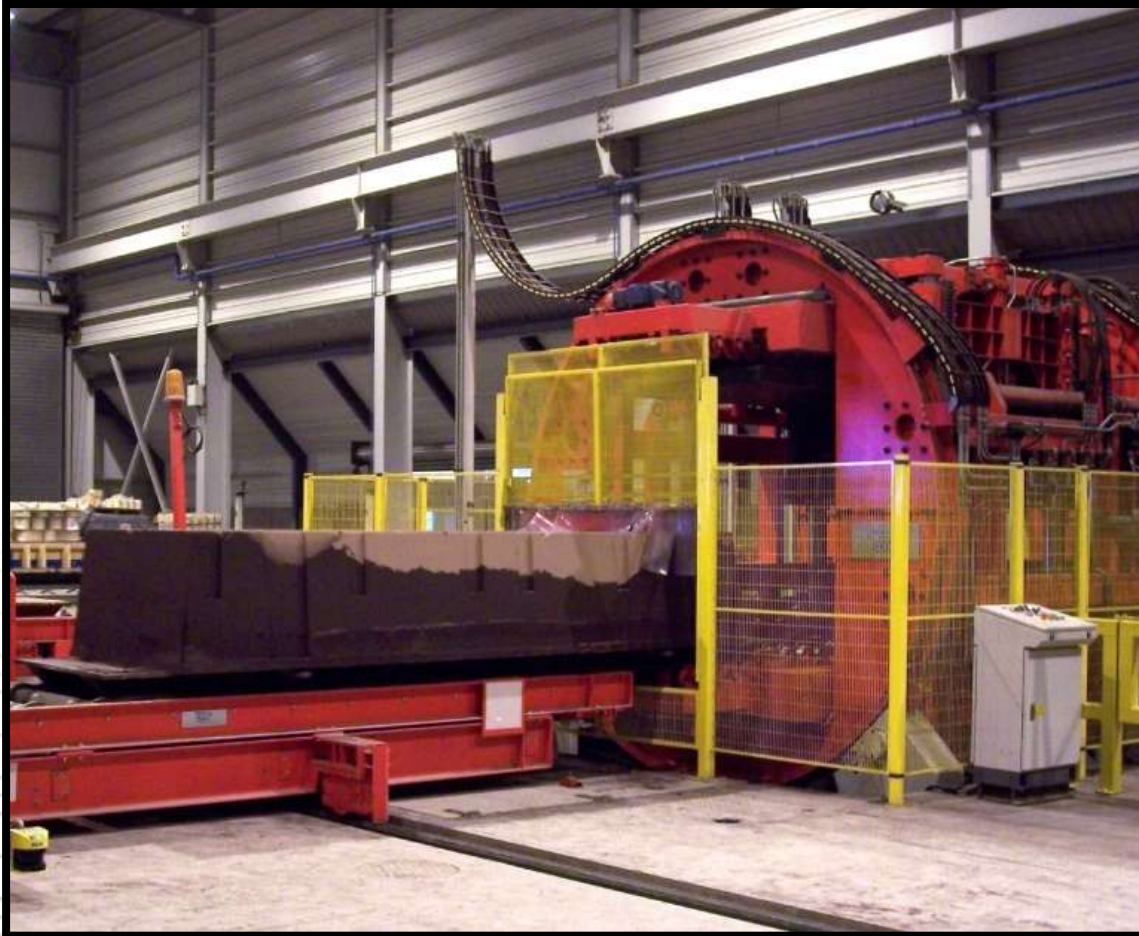
# Moulding

*Boxless moulds*

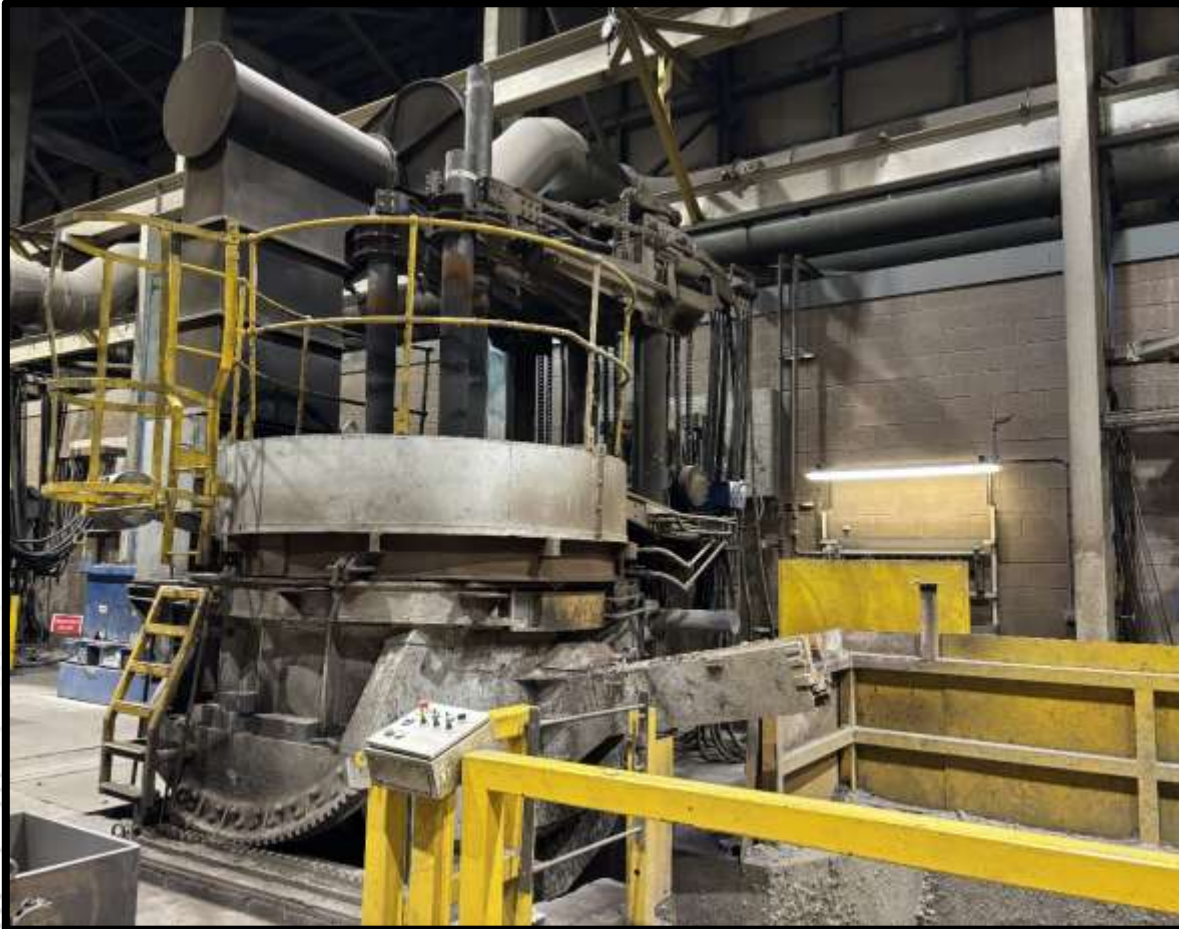
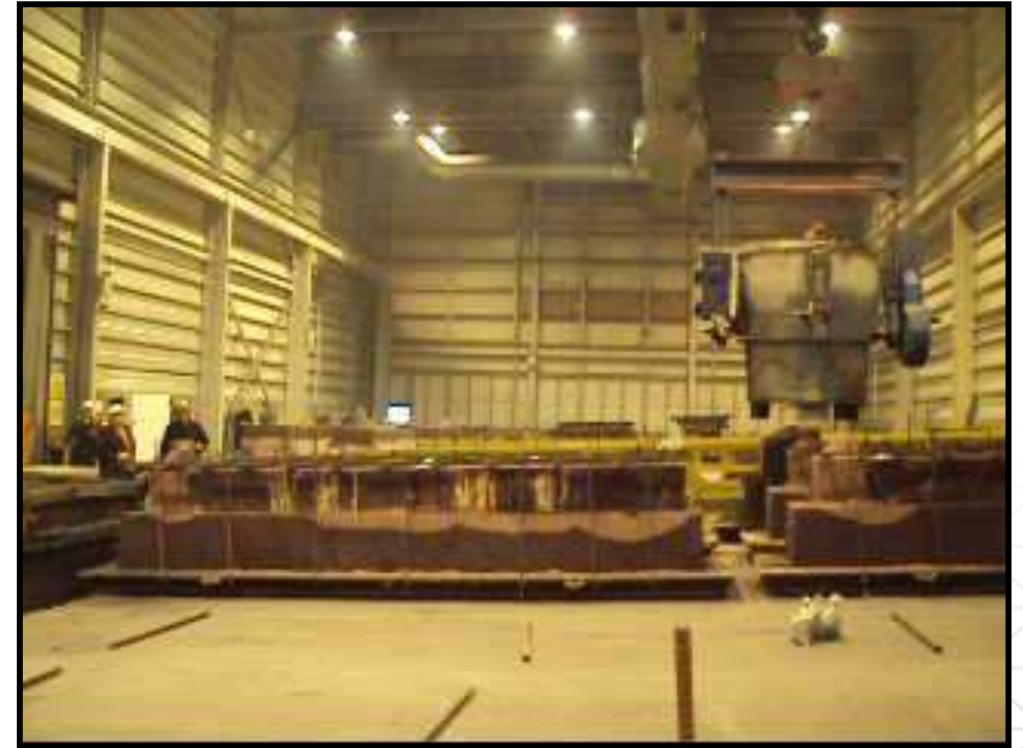
# Steel making

*2 electric arc furnaces*

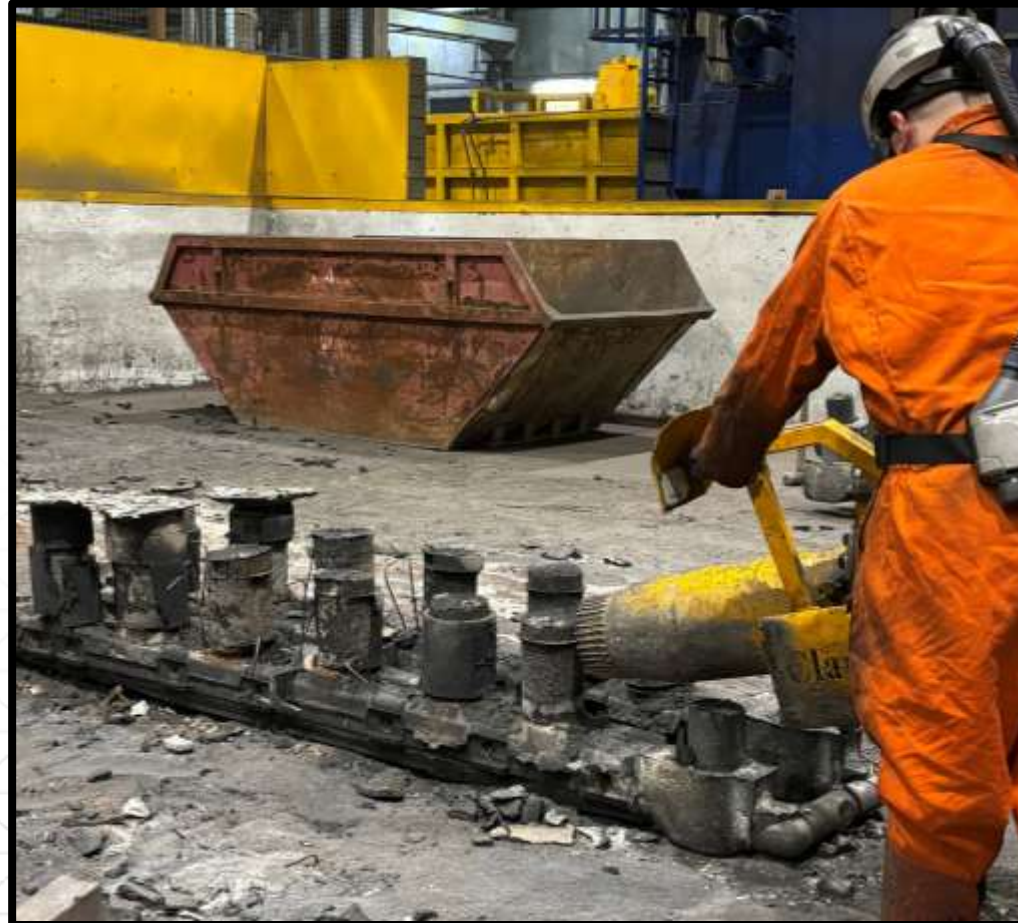
# Post-cast – knock off

*Riser removal*

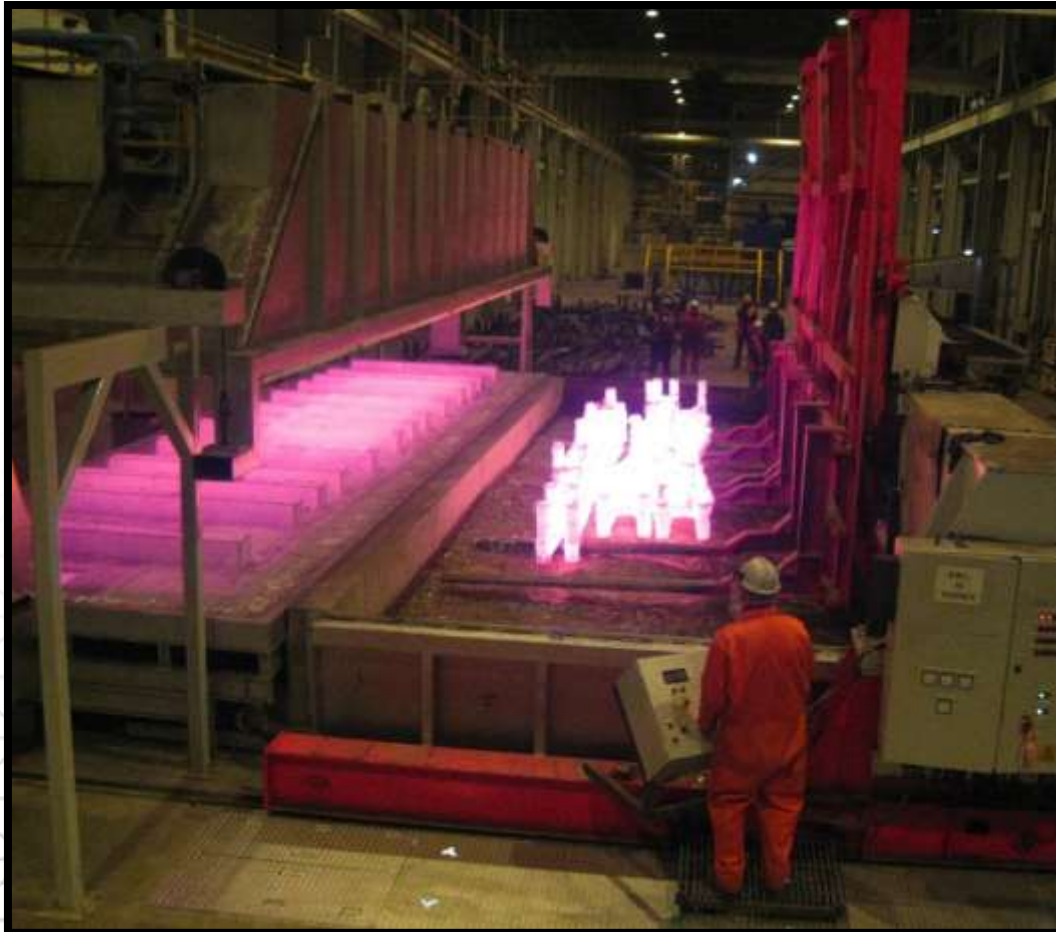
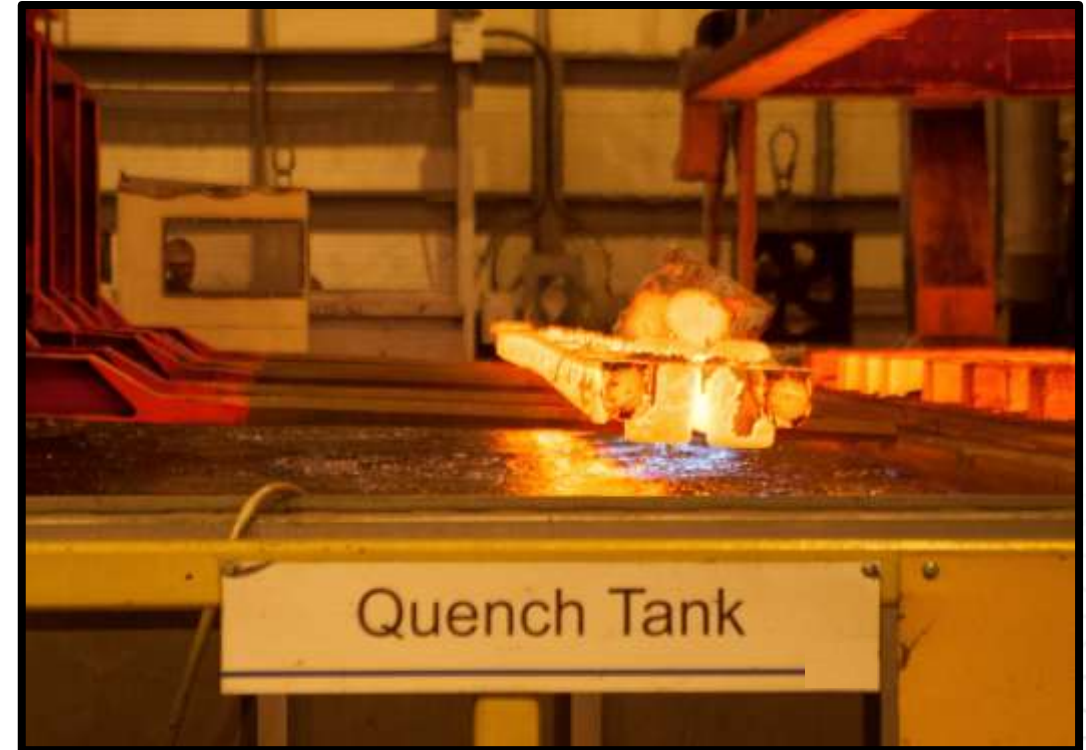
# Post-cast – heat treatment

*Heated to 1050°C*

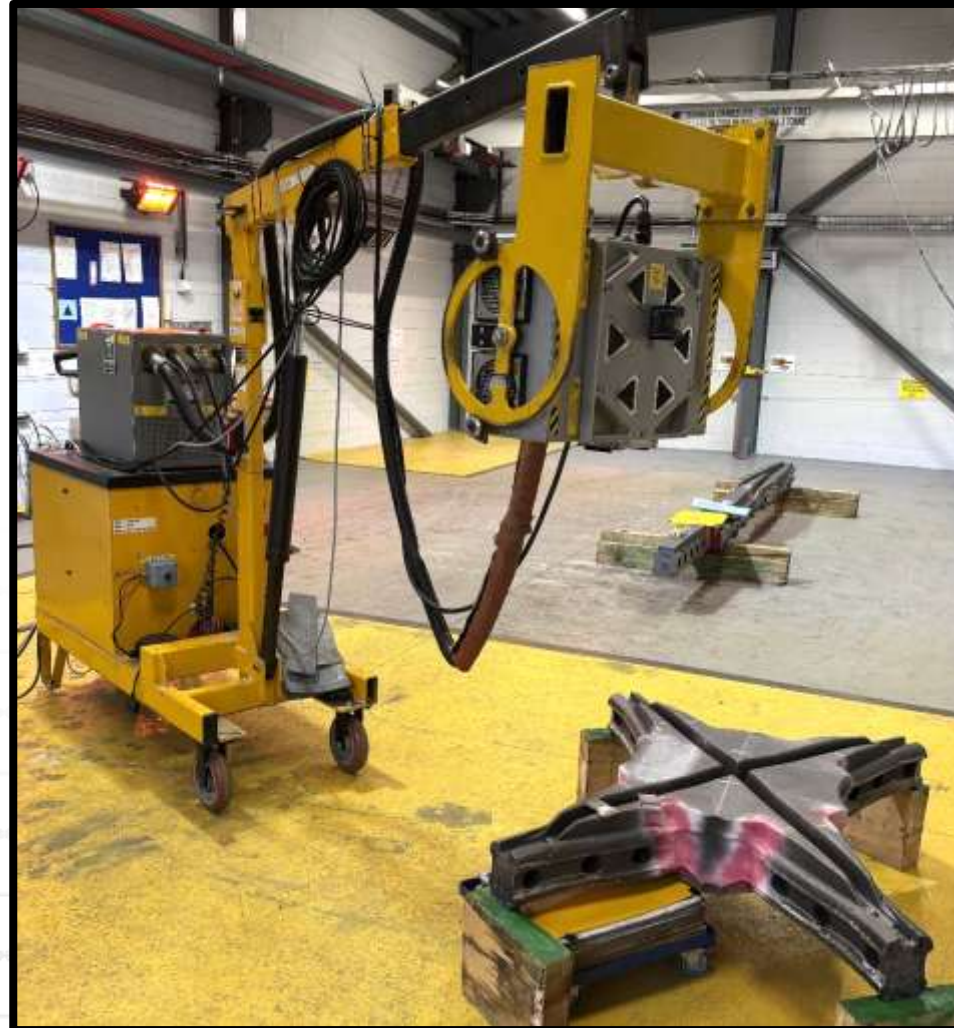
# Non-destructive testing

*In accordance with EN 15689 minimum*

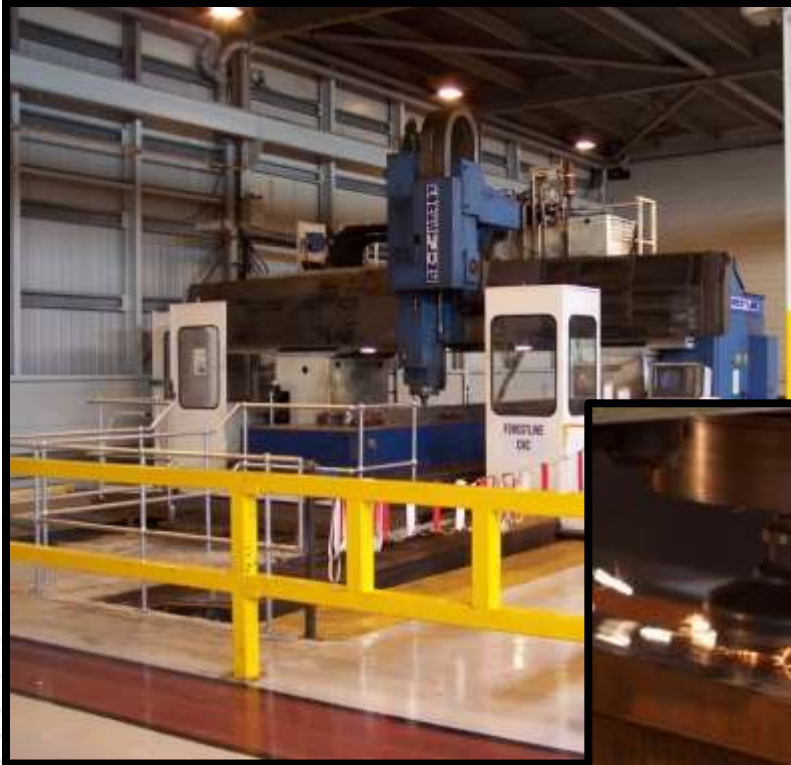
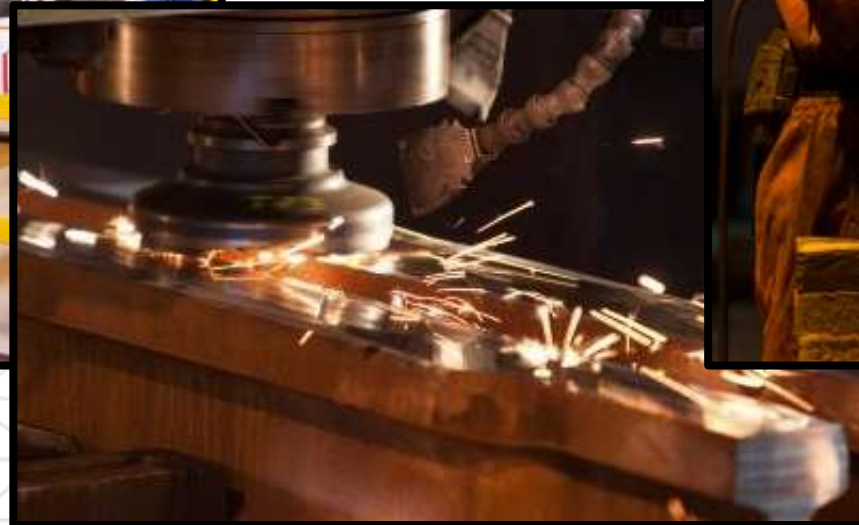
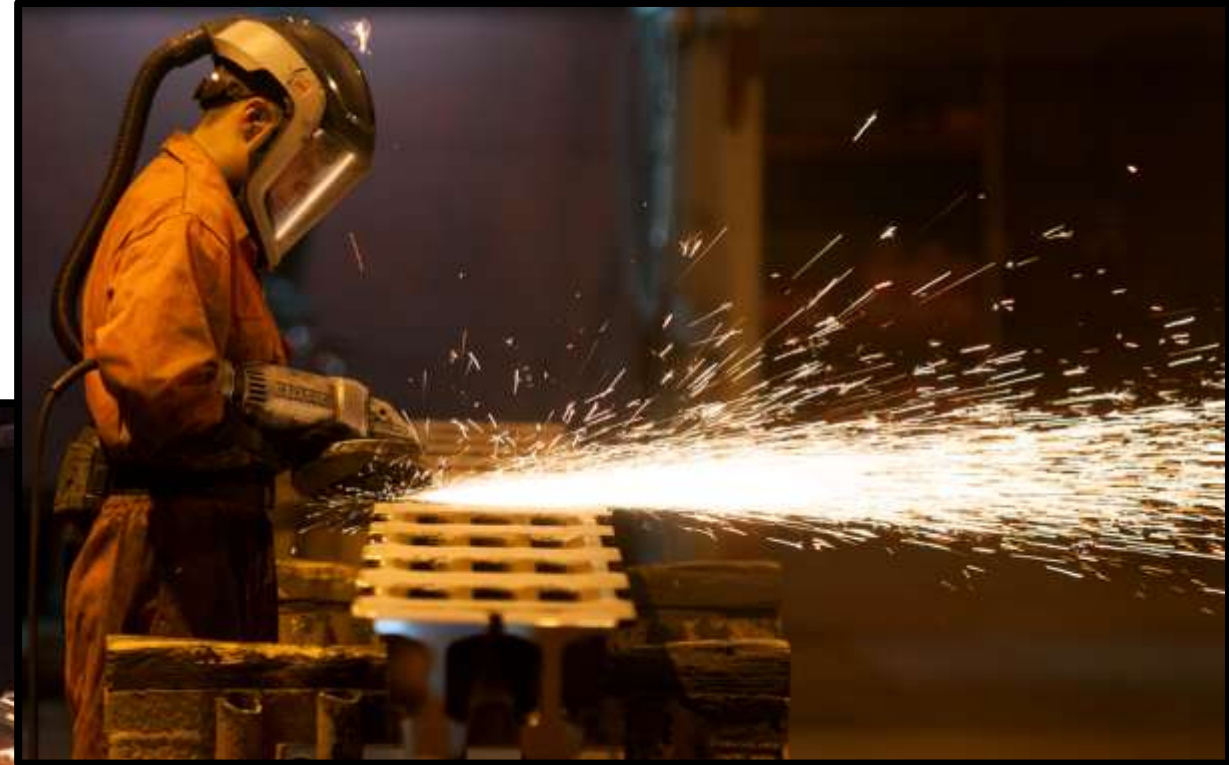
# Machining and fettling

*Cast AMS work hardens during machining*

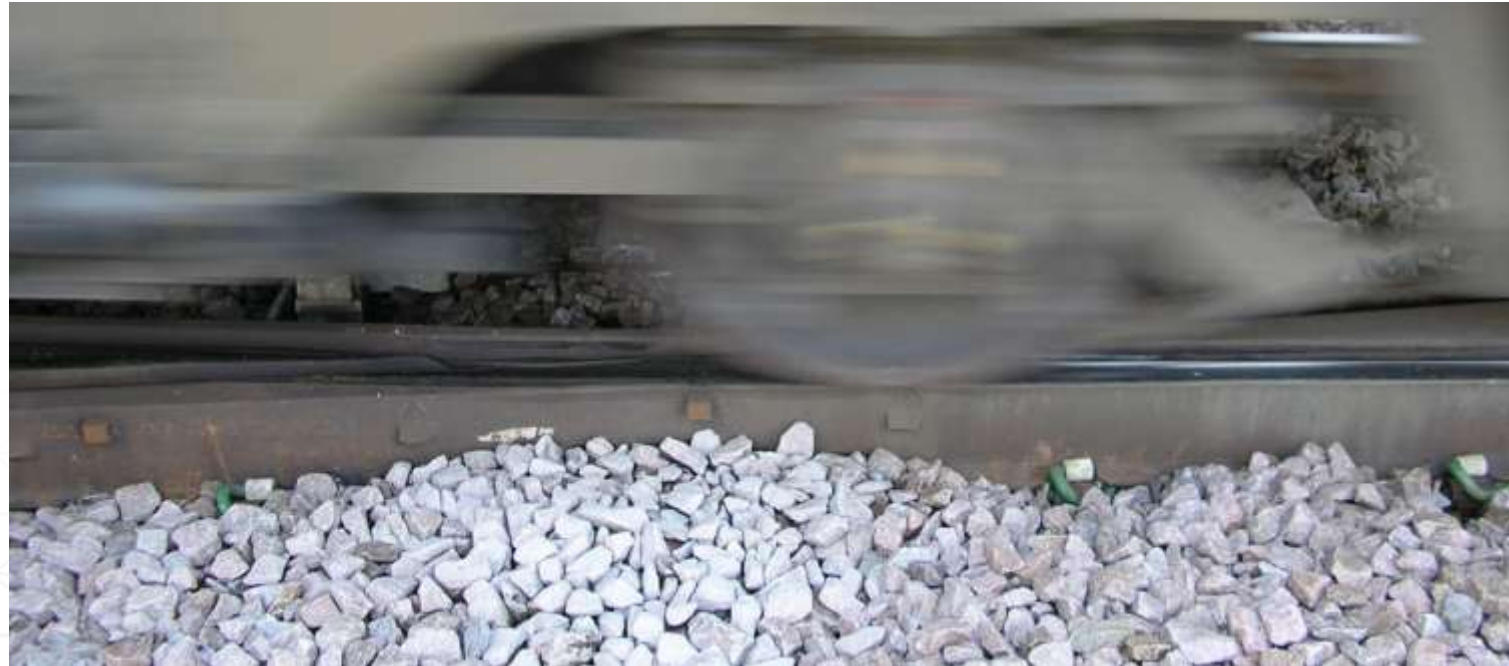
# Research and technology

*3 primary components:*

Rolling  
Stock

Track

Support  
Conditions

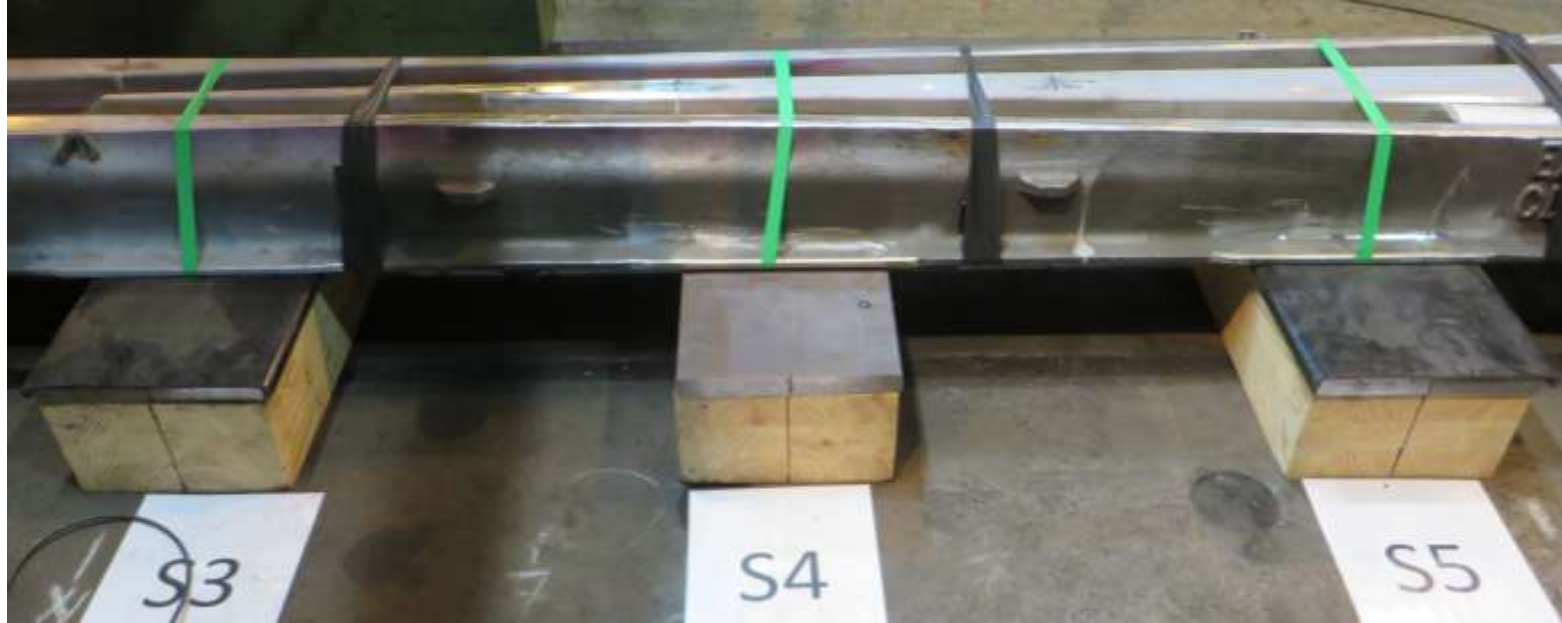
## *Voiding*

- Voiding scenarios
  - Remove 5mm EVA pad
  - Select supports
- Base design:
  - 'as designed' support conditions
  - No voiding present

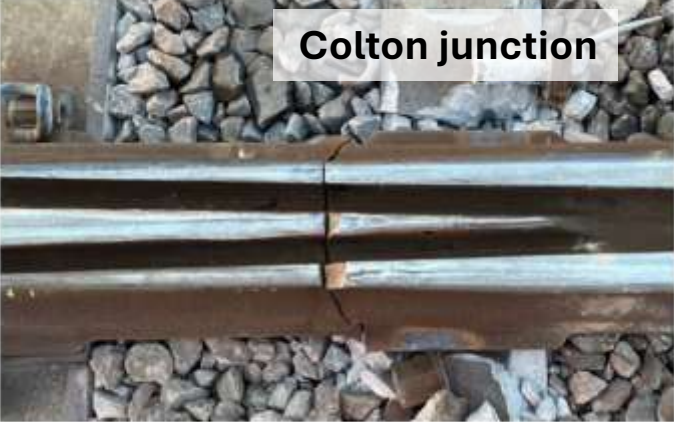
**Colton junction**

A track has broken on the major line (Image: LNER)

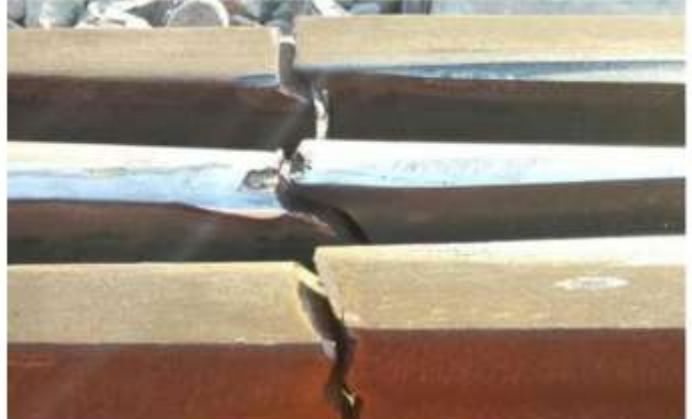
DAMAGE: THE BROKEN RAIL NEAR EAST CROYDON STATION  
NETWORK RAIL
