# Gipsy Patch Lane

PWI Briefing

2<sup>nd</sup> December 2021

**Gypsy Patch  
Bridge**

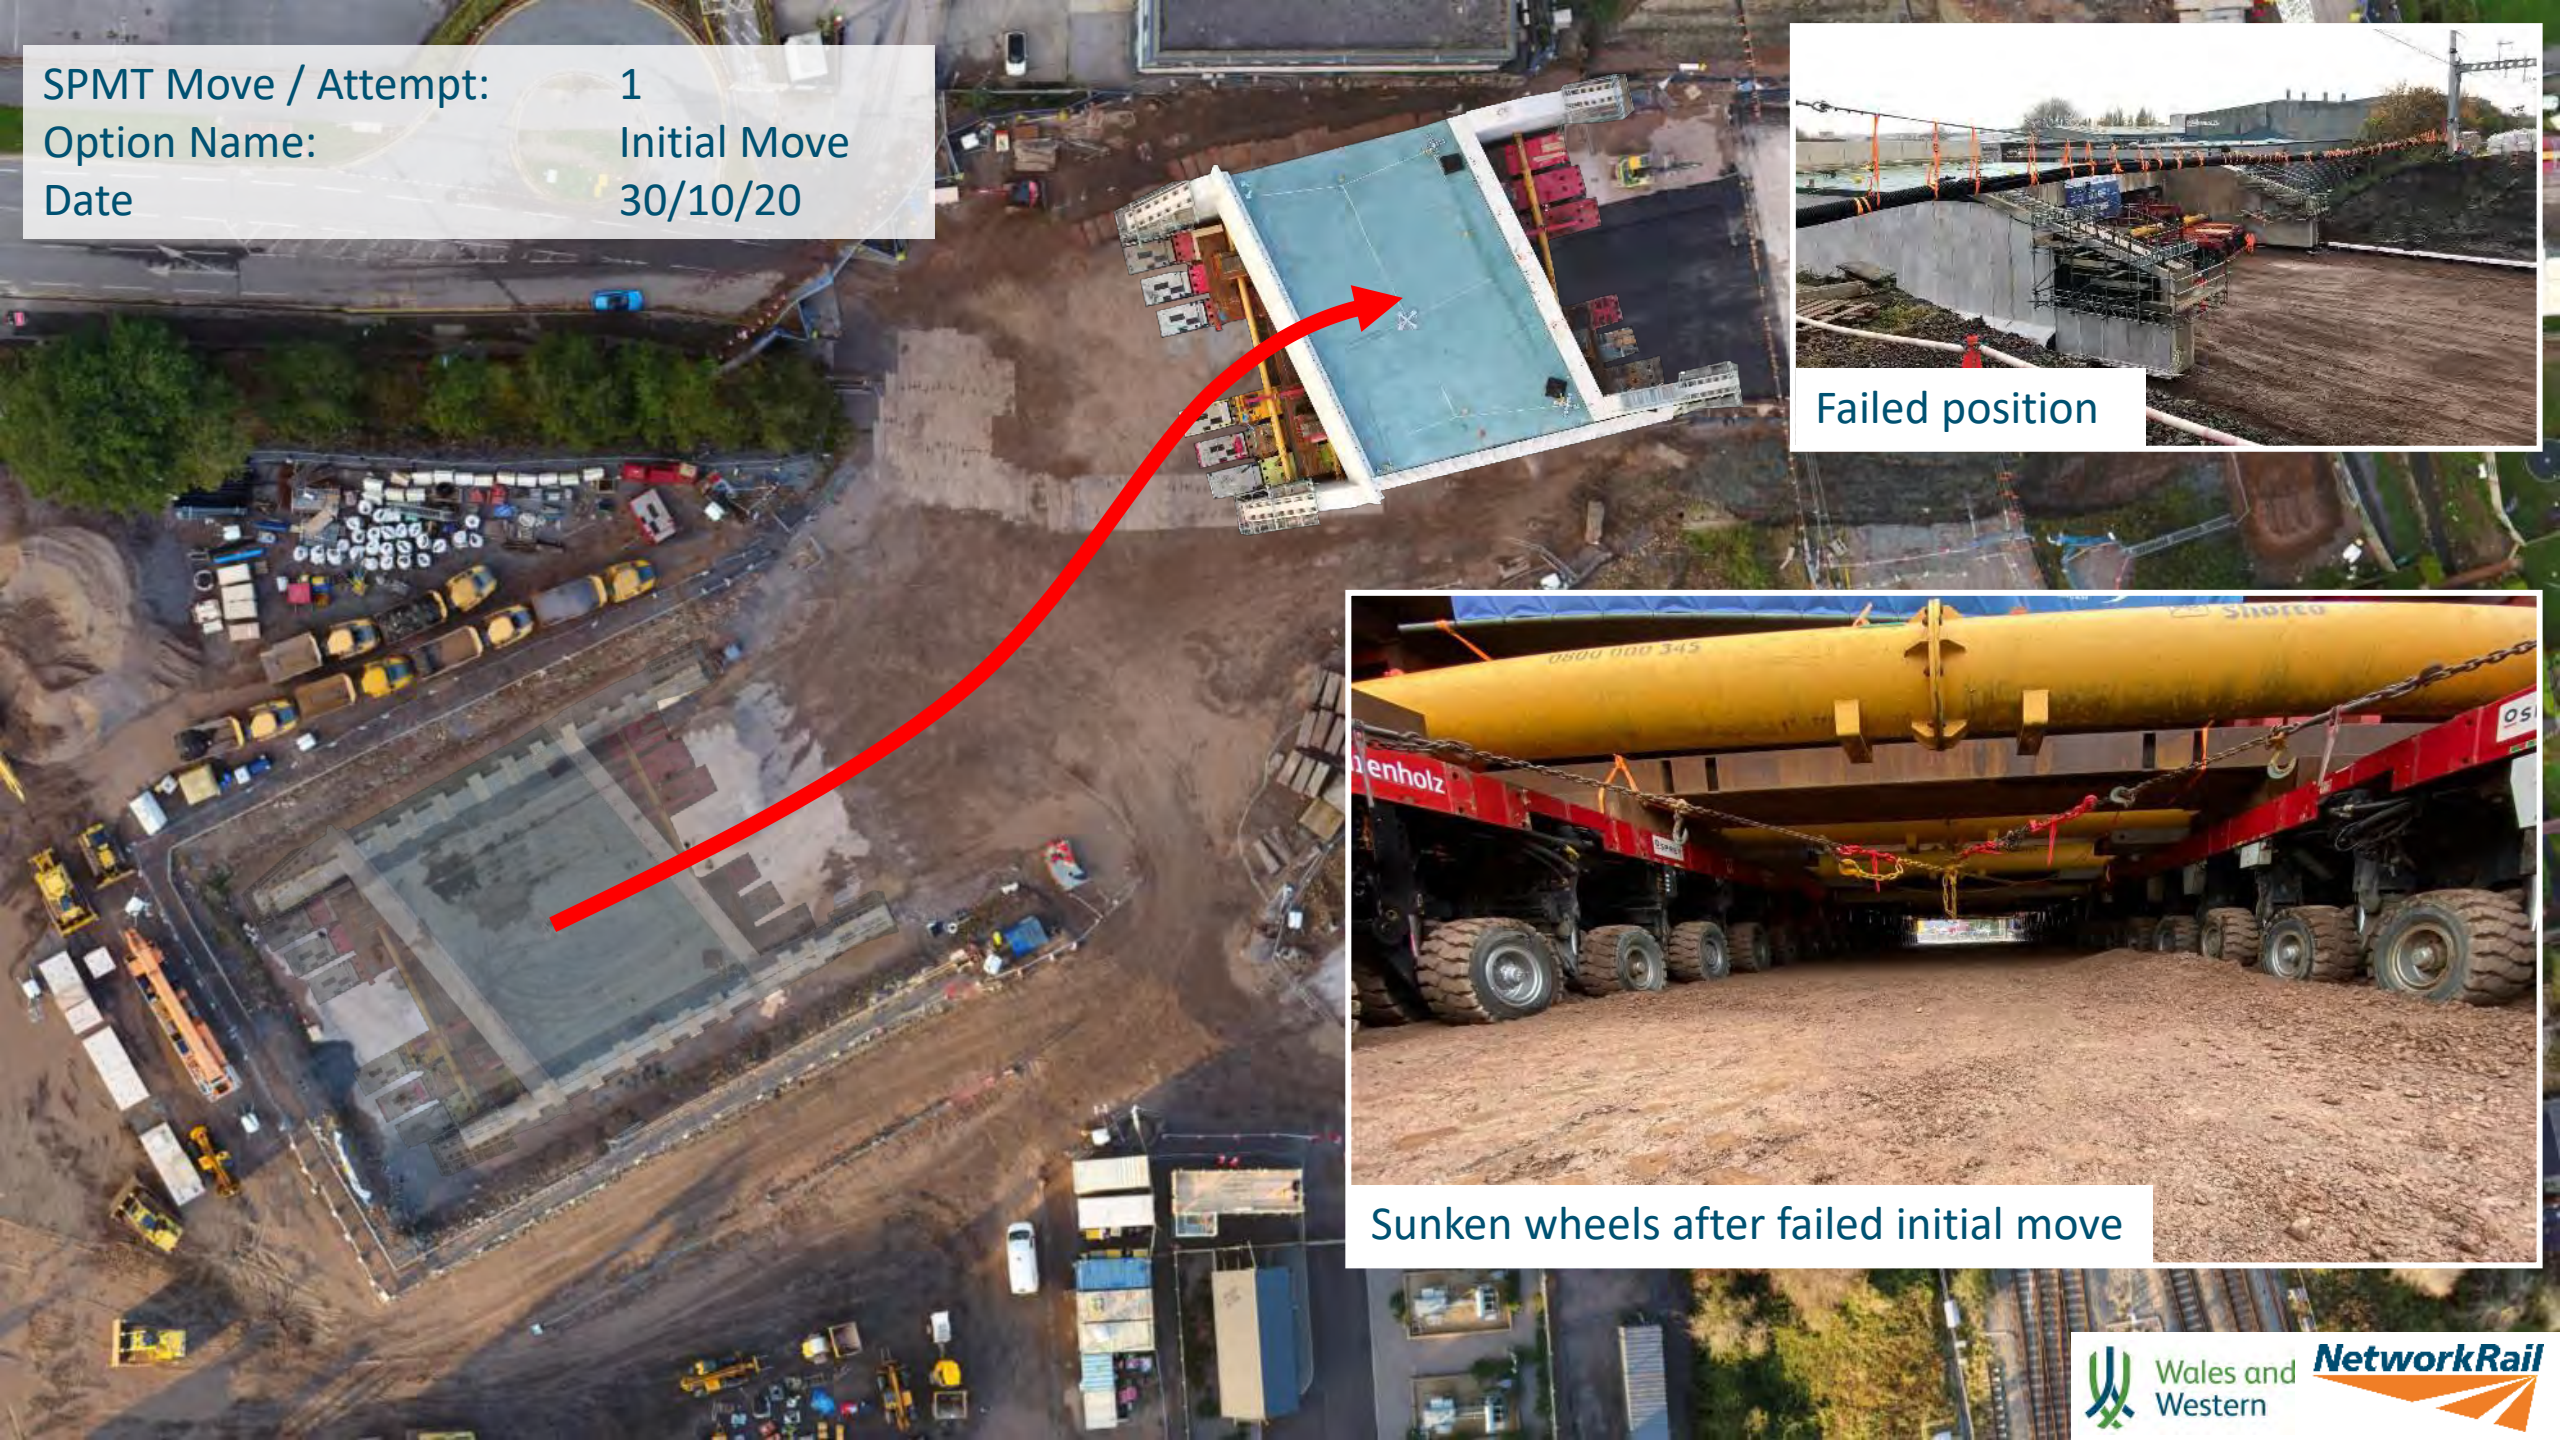
SPMT Move / Attempt: 1  
Option Name: Initial Move  
Date: 30/10/20

Failed position

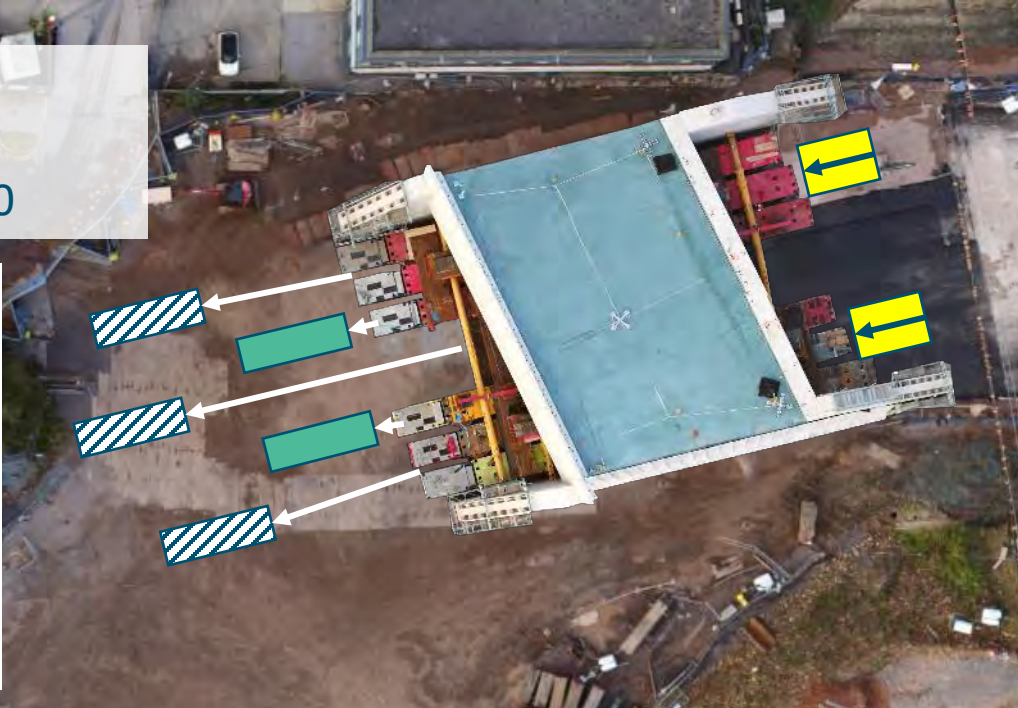
SPMT Move / Attempt: 2  
Option Name: A/B  
Date: 31/10/20

Plan A – Using just SPMT  
Plan B – Using push / pull aid

Opted to go straight to plan 'B'  
due to the risk of attempting A  
and digging all the wheels again  
Attempt failed to move

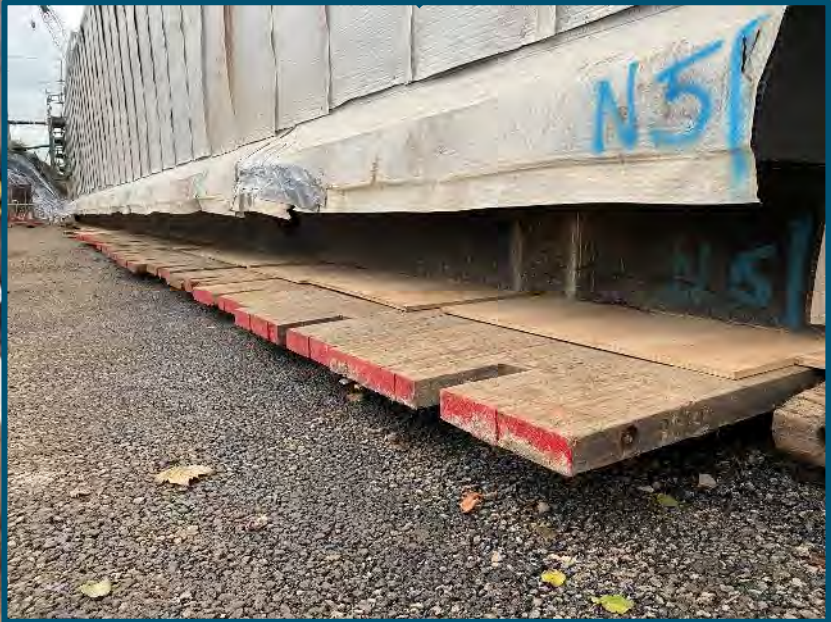
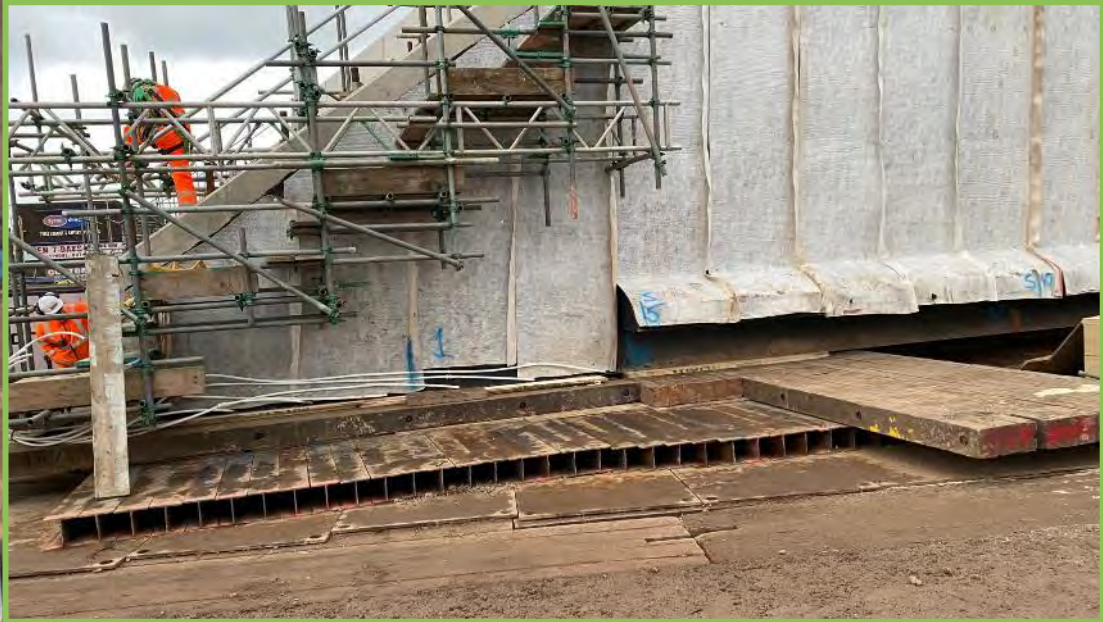
Temp Works Installation & Lower Bridge  
Option Name: Option 1  
Date: 11/11/20

Temporary works put in place to lower the bridge. Combination of ekki mats, plywood sheets (packing), steel beams and steel plates.

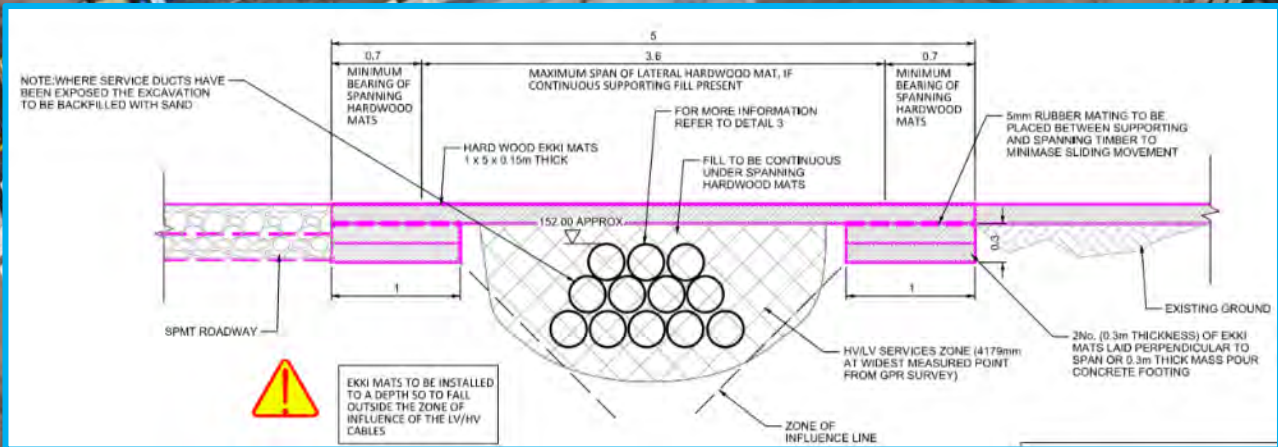
Key Constraints, once moved West:

Abutment now positioned significantly further over the buried 11kV cables, meaning a new temporary works design was required to lower the bridge (Option 1).

No clash with pile cap (NE)

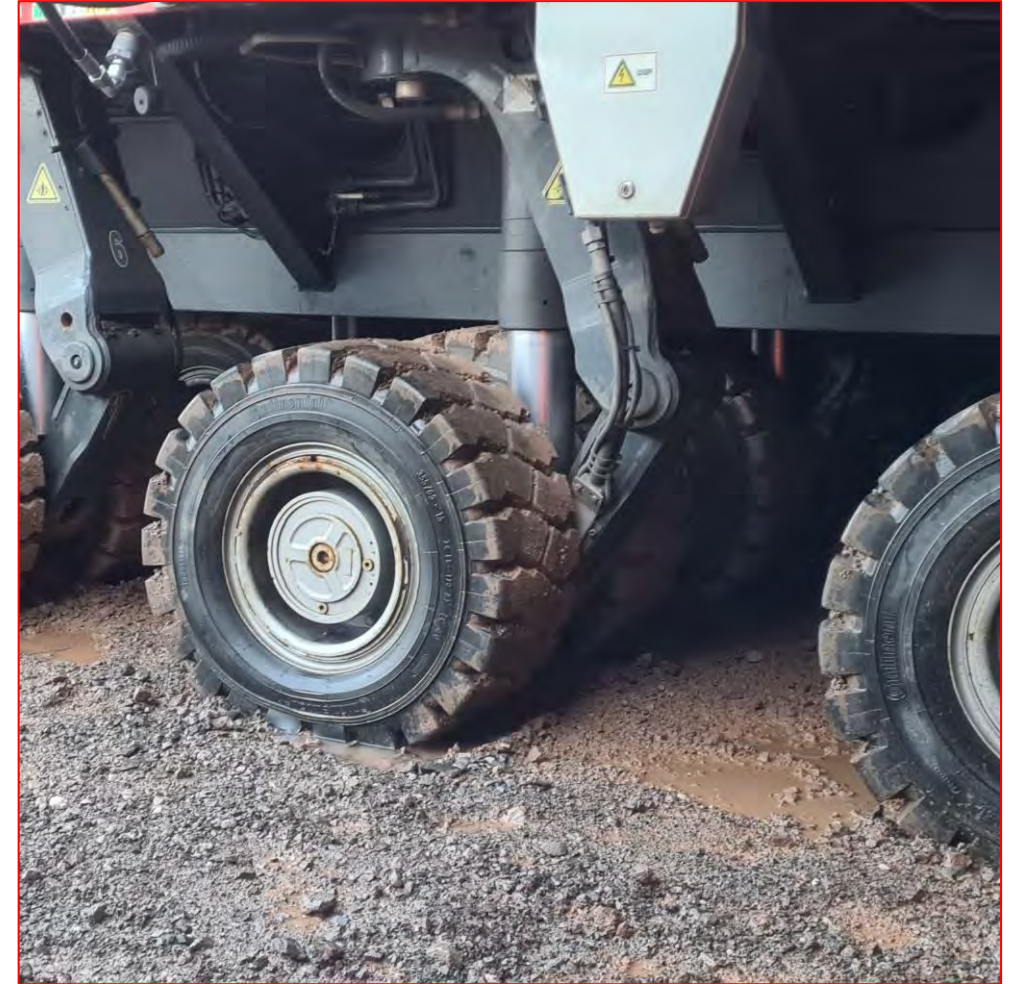
Also insufficient surface water management in place

7. Wheel turns and slewing will break up any unbound surface leading to saturation and the loss of capacity in that surface. Where wheel turns are expected, either a bound surface or surface protection (road-plates/track-mats) should be considered.

6. Should pooling/ponding or saturation occur, the designer is to be informed. Areas in question may need to be locally excavated and replaced with clean compacted fill, with appropriate testing.

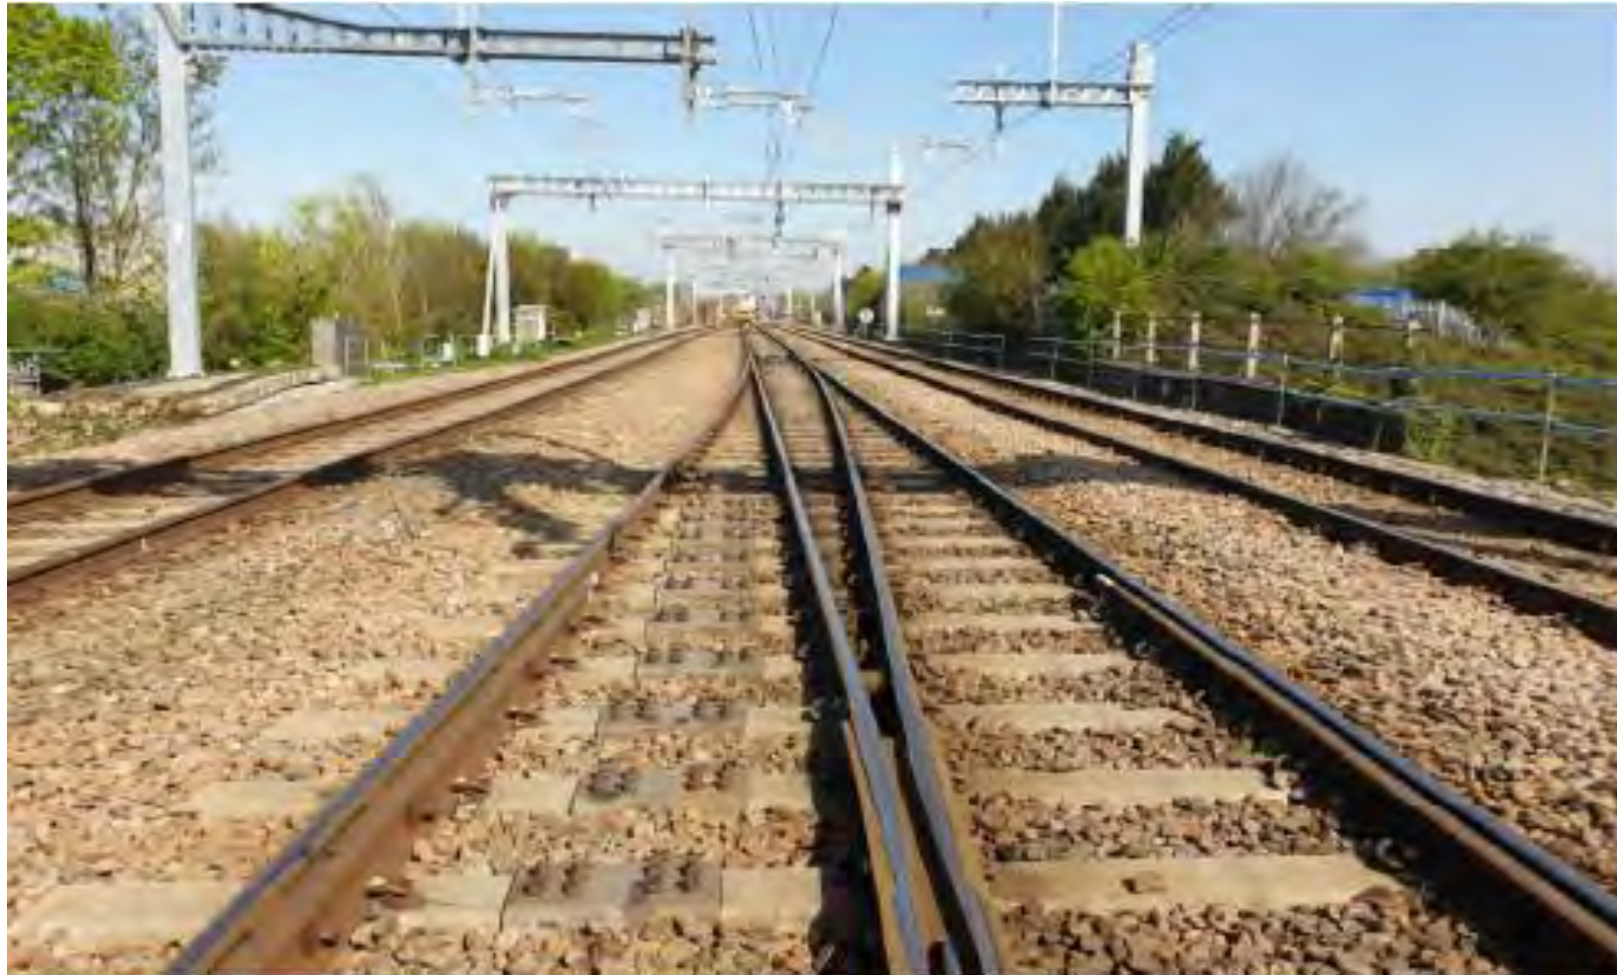
# Before – spot the complexities?

GENERAL VIEW OF POINTS 8743, SHOWING PART OF THE BRIDGE AND CROSSOVER  
3744 IN BACKGROUND (LOOKING NORTH)

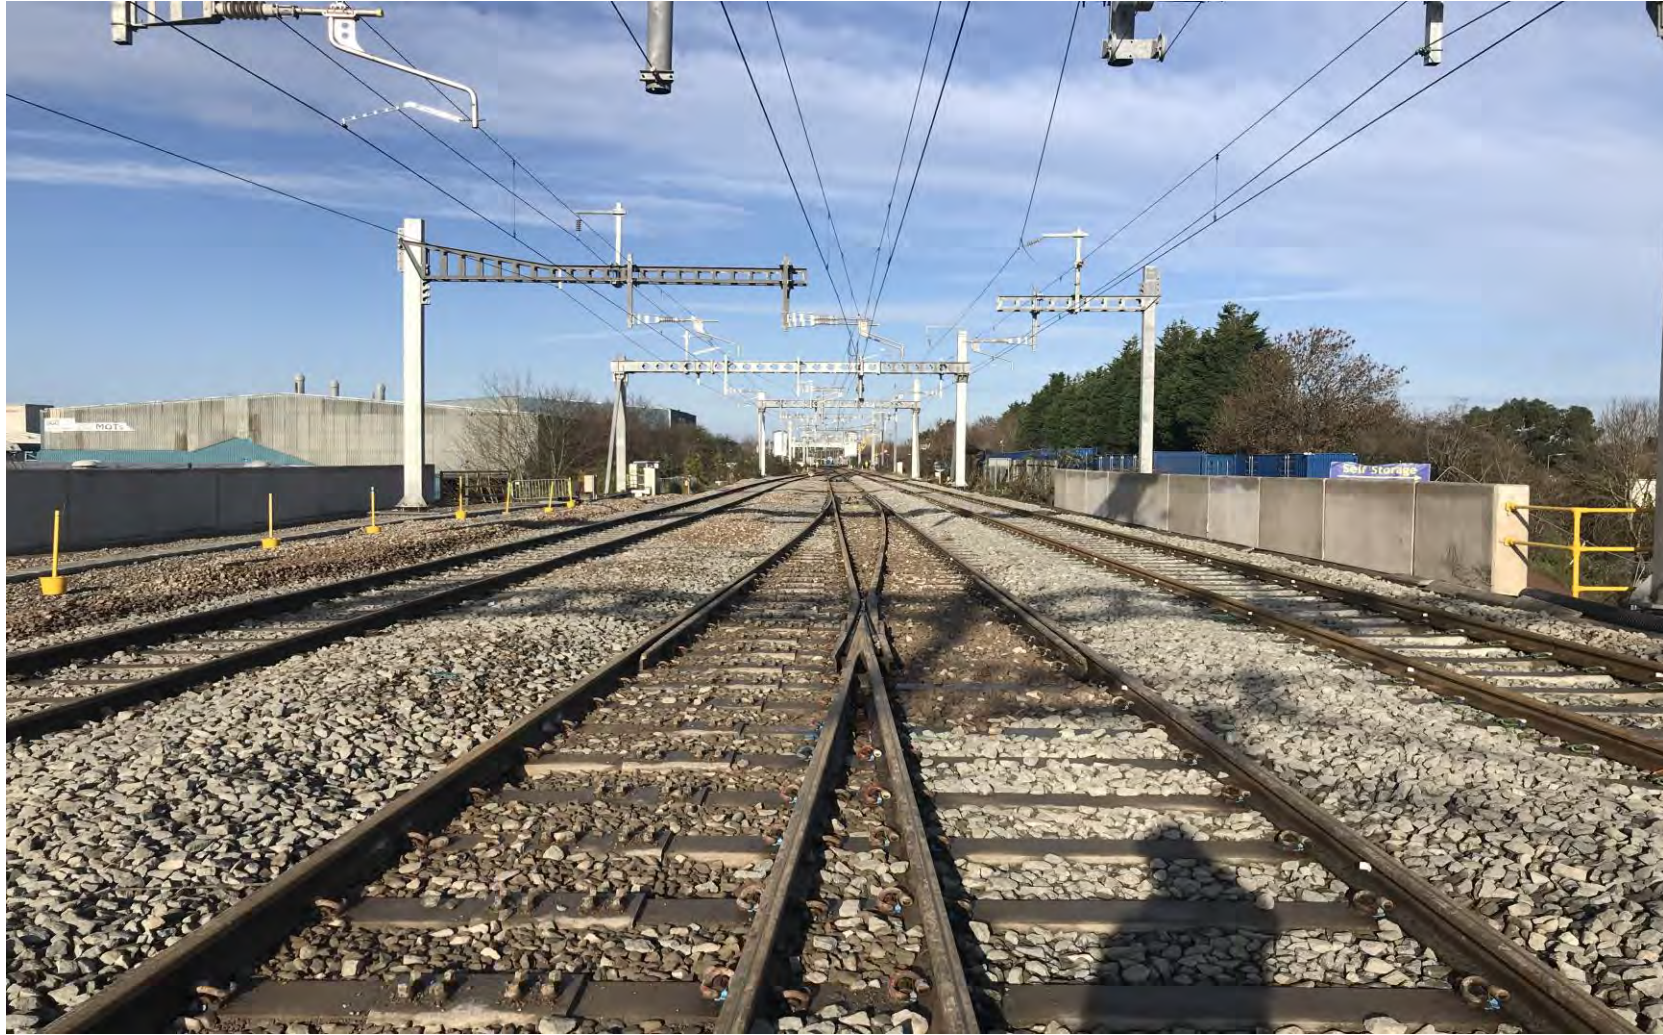
# After showing complexities

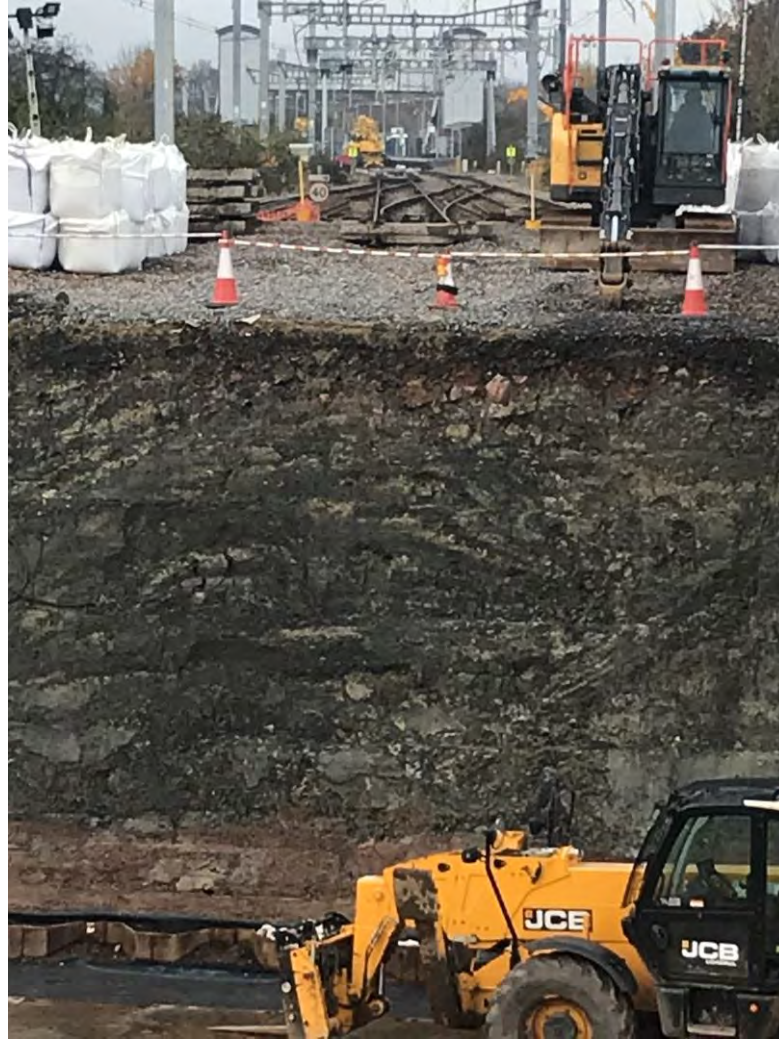
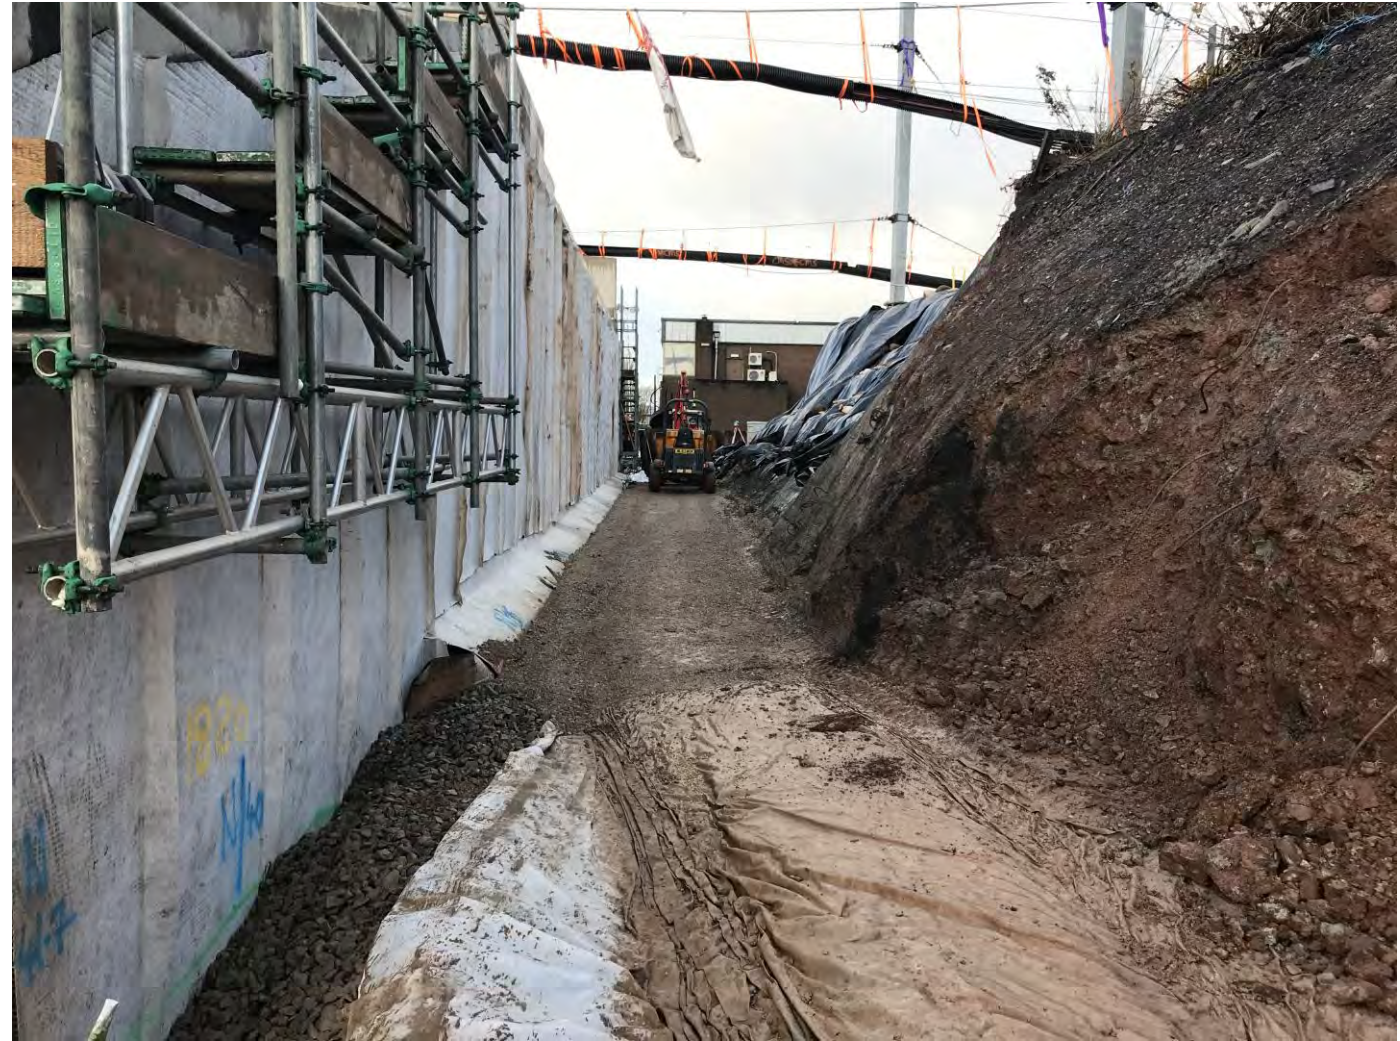
# Depth of backfill (+ EPS blocks) under Crossing

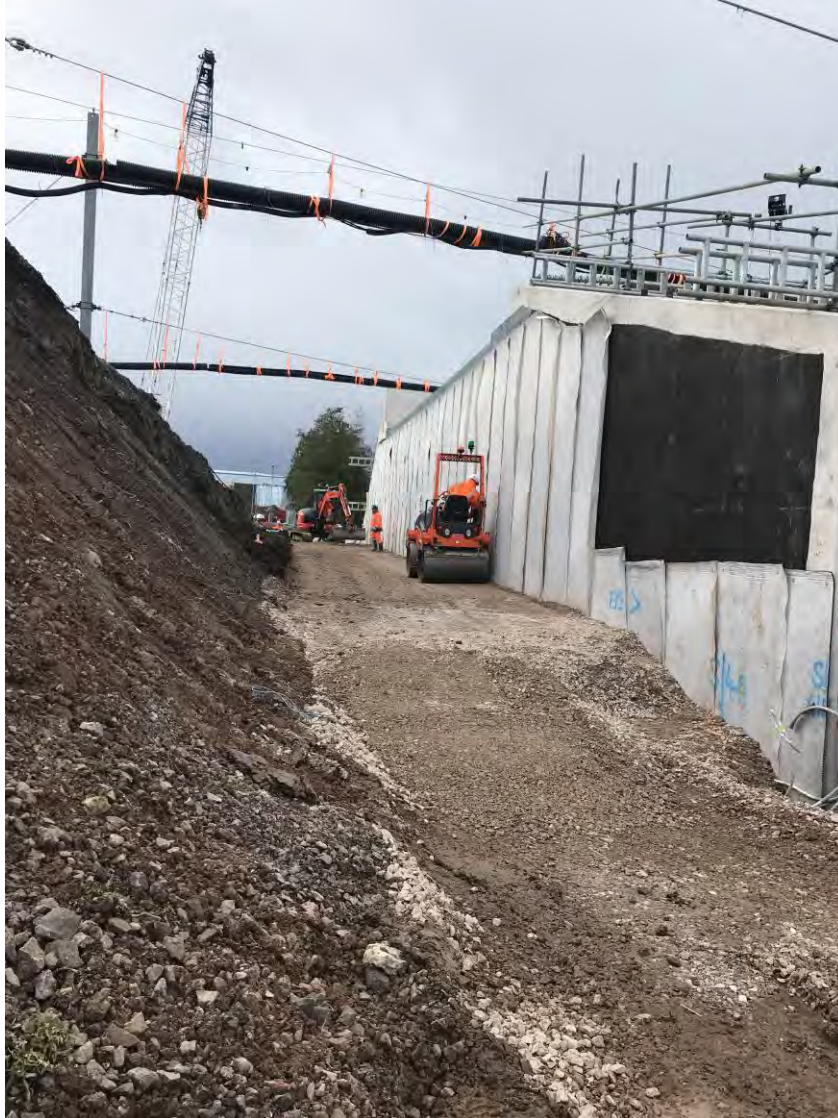
# Compacted and tested in layers

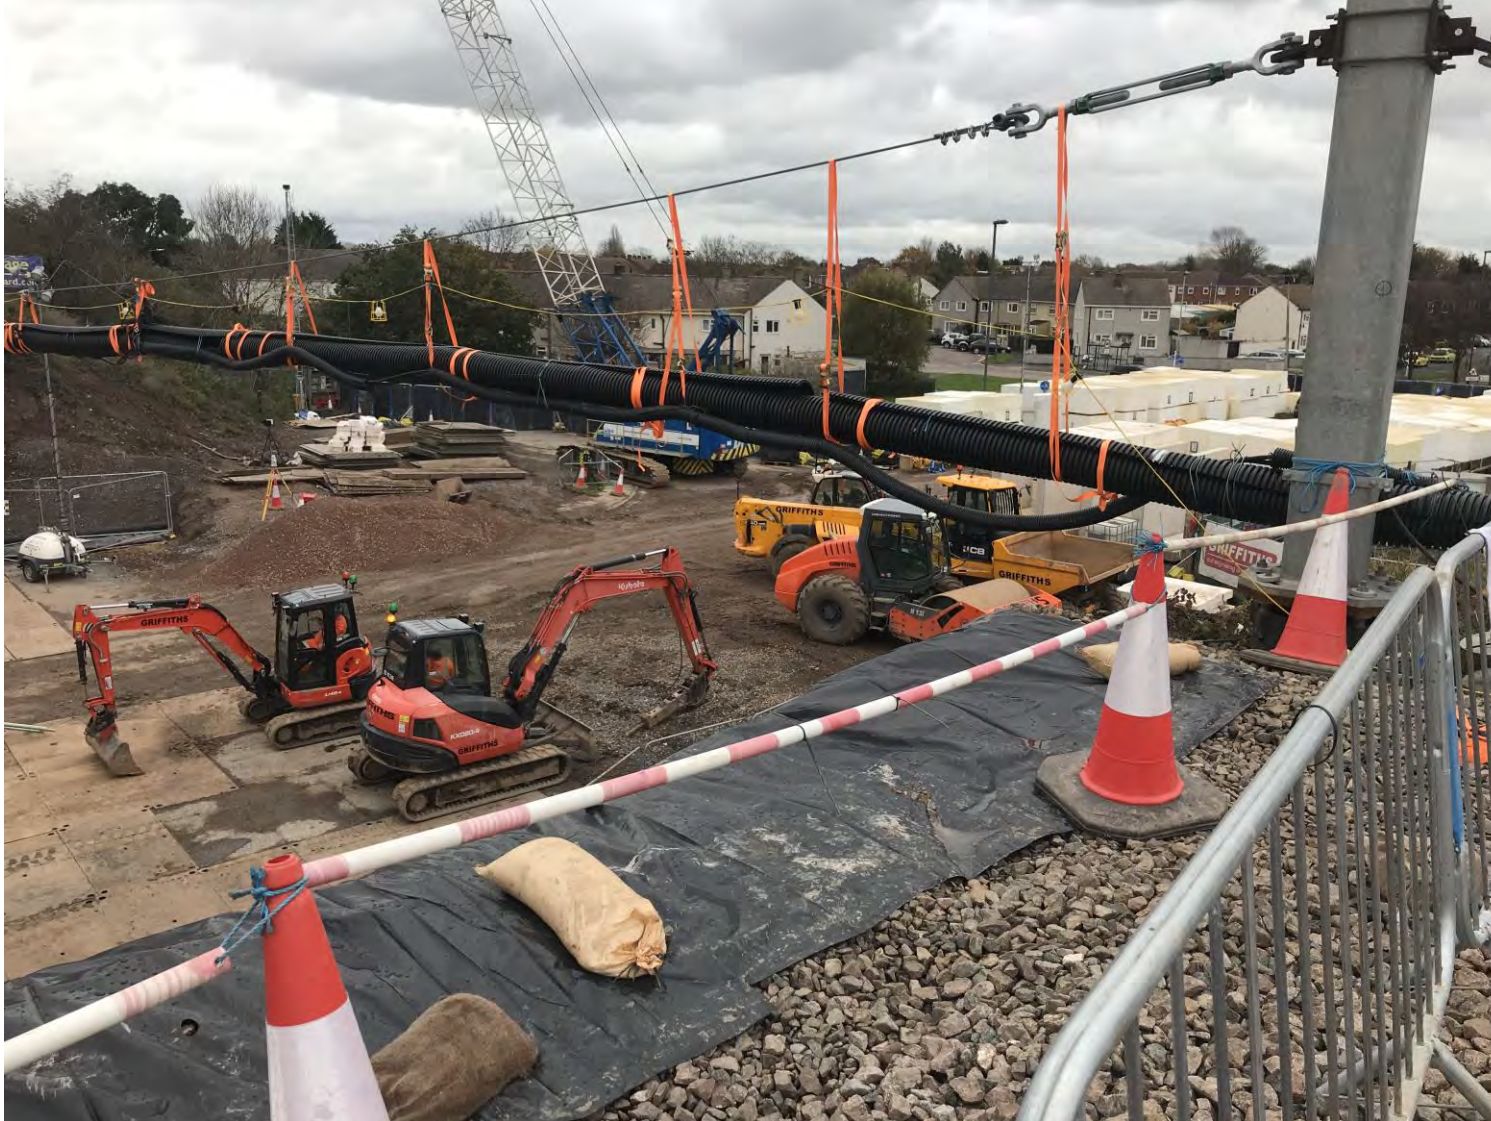
# Suspended cables both sides of structure

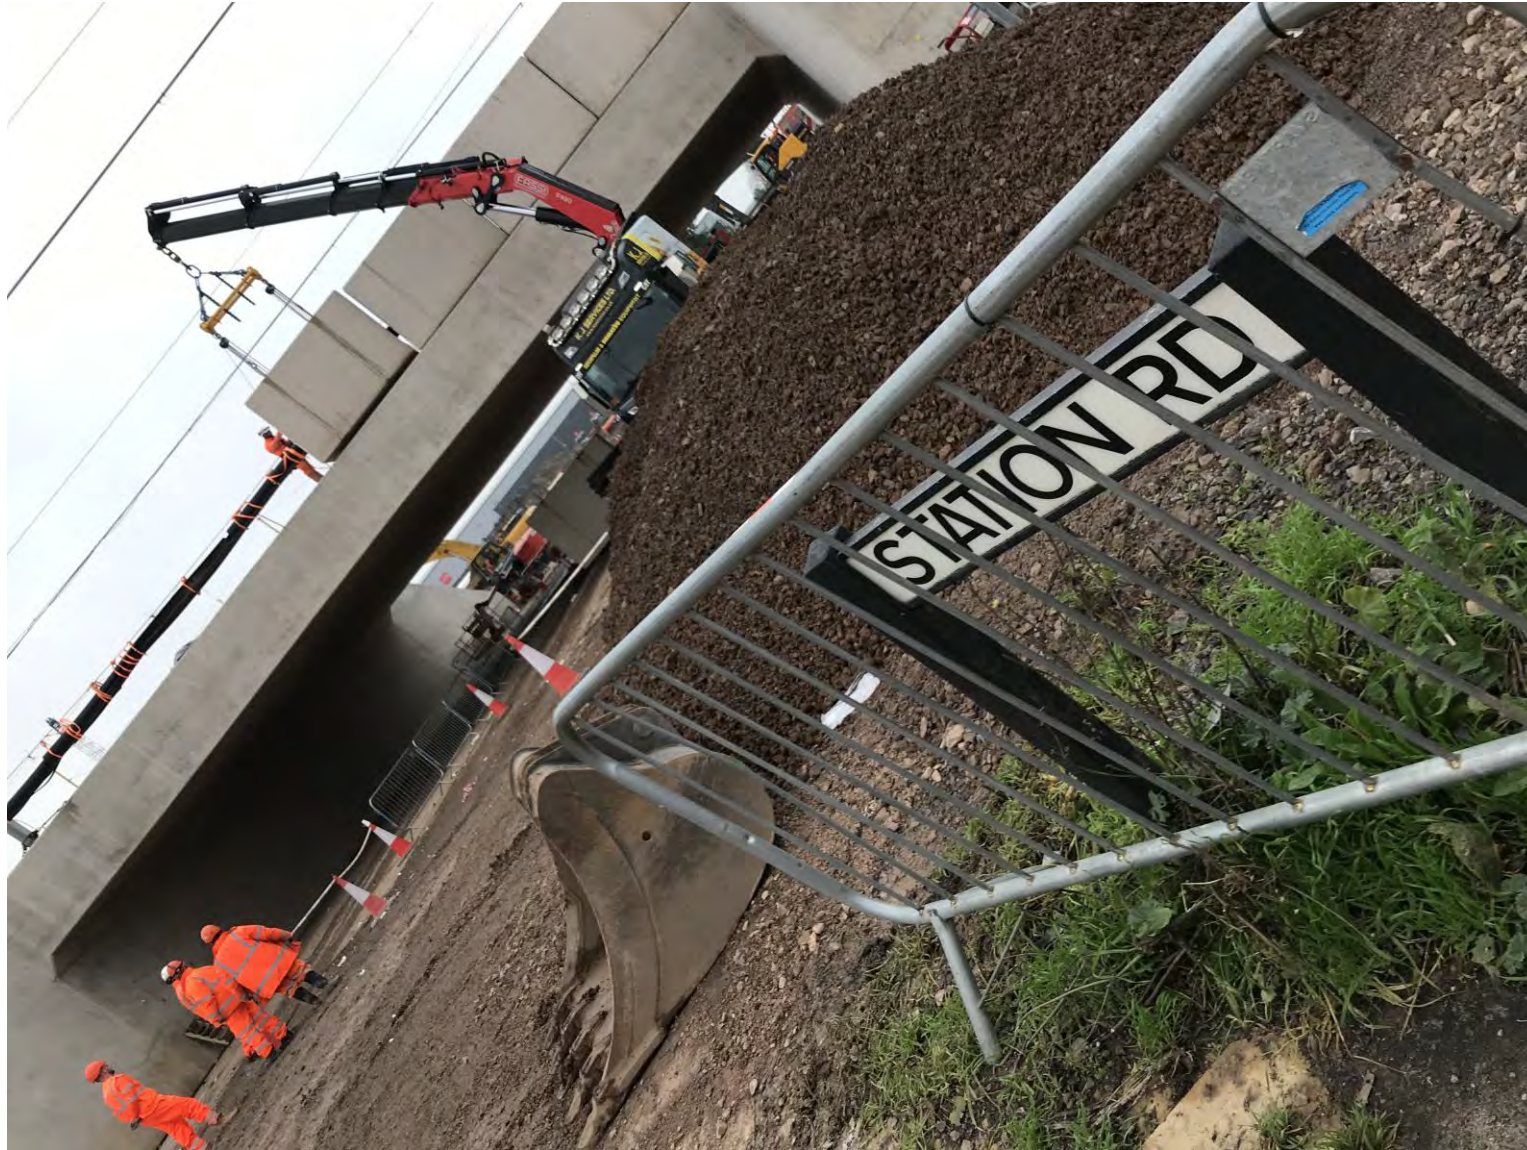
# Parapet installation around cables
