# Wide Gauge Derailment Risk

TME Conference

Chris Fuller / Rich Gibson / Andrew Turner

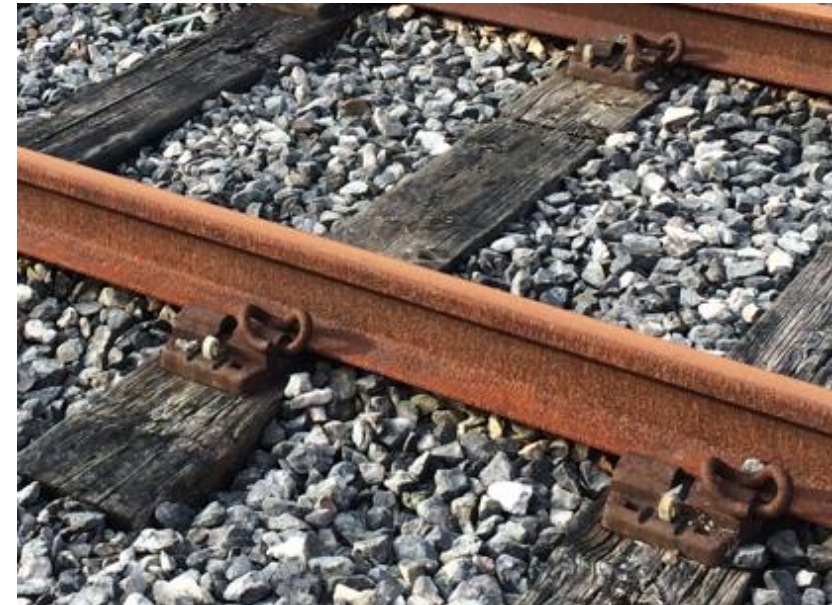
- Ineffective wood sleepers
- Pan 8 Lockspike fastenings
- F19 sleeper SHC broken hoops
- Longitudinal bearers failure
- Timber S&C broken screws
- Concrete S&C broken screws
- Concrete S&C broken housings

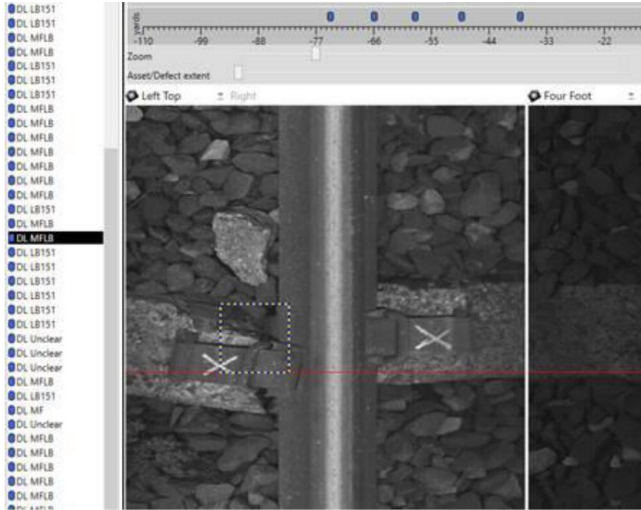
Can identify missing clips / broken hoops with missing clips

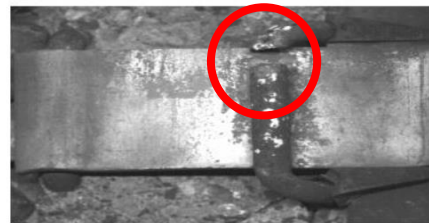
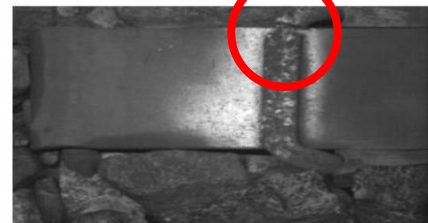
- Some examples of SHCs with a 'Defective Housing' defect class from the trial that were not identified are shown in the images below

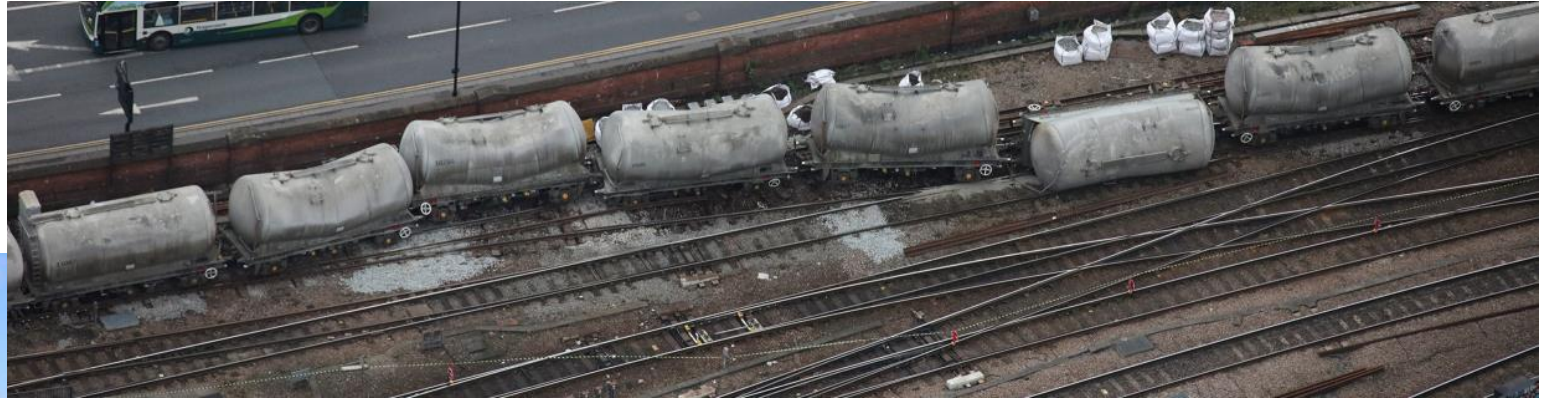
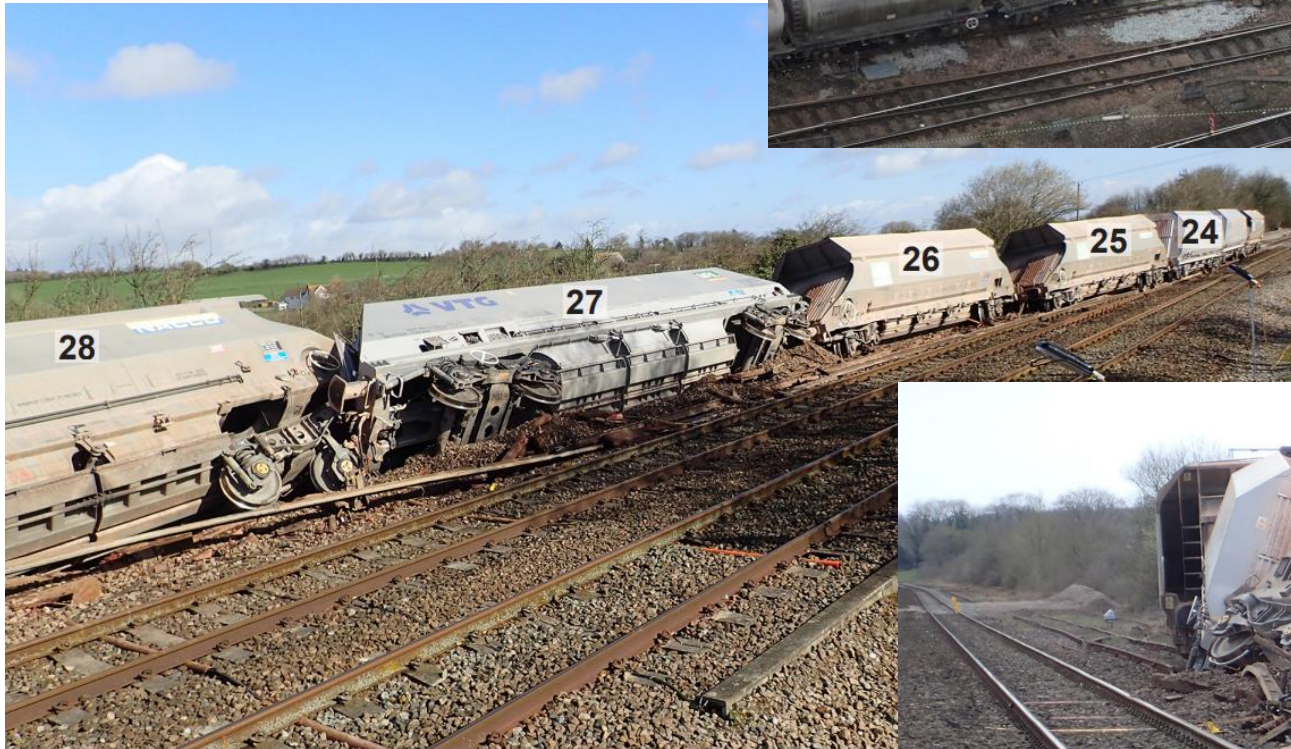
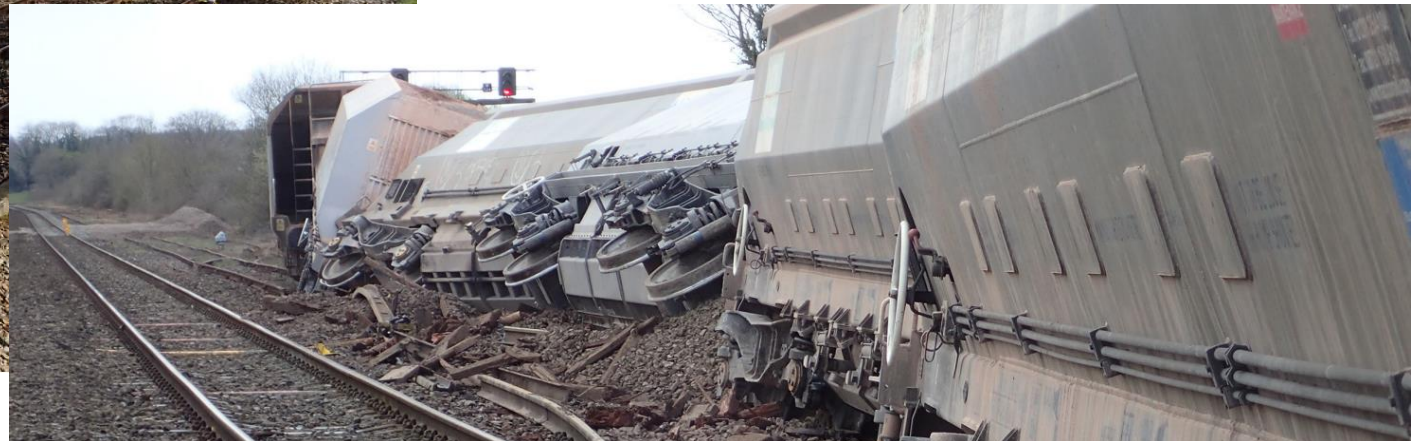
- Sheffield
- East Somerset Jcn.

# Broken Screws In Timber S&C Layouts

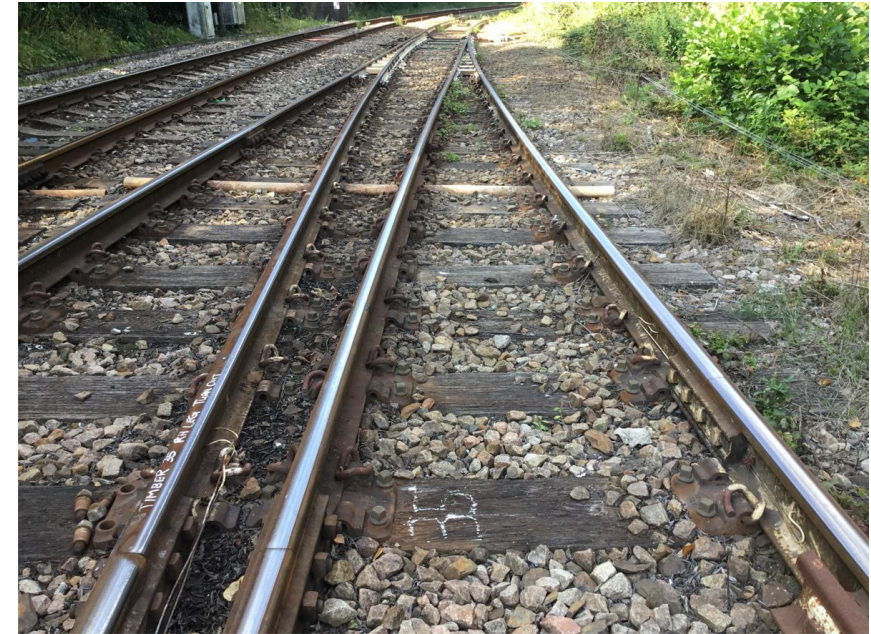
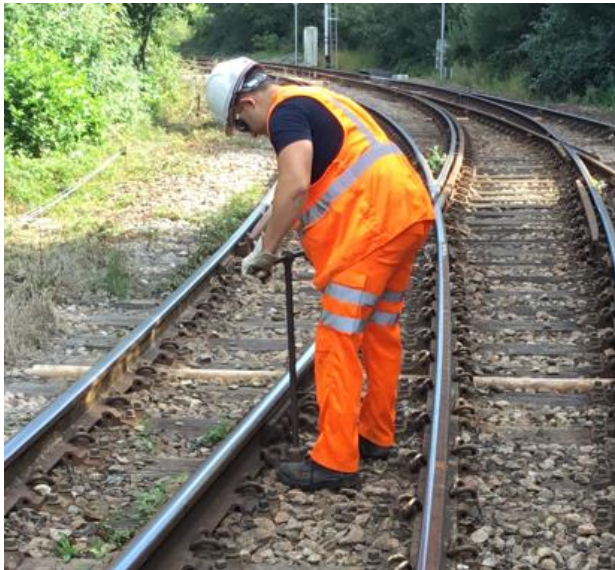
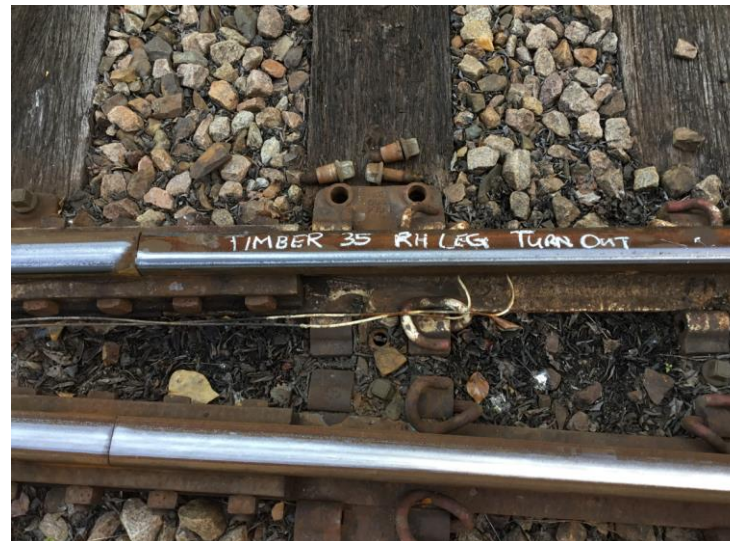
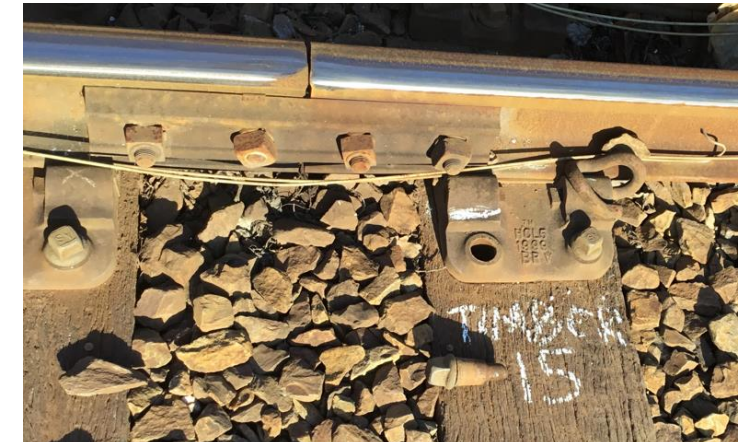
Checking screws in tight radius timber S&C

## Inspection Notice

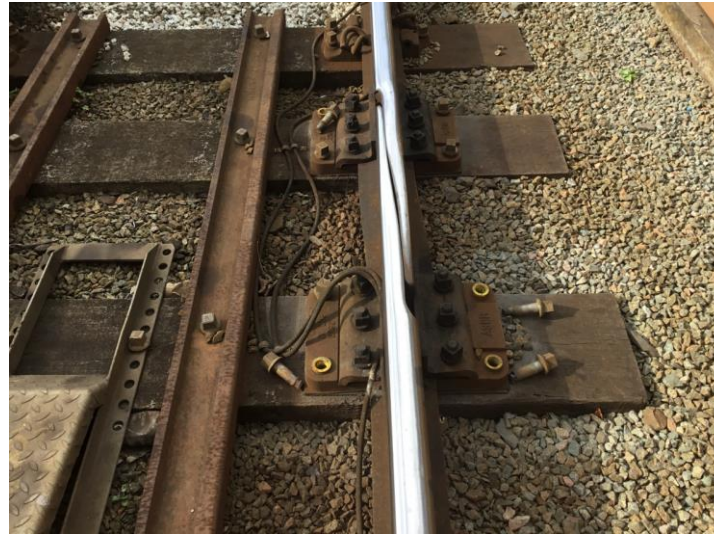
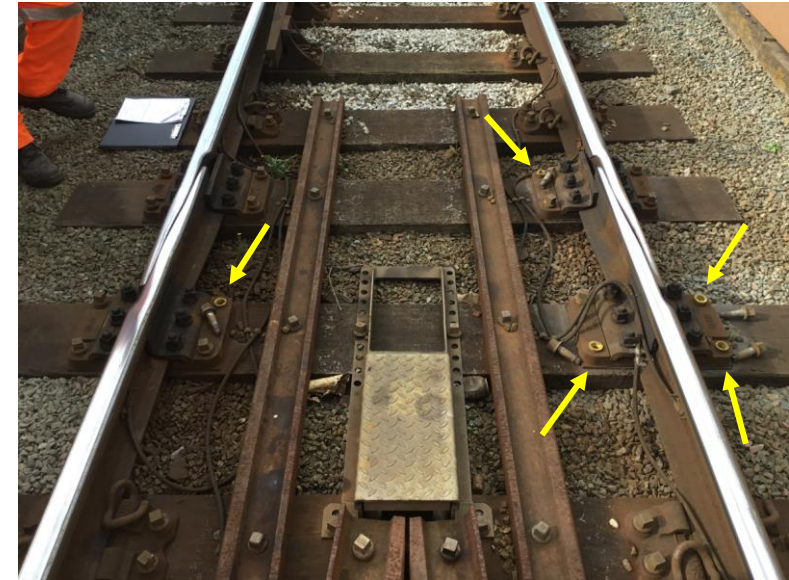
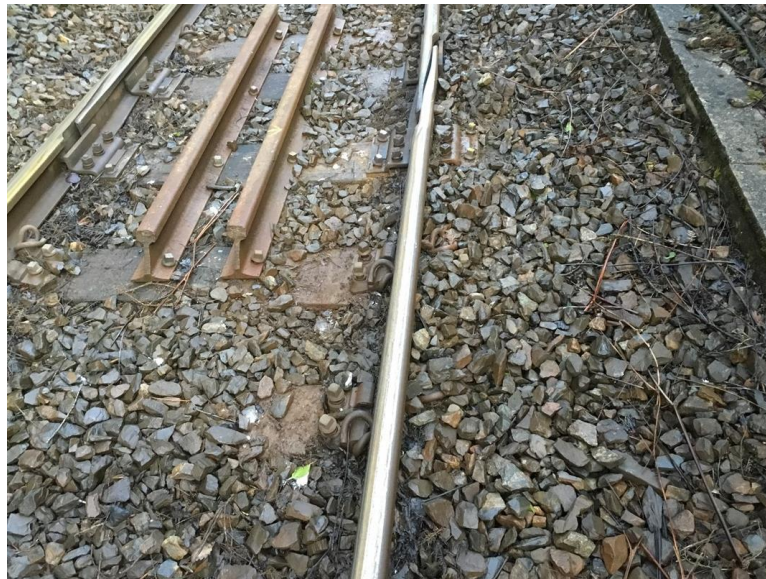
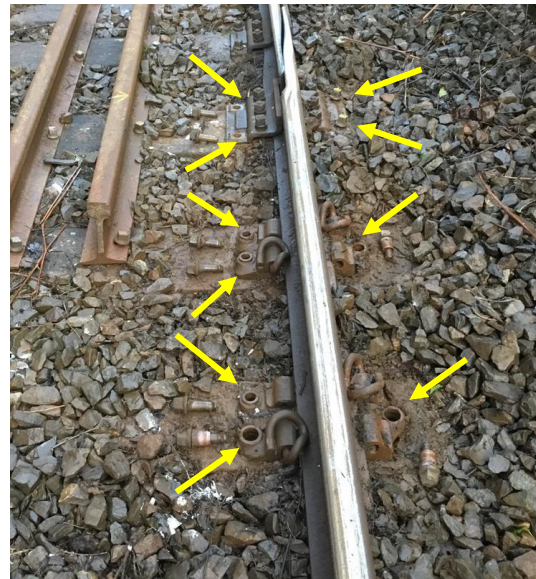
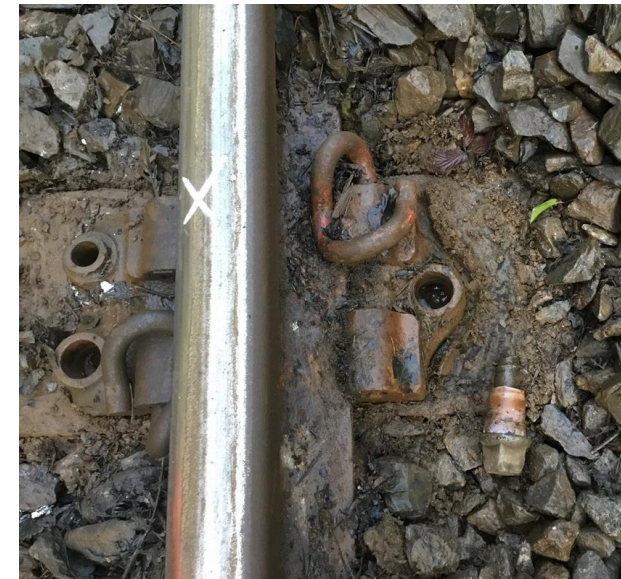
- RAB adjustment switch
- Pontsmill adjustment switch

# Broken Screws In Timber Layouts

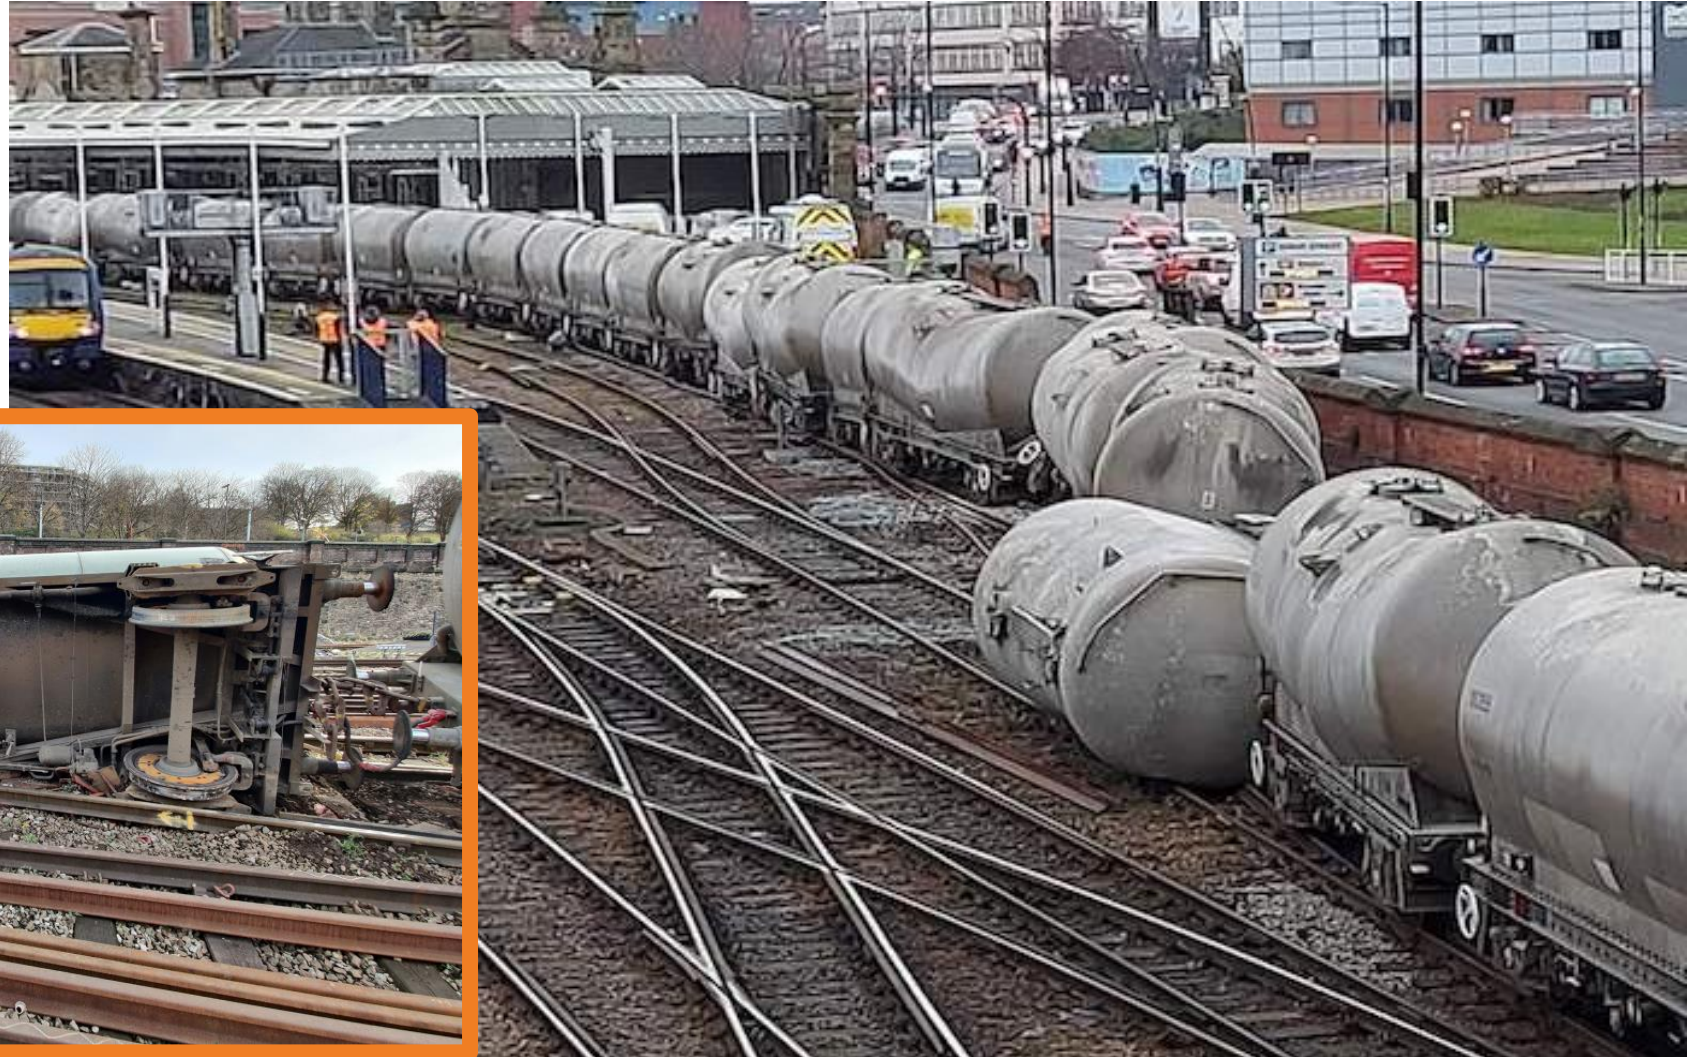
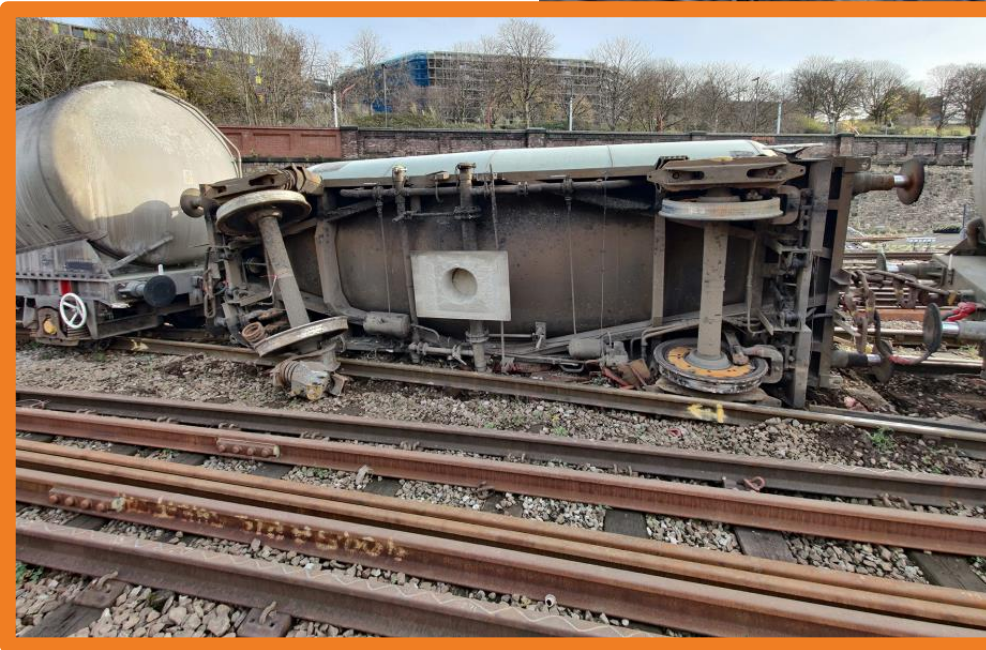
Above: Wagon BCC10756 toppled on its side

The track gauge had widened because a number of screws in the timber bearers had broken, allowing the rails to spread apart under load.

The repeated lateral loading of the outer rail under the passage of loaded freight trains led to fatigue cracking of the screws and subsequent failure over an extended period, despite the track screws being compliant with standards.

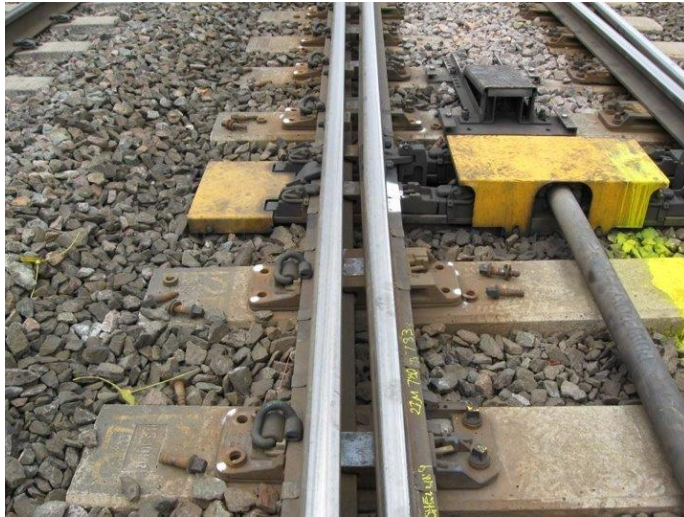
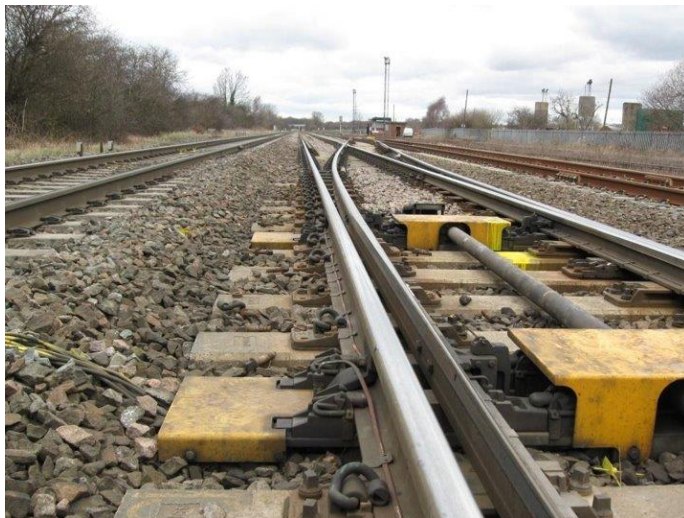
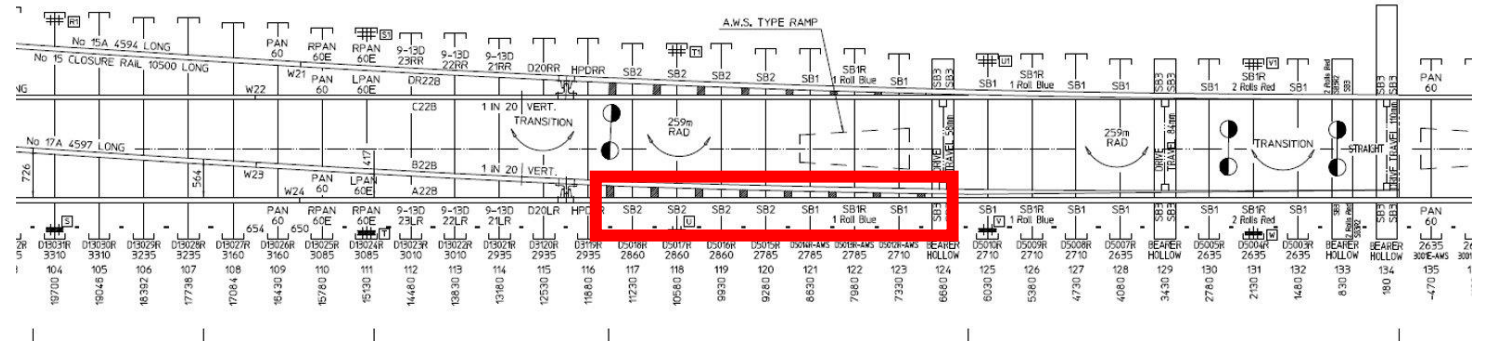
2009

# Broken Screws In Concrete Layouts - Kingsbury Junction

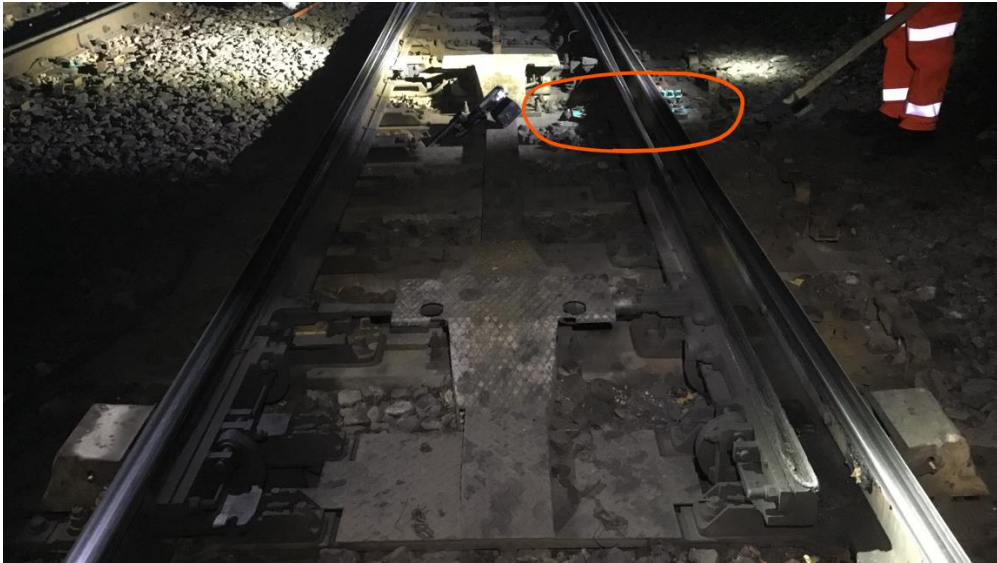
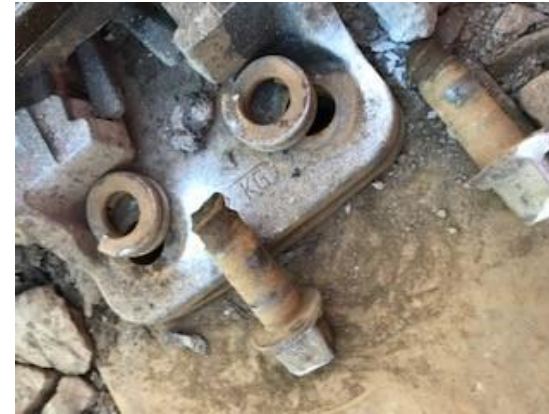
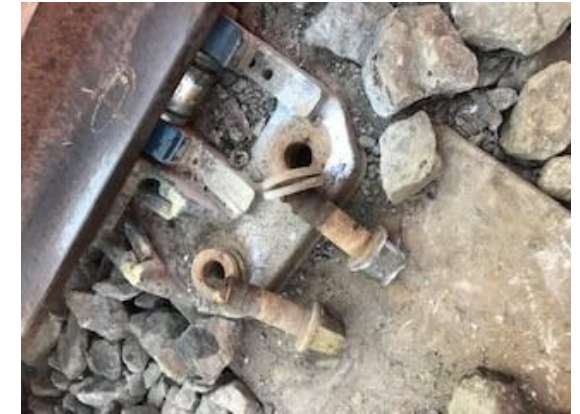
Pts 8806A

# Similar failures

## Oxford Road - Reading

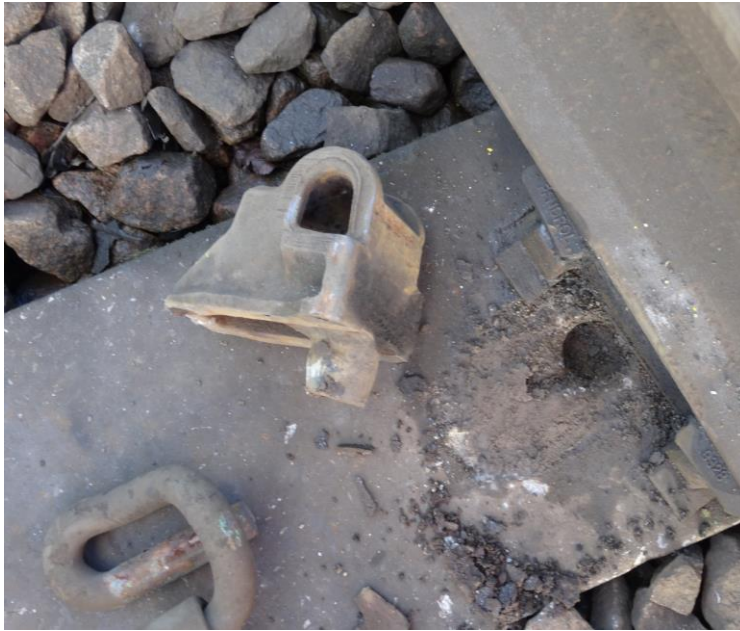
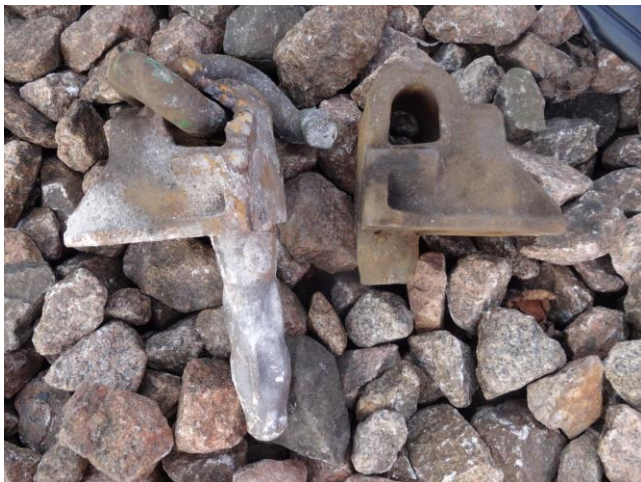
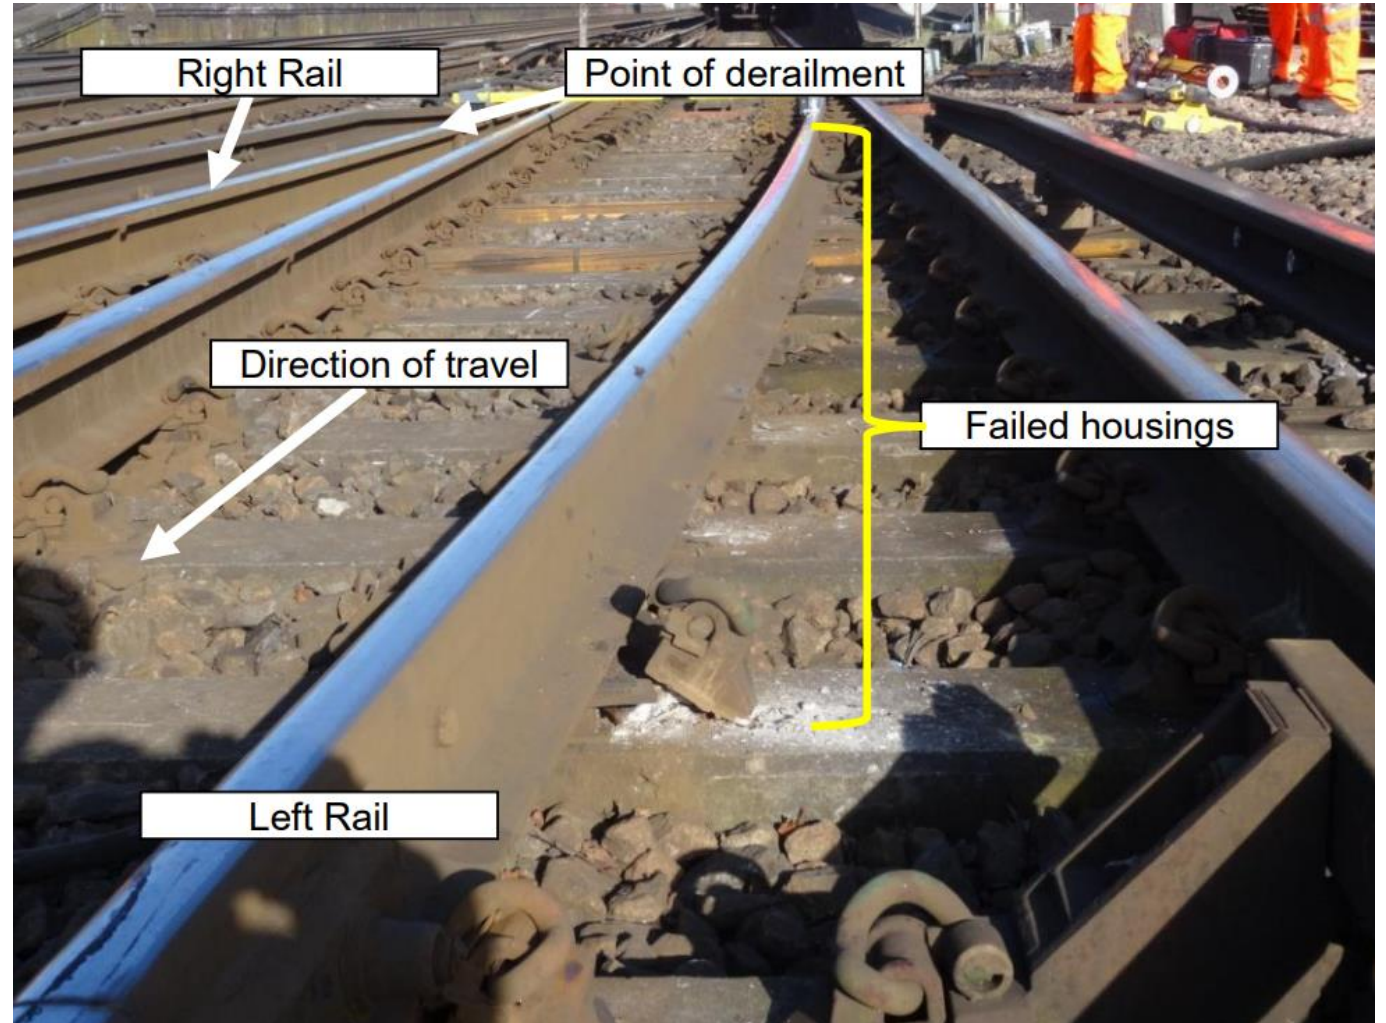
- Eastleigh 450A points
- 28<sup>th</sup> January 2020
- Balfour Beatty RT60 S&C
- Failure of elevated housings leading to gauge spread

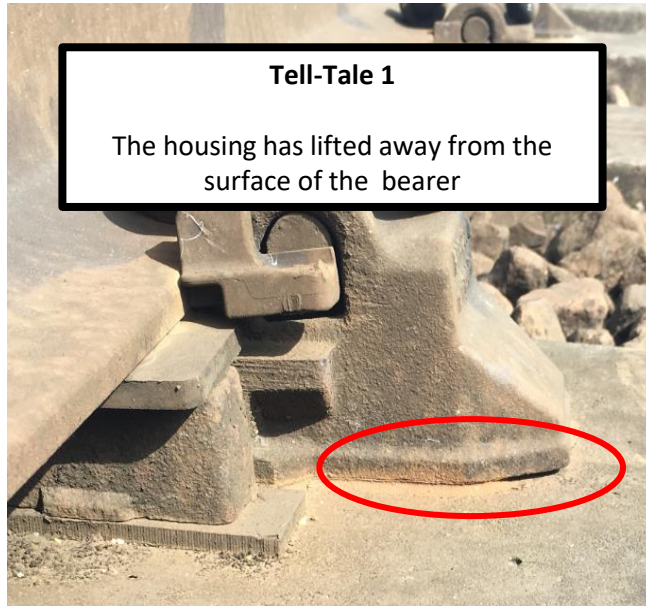
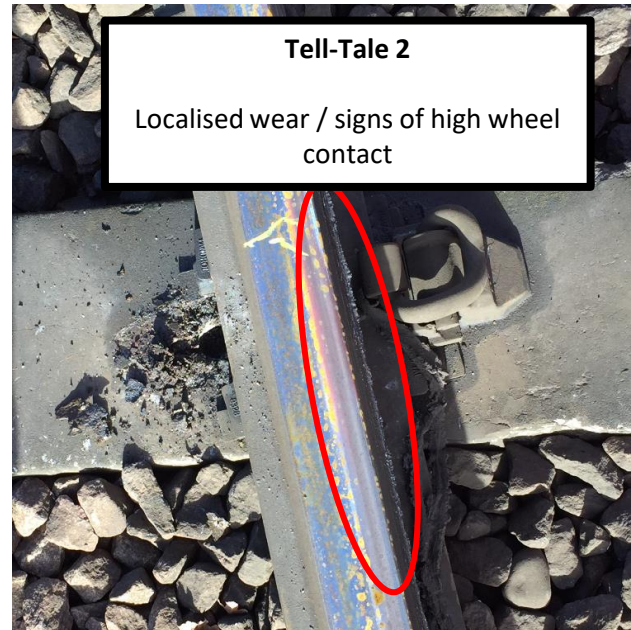
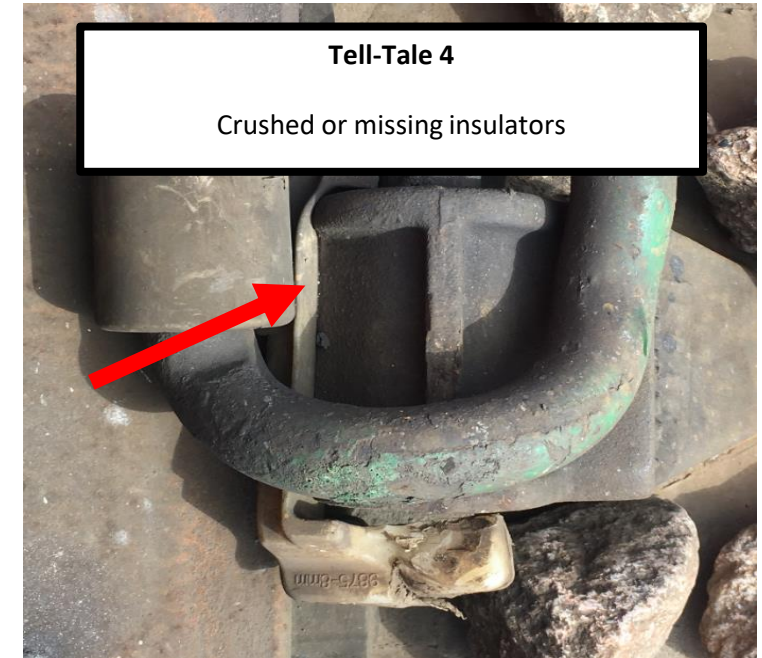
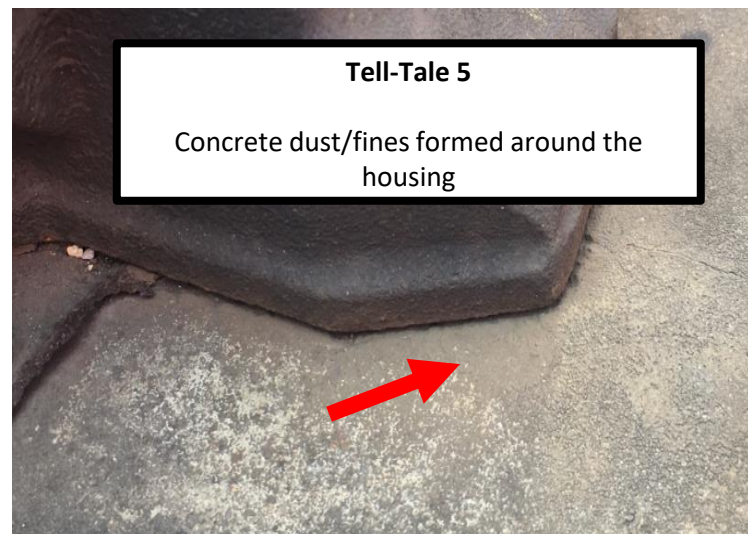
# Visual Tell-Tale Signs

Visual tell-tale signs of elevated housing failure include:

1. The housing has lifted from the surface of the bearer (see Figure 2)
2. Localised wear / signs of high wheel contact (see Figure 3)
3. Wear / gull on the rail foot where the fastening has moved away from its original position
4. Crushed or missing insulators
5. Concrete dust/fines formed around the housing
6. The housing is rotated relative to the foot of the rail
7. The bearer rebar has retreated inside the bearer (indicative of a loss of pre-stress)

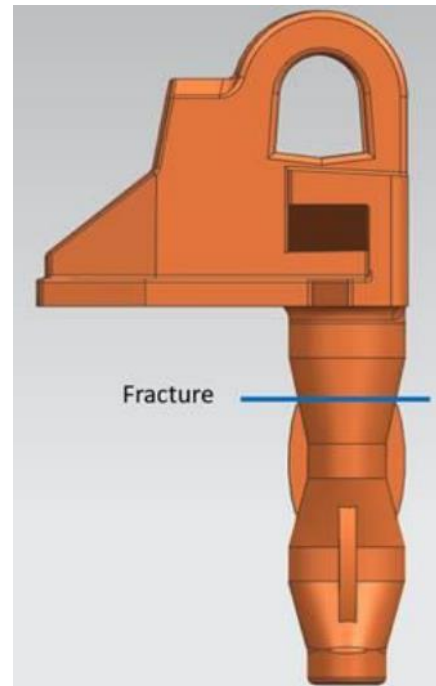
Existing design

FEA conducted on existing design in an attempt to emulate current failure modes

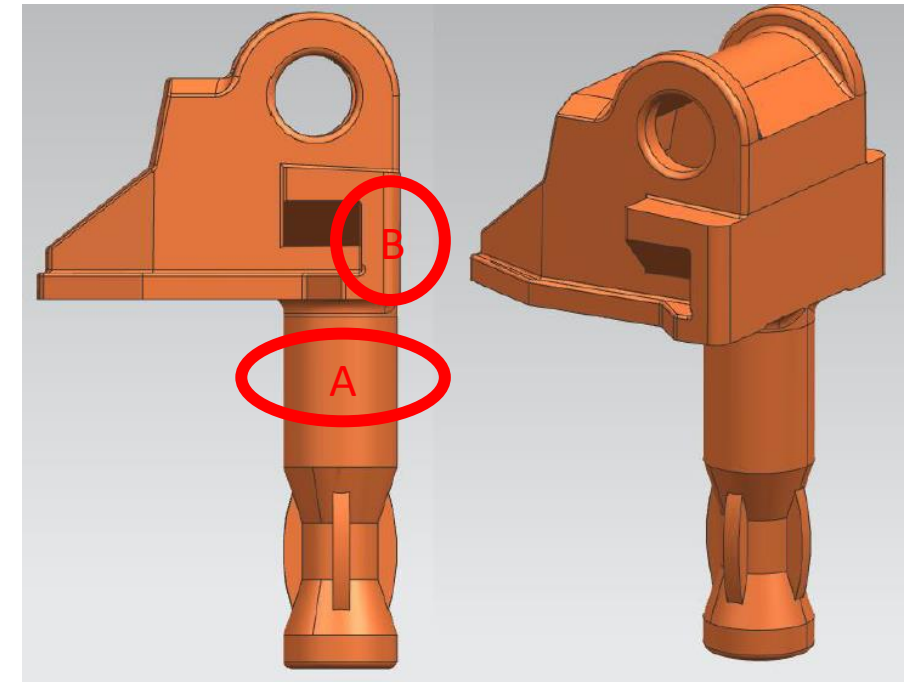
Proposed new design, including:

- A. Movement of anti-rotation features away from the peak stress zone
- B. Wall thickness increased, raising overall stiffness of the stem

Chosen modifications will be prototyped and mechanically tested before implementation in rail

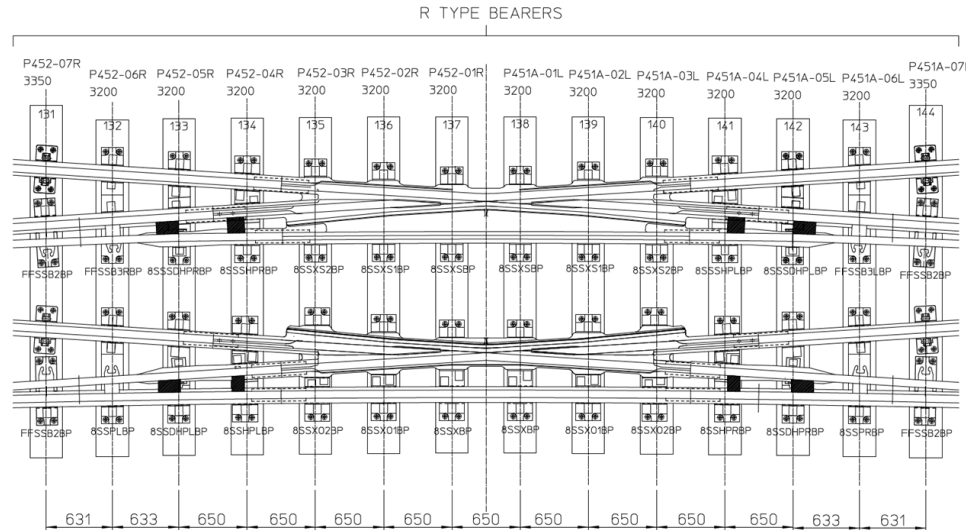
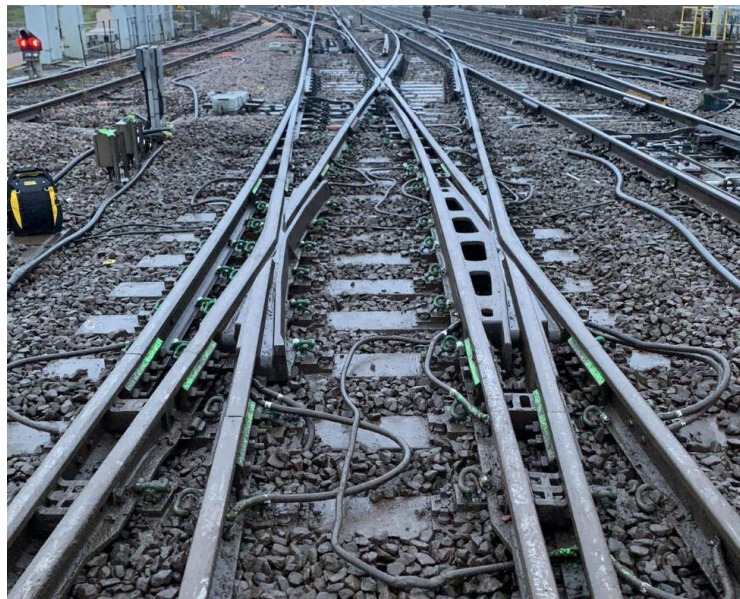
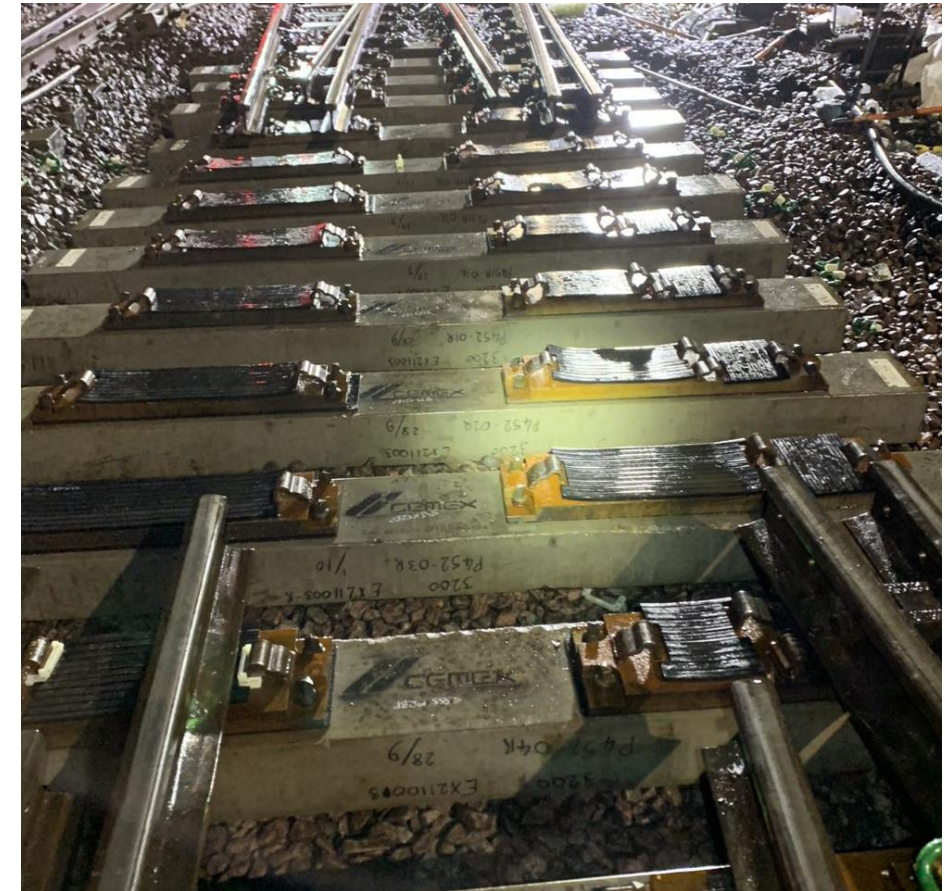
Trial site photos from Eastleigh 465 SD

Installation over Christmas period successful

Trial and implement use of NR60 equivalent bearers as an alternative design at failed sites
