# TRAETH MAWR (BIG SANDS) TIMBER TRESTLE RAILWAY VIADUCT REFURBISHMENT

**F**urther to presentations given to PWI Section meetings at Cheshire & North Wales plus Manchester & Liverpool, this article has been prepared to share an interesting project delivered in 2021.

The Dovey Junction to Pwllheli railway crosses the River Glaslyn over Traeth Mawr just outside Porthmadog. The structure was built before the opening of the railway in 1867 and was originally 40-plus spans, but was significantly altered over the years to its present day 16 spans. (**Figure 1**).

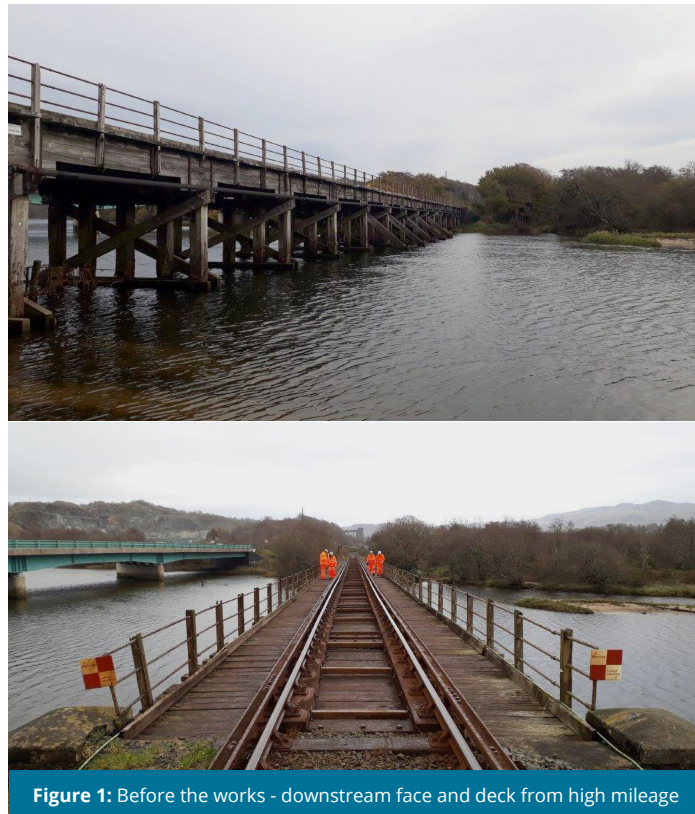
**Figure 1:** Before the works - downstream face and deck from high mileage

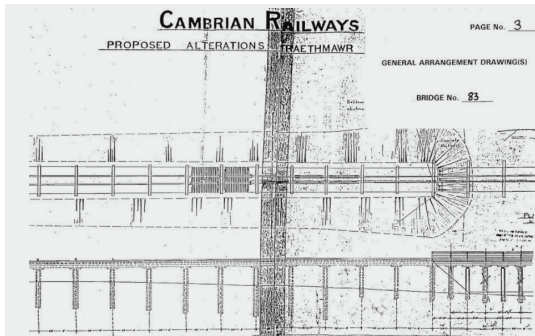
The structure was 40 plus spans originally and then rebuilt around 1914 to 21 spans, with the embankments/abutments brought forward and spans reduced and then modified again to its current 16 spans. The structure was rebuilt by installing intermediate trestles at mid-span, and the original piles are still on site and in remarkable condition. (**Figure 2**).

Figure 2: Original piles – Archive drawing showing reconstruction, with photo of intermediate trestles, embankment extension and original pile stumps

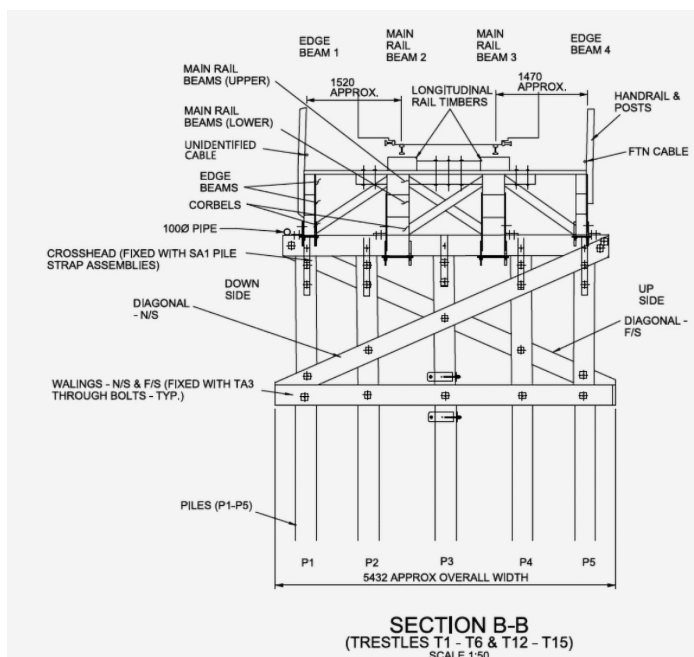
Figure 5: Trestle section, element descriptions

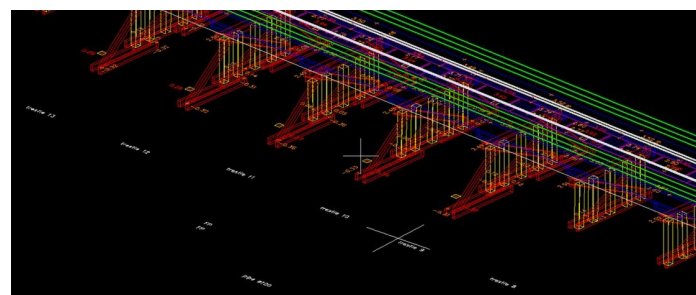
Figure 8: Wireframe model extracted from pointcloud

The structure was surveyed using pointcloud scanning techniques and a wireframe 3D model extracted from the pointcloud as detailed in the extract in Figure 8.

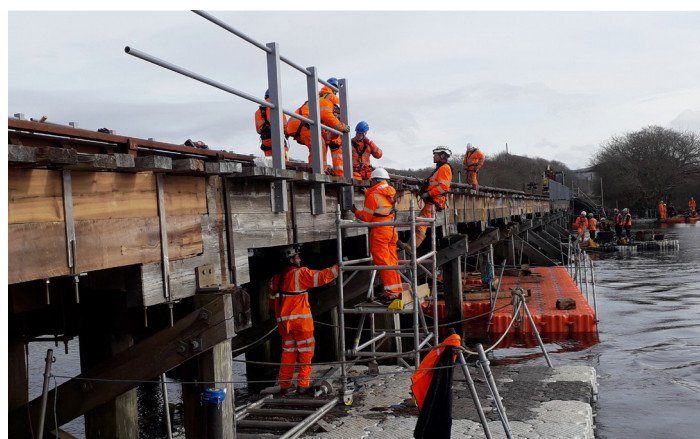
Access to the structure from the water was enabled with the use of scaffold on pontoons, barge platforms and boats and the extensive use of divers (**Figure 11**).

Figure 11: Staff working from cellular pontoons and tethered with safety lines

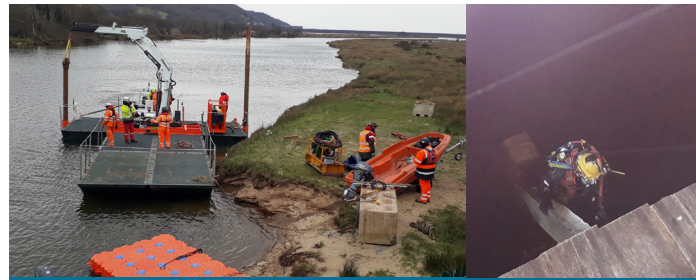
Figure 15: Barge and pontoons. Diver navigating a trestle outrigger

water was around 5°C so divers would get cold quickly even with warm air being pumped into the suits. Divers used specialist underwater tools for cutting and drilling wood and metal (**Figure 15**).

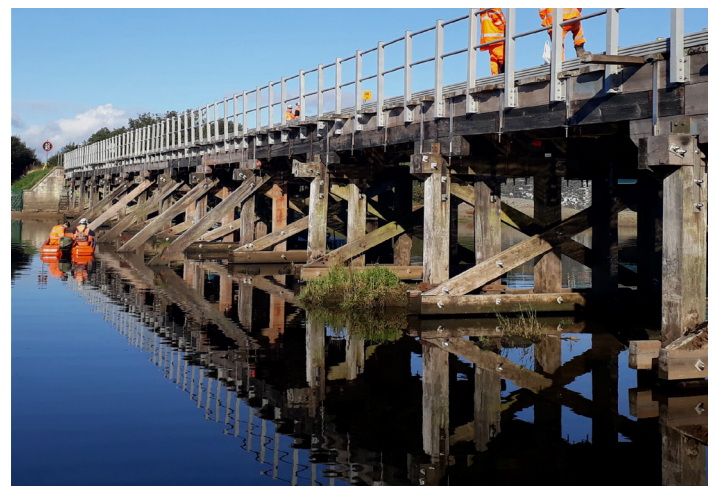
Figure 16: The finished product in September 2021 in sublime conditions
