# Rail Management Hot Topics and Developments

## Brian Whitney – Engineering Expert Track & S&C

### PWI West of England Section

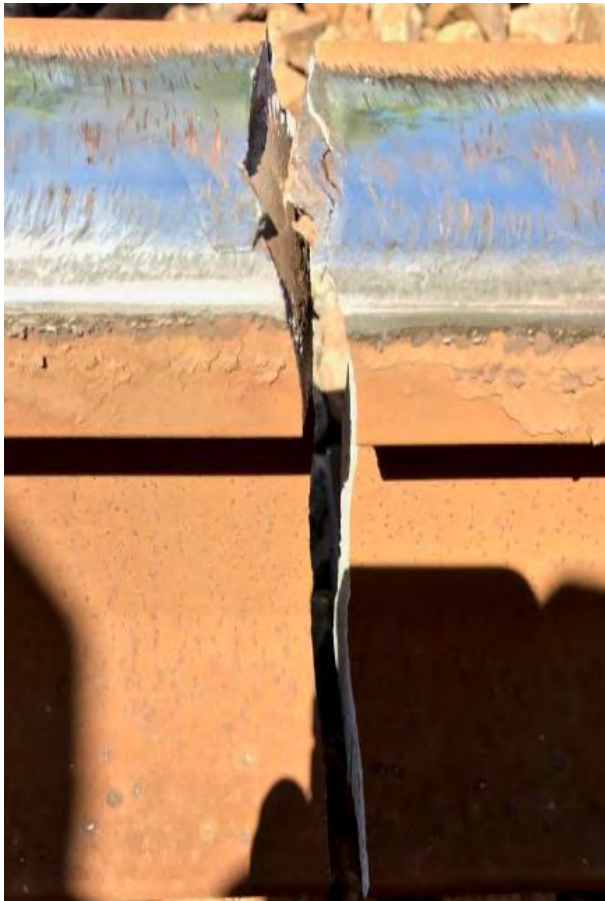
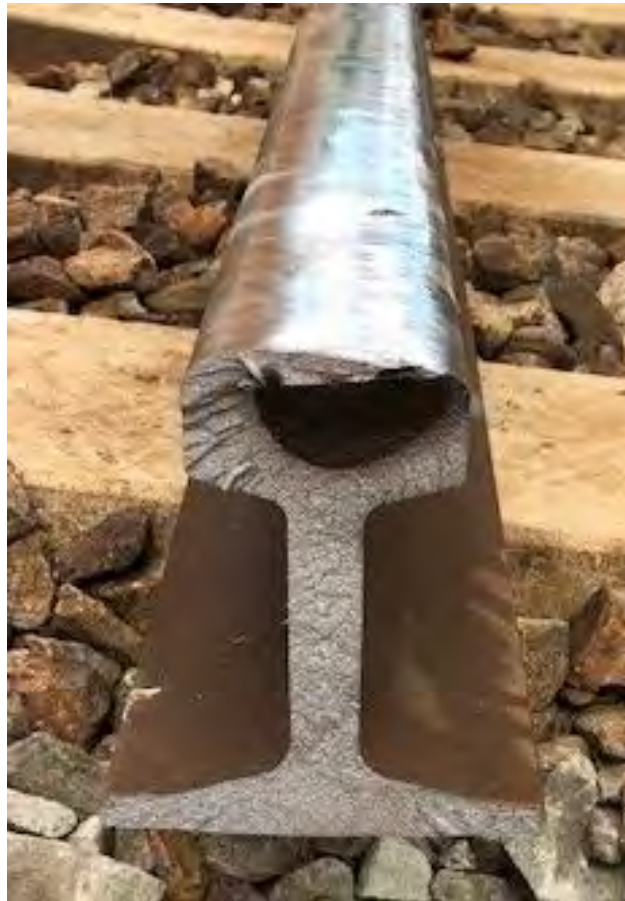
## Broken Rail, RCF, 12th May 2020, VTB2, 1100, 19m 1078yds

At 0635, DP track circuit failed on the Up Quarry Line, between Redhill Tunnel and Quarry Tunnel, fortunately only a single break.

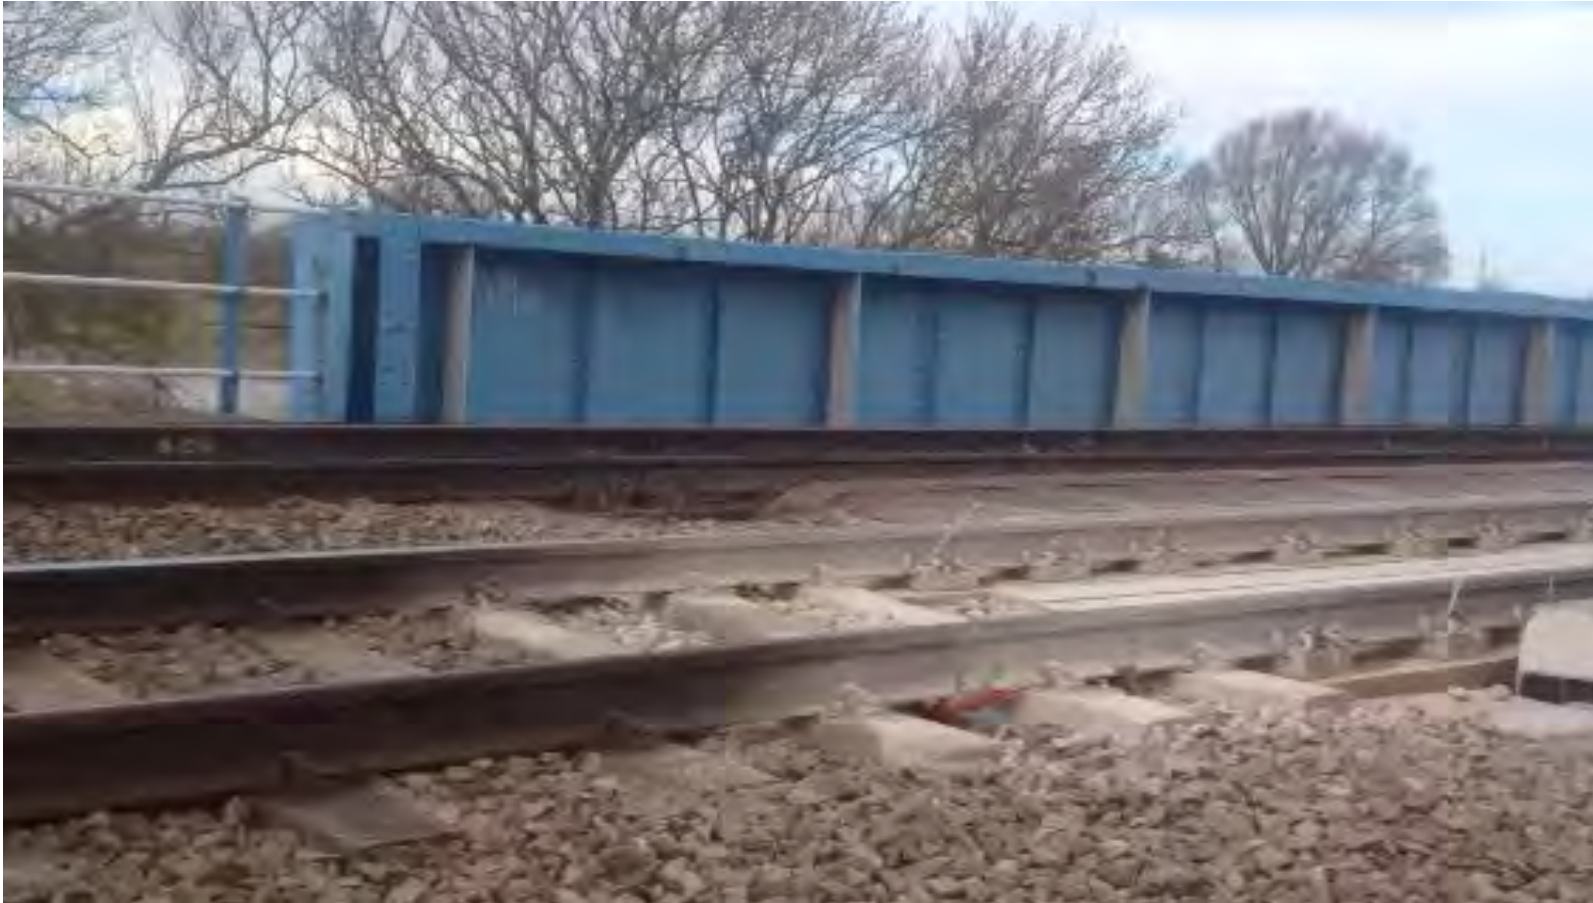
# *Rail Foot Failures Account For Around 50% Of Annual Breaks*

There has been a previous rail break at this location and the majority of rail breaks in the rail foot are caused by poor support conditions

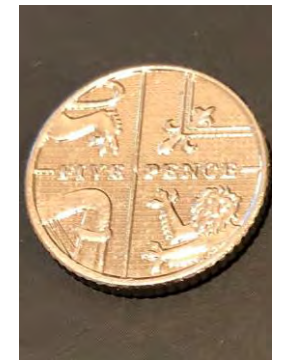
High contact stresses and an aggressive environment.

Static wheel loads from 60 to 125 kN on a small contact patch (5 pence)

125kN on 250mm<sup>2</sup> is around 500N/mm<sup>2</sup> without any lateral or longitudinal forces or the dynamic effects of the wheel in motion due to track and wheel irregularities

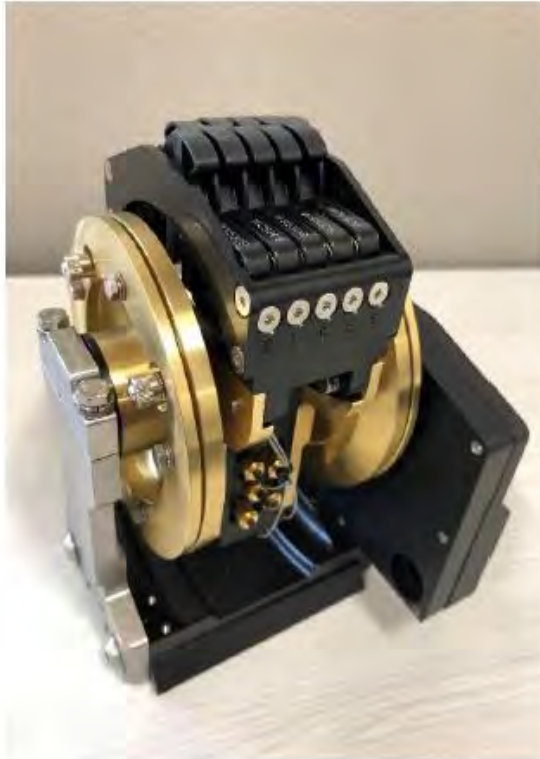
# Surface Crack RSU

10 probes providing full  
coverage across rail head

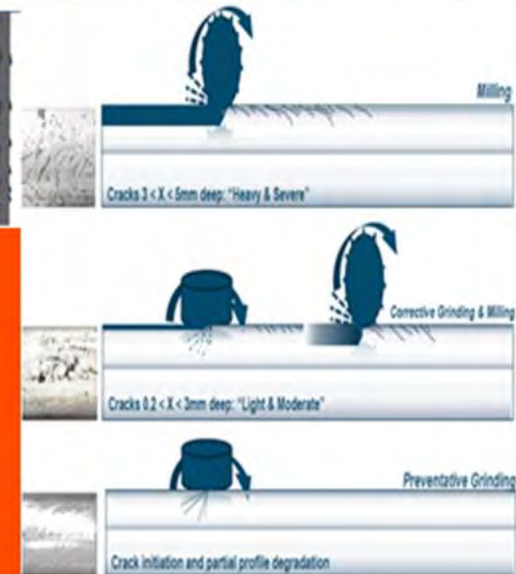
### Rail Milling Profile Management

- ▶ Two Contracts agreed,
  - Schweerbau HSM 3 year service starting 07-2018
  - Linsinger Duplex procurement delivery March 2021
- ▶ Delivering rail re-profiling & defect removal = increased rail life

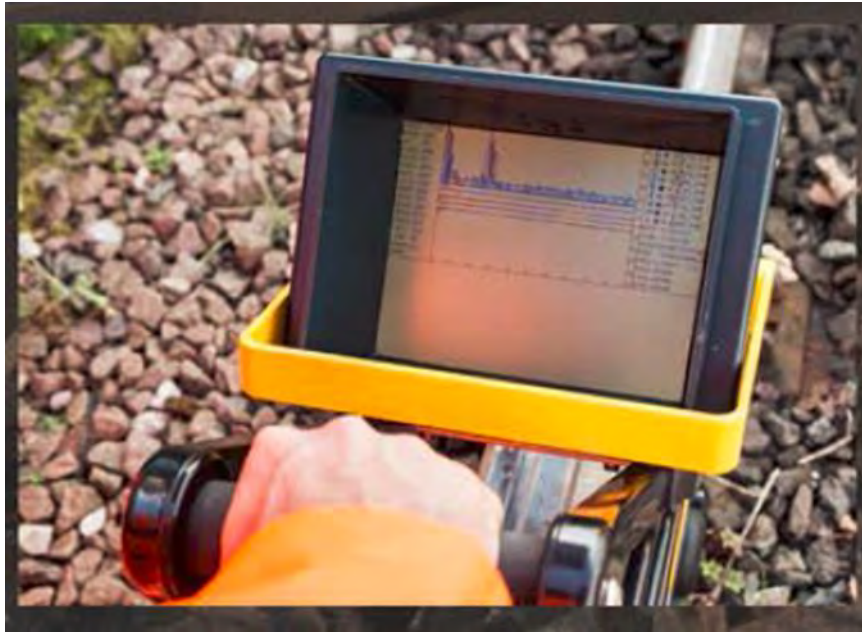
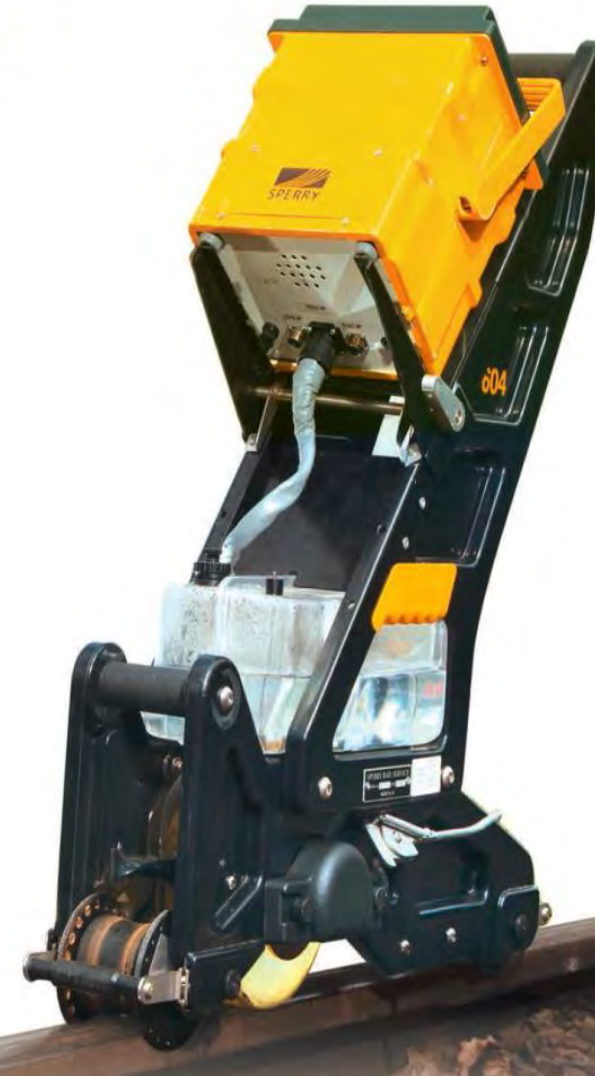
## Sperry B Scan Flaw Detector

- Upgrade of existing equipment using original frame and roller search unit
- Output mirrors B Scan output from UTUs
- Can be used in A Scan mode replicating the current equipment
- B Scan equipment provides full recording of all test data
- Reduced weight as no additional flaw detector required
- Can be used with range of hand probes
- Increased battery life
- Built in GPS and encoders for accurate location
- Menu driven screen for more accurate in built defect reporting

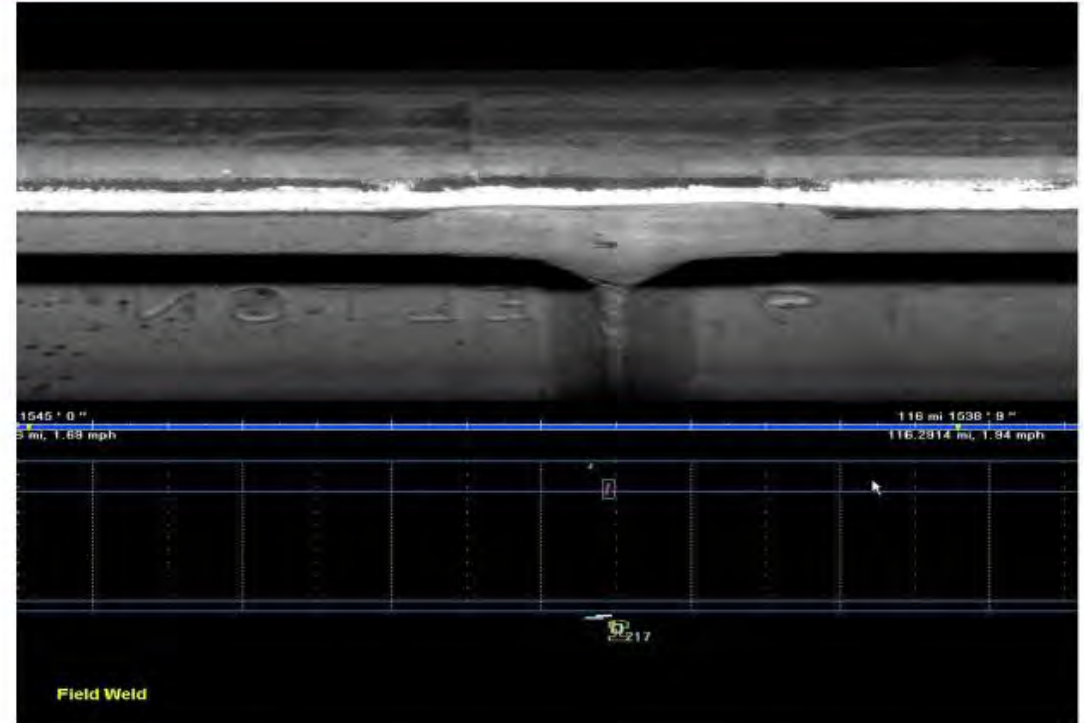
Vision Hardware

Vision image is accessible to analyst  
from BScan

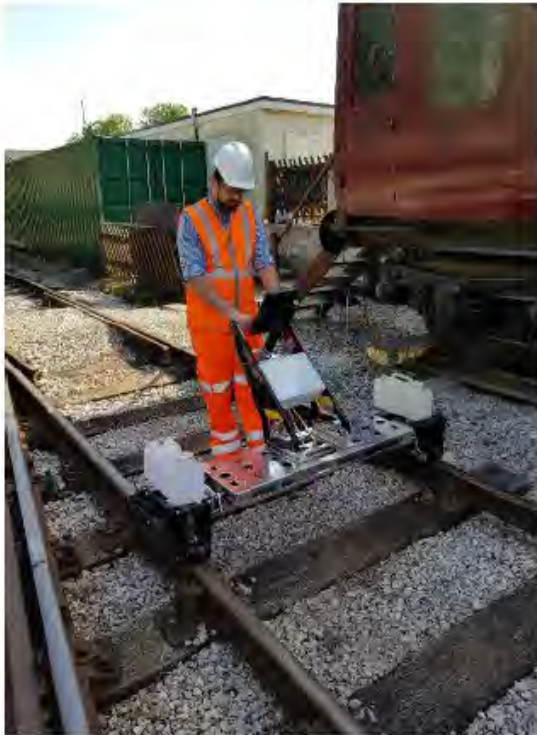
# BScan Lite Dual Rail Inspection System DRIS

- 2 x UX9 RSU (Inspects Both Rails in One Pass)
- Light Weight Design Construction (Total = 47 kg)
- A Scan and B Scan Display Modes (Tablet)
- B-Scan Lite H/W and S/W Compatibility (Limited Operator Training Transfer from B-Scan Lite W.Stick)
- Offers Real-time and Offline Data Analysis
- Two Supply Configurations (Complete System or Mech and Elect + 2 x Existing NR W.Stick RSU)

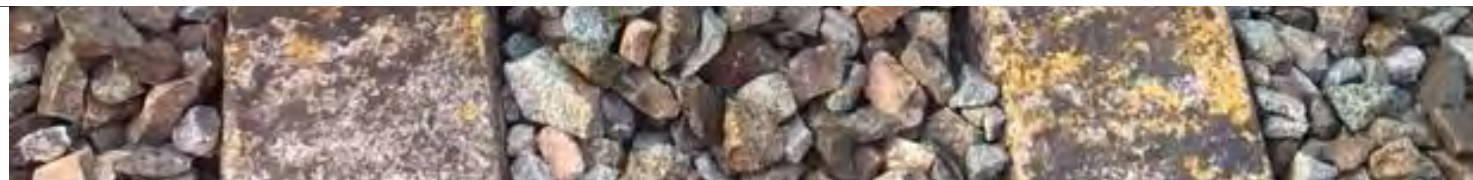
Confirmed during verification as a 1B defect – 20mph ESR, remove within 7 days

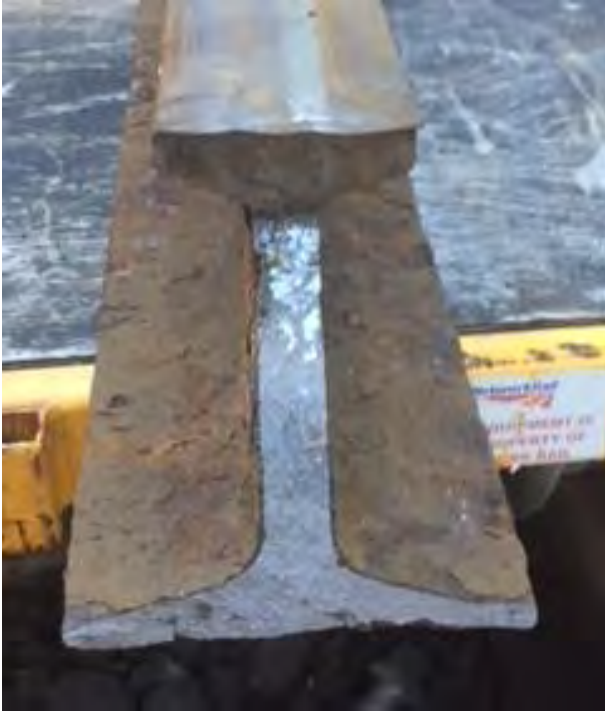
## Combinations of Defects – Increased Risk

Known wet spot in tunnel

- Significant head and foot loss due to corrosion (rail depth recorded as 143 to 146mm, loss of around 15mm compared to a new rail, below minimum rail depth)
- Significant dip angle in plain line present for a long time (repeated dip angle in plain line 27 mrad repeated 36 times) voiding / localised head loss? Fatigue
- 1989 113A R220 rail – no coating
- 90 mph, Track Cat 2, EMGTPA
- 2 sections identified with significant reduction in rail depth / localised head loss
- Dispensation timescales, risks and mitigation?
- Consider other factors when assigning MACs and determining action timescales – dynamic loading from dip, poor support conditions, rail strength

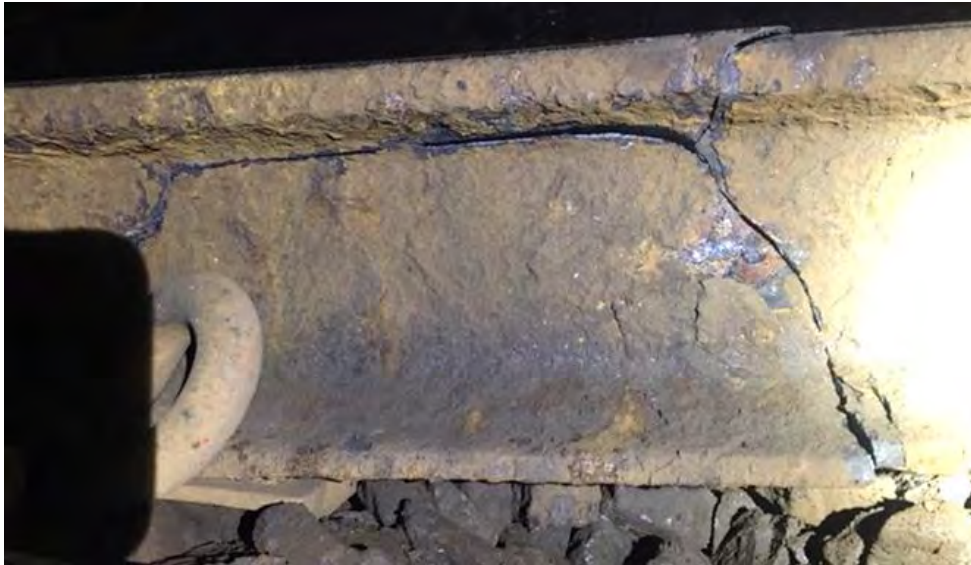
# Combinations of Defects – Increased Risk

- Identified as a cracked rail by PLPR inspection 2<sup>nd</sup> September 2018
- Rail has fractured up from the rail foot and propagated along the top of the web for approximately 300mm with a significant risk of a section of the rail head breaking out
- Minimum rail depth exceeded at one location and entered into RDMS as a 3L (52 week defect), original removal date May 2017 dispensed until May 2019

Minimum rail depth reached and rail entered into RDMS in May 2018 as a three year defect due May 2021.

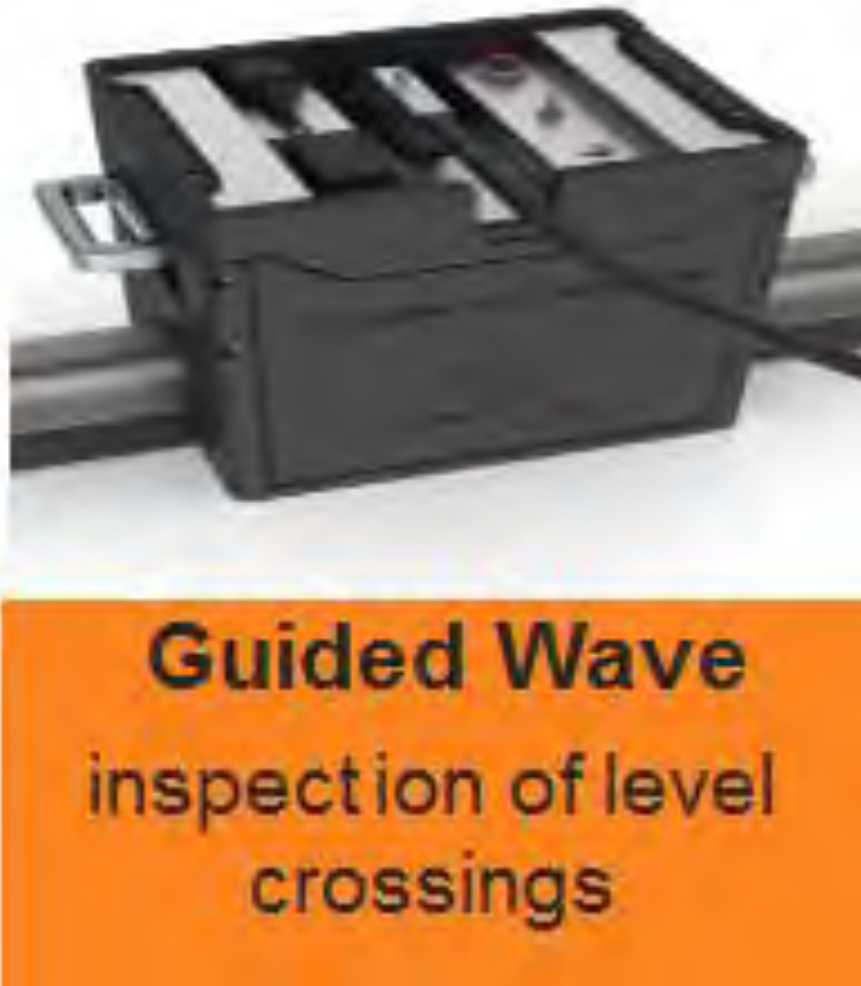
## Guided Wave Ultrasonics - G – Scan Mk 2

Second generation longitudinal wave ultrasonic equipment now being trialled on LNE to screen level crossings for corrosion and potential loss of rail section.

System using a longitudinal wave and mode transformation caused by any loss of rail section anywhere in the rail rather than conventional ultrasonics which works based on a reflected signal from a specific defect or surface.

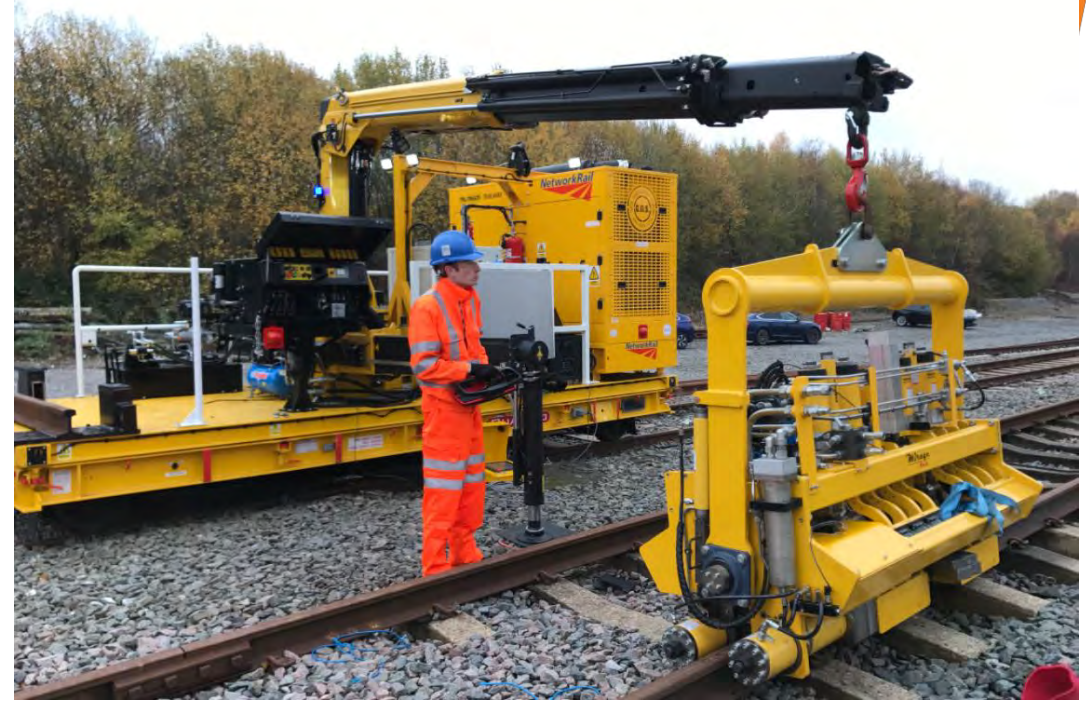
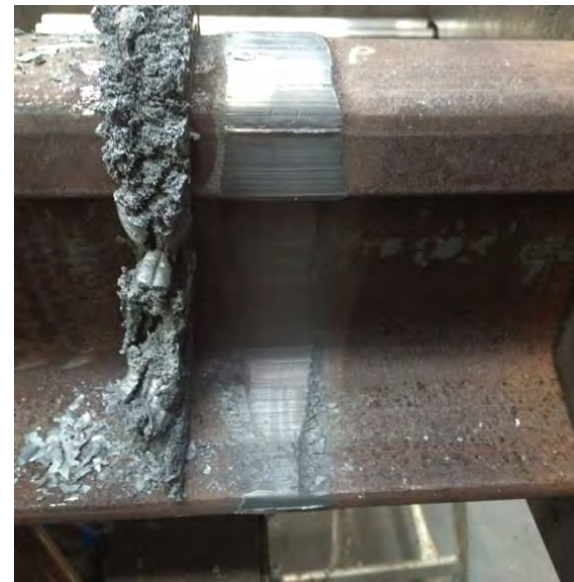
## Induction Welding

Weld is then allowed to cool and finished by profile grinding around the head of the rail.

Grinding carried out to achieve the high degree of accuracy (+0.4 / -0.0 mm) flatness across the weld.

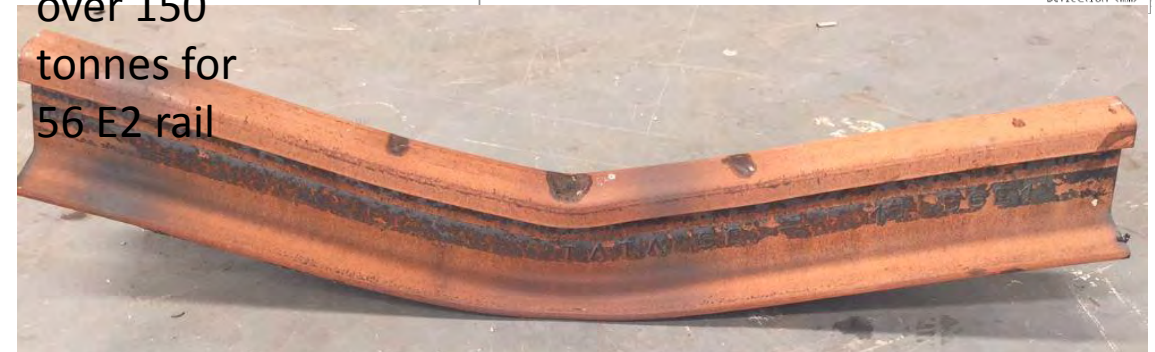
Bend tests indicate a weld strength over 150 tonnes for 56 E2 rail

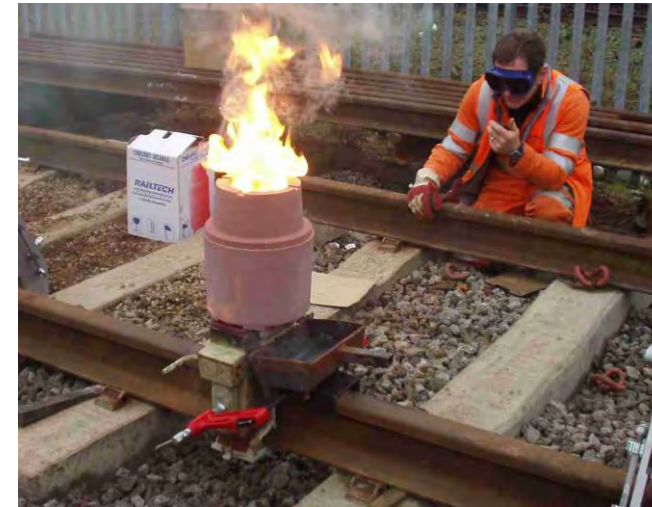
Now very reliable with failure rates of around 1 in 50,000

Typical weld time around 2 hours plus finishing time

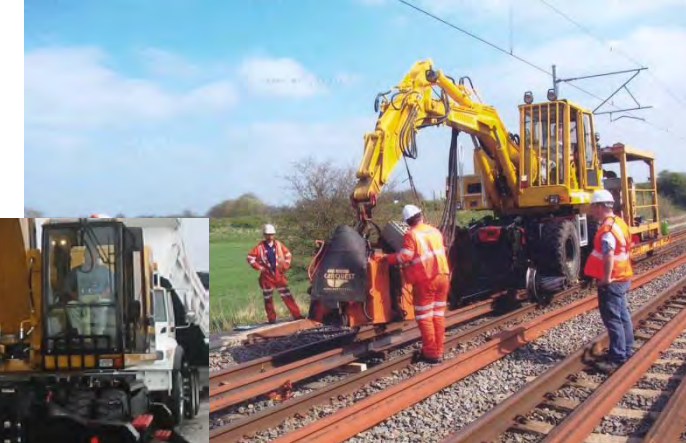
Very reliable with failure rates of around 1 in 100,000

Flash butt welding consumes a length of rail during forging

Typical weld time around 8 minutes plus finishing time
