## **Permanent Way Institution Ashford**

**Eur Ing John Dolan FICE FCILT FPWI**

# Infrastructure Asset Management

- Get it right
- Get it wrong

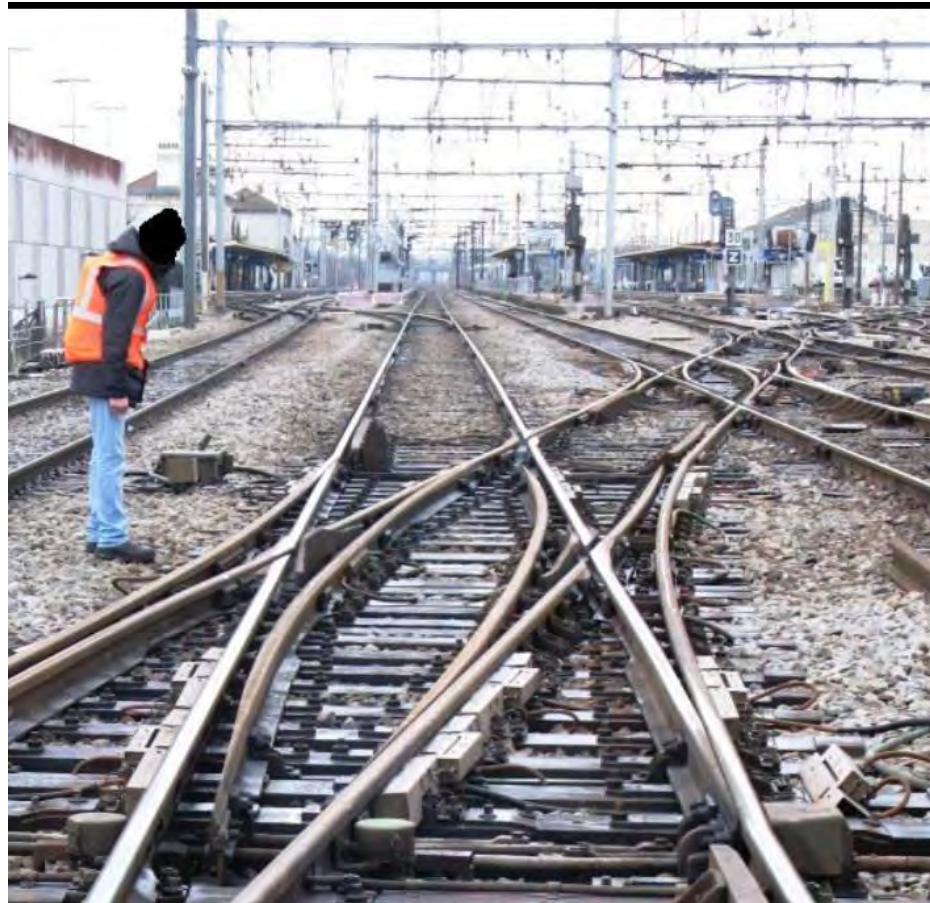
# Not just here – SNCF (2)

Photo from BEA-TT Accident Report

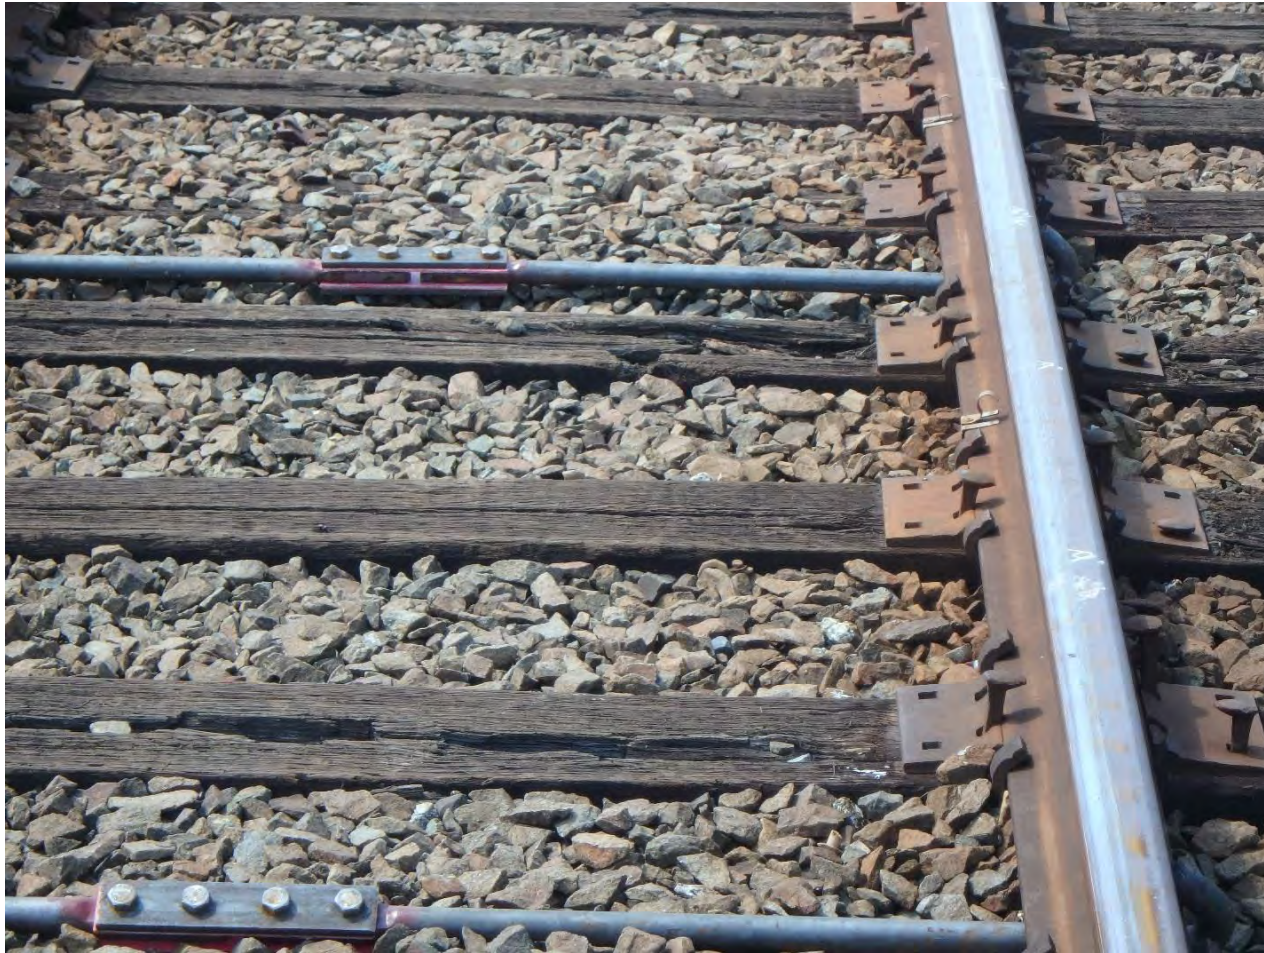
# Washington DC (3)

Photo from NTSB Accident Report

- Derailment due to wide gauge 29 July 2016
  - Gauge  $1\frac{3}{4}$ " above immediate action limit
  - 16 of 18 bearers defective in turnout
  - 400" (10m) of rail unrestrained by fastenings
  - Inspection required twice weekly
  - Inspected monthly
- 16,828 outstanding track defects on system
- Gauge ties in photo added after derailment

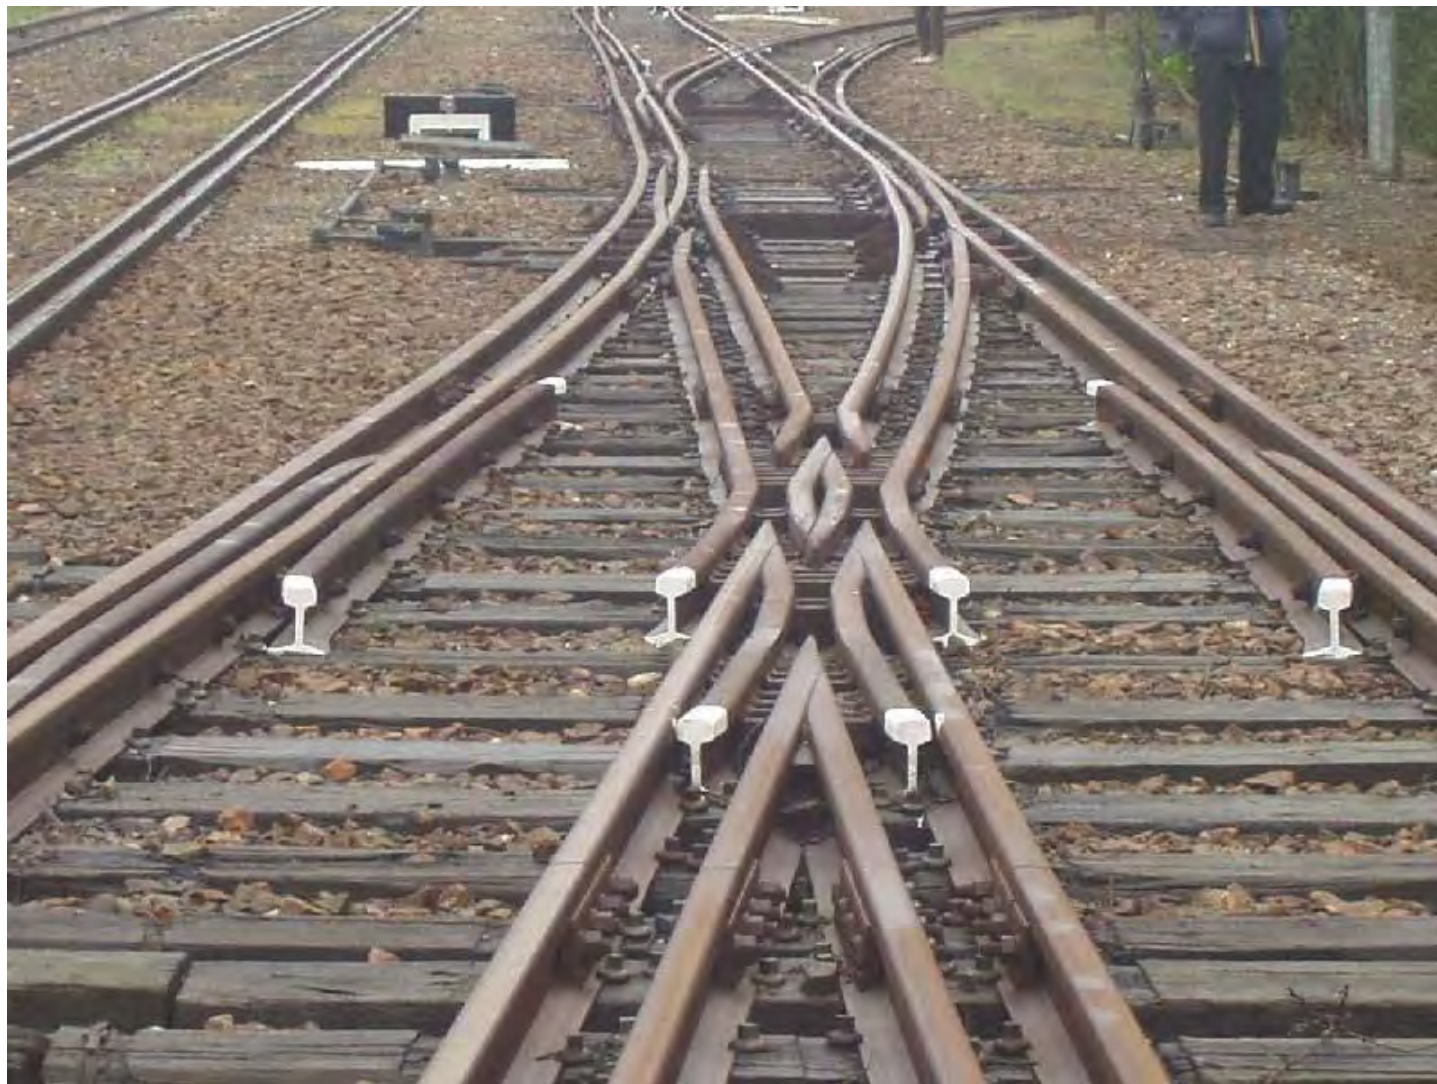
This was the Maidstone East derailment, 1993

## What's going on here ... and why?
