# PANThealth

Keep the trains on track

# Hardware

# Root Cause Analysis: Pantograph and Catenary Wear Progression

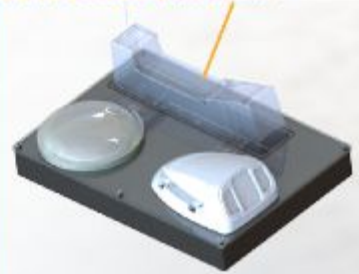
**PANTObase and laser**

A case installed on the train's roof include camera, antenna and laser(optional) .

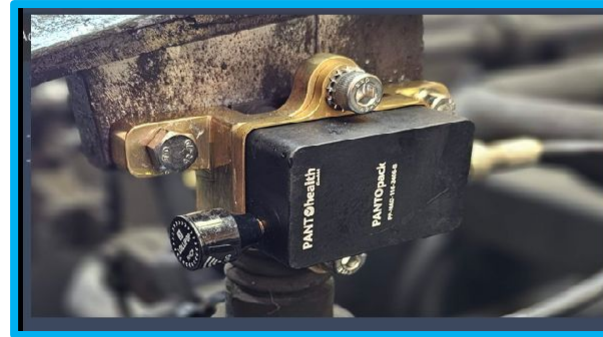
Accelerometer

# Sensor implementation and data acquisition for overhead lines

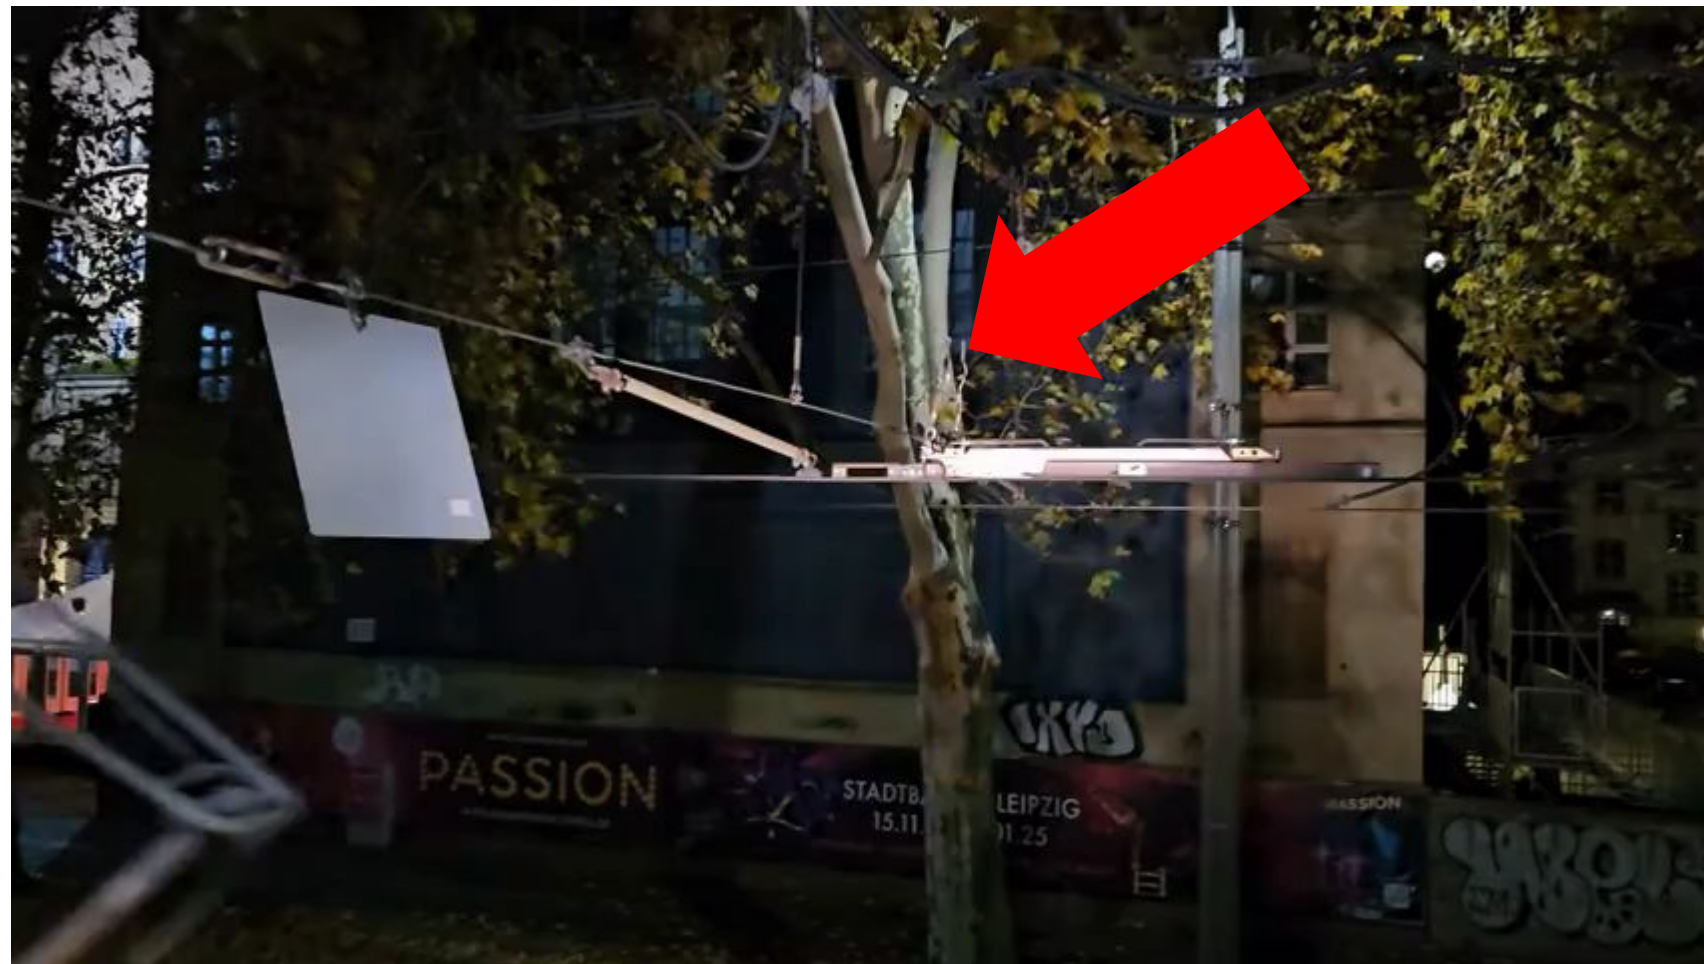
## 1. Miss adjusted section insulator 1

A misadjusted section insulator was identified as a **recurring source of mechanical shock** to every passing pantograph.

Vibration-based signal analysis revealed consistent anomalies at the same location.

Visual footage supported the analysis, showing **consistent sparking as pantographs crossed the insulator**.

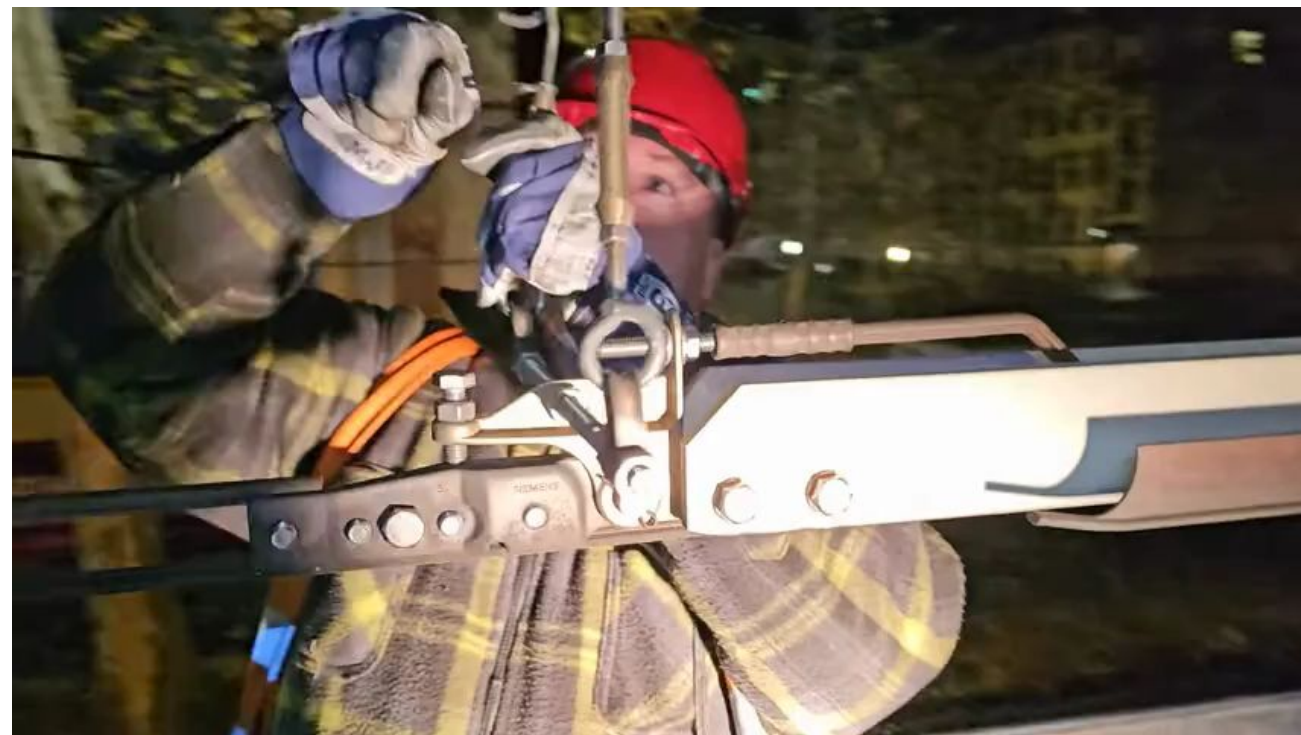
## Effect of a simple adjustment

Following a targeted field inspection, the reason was traced to a **simple cable misalignment**. The adjustment required less than two minutes of manual intervention.

Subsequent monitoring showed a marked **improvement in signal stability**, highlighting the value of real-time abnormality detection and prioritization in preventing progressive damage to the pantograph and catenary infrastructure.

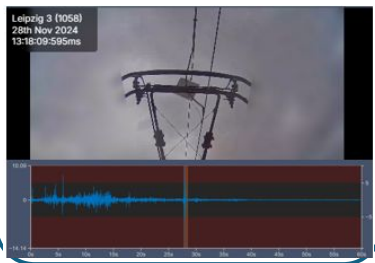
PANTOhealth  
vibration-based  
monitoring

**Step 1:** Hard point or irregularity in line

• **How to detect:**  
vibration-based monitoring
