# S&C Asset Management

S&C -Route Asset management and scoping perspectives

# Transforming How We Inspect, Maintain, and Operate the Railway

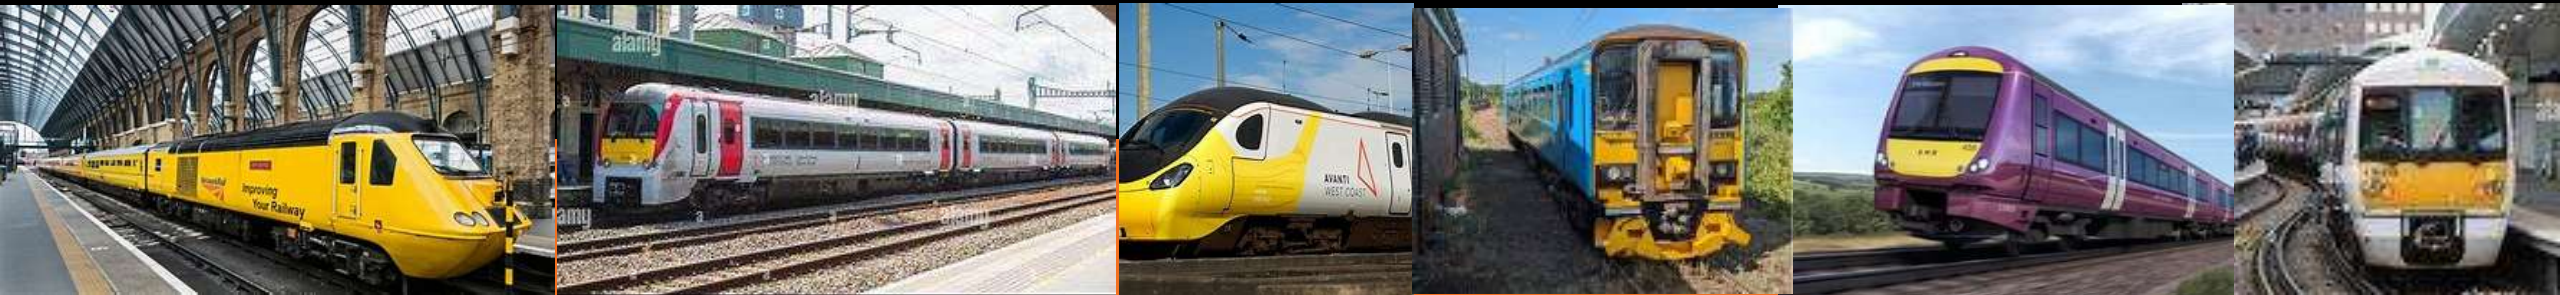
### **Downwards Facing Cameras**

- Basic Visual Inspection of plain line track, S&Cs, obsolete fastenings, Pre79 rails
- Supervisor's Visual Inspections
- Seasonal inspection of IBJs, adjustment switches
- UTU suspect verification
- Effectiveness of Lubrication
- Rail head contamination
- Broken/cracked rail detection

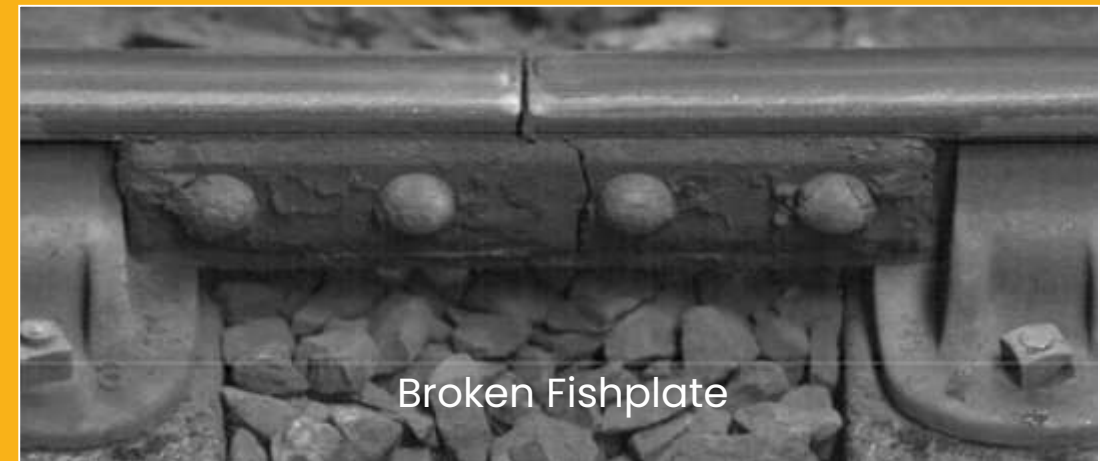
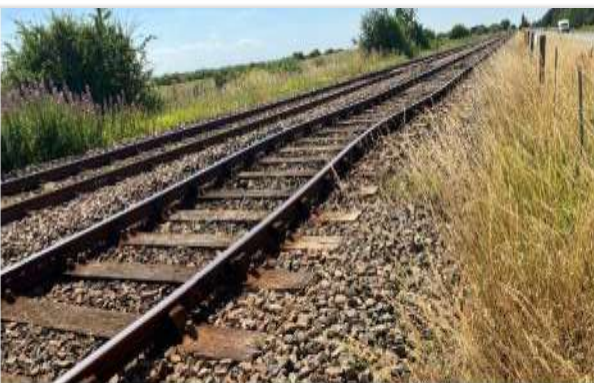
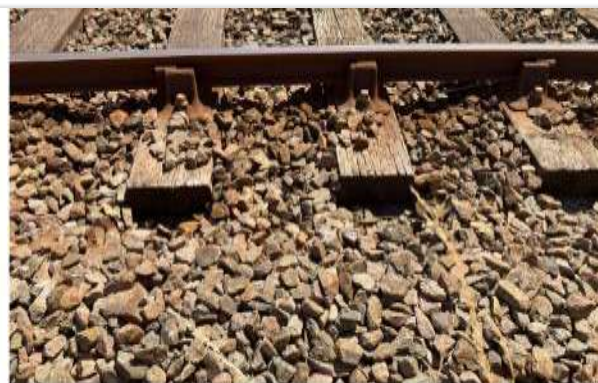
# AI Benefits – Hot Weather & Rail Defect Detection

- AI developed by Eastern and its suppliers has delivered strong hot-weather performance for the past three years – outperforming all other regions except Scotland, which experienced no extreme temperatures.
- AI developed by Eastern and its suppliers has identified more than 70 broken fishplates and broken rails nationally.

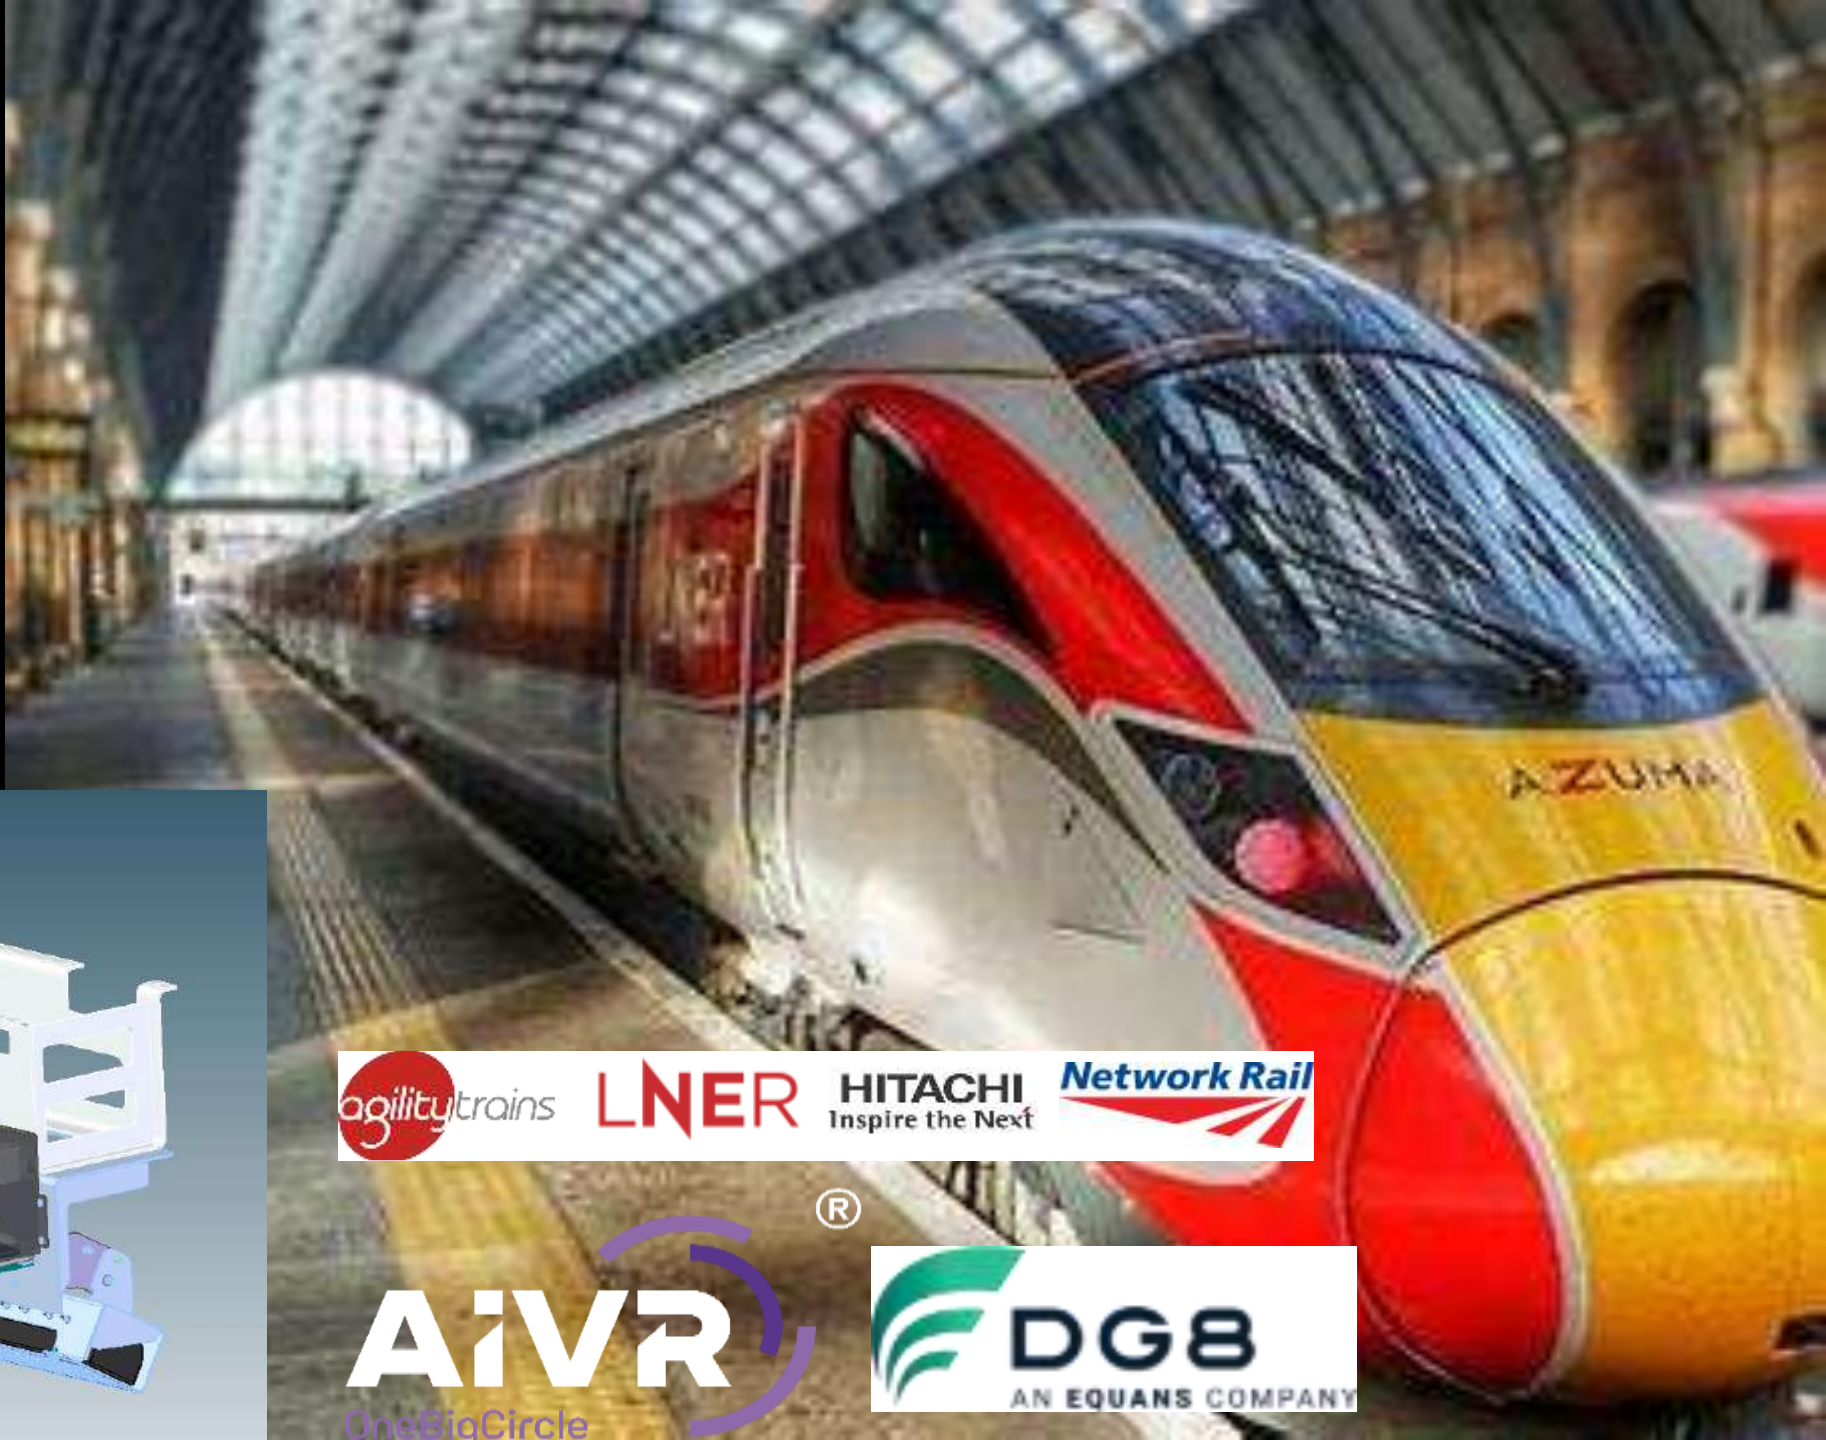
## In-Service Trains – AIVR & UGMS Deployment

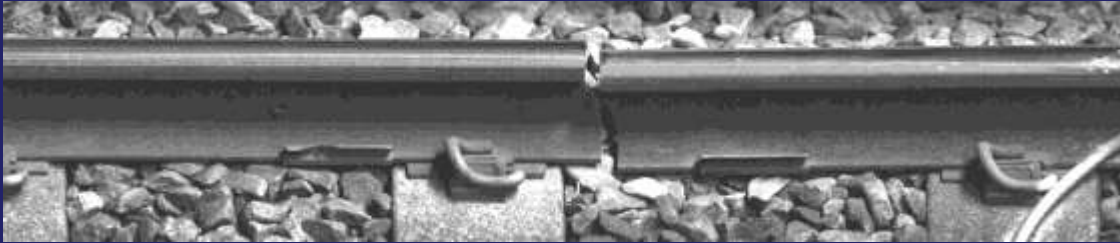
## Hambleton South Broken Rail 15/02/2026

**Recorded by the LNER 800 110 at 123mph**

Vertical acceleration data from Class 800 trains showed the rail broke between:

- 20:11 13/02/26 **1.8g** and
- 06:31 14/02/26 **3.8g**

**Example acceleration dashboard**
